Report Number 301-75-DYS-78-023

FMVSS 301-75 STANDARDS ENFORCEMENT TESTING  
OF FUEL SYSTEM INTEGRITY

Chrysler Corporation  
1978 Plymouth Horizon Four-Door Hatchback  
NHTSA 780311

FINAL REPORT

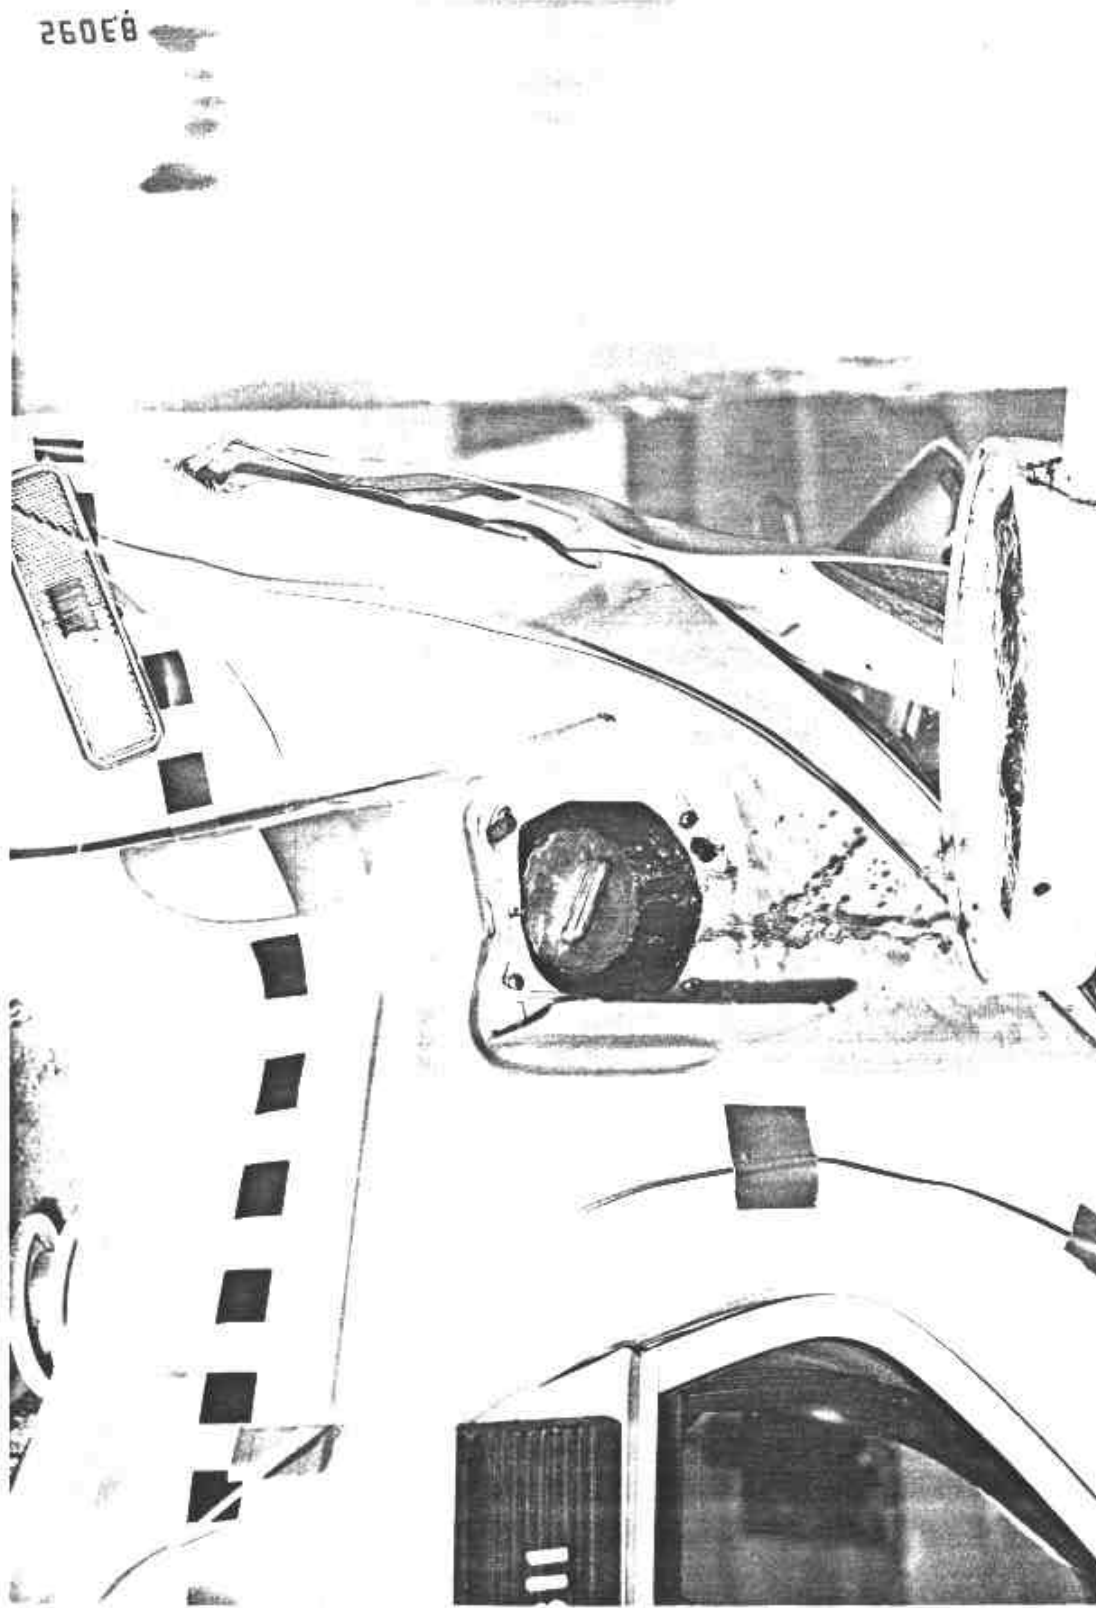
When rolling from 90° to 180°, profuse leakage began from the filler cap (see Figure 2-1). Leakage of 158.7 oz was measured during the first five minutes of this period. Since this rate exceeds the 5 oz allowed by the standard, the vehicle appears to be in noncompliance with the standard. The foregoing data is illustrated graphically in Figure 2-2.

Figure 2-1. Post-test Close-up View of Filler Cap Leakage During Static Rollover - 1978 Plymouth Horizon Four-Door Hatchback - NHTSA 780311.

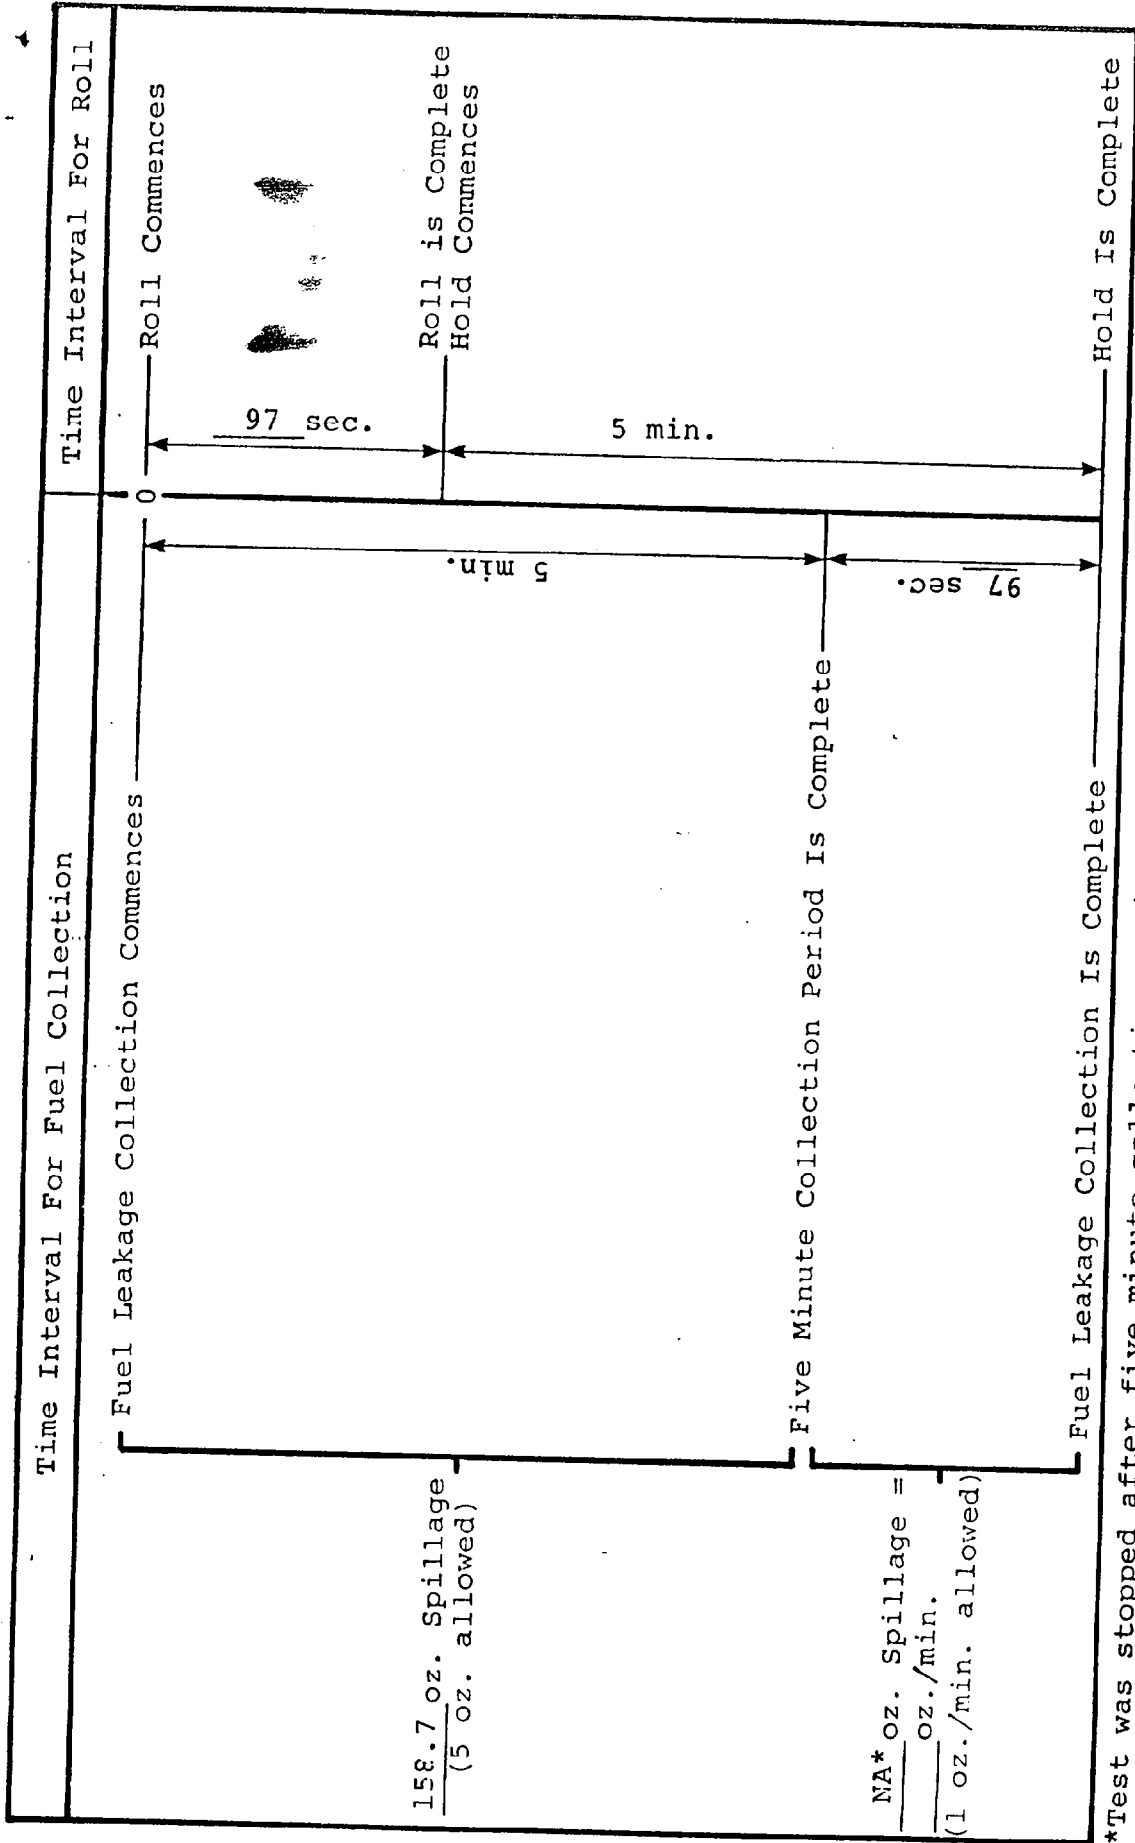
\*Test was stopped after five minute collection period, due to massive leakage.

Figure 2-2. Time Relationship Between Fuel Collection Period and 90° to 180° Static Roll Period - 1978 Plymouth Horizon Four-Door Hatchback, NHTSA 780311.

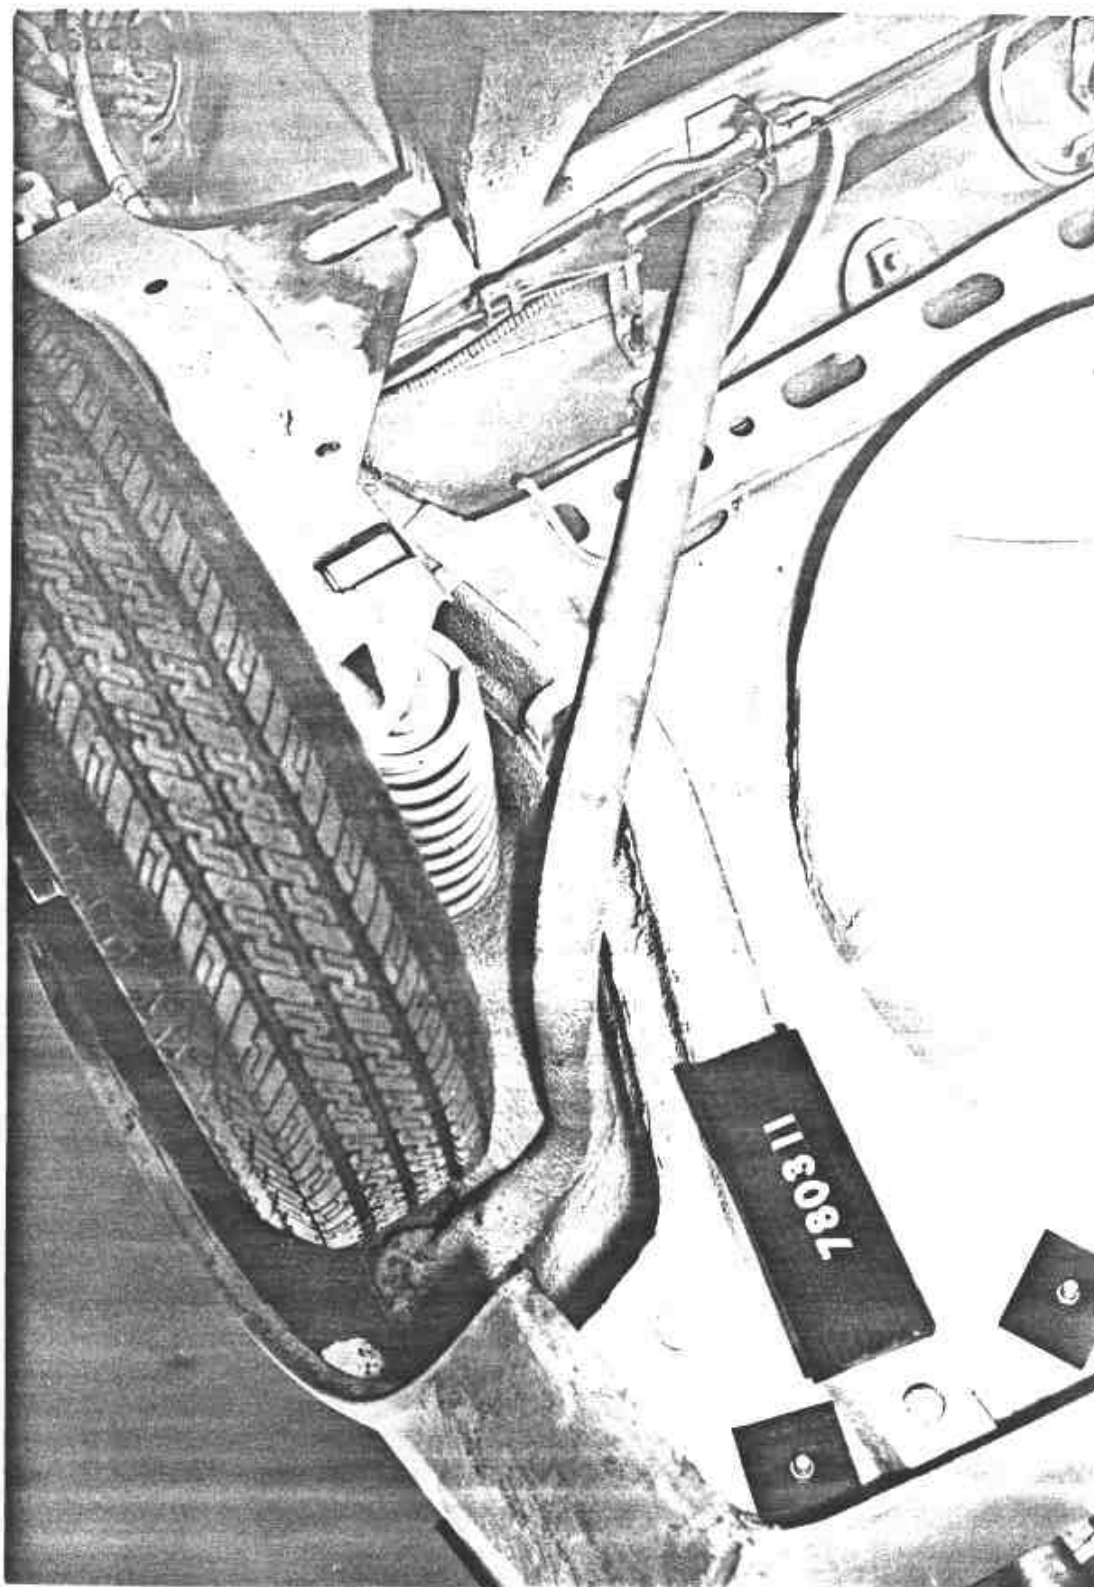
The filler cap was later removed for examination and showed no obvious damage. The high-speed film was reviewed and it was noted that the tire well bore directly against the filler tube (see Figures 2-3 and 2-4) during impact. The filler tube was brushed forward during this contact and the seating of the filler cap may have been affected by this action.

Figure 2-3. Overall View of Filler Tube - 1978 Plymouth Horizon Four-Door Hatchback - NHTSA 780311.

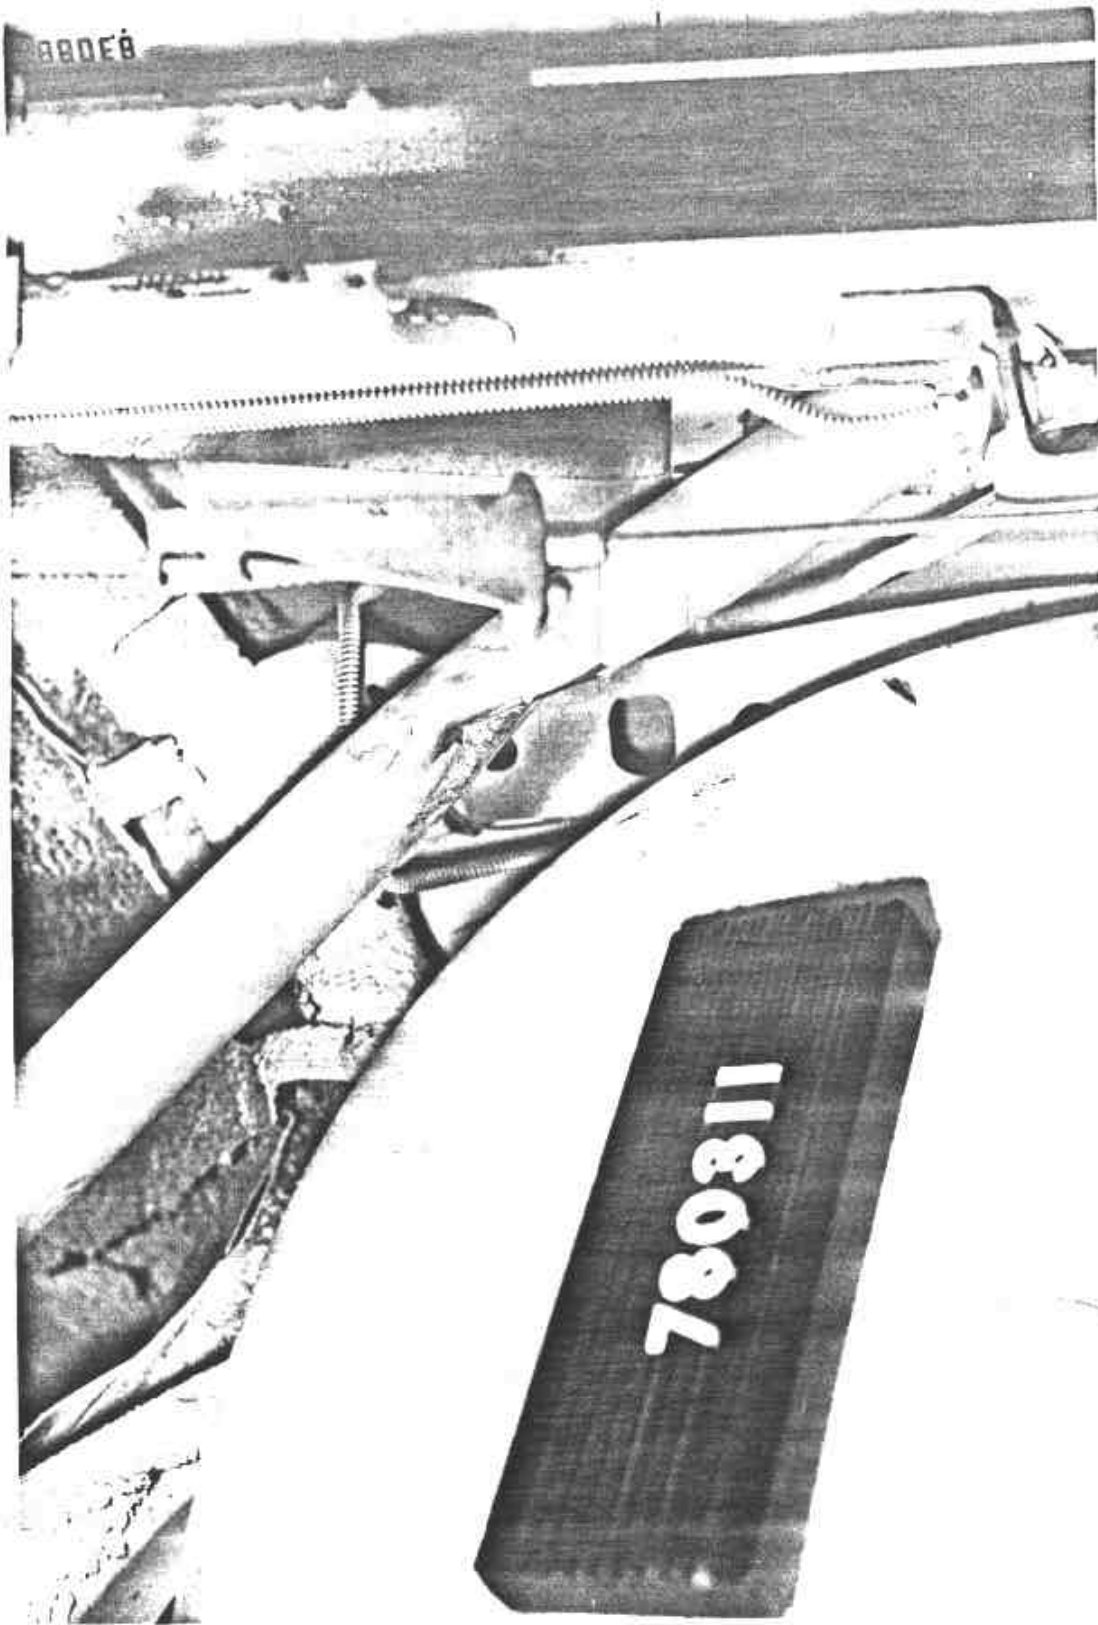
Figure 2-4. Post-test Close-up of Damage to Filler Tube - 1978 Plymouth Horizon Four-Door Hatchback - NHTSA 780311.

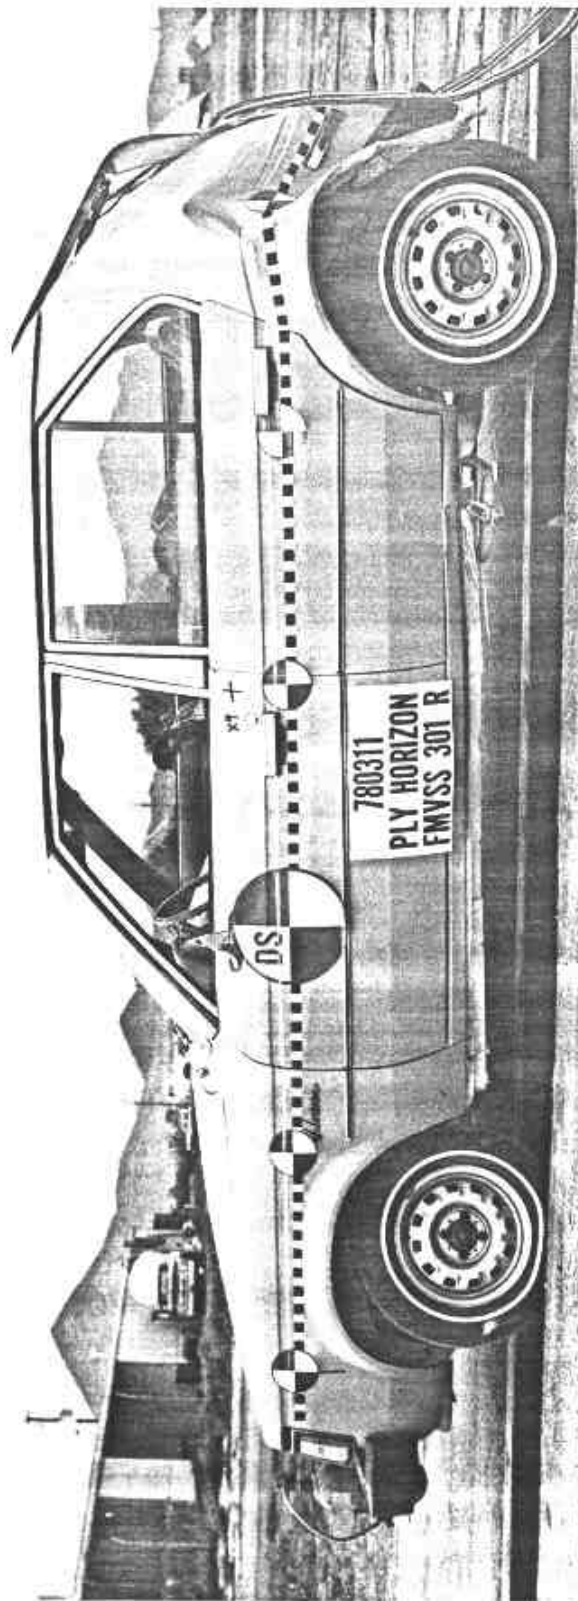
OTHER NOTABLE IMPACT EFFECTS: Both rear fenders locked up the rear wheels.

Body buckled up to front of rear wheels.

Figure 4-2. Post-test Side View - 1978 Plymouth Horizon Four-Door Hatchback - NHTSA 780311.

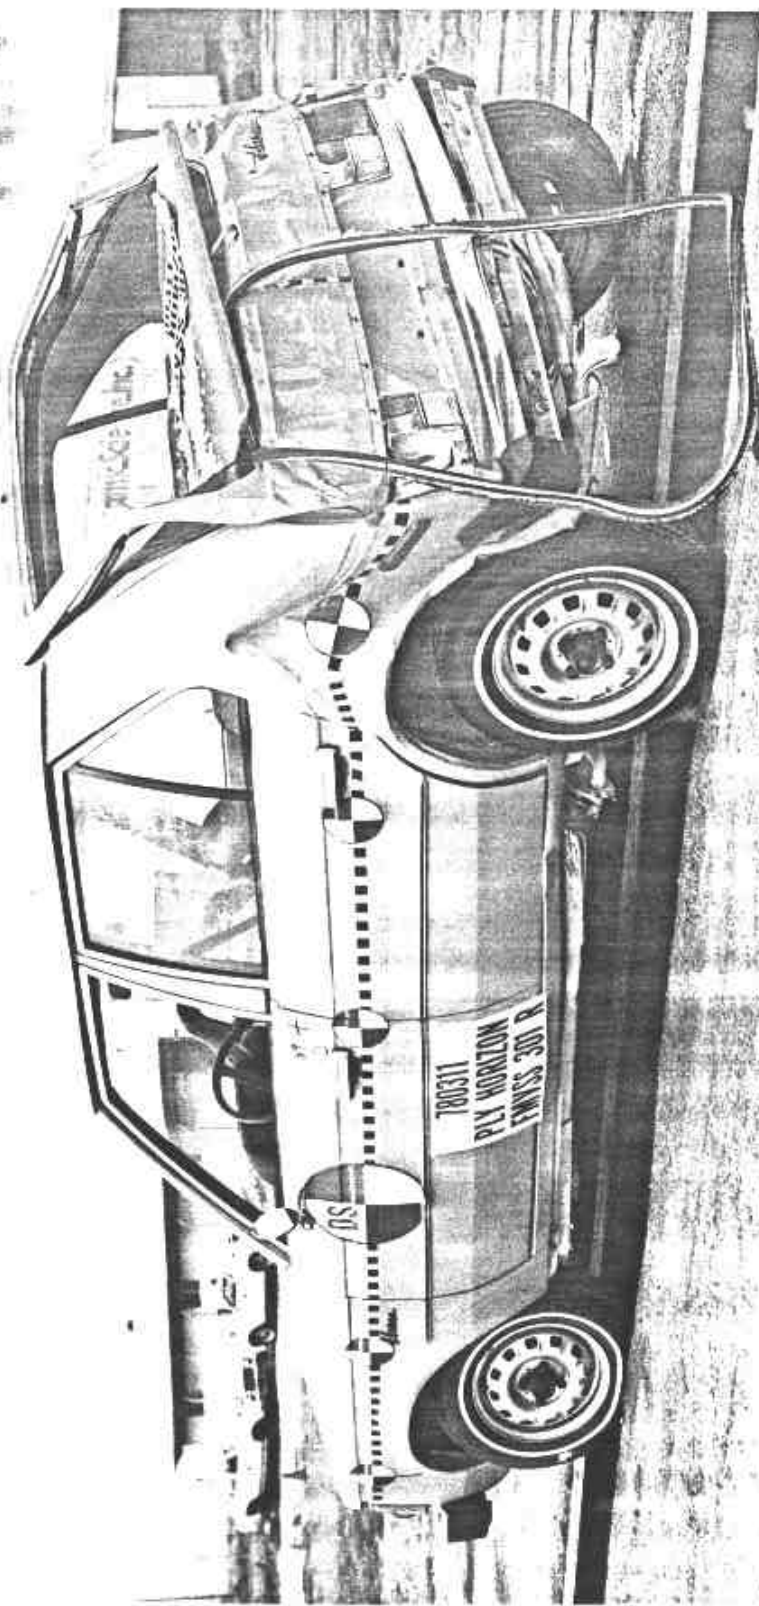
Right rear bumper absorber leaked hydraulic fluid.

Figure 4-4. Post-test Rear View - 1978 Plymouth Horizon Four-Door Hatchback - NHTSA 780311.

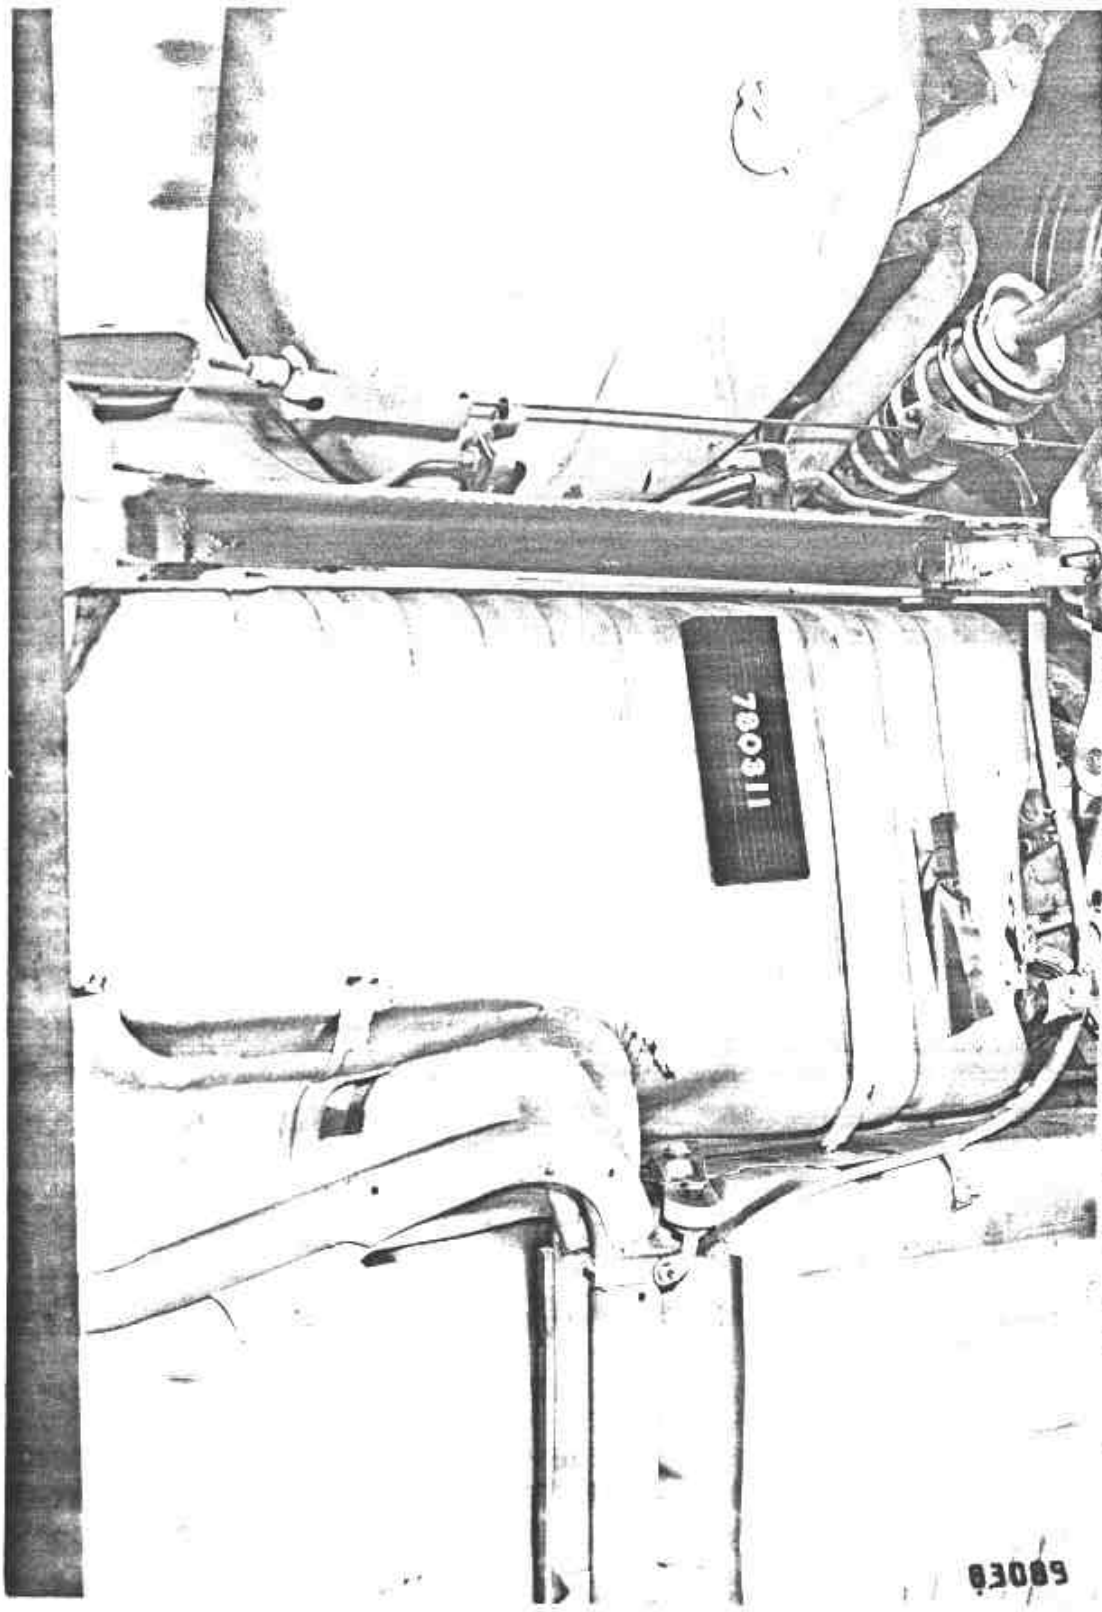
Figure 4-6. Post-test View of Fuel Tank - 1978 Plymouth Horizon Four-Door Hatchback - NHTSA 780311.

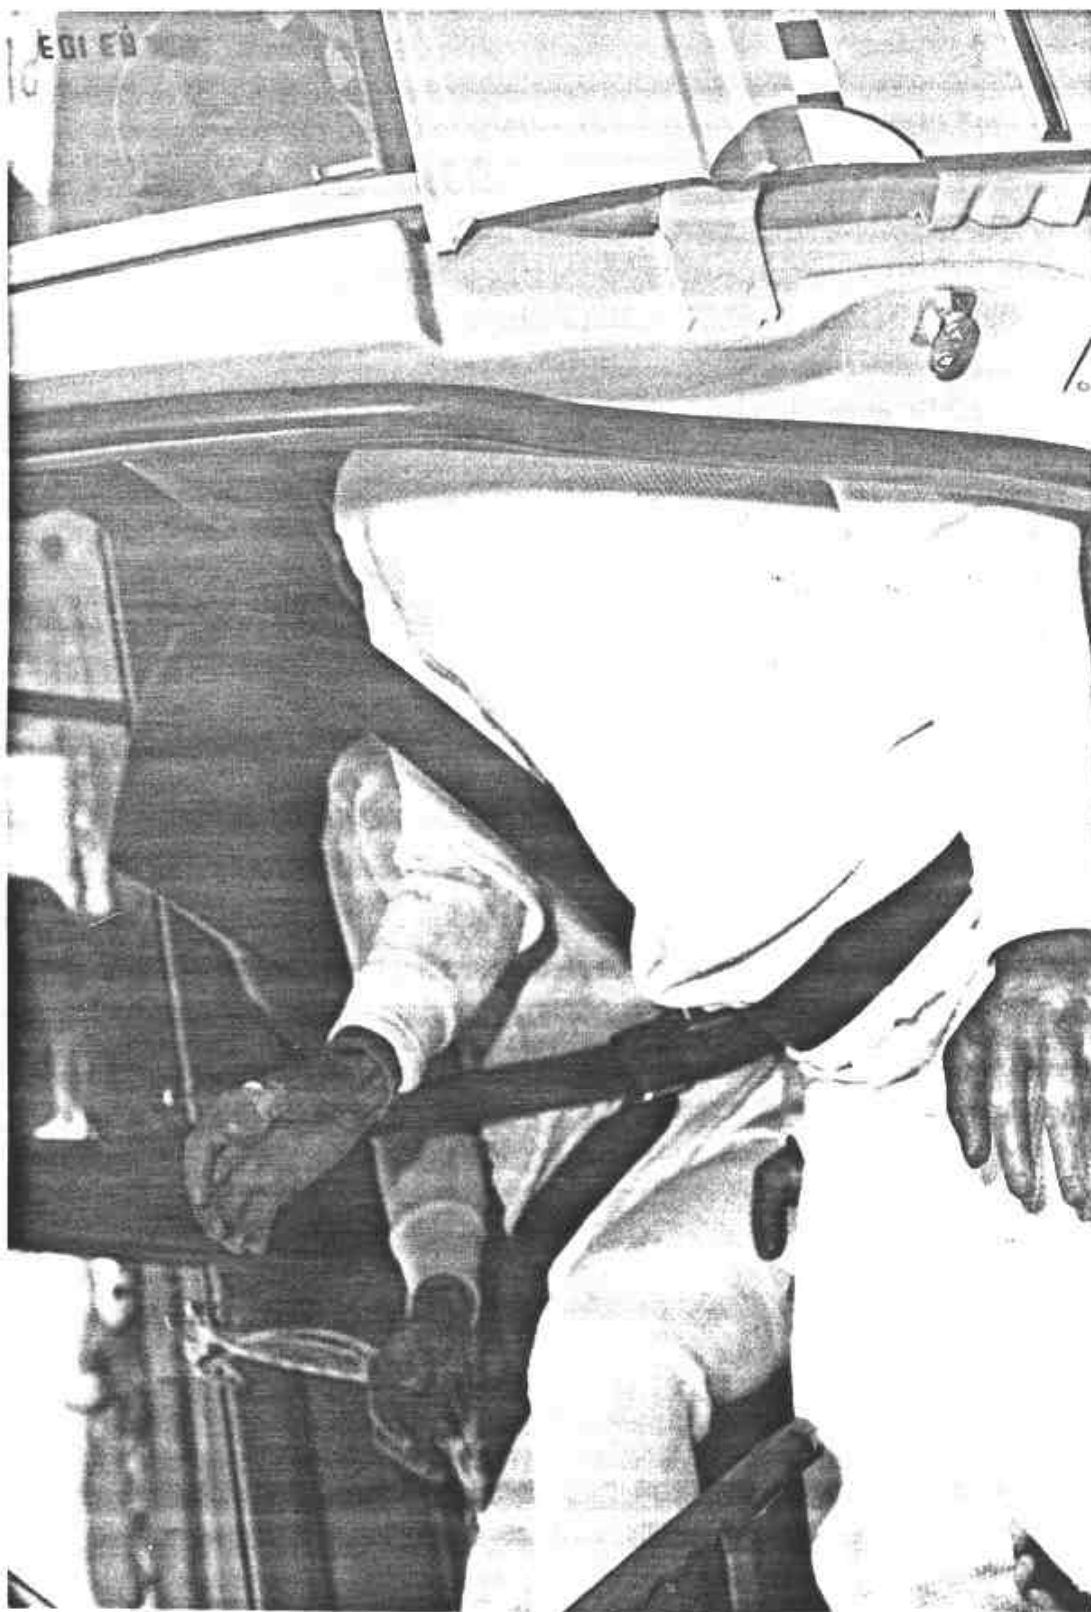
Both seat backs failed at left side mount attachment point.

Passenger seat moved rearward 1.5 inches.

Figure 4-7. Post-test View of Dummies - 1978 Plymouth Horizon Four-Door Hatchback - NHTSA 780311.
