REPORT NO. 301-AETL-79-082-671-1489-82

NEW VEHICLE ASSESSMENT AND STANDARDS  
ENFORCEMENT INDICANT TESTING  
OF  
FMVSS 301-75  
FUEL SYSTEM INTEGRITY

CHRYSLER CORPORATION  
1979 PLYMOUTH HORIZON - 2 DOOR HATCHBACK  
NHTSA 790317

FINAL REPORT

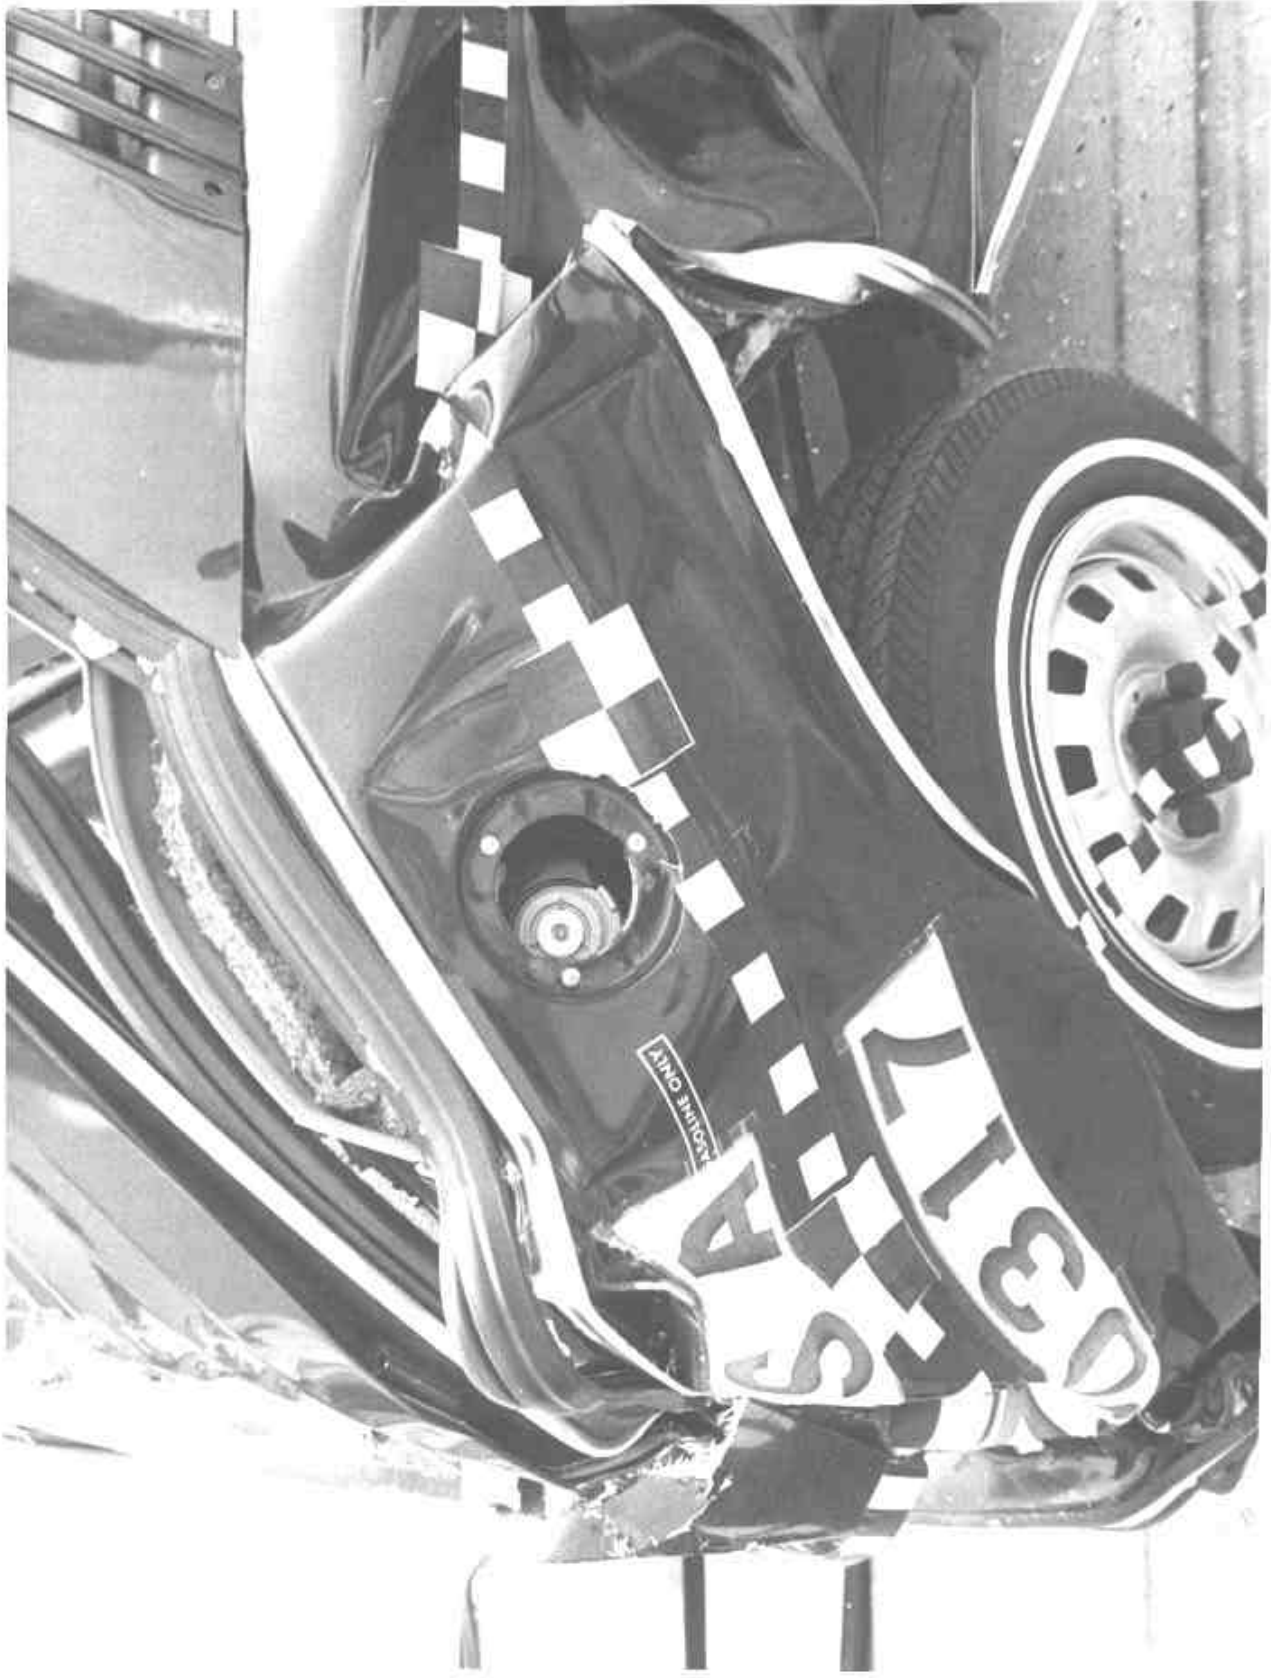
**Post-Impact, Fuel Filler Cap View**

mounting assembly tore loose and the fuel filler cap cover severed from the inner cap housing, which remained installed in the filler neck. Both front seat assemblies deformed inward and each seat back bent backward into the rear seat cushion. Both driver and passenger dummy heads made contact with the rear seat back cushion.

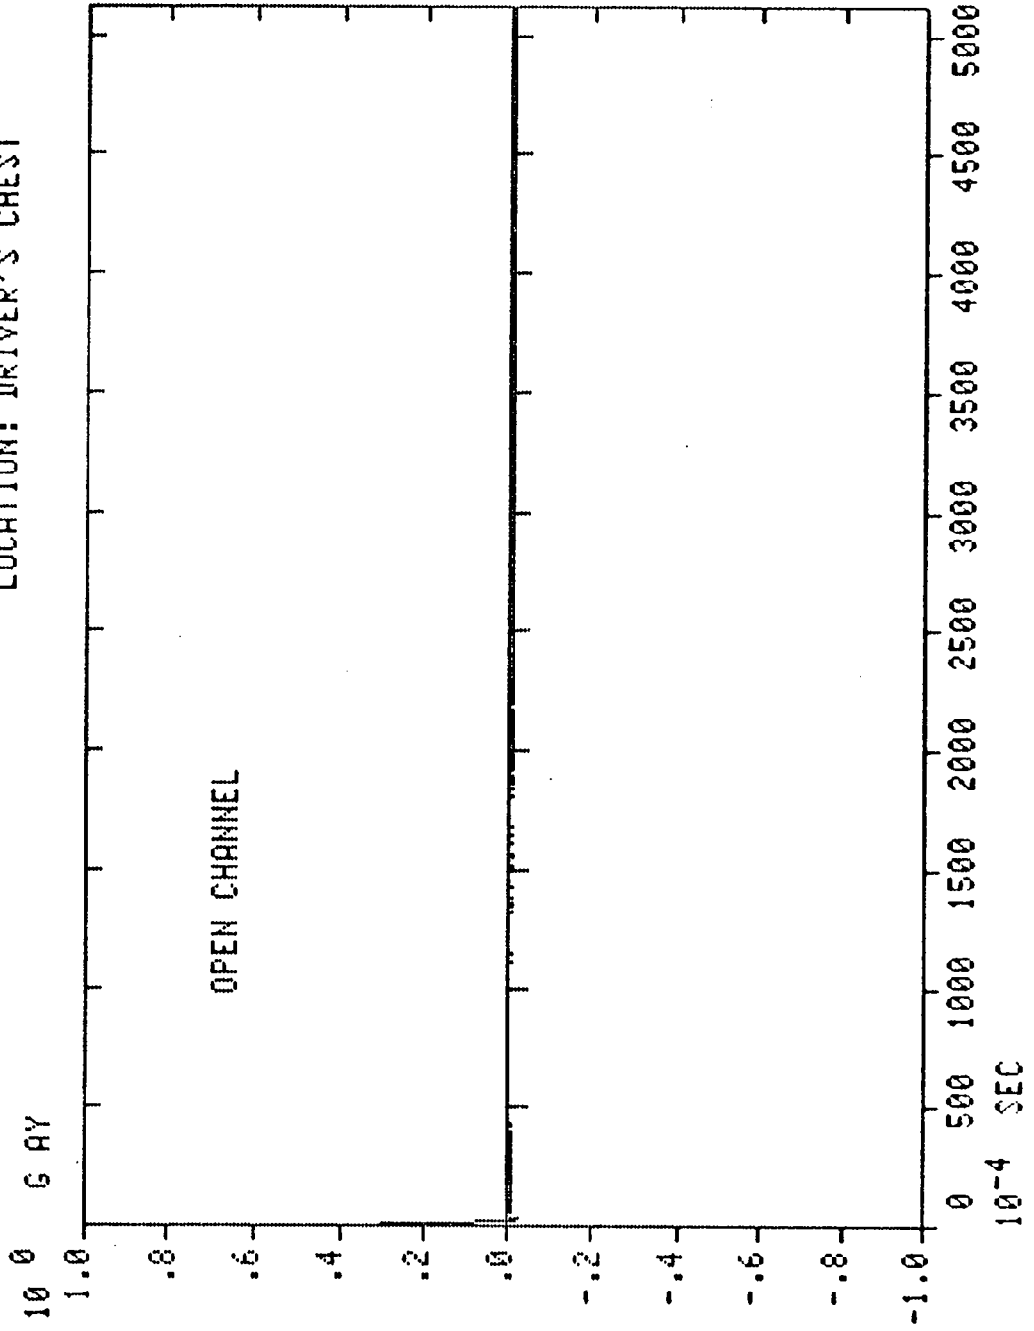
MJO NO.: 671-1489-82  
FILTER: CLASS 180  
ACCELEROMETER: TAPE 1, CH 6  
DIRECTION: LEFT  
LOCATION: DRIVER'S CHEST

The driver dummy lateral chest accelerometer response (Tape 1, channel 6) and passenger dummy lateral chest accelerometer response (Tape 2, channel 6) data was not acquired after impact initiation due to apparent accelerometer/cable failure.
