REPORT NO. 301-AETL-80-009-971-3882-9

NEW VEHICLE ASSESSMENT  
AND  
STANDARDS ENFORCEMENT INDICANT TESTING

FMVSS 301-75

GENERAL MOTORS CORPORATION  
1980 OLDSMOBILE CUTLASS LS - 4 DOOR SEDAN  
NHTSA 800111

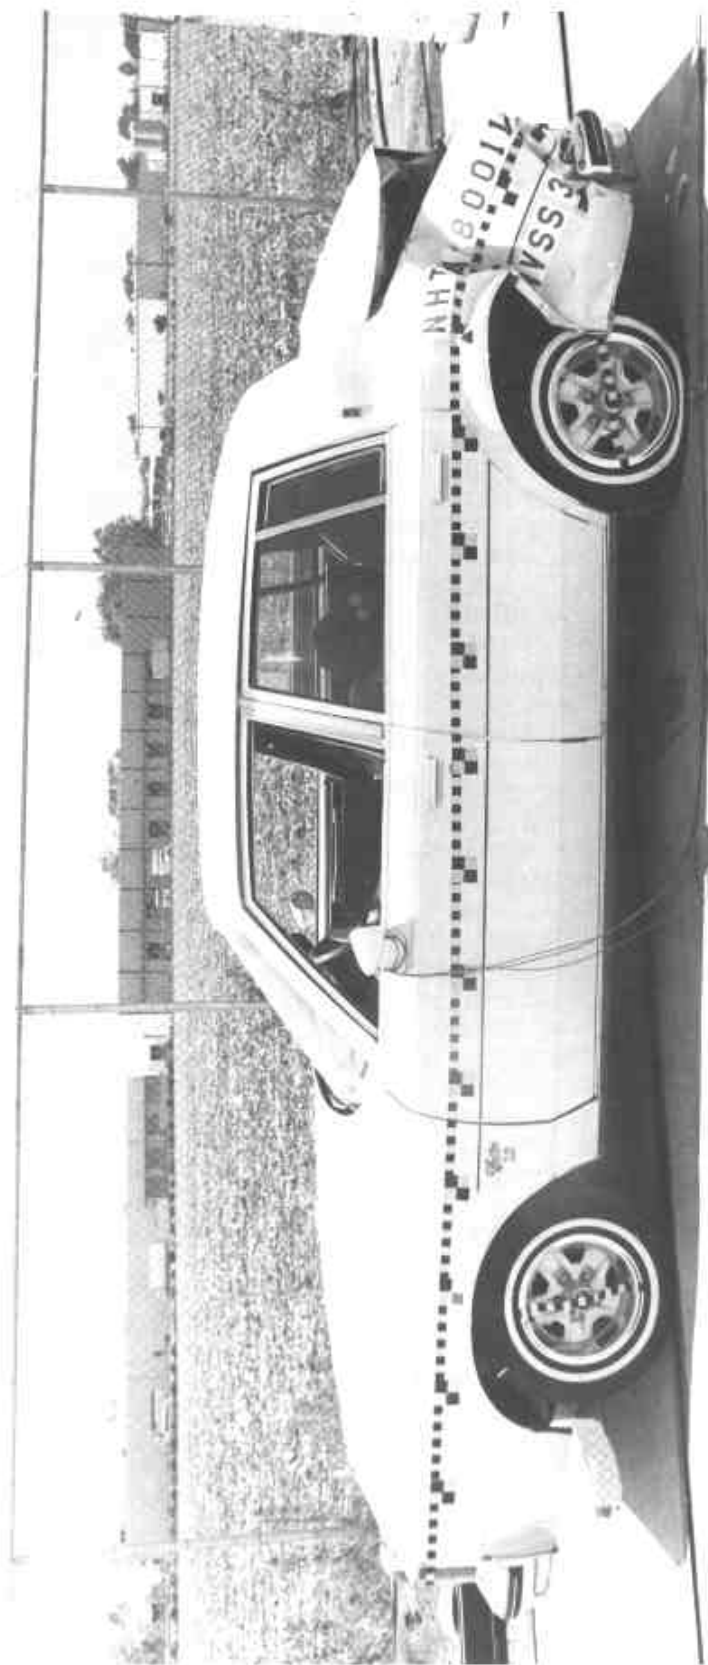
Crush Details: Frame buckled under rear doors, roof buckled over both "C" posts, both dummies made contact with rear seat back.

Post-Impact, Left Side View

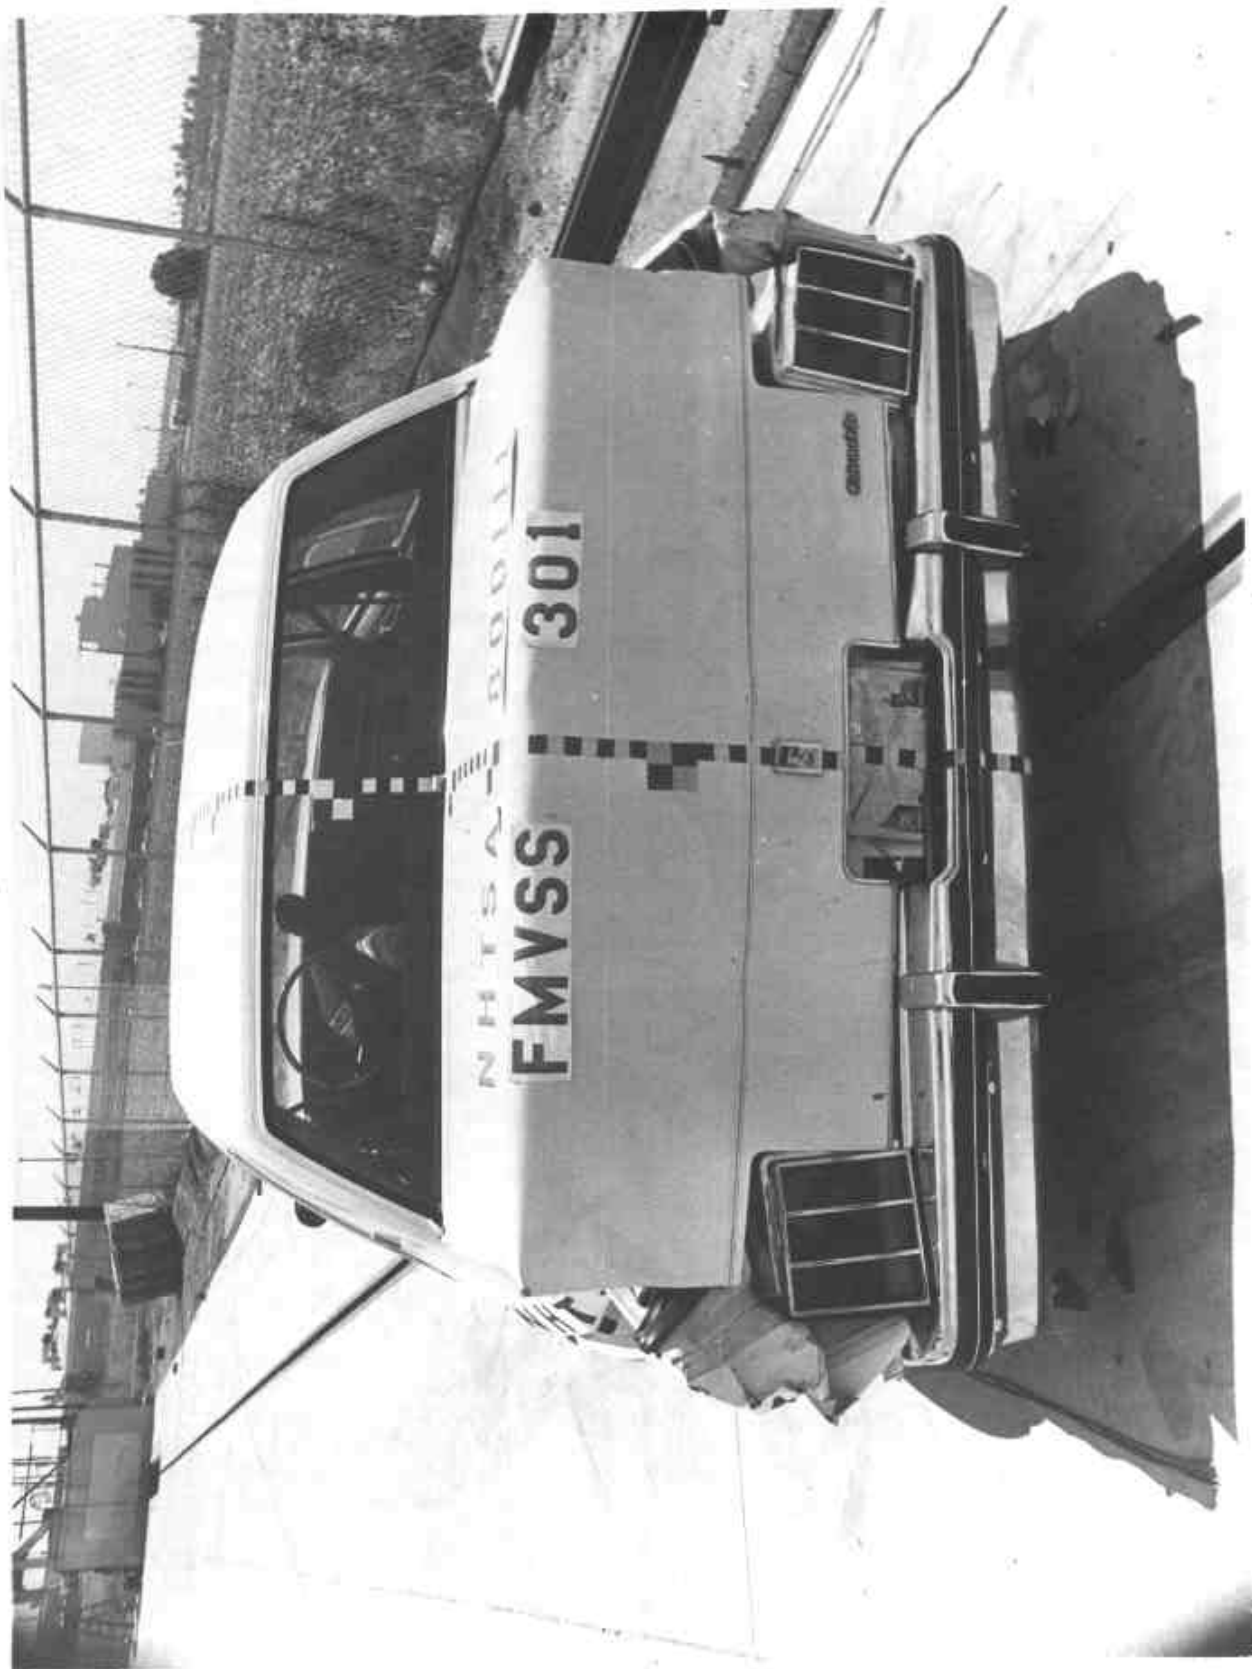
Figure 3-5  
1980 Oldsmobile Cutlass LS - 4 Door Sedan  
NHTSA 800111  
Post-Impact, Full Rear View

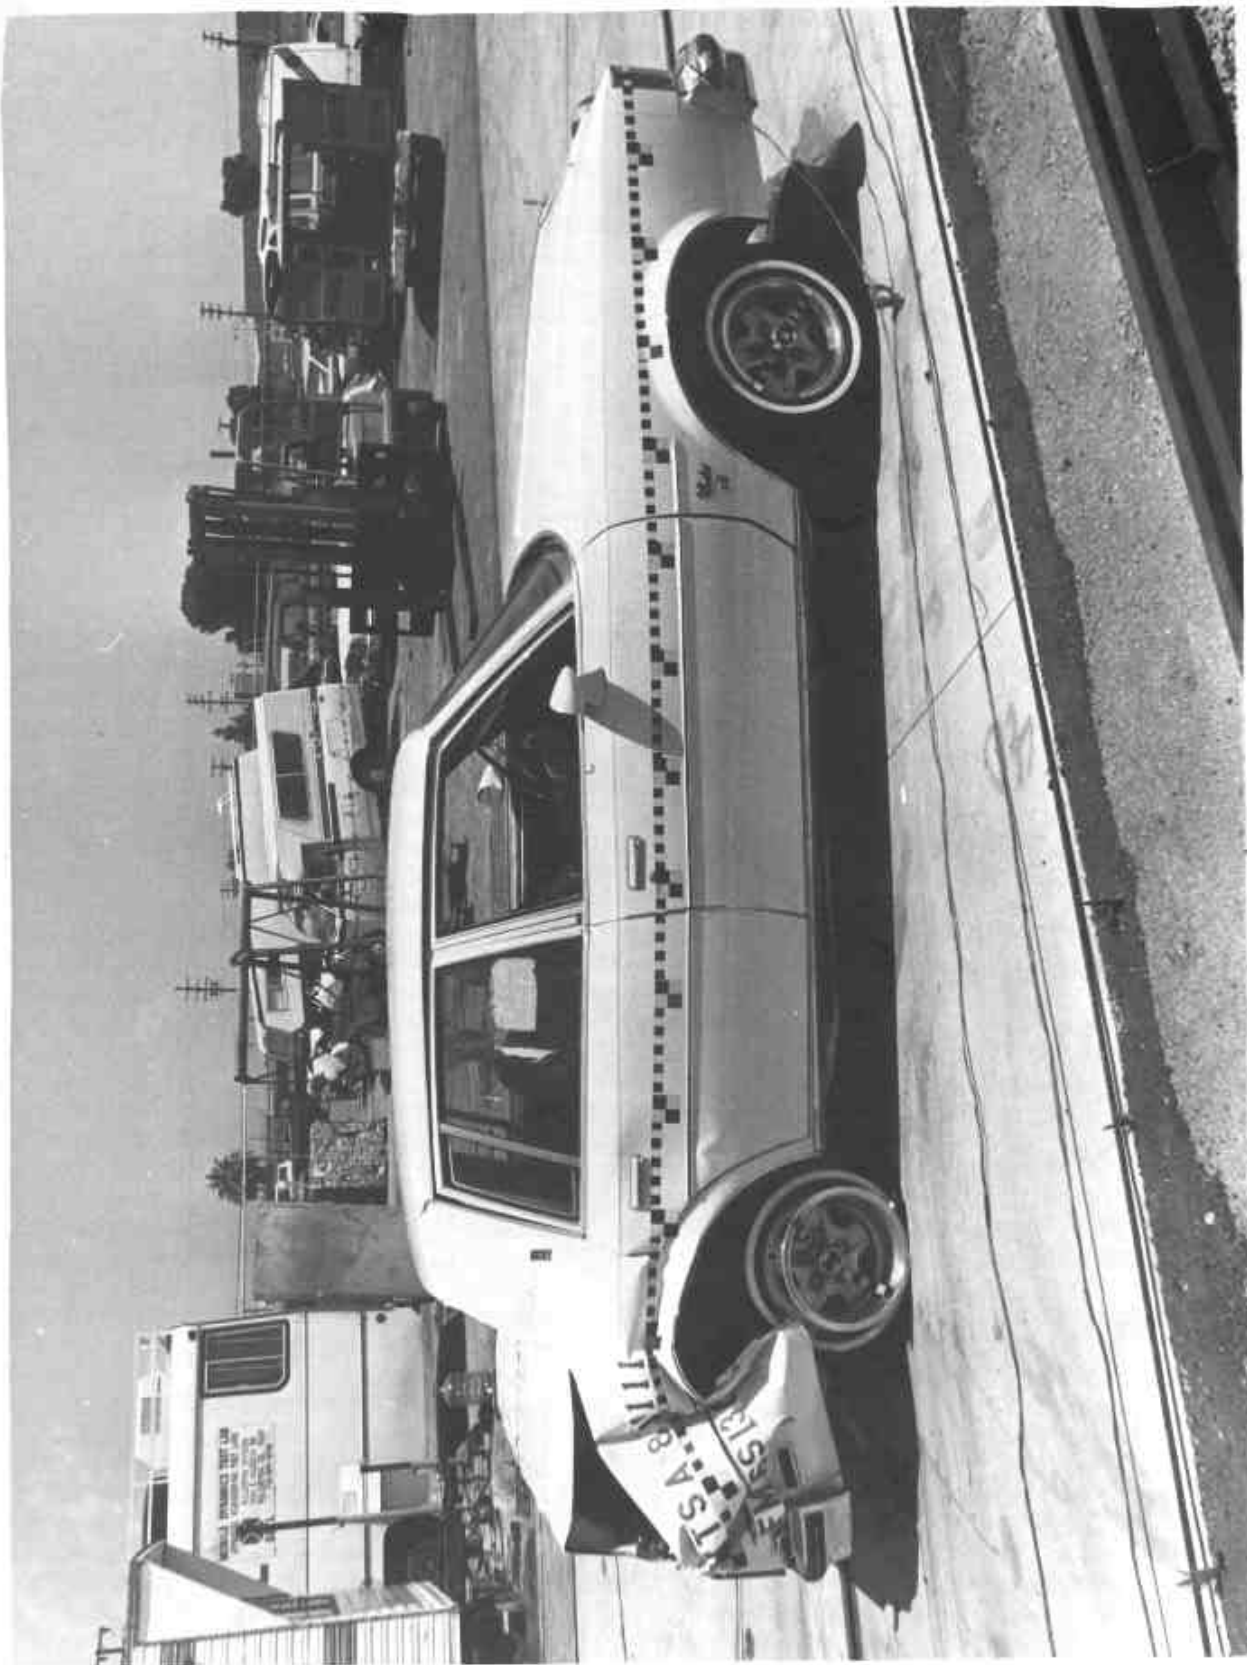
Figure 3-6  
1980 Oldsmobile Cutlass LS - 4 Door Sedan  
NHTSA 800111  
Post-Impact, Right Side View

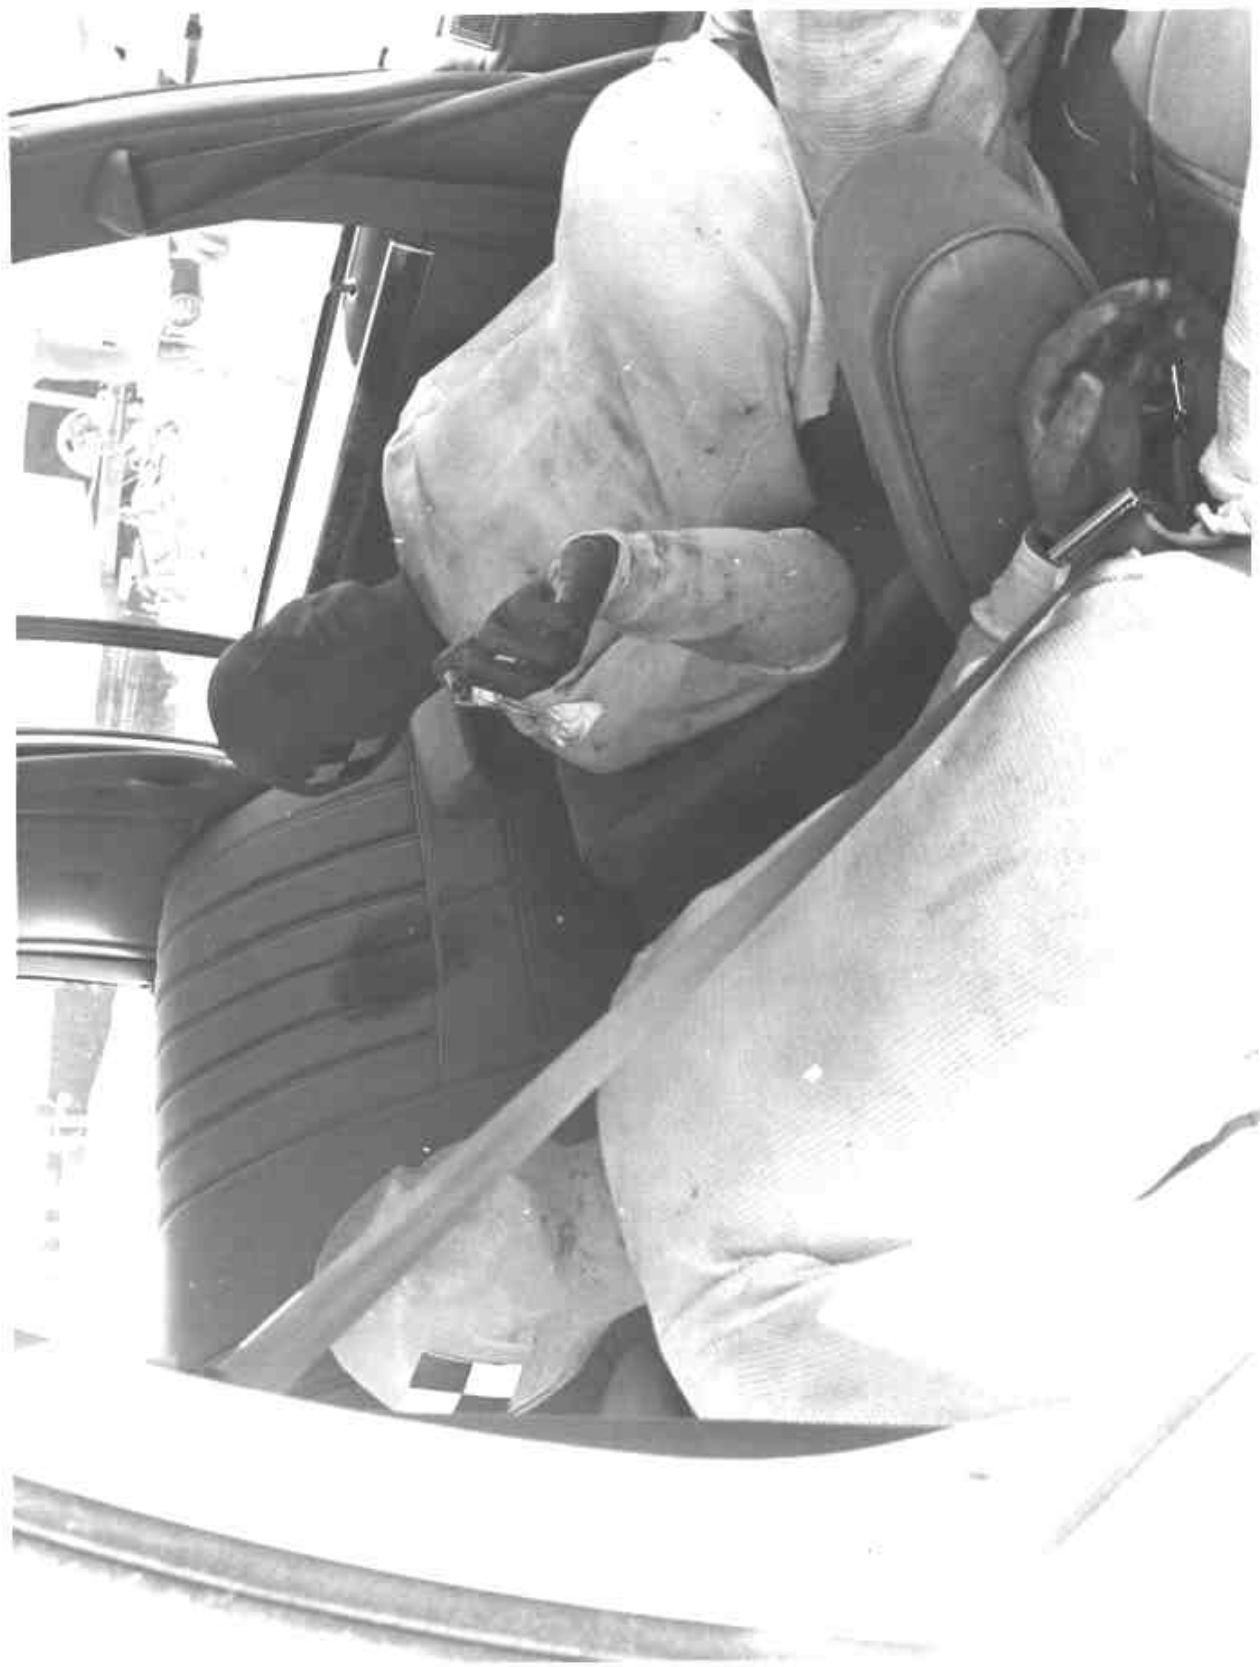
Figure A-4  
1980 Oldsmobile Cutlass LS - 4 Door Sedan  
NHTSA 800111  
Post-Impact, Driver Dummy Contact Area

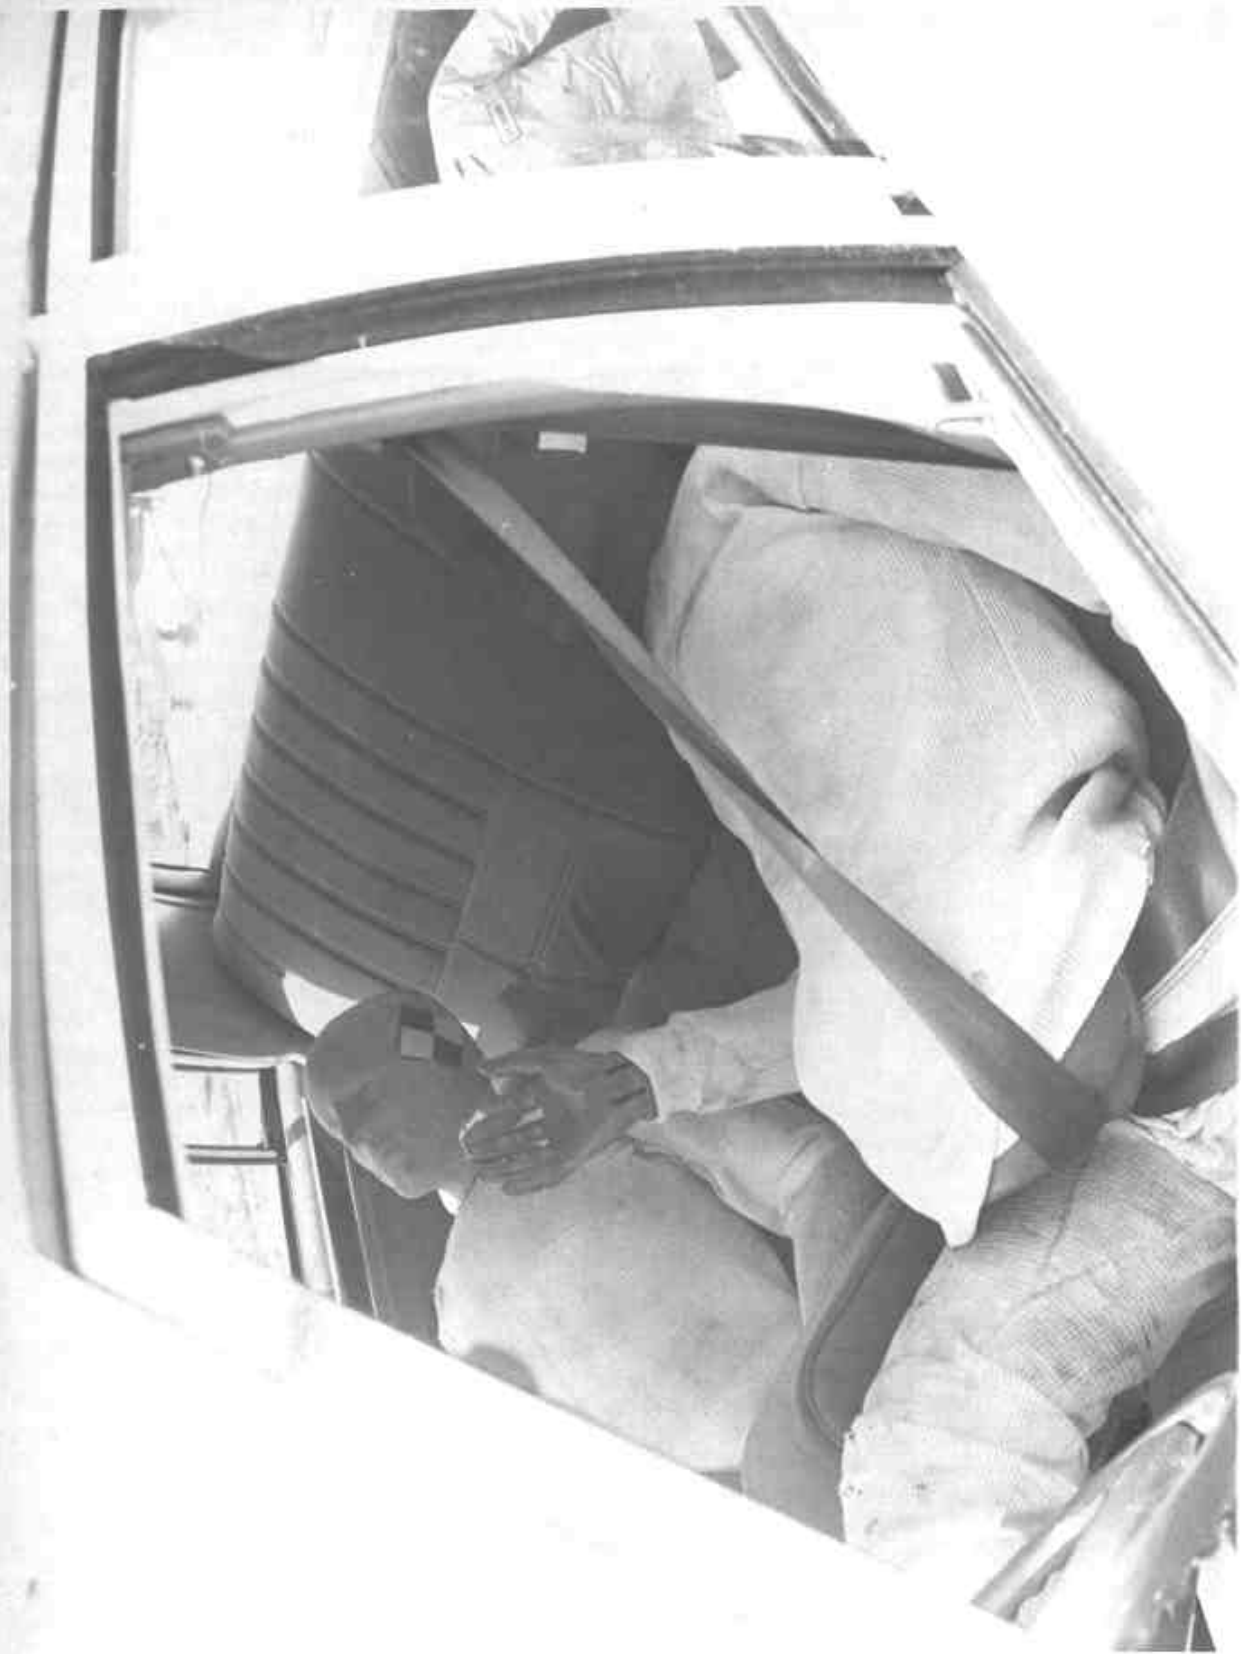
Figure A-5  
1980 Oldsmobile Cutlass LS - 4 Door Sedan  
NHTSA 800111  
Post-Impact, Passenger Dummy Contact Area
