TEST REPORT 5  
60° SIDE IMPACTOR-TO-OLDSMOBILE  
CUTLASS TEST 4.7 AT 35 MPH  
Contract DOT-HS-8-01933

J. Beharrell  
R. Cropper  
S. Davis

December 1979

| 15. Supplementary Notes<br>Test Number 8321-4.7 | | | |

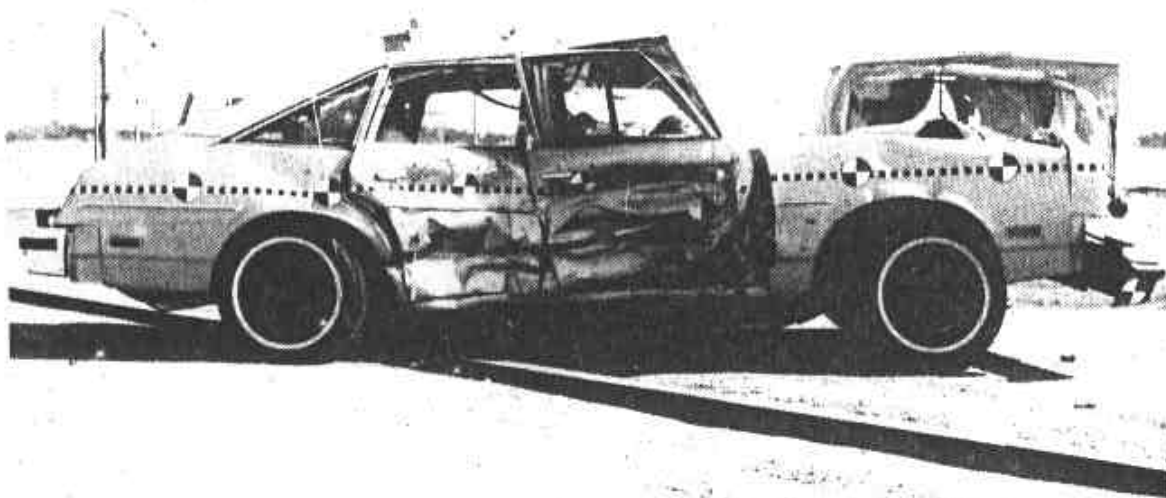
a) Post-test Oldsmobile Cutlass

General Observations: Front door pushed over rocker sill and approximately 18 inches into the occupant compartment. Welds at top of B-pillar all broken. The hinges on the front door were bent but still attached to the A-pillar. Vehicles 44 feet apart post-impact. Side impactor bumper pulled out on left side due to tensile failure of honeycomb.

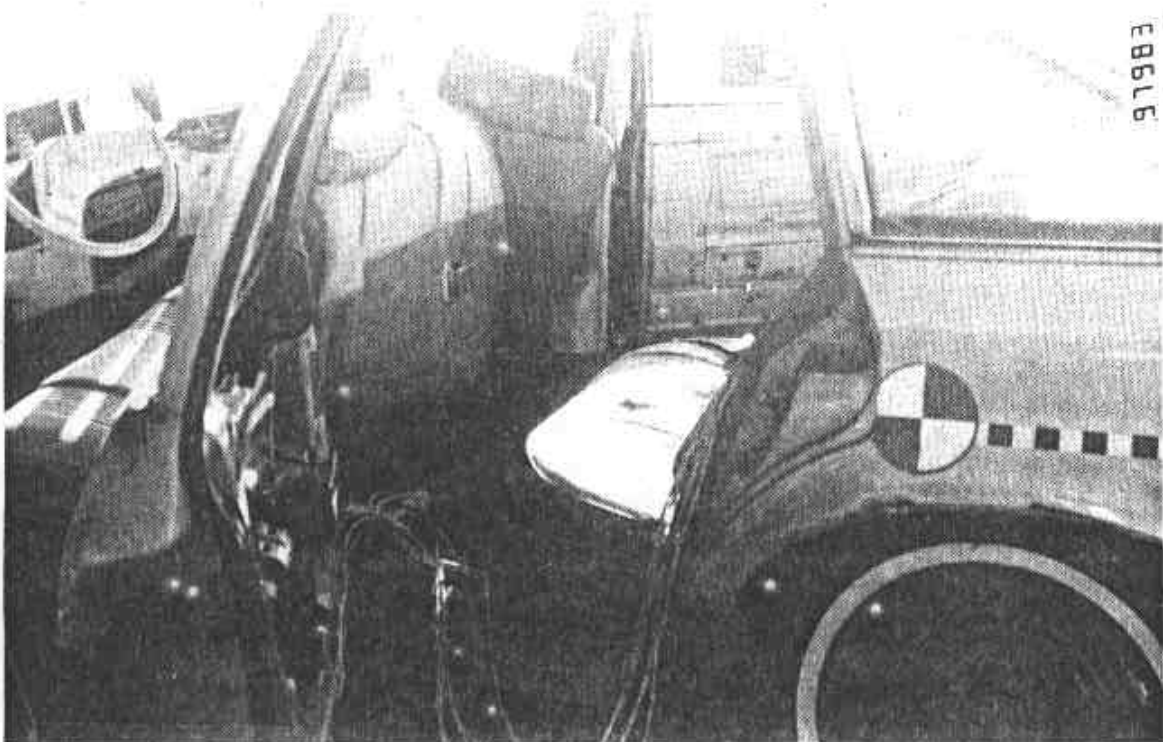
b) Post-test Rear Occupant Compartment

As may be seen from Table C-1, the injury criteria levels for both dummies are well below the maximum allowed in FMVSS 208, although the head injury levels for the rear dummy were caused by its head striking the C-pillar during the impact.

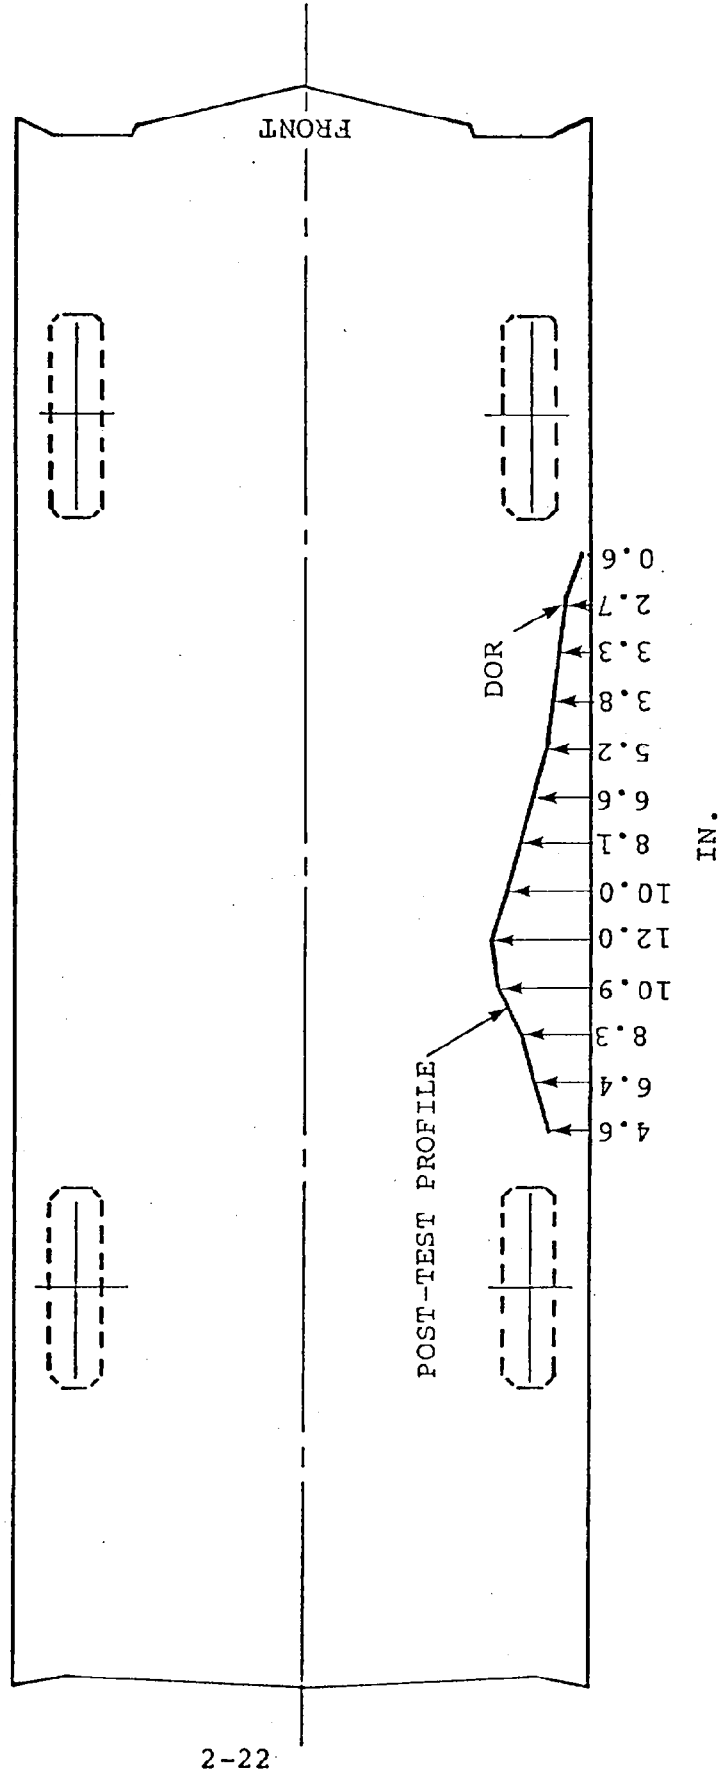
Figure 2-13. Exterior Vehicle Profile and Static Crush (Test 8321-4.7).

AXLE LEVEL - 12.2 IN. ABOVE GROUND  
 1979 OLDSMOBILE CUTLASS SALON  
 (DATA FROM TABLE 2-8)  
 SCALE: 0 6 12 IN.

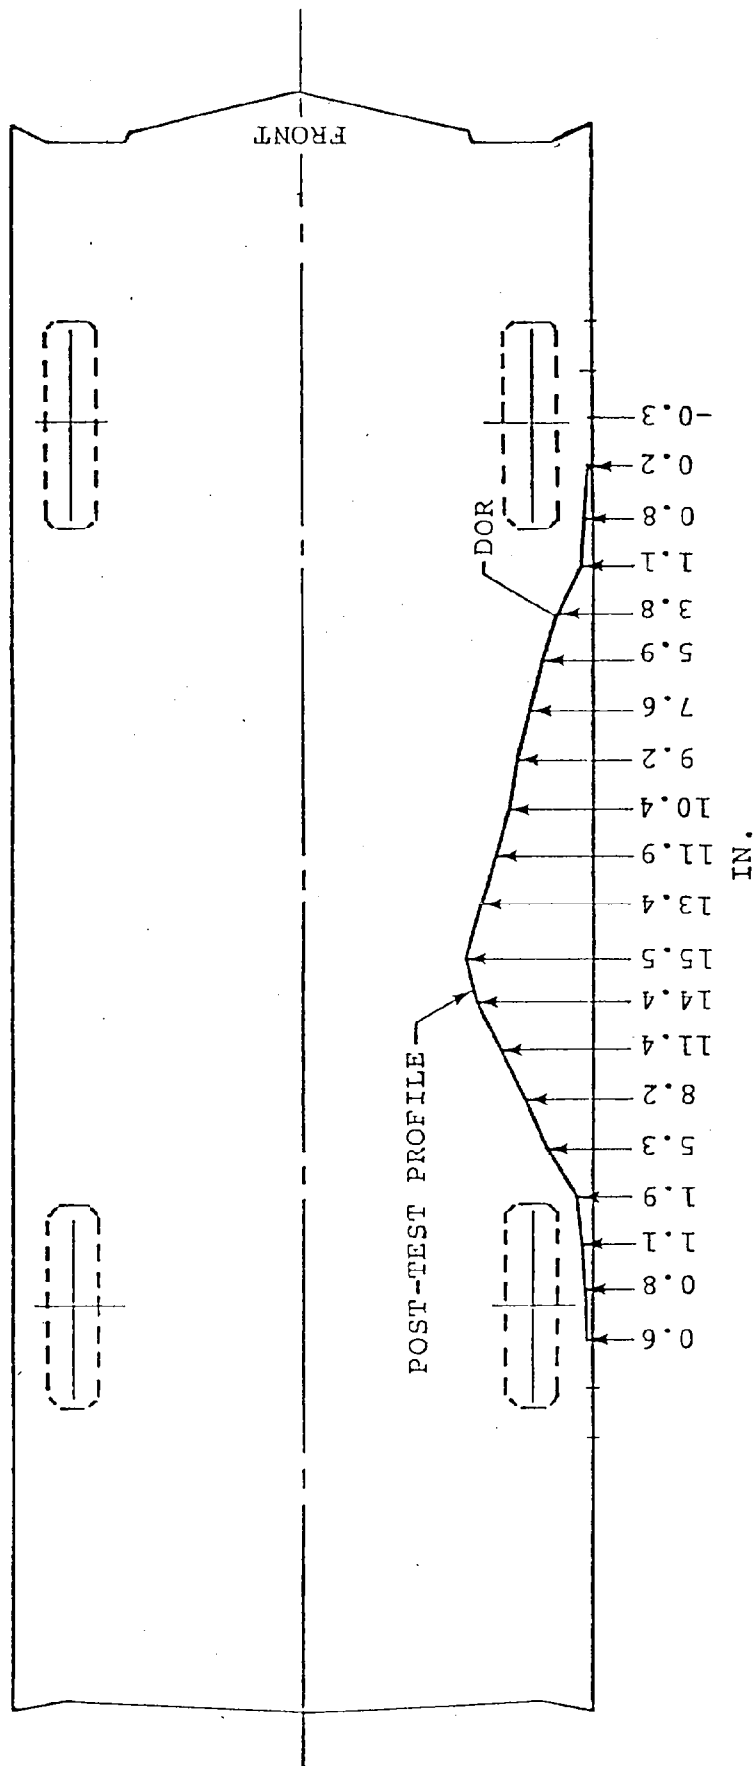
Figure 2-15. Exterior Vehicle Profile and Static Crush (Test 8321-4.7).

WINDOW SILL LEVEL - 35.1 IN. ABOVE GROUND  
 1979 OLDSMOBILE CUTLASS SALON  
 (DATA FROM TABLE 2-8)  
 SCALE: 0 6 12 IN.

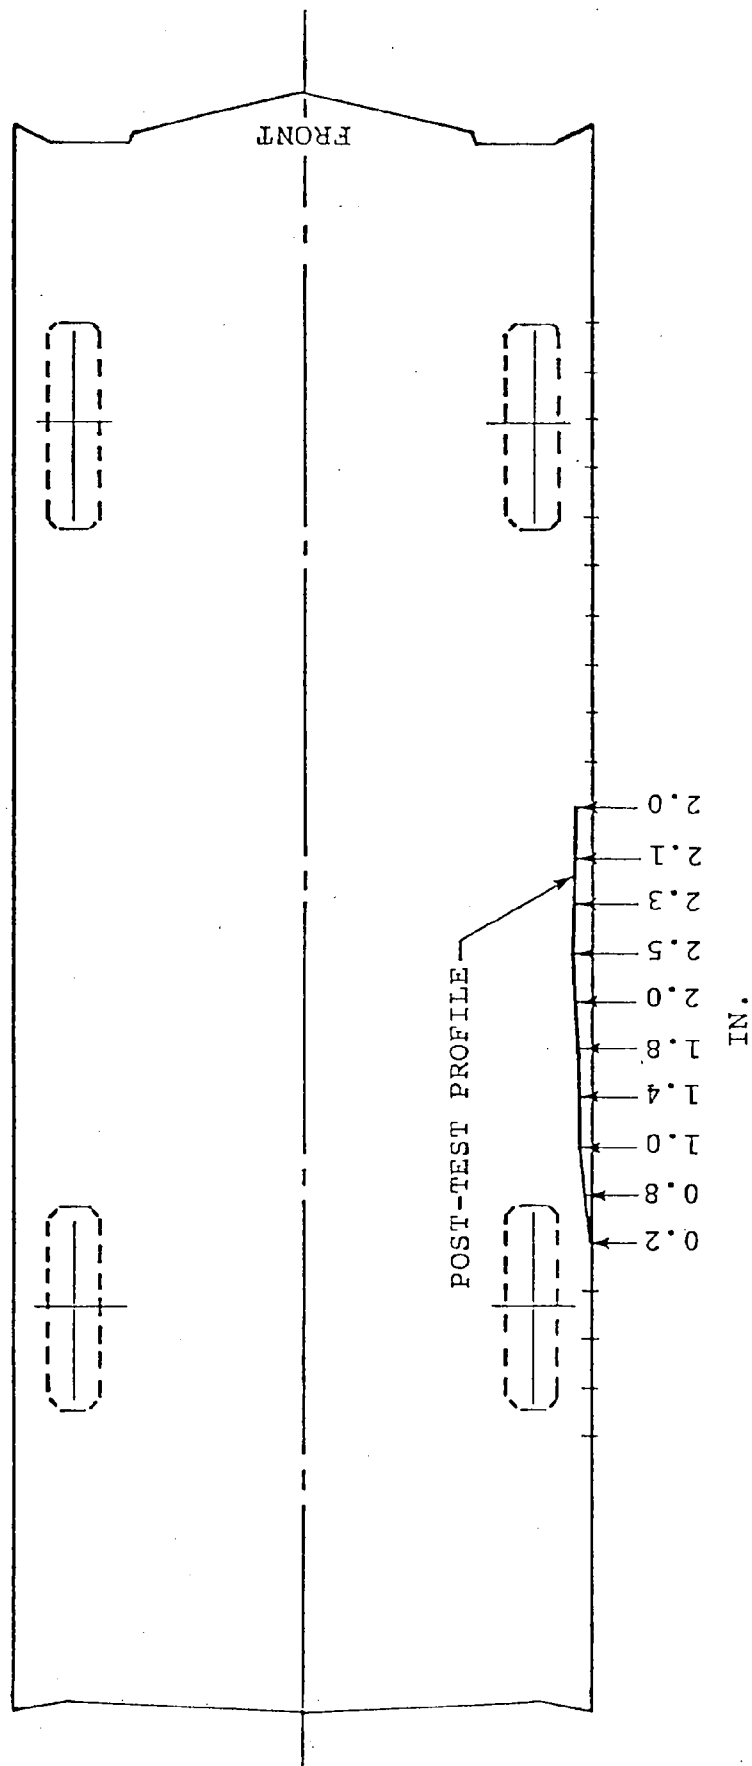
Figure 2-16. Exterior Vehicle Profile and Static Crush (Test 8321-4.7).

WINDOW TOP LEVEL - 54.6 IN. ABOVE GROUND  
 1979 OLDSMOBILE CUTLASS SALON  
 (DATA FROM TABLE 2-8)  
 SCALE: 0 6 12 IN.

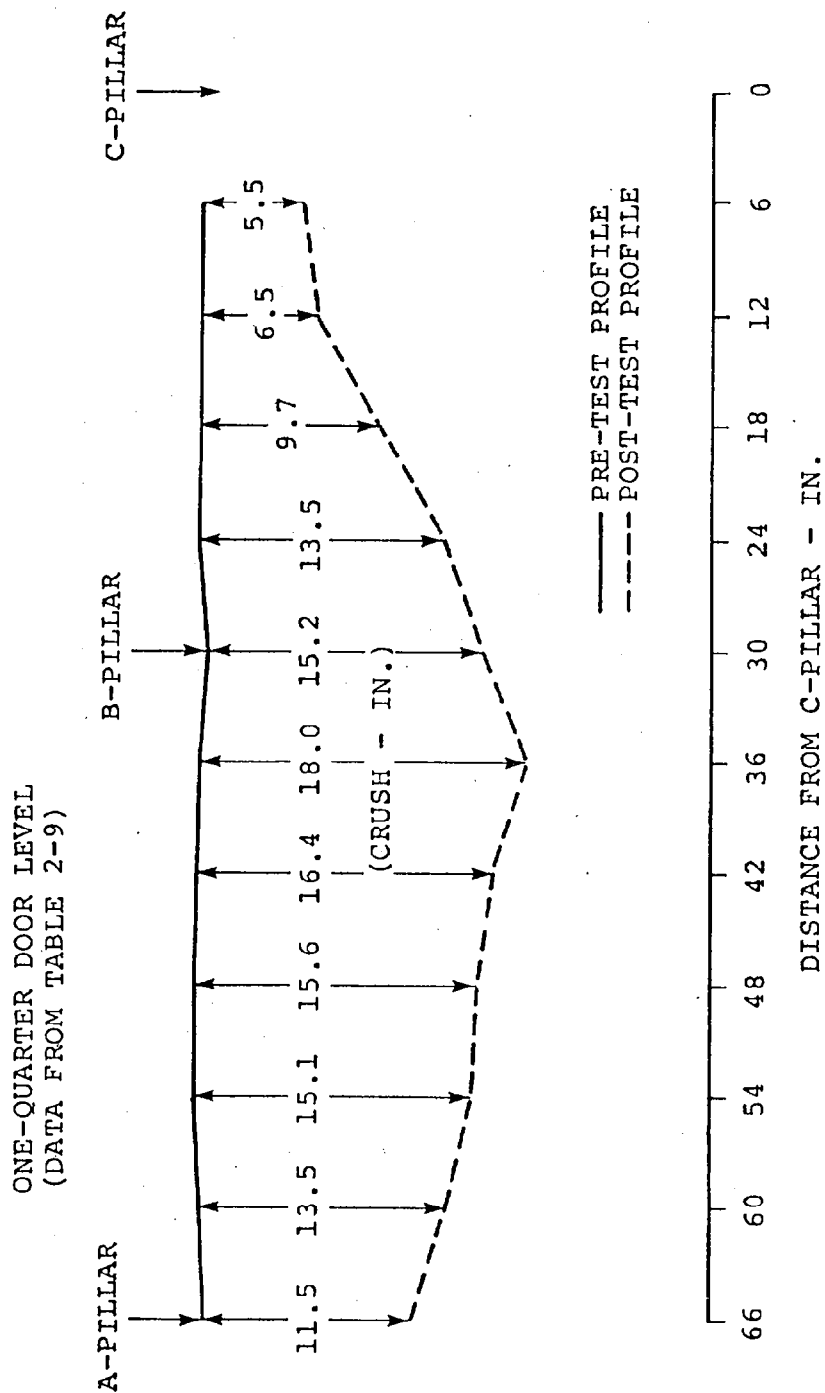
Figure 2-17. Interior Profile and Intrusion at One-quarter Door Level for 1979 Oldsmobile Cutlass (Test 8321-4.7).

| Location | Height @<br>B-pillar<br>(in.) | Distance From Rearmost Edge of Rear Door Panel (in.) | | | | | | | | | | | |
|---|---|---|---|---|---|---|---|---|---|---|---|---|---|
| 1/4-door Level | -2.6 | | 11.5 | 13.5 | 15.1 | 15.6 | 16.4 | 18.0 | 15.2 | 13.5 | 9.7 | 6.5 | 5.5 |

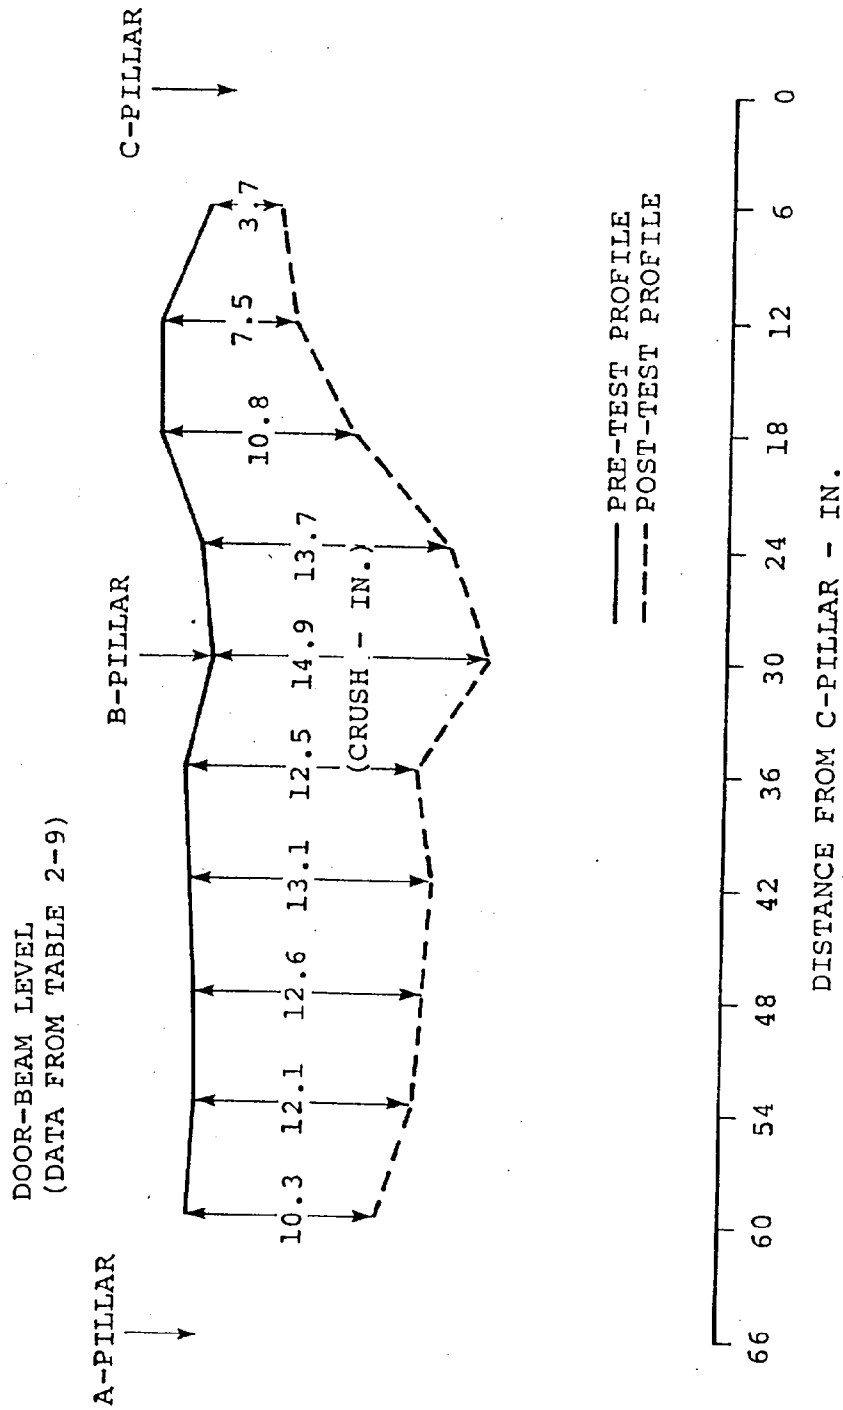
Figure 2-18. Interior Profile and Intrusion at Door Beam Level for 1979 Oldsmobile Cutlass (Test 8321-4.7).

| Location | Height @<br>B-pillar<br>(in.) | Distance From Rearmost Edge of Rear Door Panel (in.) | | | | | | | | | | | |
|---|---|---|---|---|---|---|---|---|---|---|---|---|---|
| Door Beam Level | -2.1 | | 10.3 | 12.1 | 12.6 | 13.1 | 12.5 | 14.9 | 13.7 | 10.8 | 7.5 | 3.7 | |
