Report Number 301-75-DYS-78-003

FMVSS 301-75 STANDARDS ENFORCEMENT TESTING  
OF FUEL SYSTEM INTEGRITY

General Motors Corporation  
1978 Chevrolet Monza 2+2 Two-door Hatchback  
NHTSA 780114

FINAL REPORT

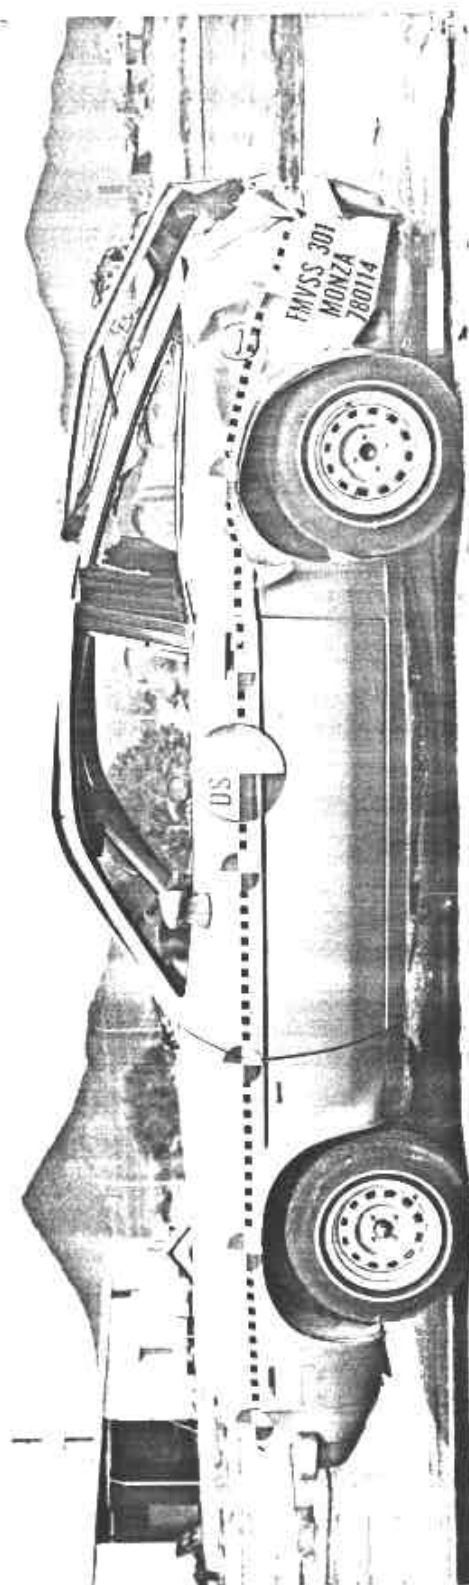
Figure 4-2. Post-test Side View - 1978 Chevrolet Monza 2+2  
Two-door Hatchback - NHTSA 780114.

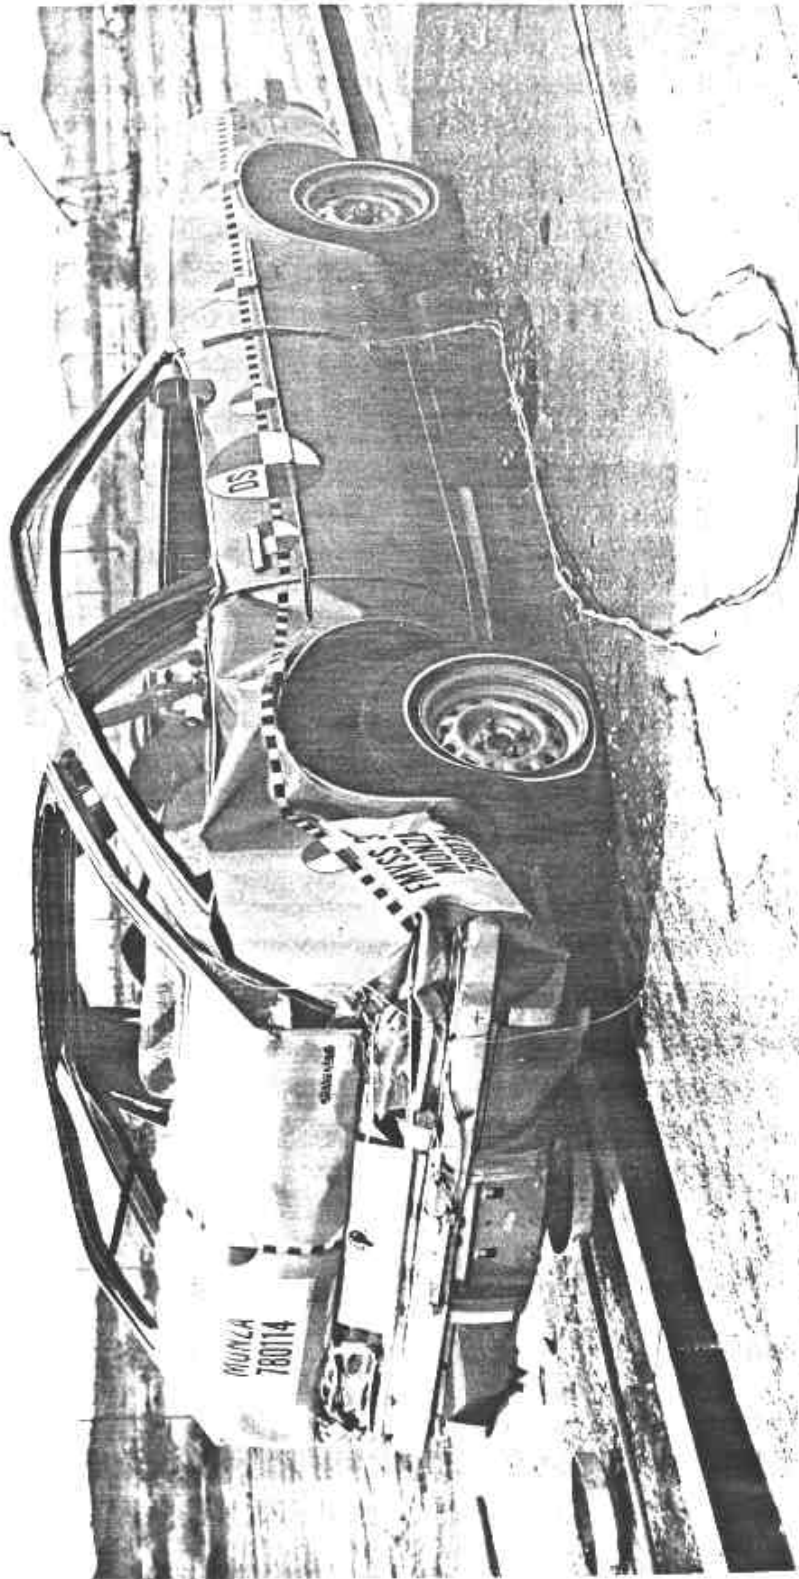
Figure 4-4. Post-test Rear View - 1978 Chevrolet Monza 2+2  
Two-door Hatchback - NHTSA 780114.

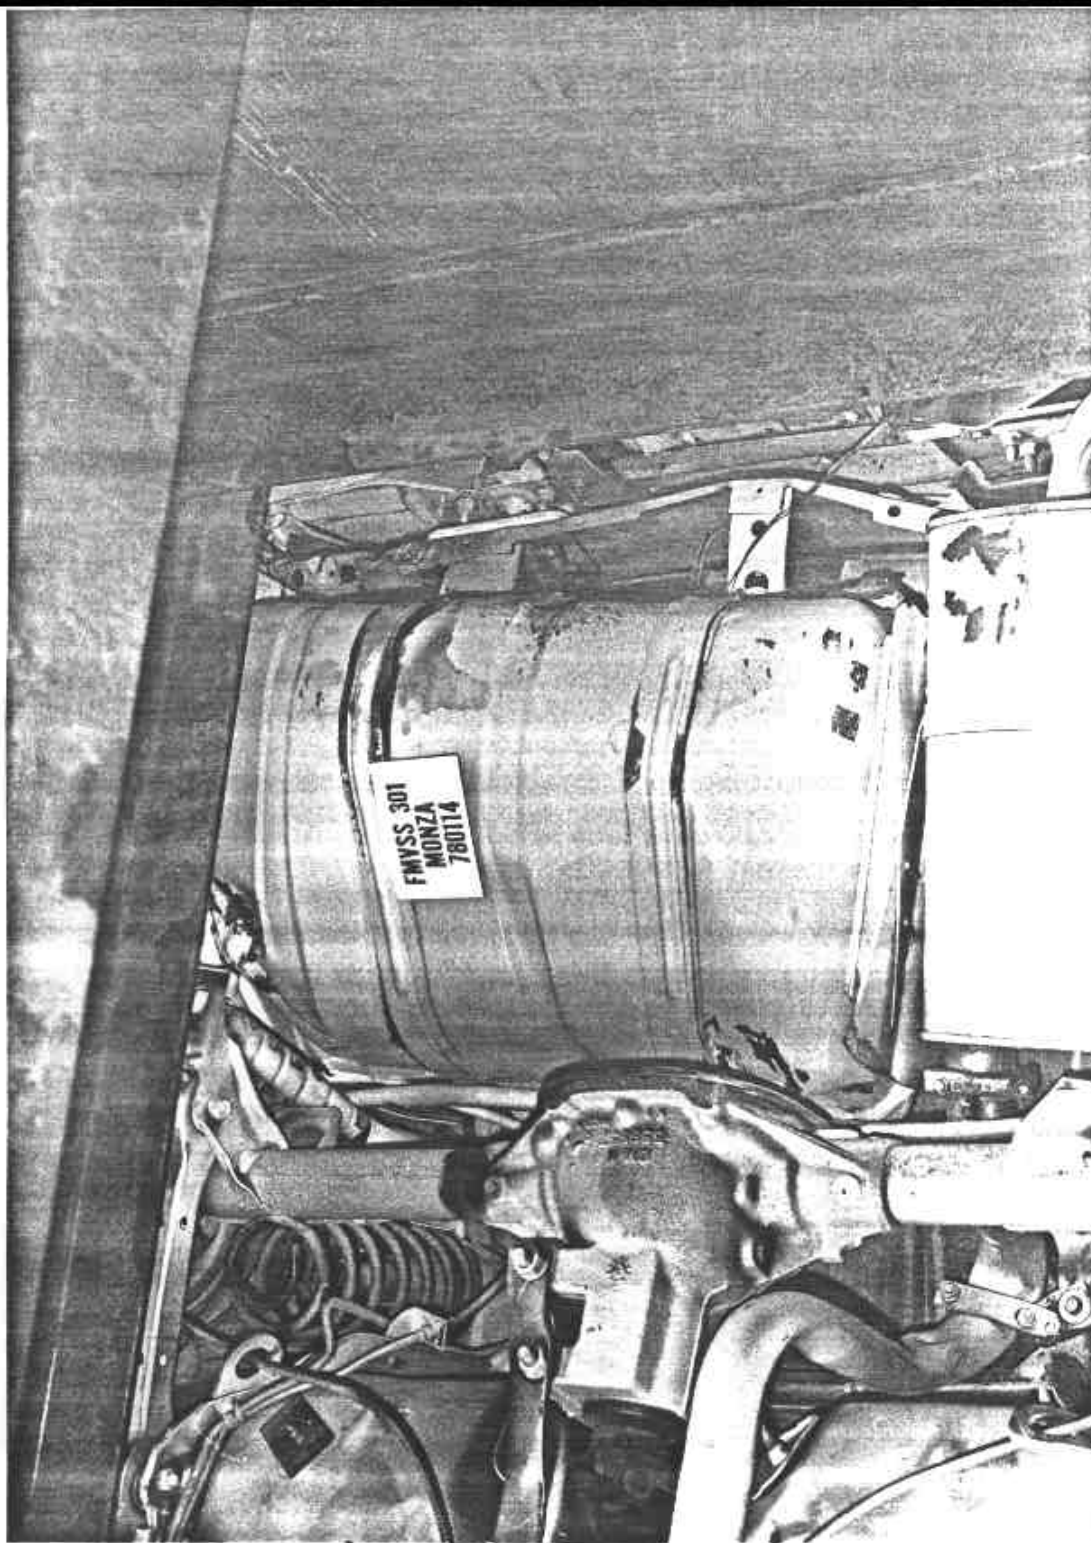
Figure 4-6. Post-test View of Fuel Tank - 1978 Chevrolet Monza 2+2 Two-door Hatchback - NHTSA 780114.

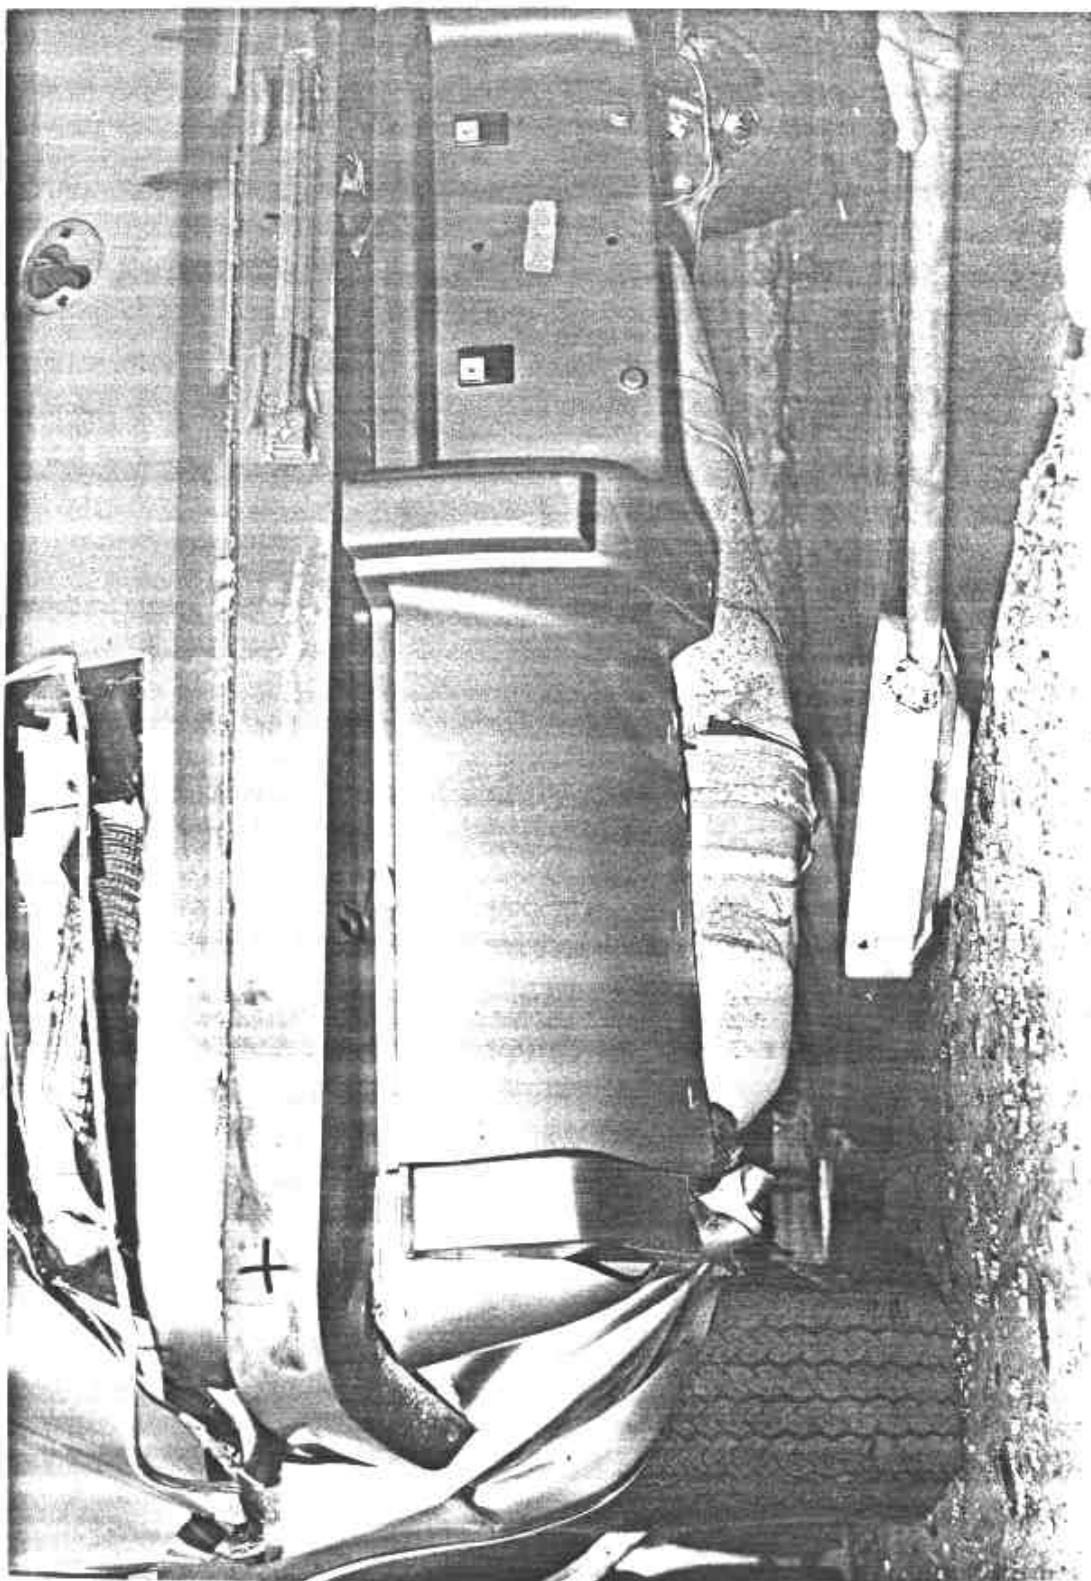
Figure 4-7. Post-test Leakage at Test Site - 1978 Chevrolet Monza 2+2  
Two-door Hatchback - NHTSA 780114.

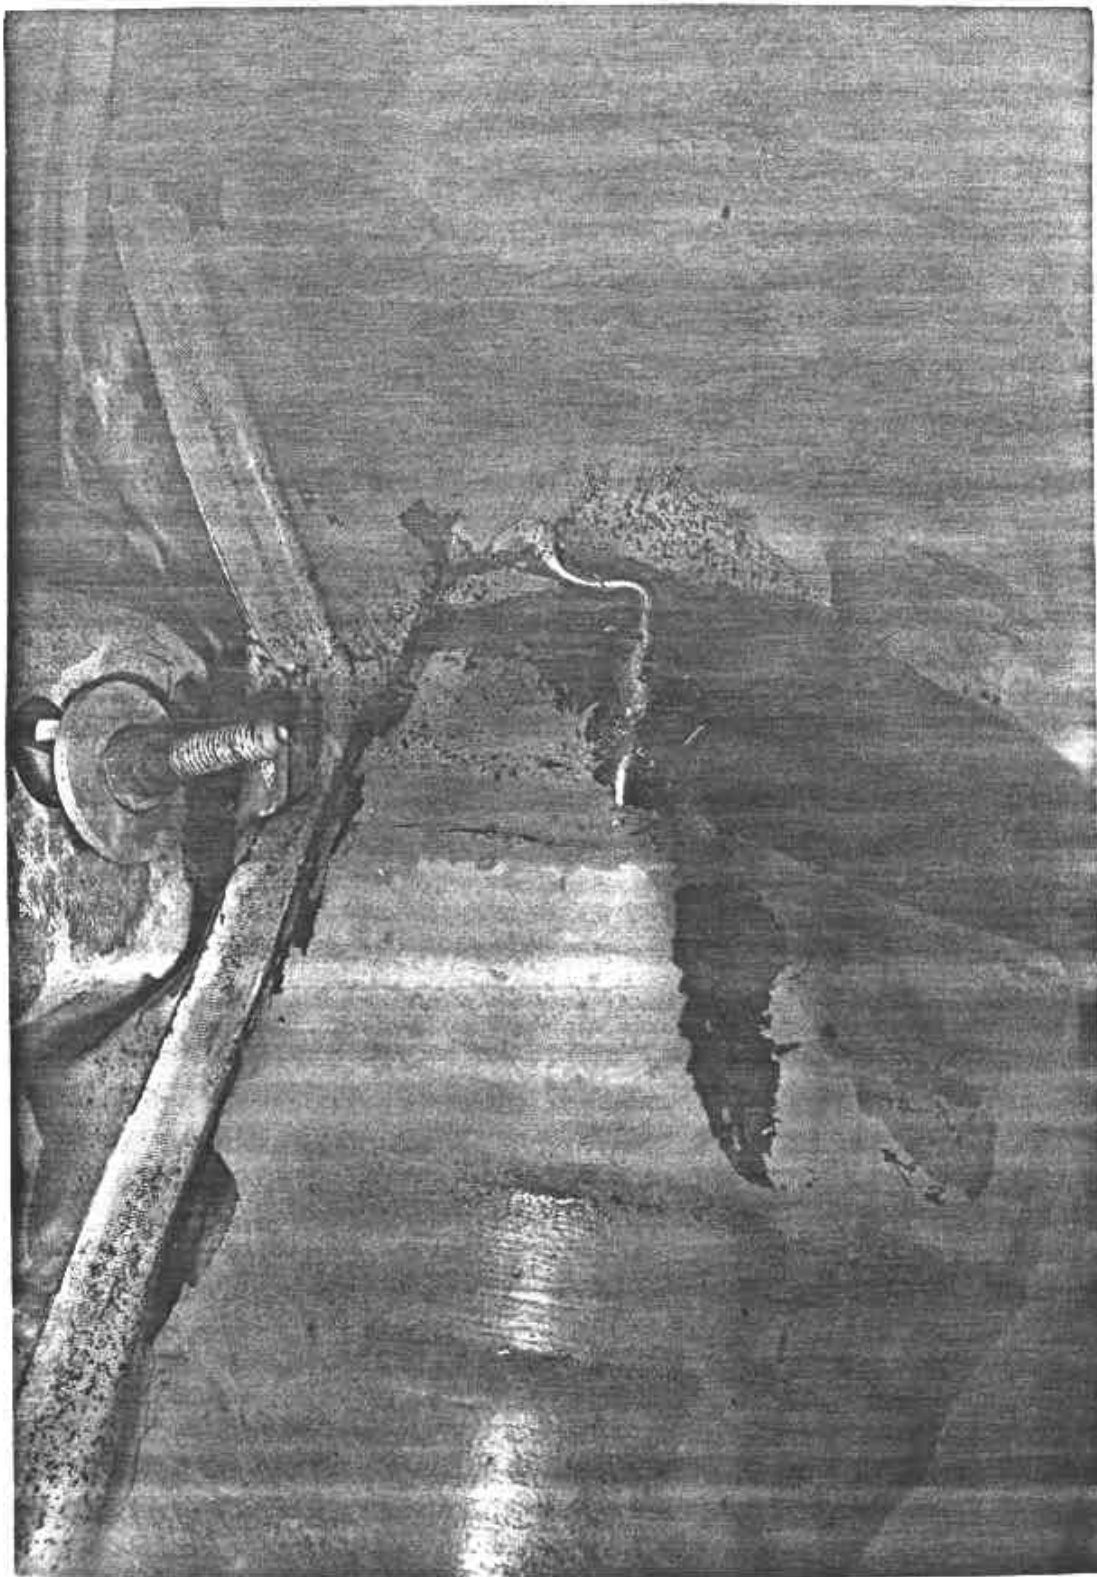
The fuel tank rear seam suffered a cut at the left support strap (see photographs on pages 4-9 and 4-10). Fuel spillage occurred following barrier impact and during the static rollover. The amounts spilled were within the amounts allowed.

Figure 4-8. General Area of Leakage (Support strap removed) - 1978 Chevrolet Monza 2+2 Two-door Hatchback - NHTSA 780114.

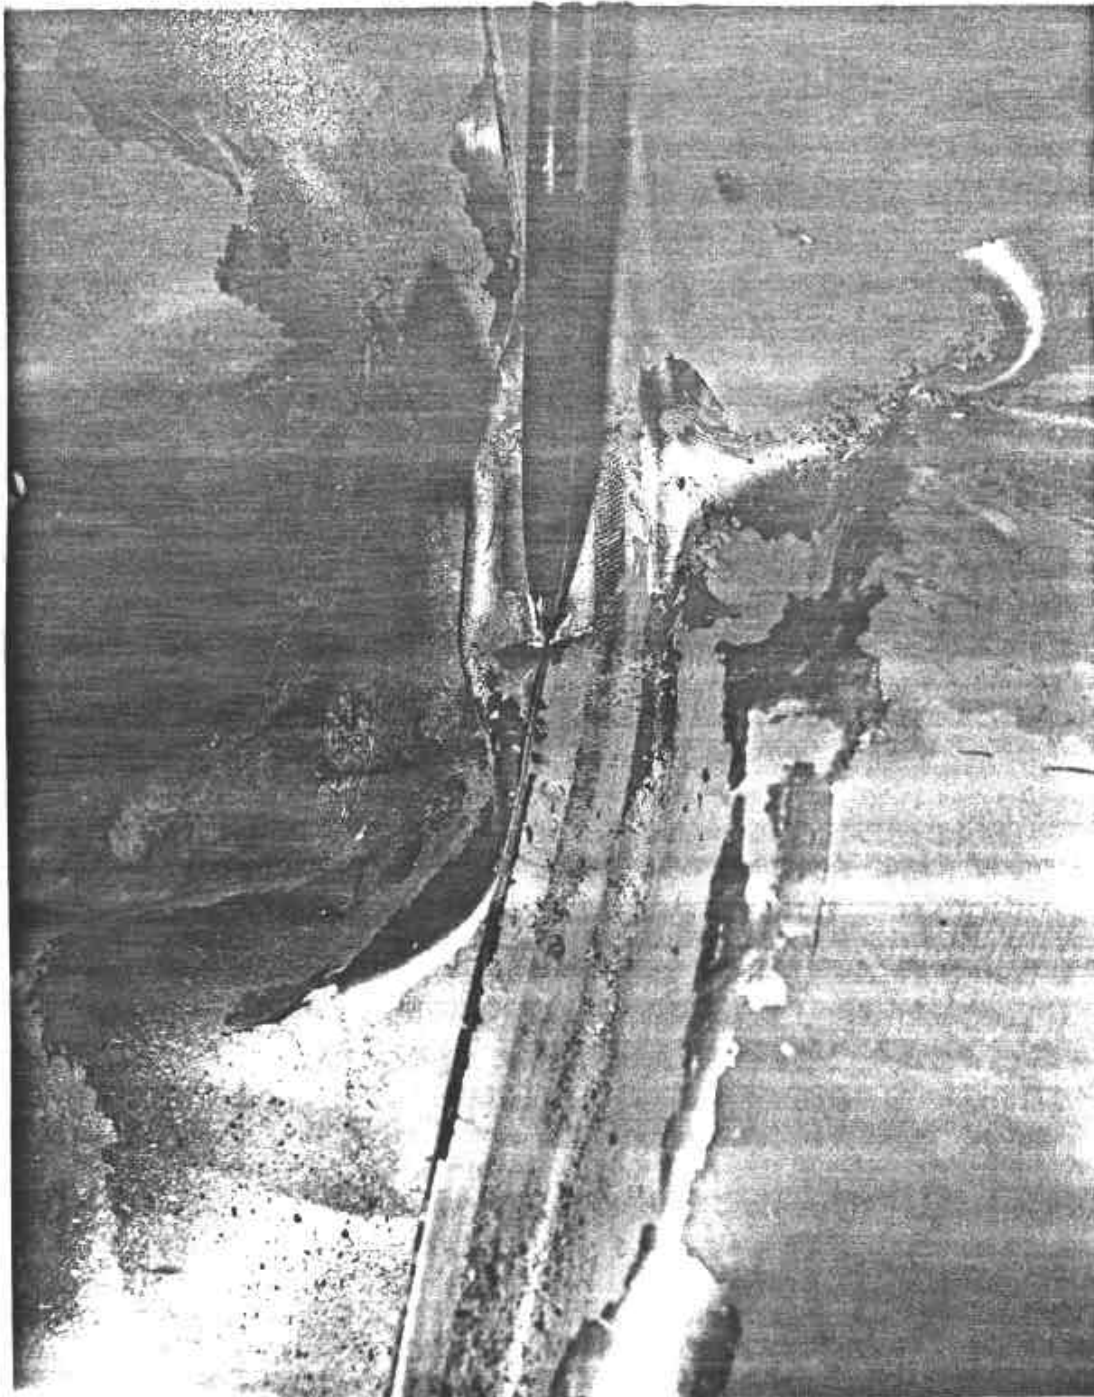
Figure 4-9. Close-up of Fuel Tank Cut - 1978 Chevrolet Monza 2+2  
Two-door Hatchback - NHTSA 780114.

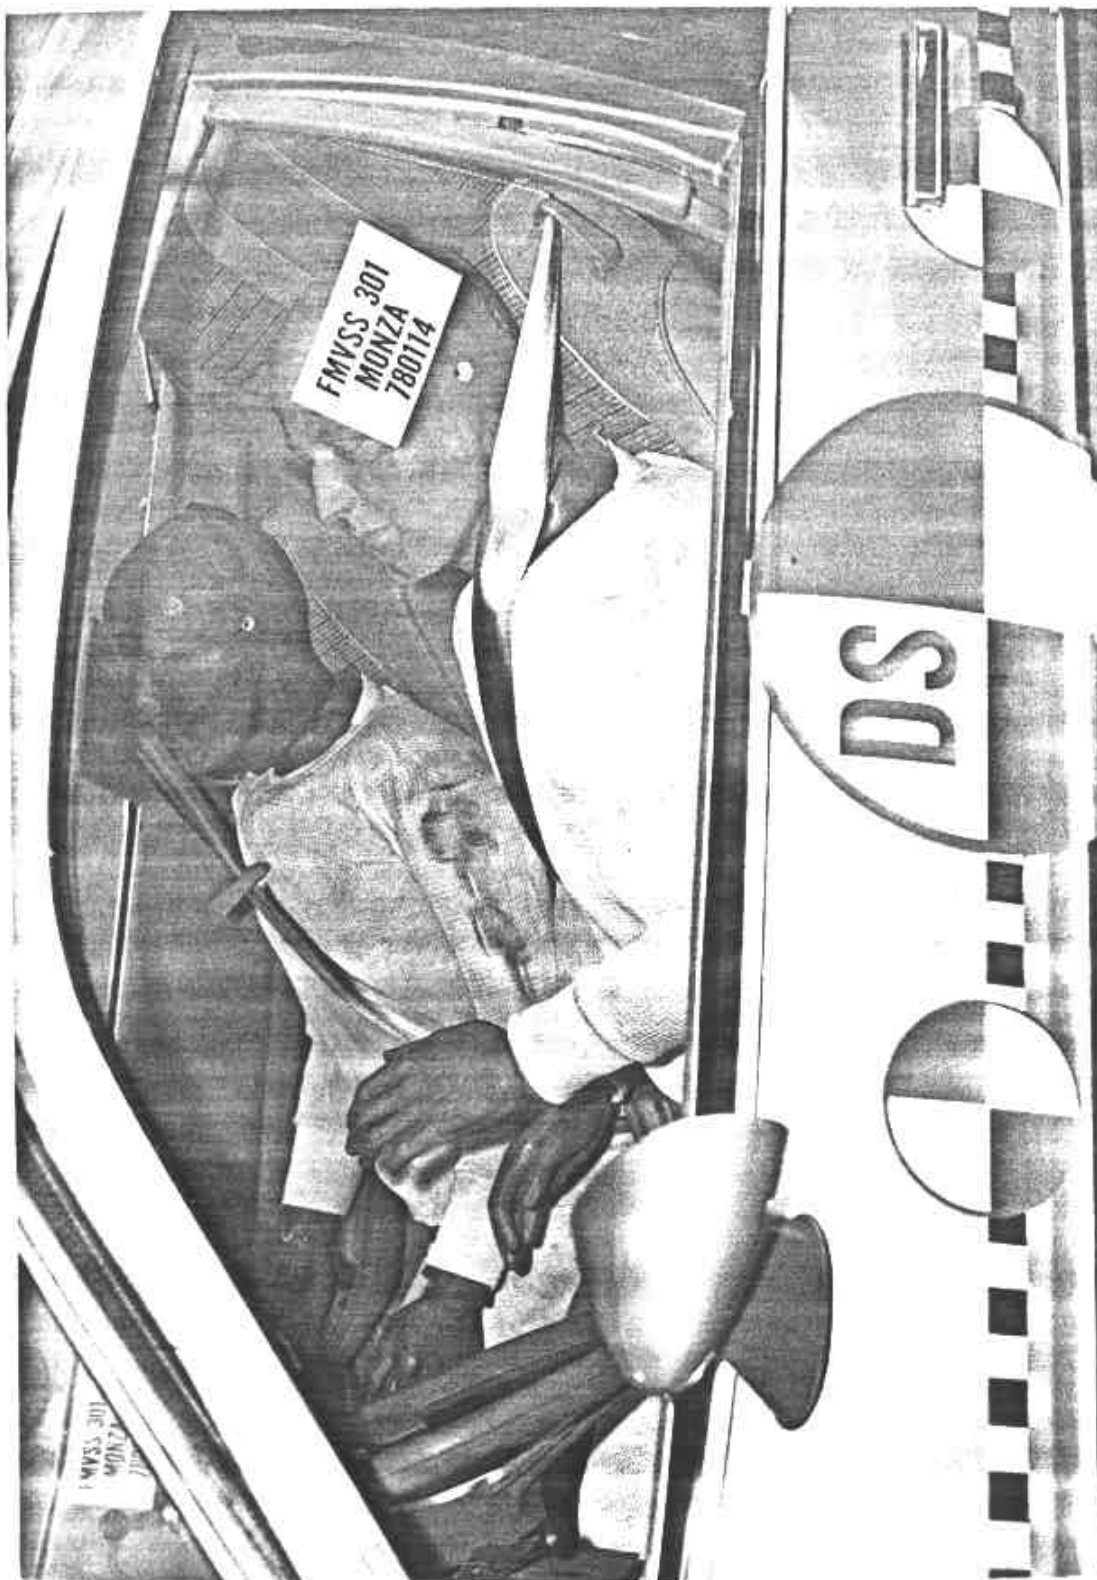
Figure 4-10. Post-test View of Dummies - 1978 Chevrolet Monza 2+2  
Two-door Hatchback - NHTSA 780114.
