Report Number 301-75-DYS-78-019

FMVSS 301-75 STANDARDS ENFORCEMENT TESTING  
OF FUEL SYSTEM INTEGRITY

BMW of North America  
1978 BMW 320i Two-Door Sedan  
NHTSA 780513

FINAL REPORT

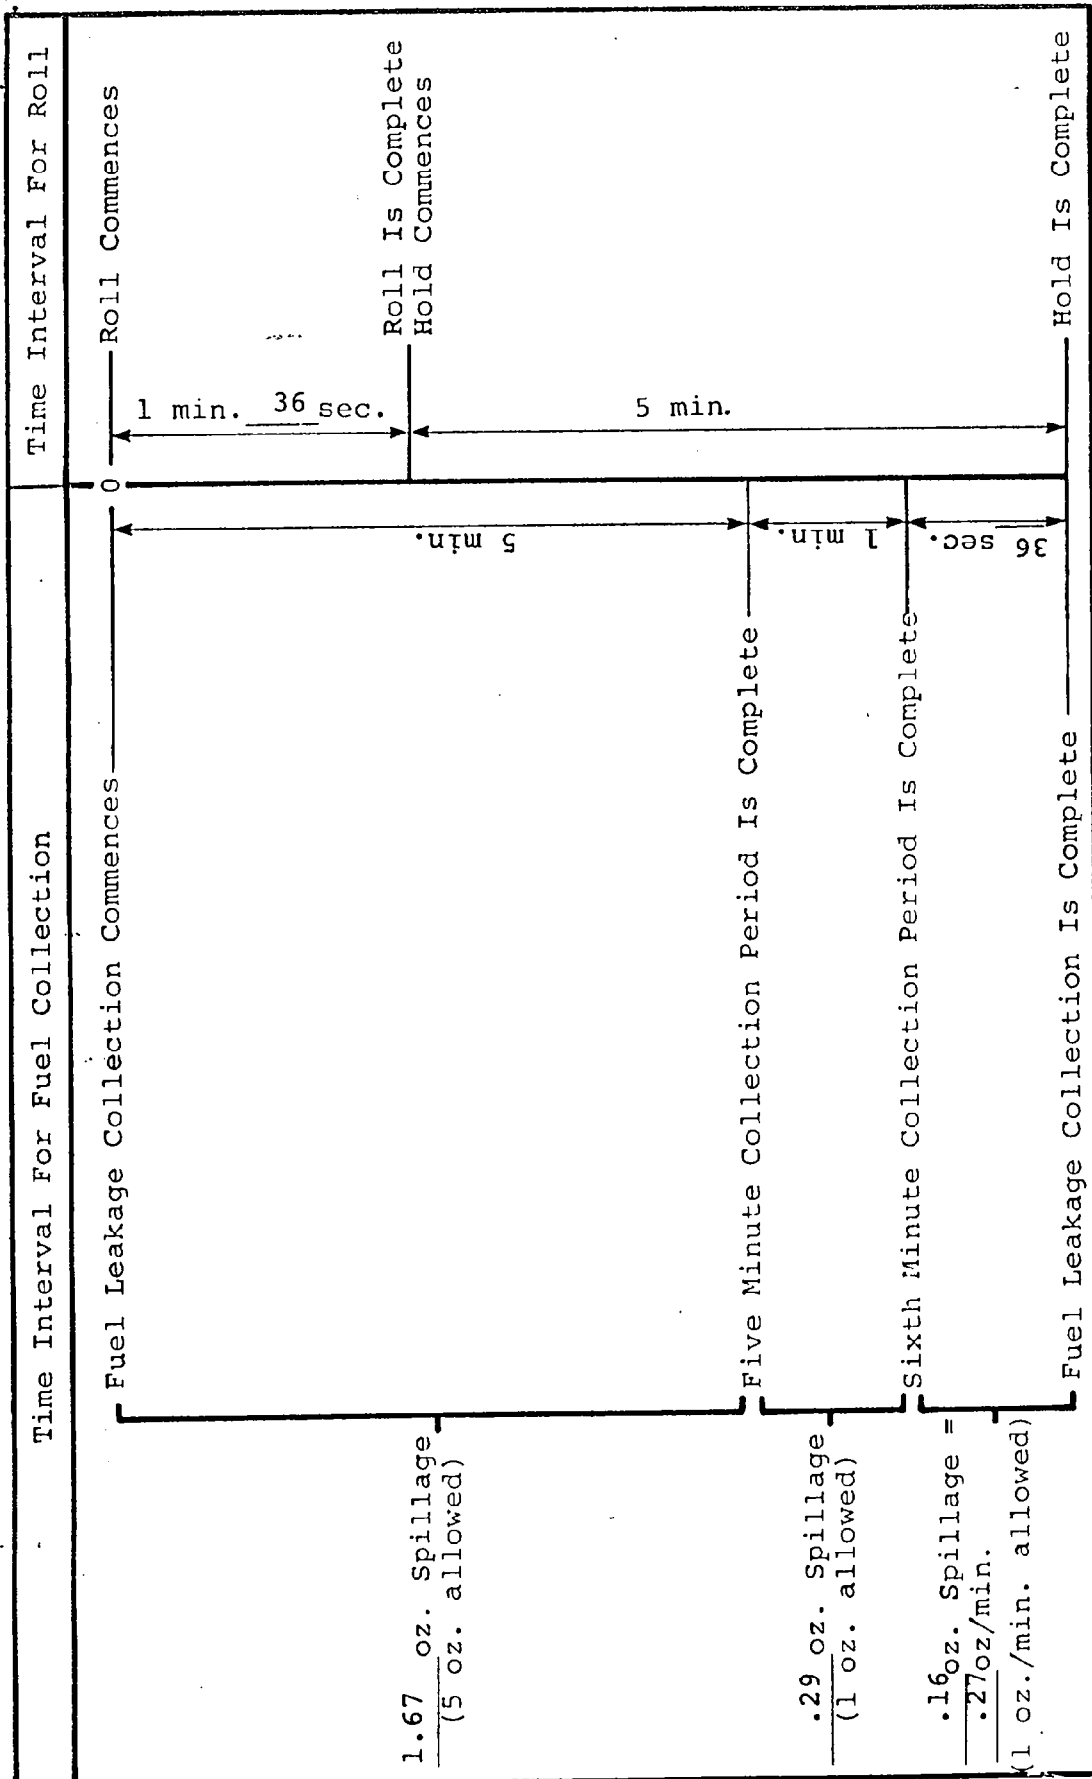
Figure 2-1. Time Relationship Between Fuel Collection Period and 180° to 270° Static Roll Period - 1978 BMW 320i Two-Door Sedan, NHTSA 780513.

No fuel spillage occurred during and following barrier impact. Fuel spillage during the static rollover was within the amount allowed, an example of which is illustrated graphically in Figure 2-1.

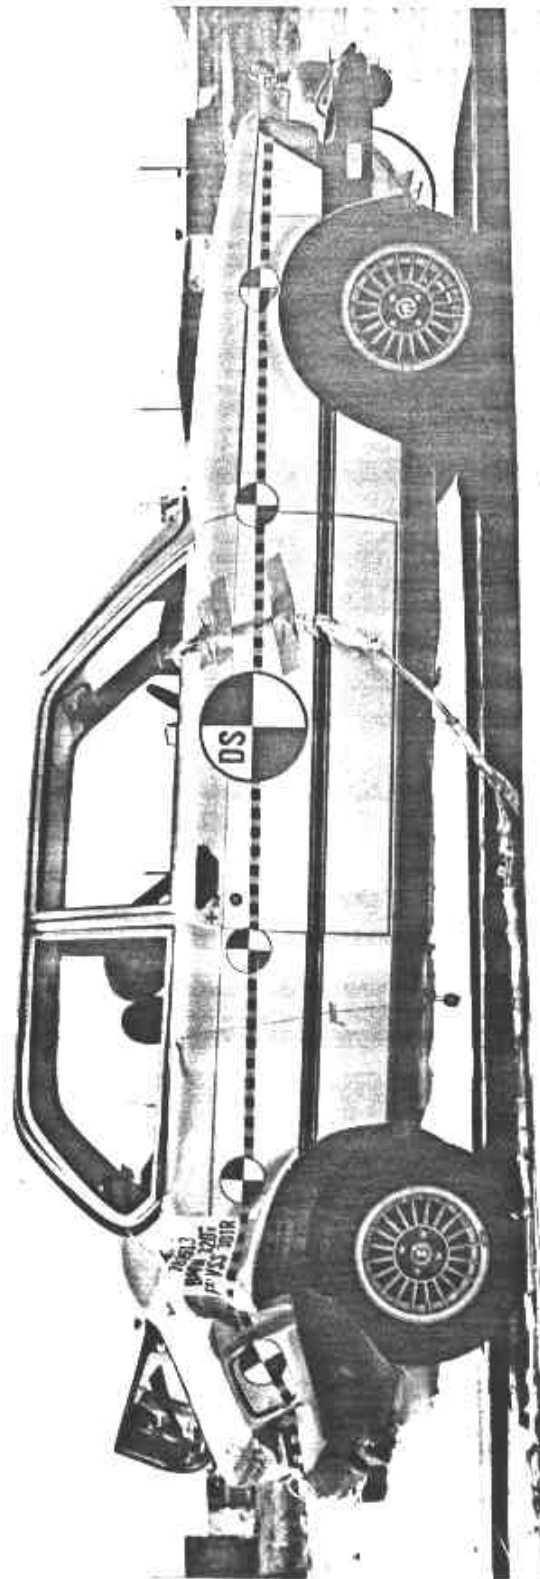
Figure 4-2. Post-test Side View - 1978 BMW 320i Two-Door Sedan -  
NHTSA 780513.

Body buckled to point just forward of rear wheel wells.

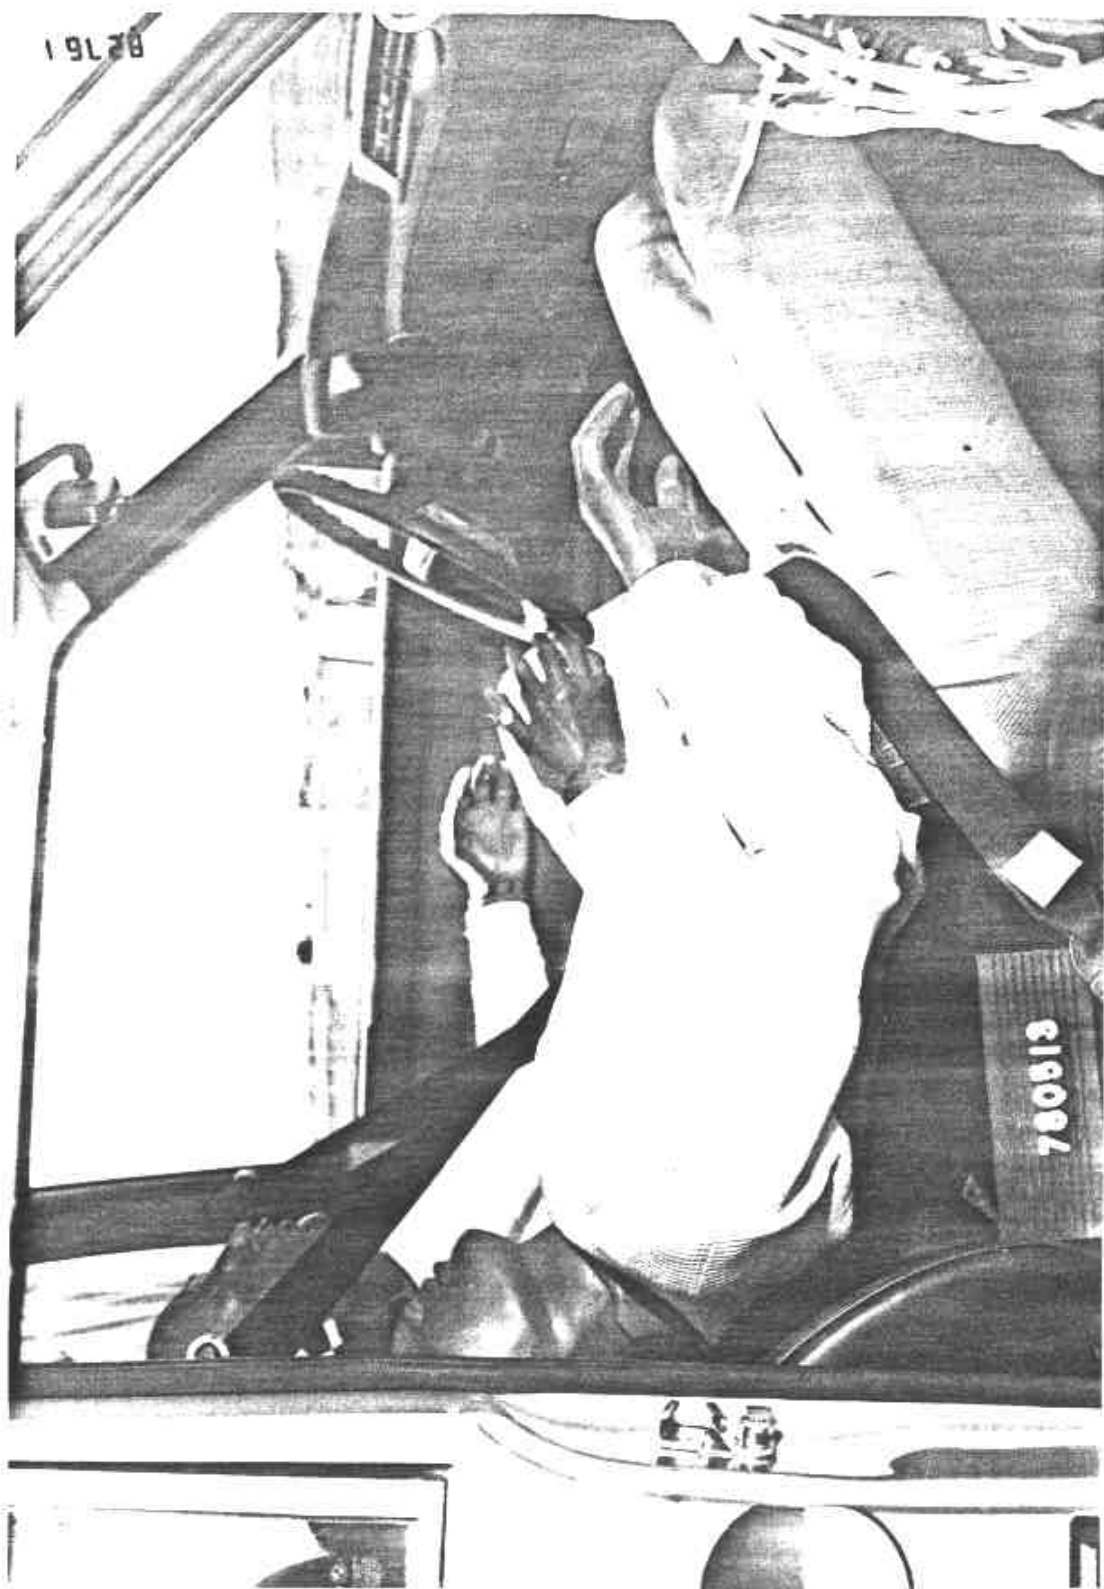
Figure 4-7. Post-test View of Dummies - 1978 BMW 320i Two-Door Sedan - NHTSA 780513.

Seat backs did not deform, but seats came off tracks (moved 8  
inches rearward).

Left seat bent the track attached to the floor.

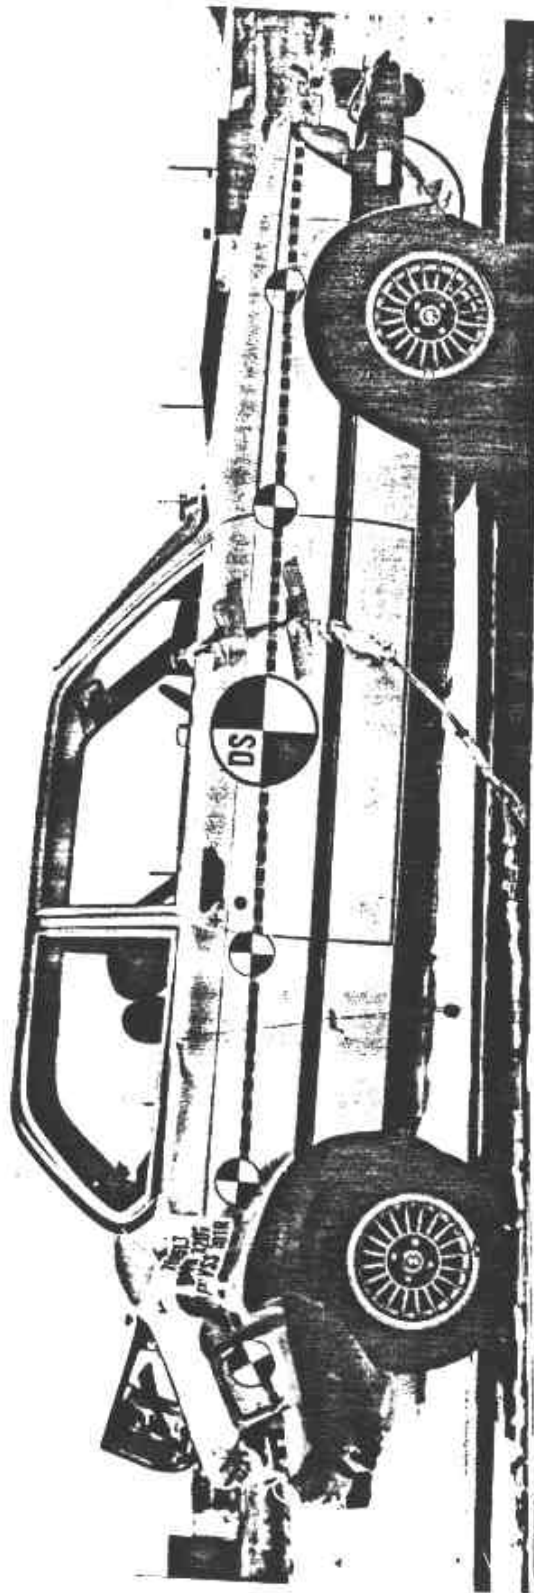
Figure 4-2. Post-test Side View - 1978 BMW 320i Two-Door Sedan -  
NHTSA 780513.

1. Rear end of BMW was demolished
2. Seats came off tracks and moved 8" forward  
(see page 3-6 of report)
3. Left seat bent track attached to floor
4. Vehicle body buckled just forward of rear wheel wells.
