TEST REPORT NO. 2  
STRAIGHT SIDE IMPACTOR-TO  
MODIFIED VW RABBIT  
FRONT-TO-SIDE TESTS @ 60°

TESTS 8327-6.5 AND 8327-6.6  
APPENDICES A, B, C, D, E, F

CONTRACT NO. DOT-HS-8-01933 (II)

U.S. DEPARTMENT OF TRANSPORTATION  
NATIONAL HIGHWAY TRAFFIC SAFETY ADMINISTRATION  
WASHINGTON, D.C. 20590

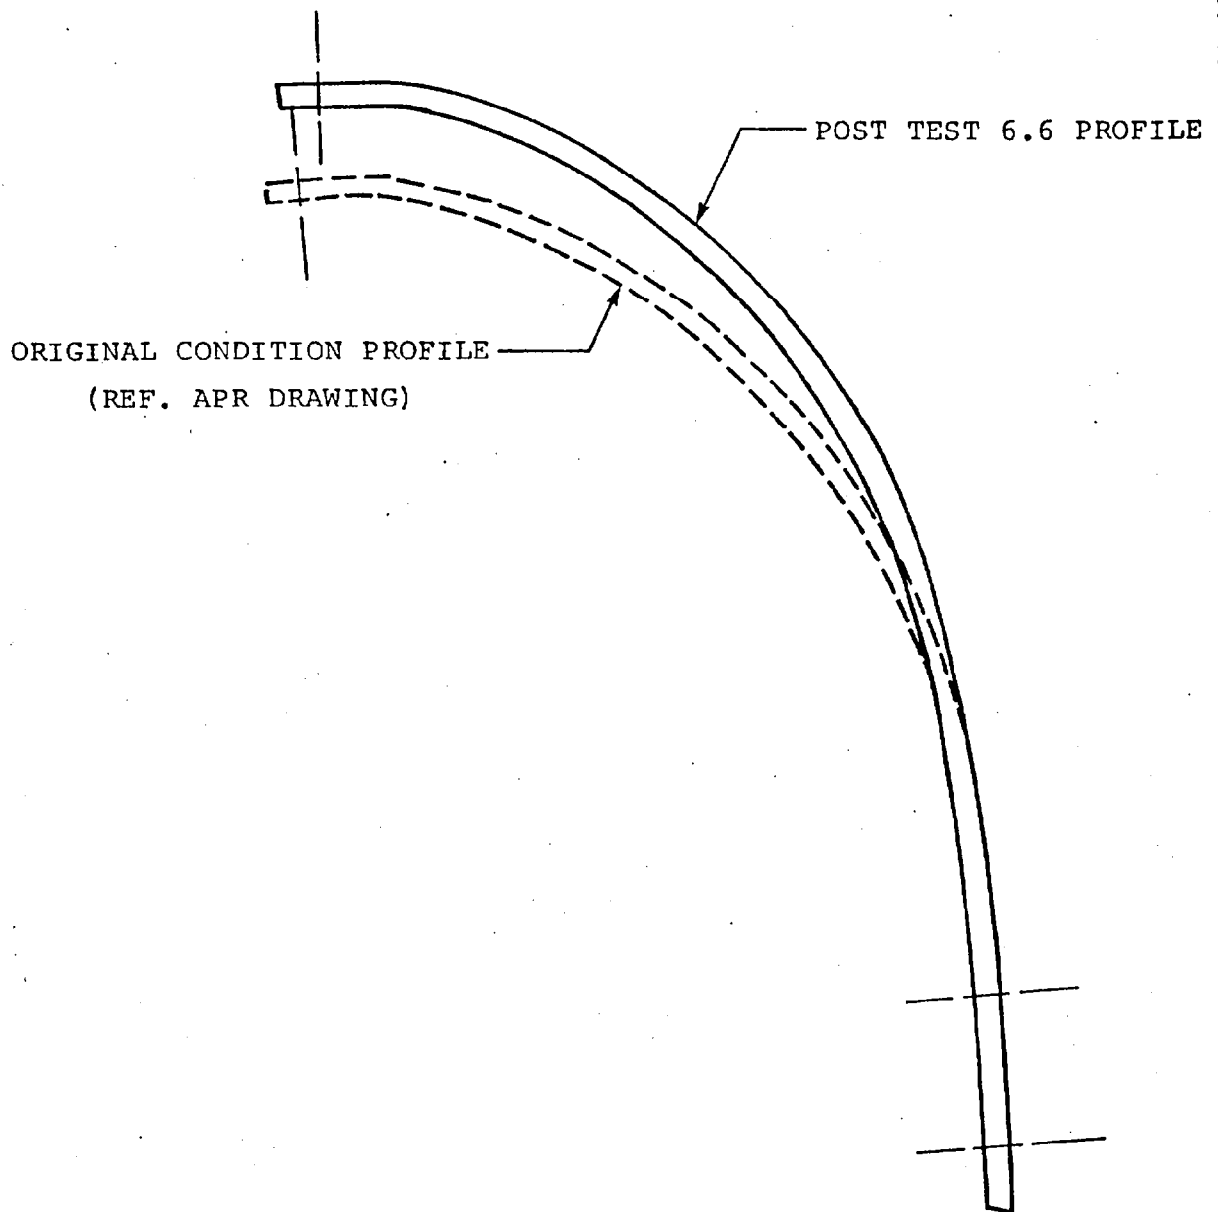
FIGURE 4-12. PRE- AND POST-TEST PROFILES SHOWING SIGNIFICANT DEFORMATION OF RIB 5R.

1. Upper and lower rib dampers jammed.
2. Leather breast plate cut along lower edge, in area adjacent to bottom edge of lower rib.
3. Vertical cut in leather breast plate on right side between second and fourth ribs.
4. Rib cage suffered deformation as noted below:
  - Significant deformation - 4R, 5R, 5L
  - Noticeable deformation - 1R, 3R, 1L, 3L, 4L
  - No apparent deformation - 2R, 6R, 2L, 6L

Figure 4-12 presents a sketch showing rib 5R in original condition and post-test 6.6 condition.

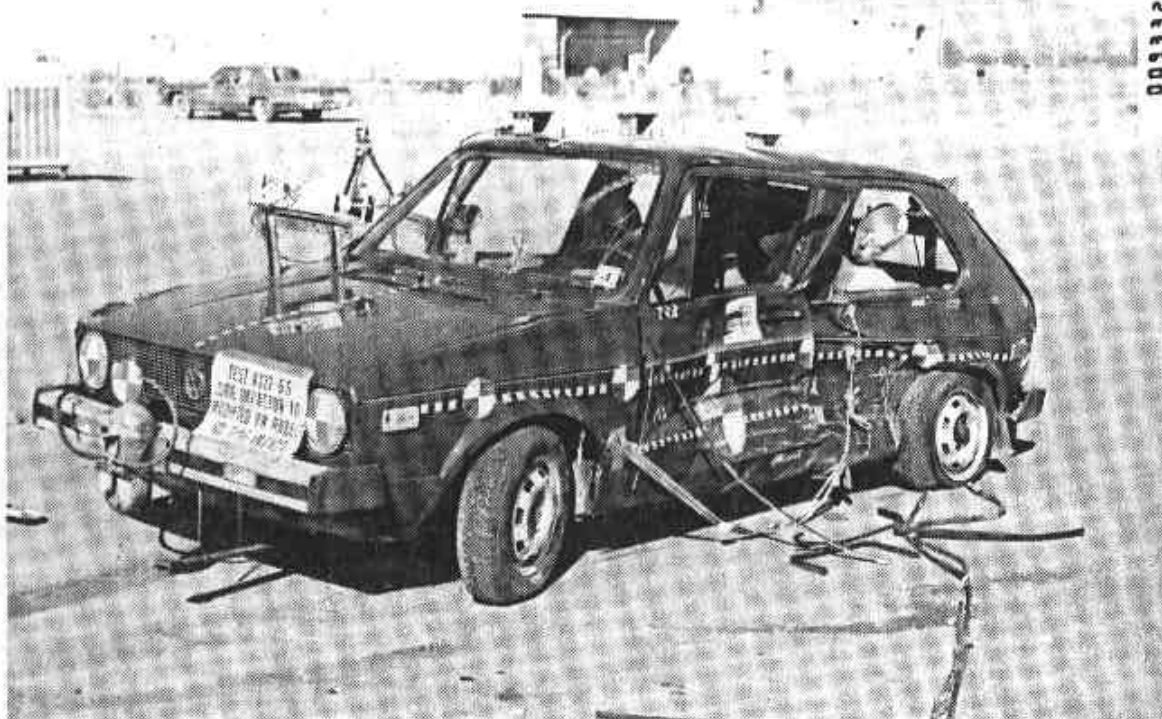
FIGURE 4-13. POST-TEST VW RABBIT FRONT THREE-QUARTER VIEW (TEST 6.6).

Glazing: Windshield cracked along left side, especially upper left corner. Left side door window shattered. Left rear window forced out of frame. All other glass remained retained and unbroken.

Doors: Left side door and "B" pillar severely damaged; door partly open post-test. Right side door operated normally.

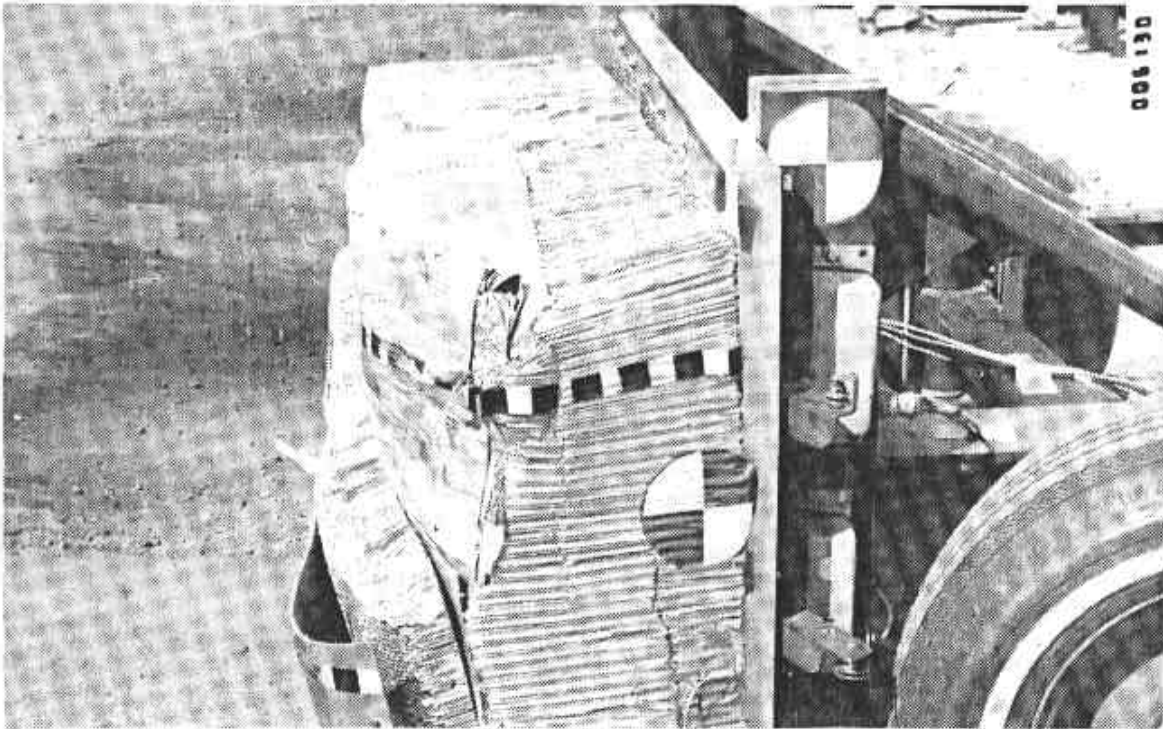
FIGURE 5-31. SIDE IMPACTOR "HOOD" SURFACE DEFORMATION (TESTS 6.1 AND 6.6).

Side Impactor Face because, in all six tests, the "hood" surface buckled and bent instead of bowing up, as was noted in the Task 5 component testing (Reference 3). This has resulted in the surface becoming a series of very stiff ridges of sheet aluminum, as shown in Figure 5-31, by the time a head strike occurs, and could result in a somewhat stiffer surface than was originally designed for when the aluminum was intended to bow up.

From the analysis presented in Section 5.2, it may be concluded that the Task 5 design changes have resulted in increased face stiffness as was desired. However, in Tests 6.1 through 6.6, the "hood" surface did not bow up in the desired manner. It is recommended that the "hood" surface be extended all the way back to the two inch aluminum mounting plate in order to provide more material between the front face sheet and the rear anchor point. This change should produce bending characteristics closer to that desired.
