NEW VEHICLE ASSESSMENT AND STANDARDS
ENFORCEMENT INDICANT TESTING
FMVSS NOS. 212, 219, AND 301-75

Ford-Werke AG
1979 Ford Fiesta
NHTSA - 790547

FINAL REPORT

1. REPORT NO. 212-MSE-79-004-TR-04 219-MSE-79-004-TR-04 301-MSE-79-004-TR-04		2. GOVERNMENT ACCESSION NO.	
		3. RECIPIENT'S CATALOG NO.	
4. TITLE AND SUBTITLE Safety Compliance Test Program FMVSS 212, 219, 301-75 1979 Ford Fiesta		5. REPORT DATE October, 1979

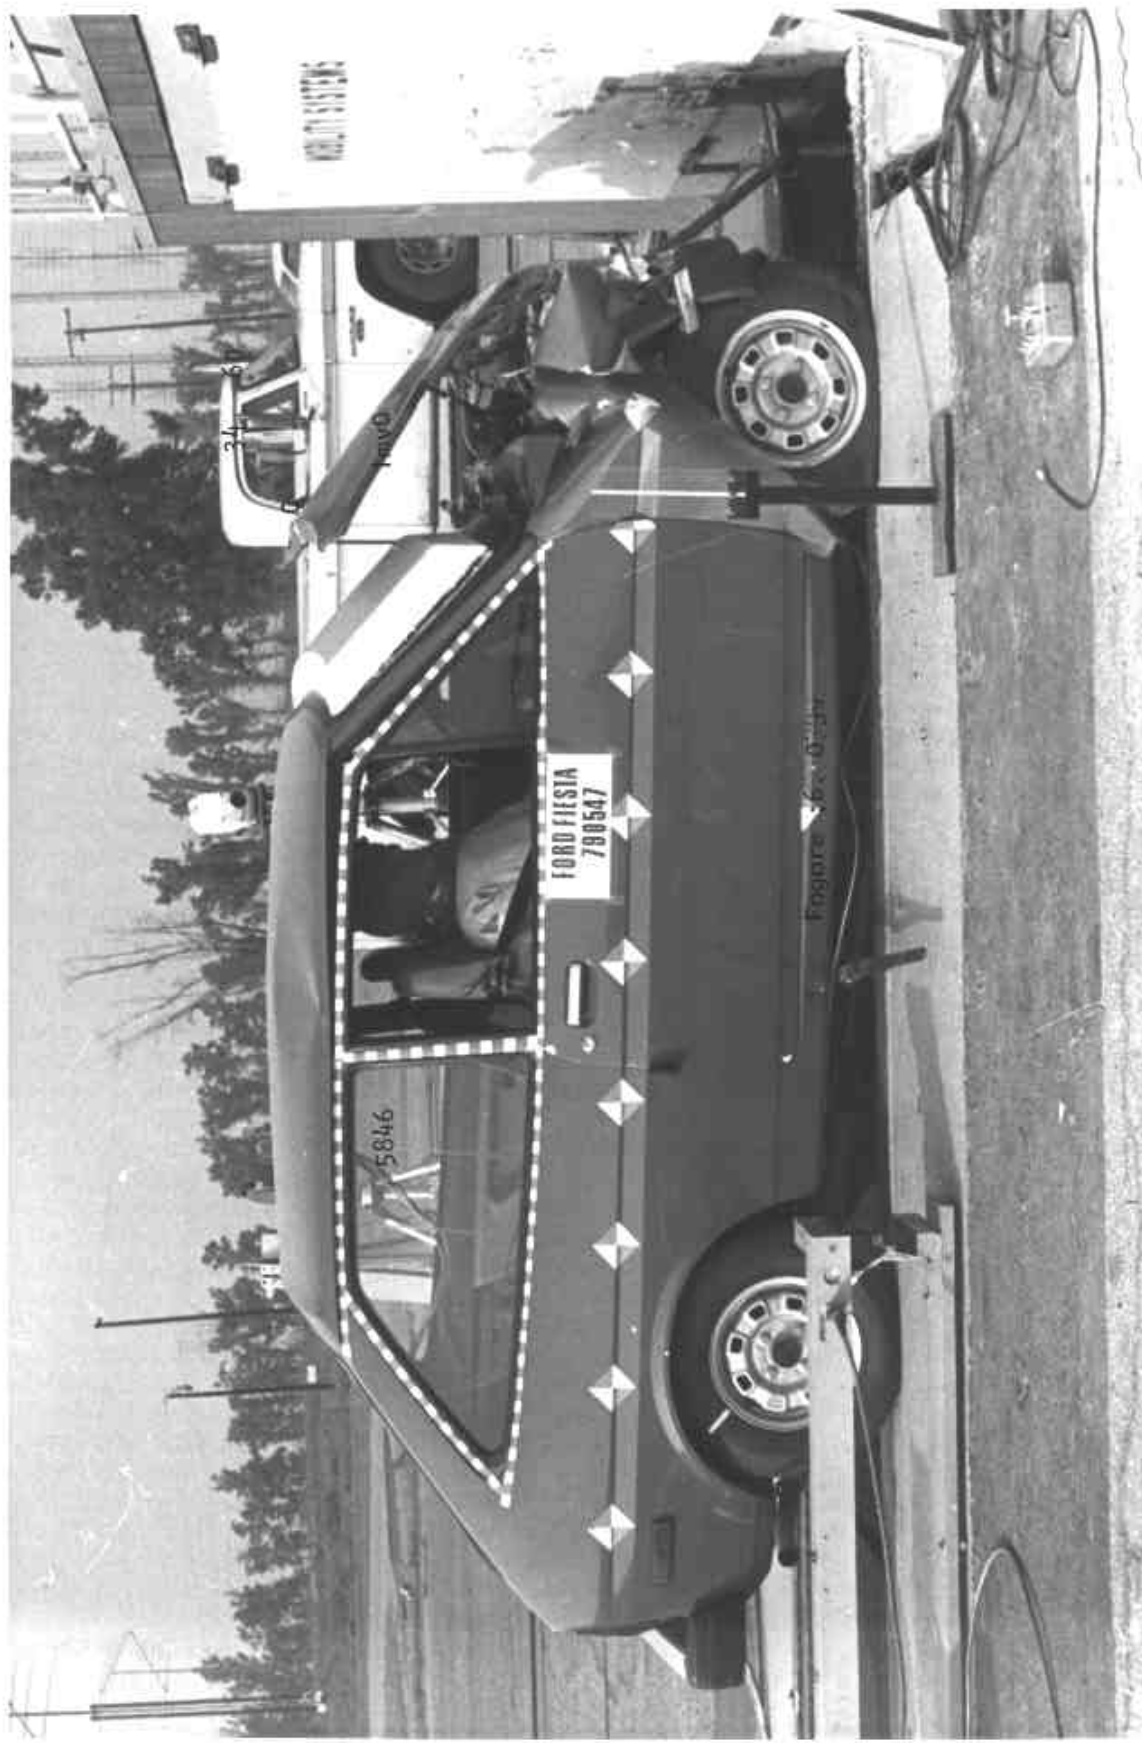
FIGURE 19 SIDE VIEW - POSTTEST

The front of the vehicle was crushed to the point where it is essentially even with the front of the tires. The front wheels were pushed rearward approximately 6" during the impact. The engine, located laterally, was pushed into the firewall for approximately 6 inches causing the firewall to buckle in towards the passenger compartment and to pull the windshield with it causing severe cracking of the windshield. The passenger compartment sustained damage but not severe. The dash panel was damaged by the impact of the occupant. The steering wheel was bent severely by the driver occupant. Not only was the wheel rim bent around the center portion of the steering column but the shaft that protrudes back from the main column was bent downward by the impact. The steering column did not break away from the dash board during the test. Some roof buckling occurred above the 'B' pillars. The doors were opened without tools.

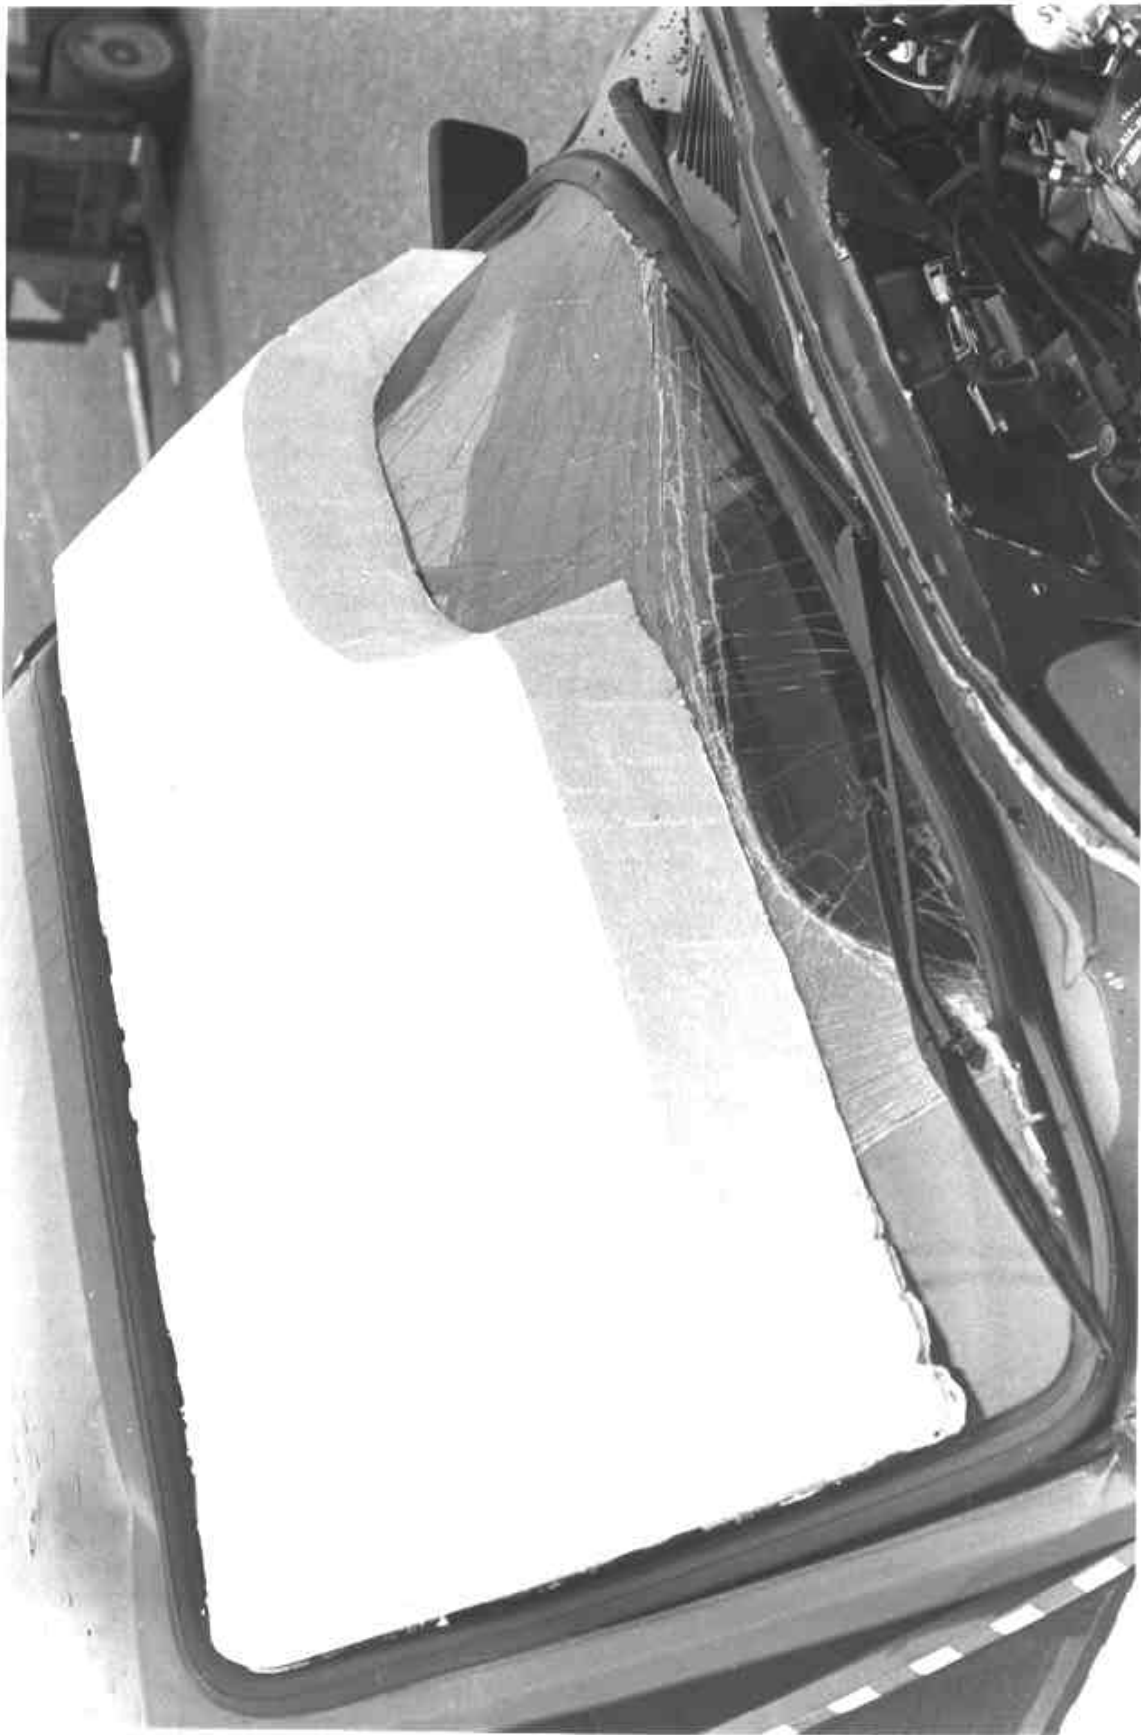
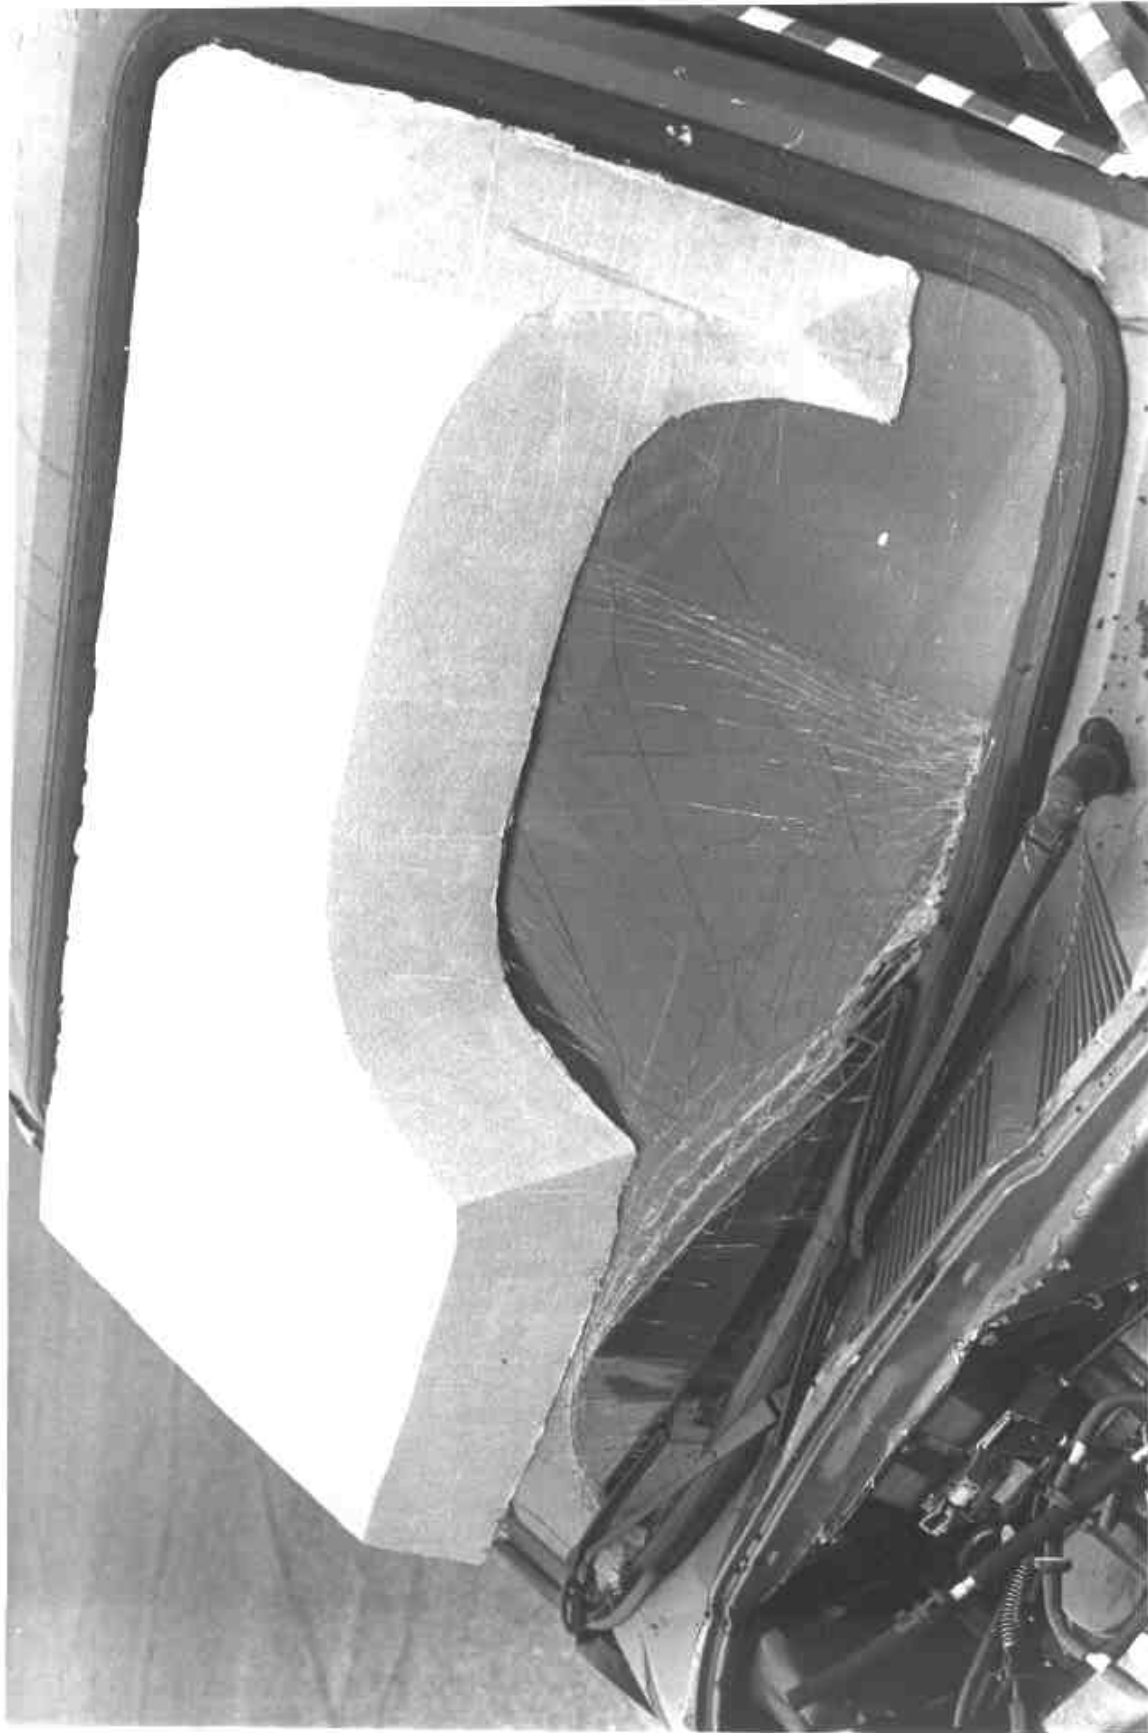
FIGURE 22 FMVSS 219 TEMPLATE - POSTTEST

The styrofoam template mounted on the windshield was not impinged by any object during the test, (see Figure 22).

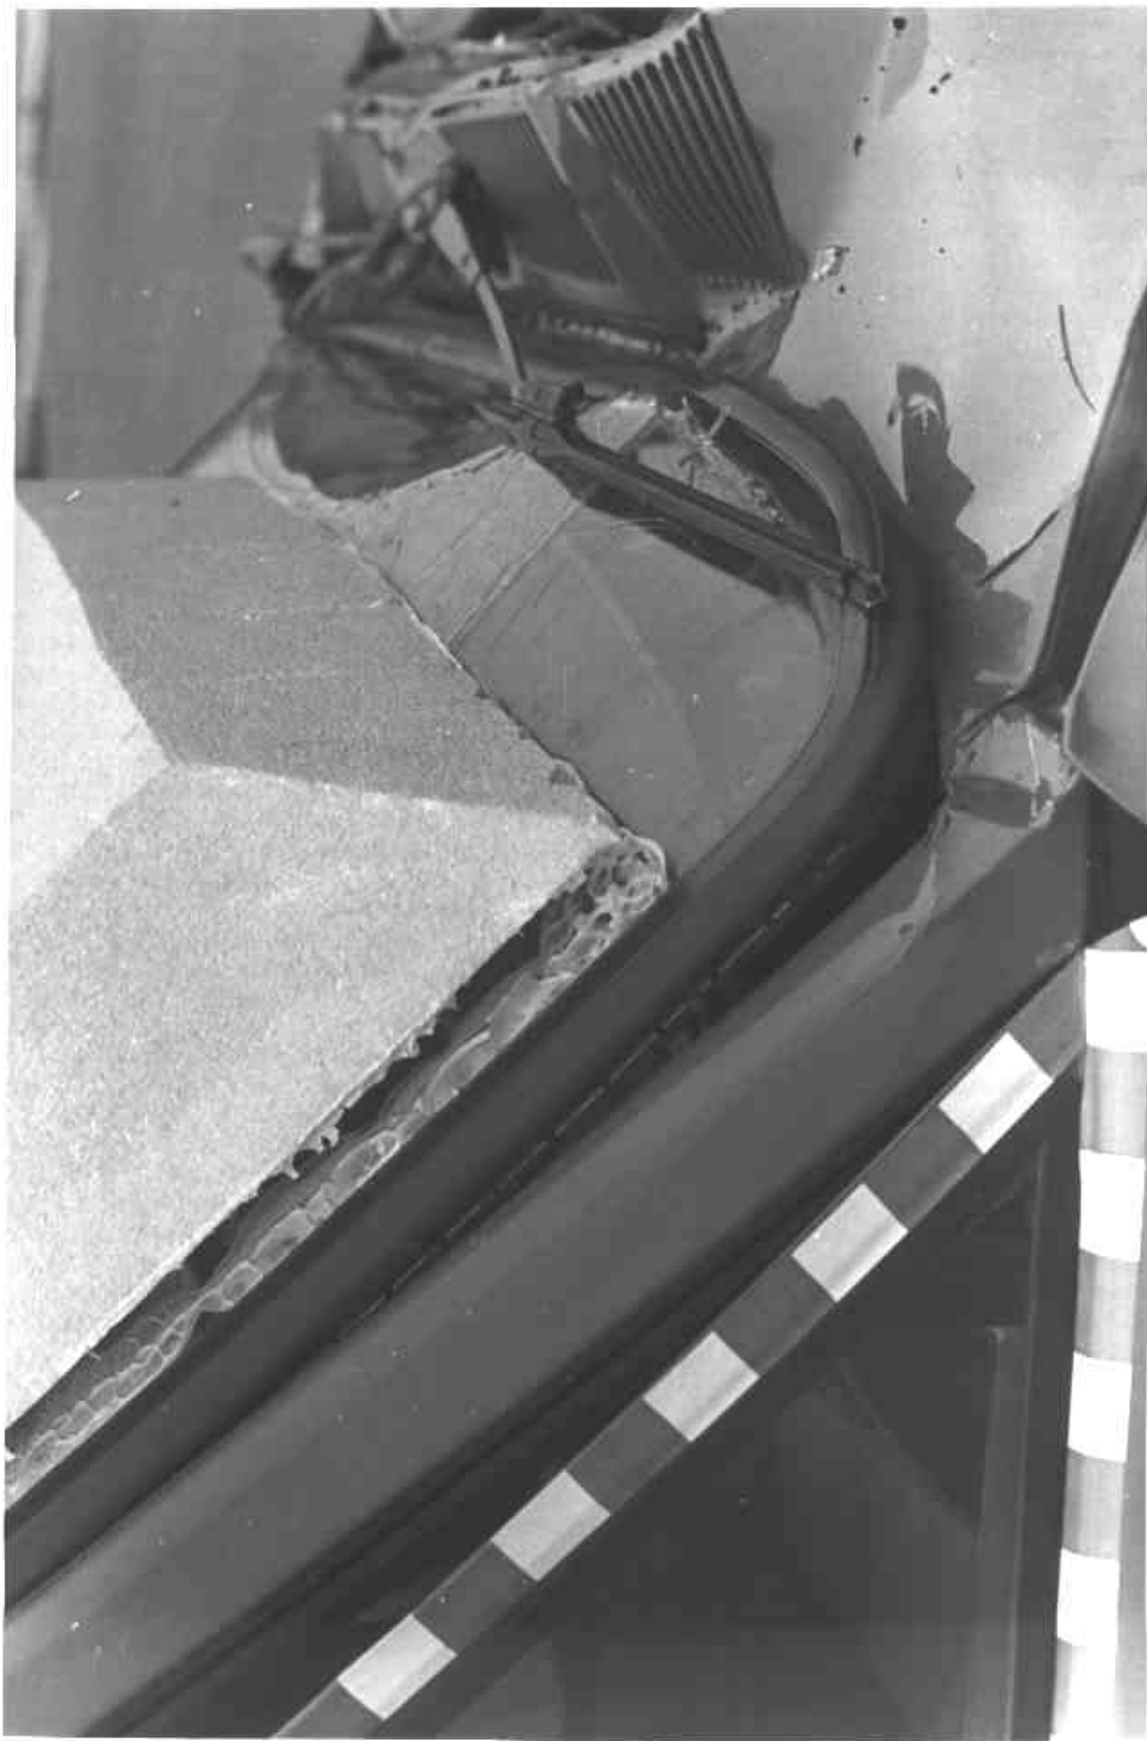
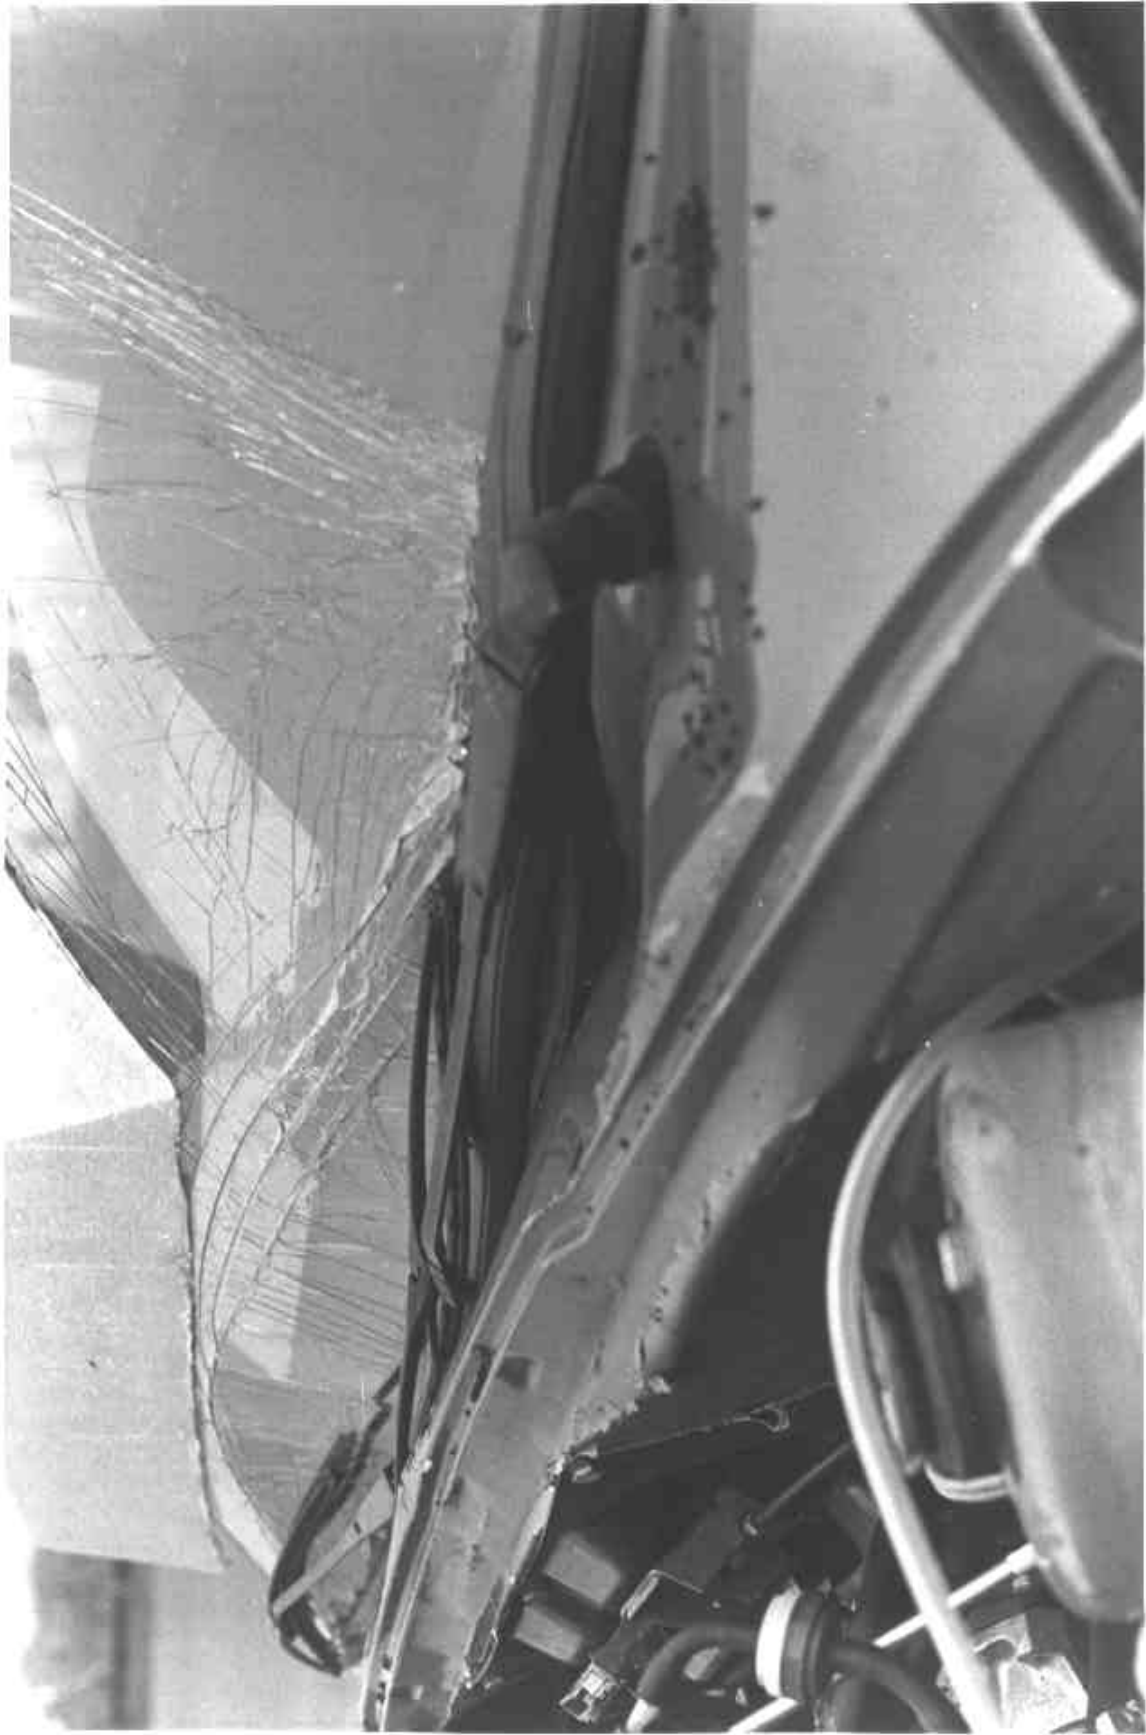
FIGURE 23 WINDSHIELD VIEW - POSTTEST

The windshield pulled away from the vehicle in the lower right hand corner and lower left half as shown in Table 7 and Figure 23. The separation occurred as a result of the clips failing that held the rubber moulding to the vehicle. The posttest retention is 81%. The windshield was heavily cracked over approximately 70% of the surface as is shown in Table 7 and Figure 22 and 23.

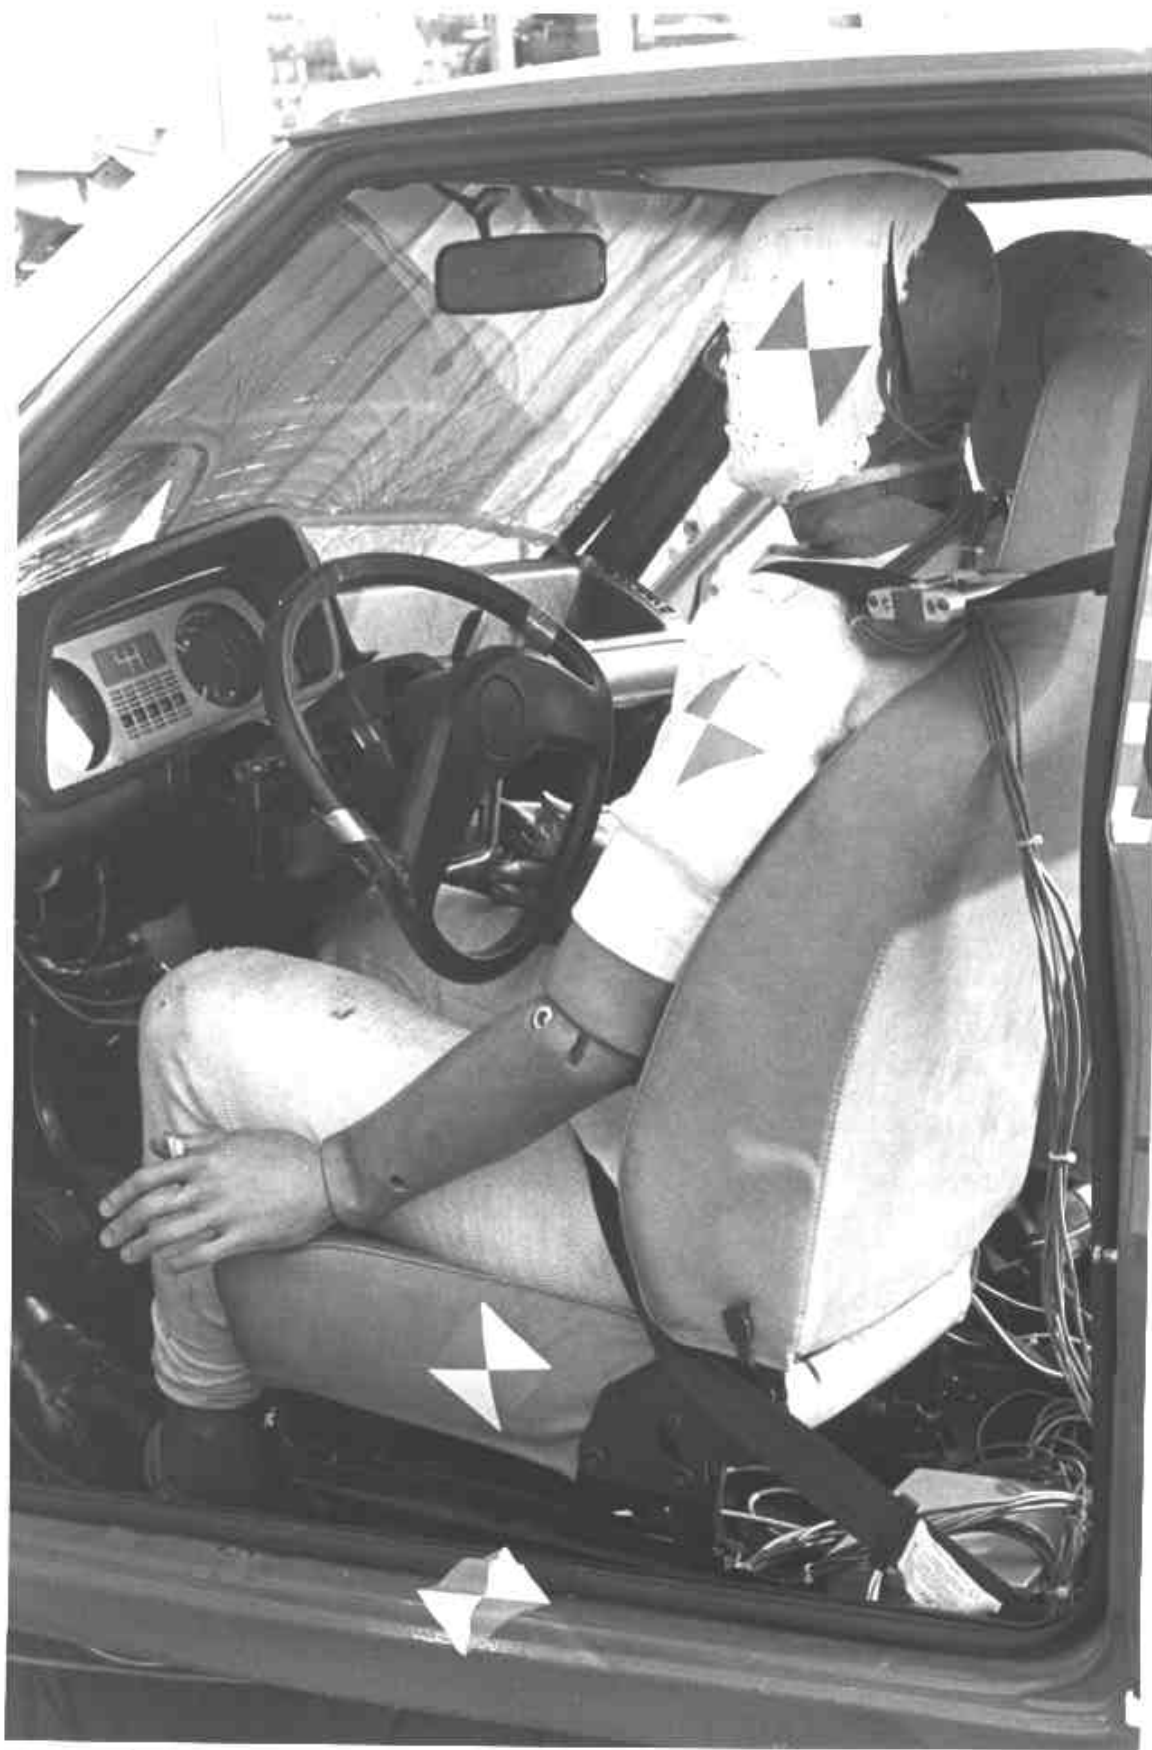
FIGURE 24 DRIVER DUMMY POSITION AND INTERIOR VIEW - POSTTEST

Posttest examination of the vehicle interior showed that the driver dummy's head struck the steering wheel at the top of the rim and the chest struck the hub and bent the lower half of the rim forward. The primary impact point for the passenger dummy's head was the top edge of the dash board. Contact was also made with the front (vertical) surface of the dash board. Posttest photographs of the dummies are shown in Figure 24. The damage to the instrument panel and dash board are also shown in Figure 24. As is shown the steering column remained attached to the instrument panel. The steering column shows very little collapse if any and the end of the column, where the steering wheel is attached, was bent downward significantly by the impact.
