# **CALSPAN ADVANCED TECHNOLOGY CENTER**

## **IMPROVED LIGHTWEIGHT SUBCOMPACT SIDE STRUCTURE CRASH TEST REPORT**

Calspan Report No. 6225-V-22

TEST: TEST NO. 19  
TYPE OF TEST: CAR-TO-CAR FRONT-TO-SIDE OBLIQUE  
TEST DATE: 15 JANUARY 1981

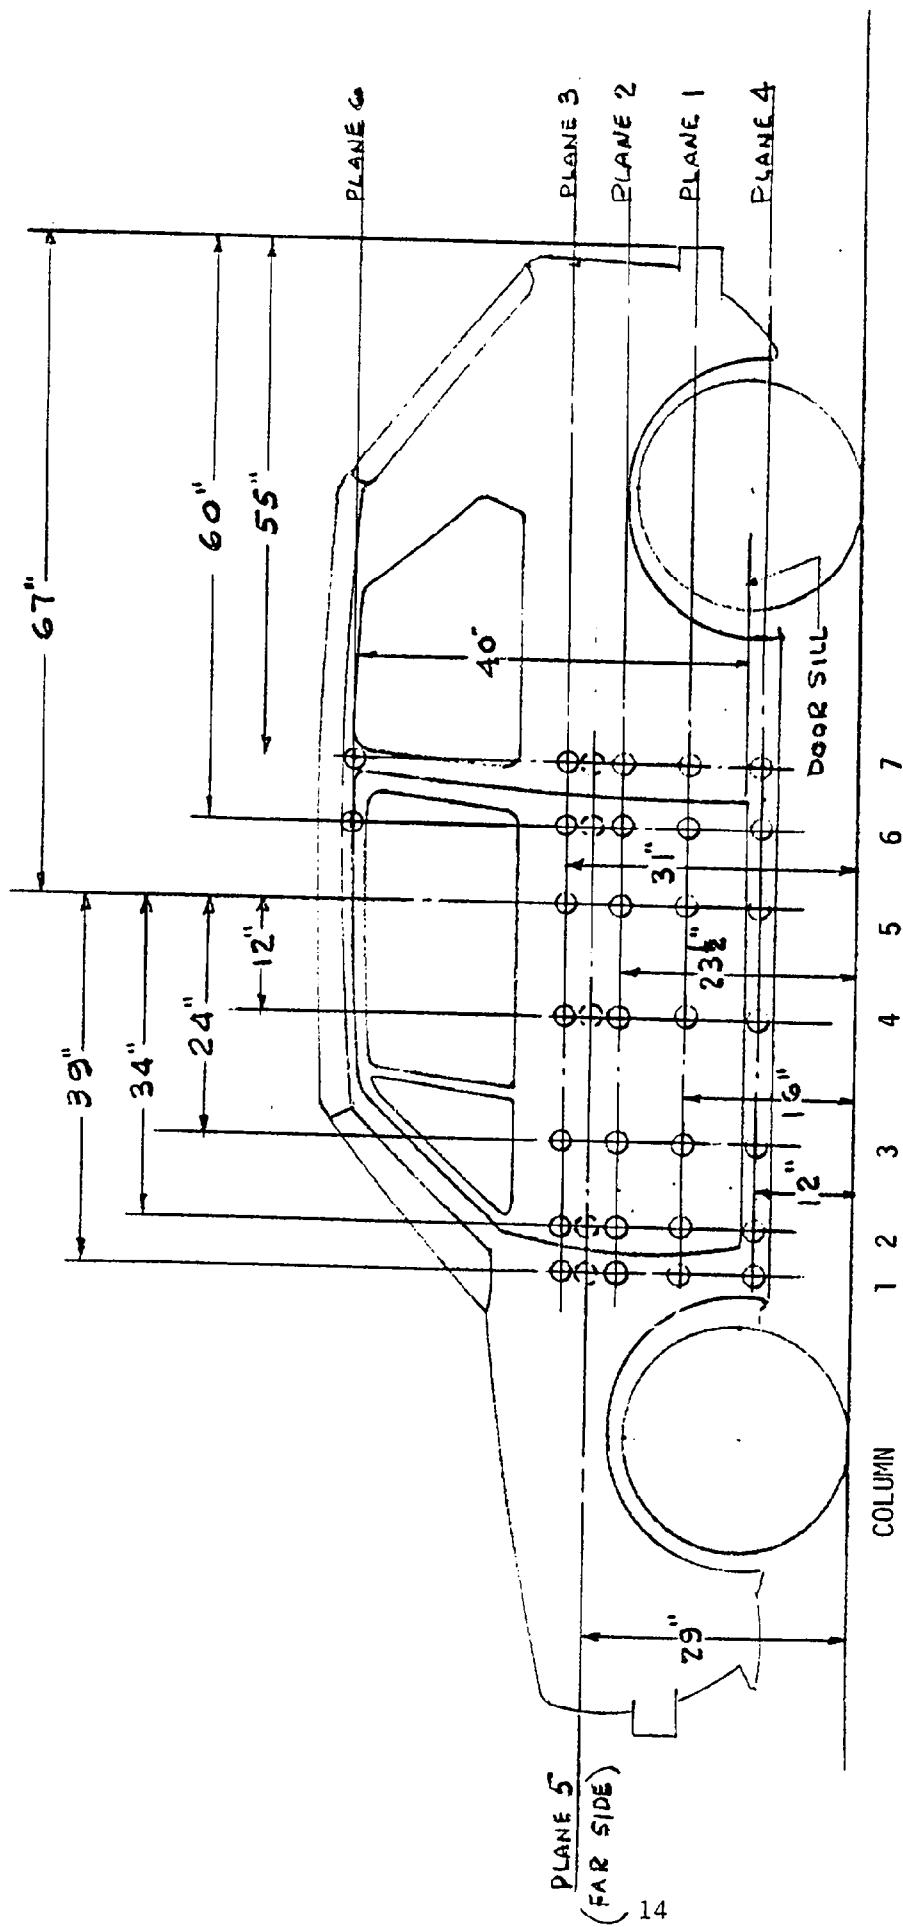
Figure 10 SIDE INTRUSION MEASUREMENT LOCATIONS

DIMENSIONS LISTED BELOW ARE FROM POINTS SHOWN ON FIG. 10 TO REF. PLANES  
LOCATED PARALLEL TO AND OUTBOARD FROM  $\phi$  OF VEHICLE (L. SIDE 34" - R. SIDE 34")

Where:  $E_1$  = pre-test exterior surface (Table 3)  
 $E_2$  = post-test exterior surface (Table 3)  
 $I_1$  = pre-test door thickness (Table 4)  
 $I_2$  = post-test door thickness (Table 4)  
 $\text{Intrusion} = (E_2 + I_2) - (E_1 + I_1)$   
 $\therefore \text{Intrusion} = (E_2 - E_1) + (I_2 - I_1)$
