REPORT NO. 301-AETL-81-040-971-3882-40

NEW VEHICLE ASSESSMENT
AND
STANDARDS ENFORCEMENT INDICANT TESTING

FMVSS 301-75

ISUZU MOTORS LIMITED
1981 ISUZU I-MARK DELUXE - 2 DOOR COUPE
NHTSA 810503

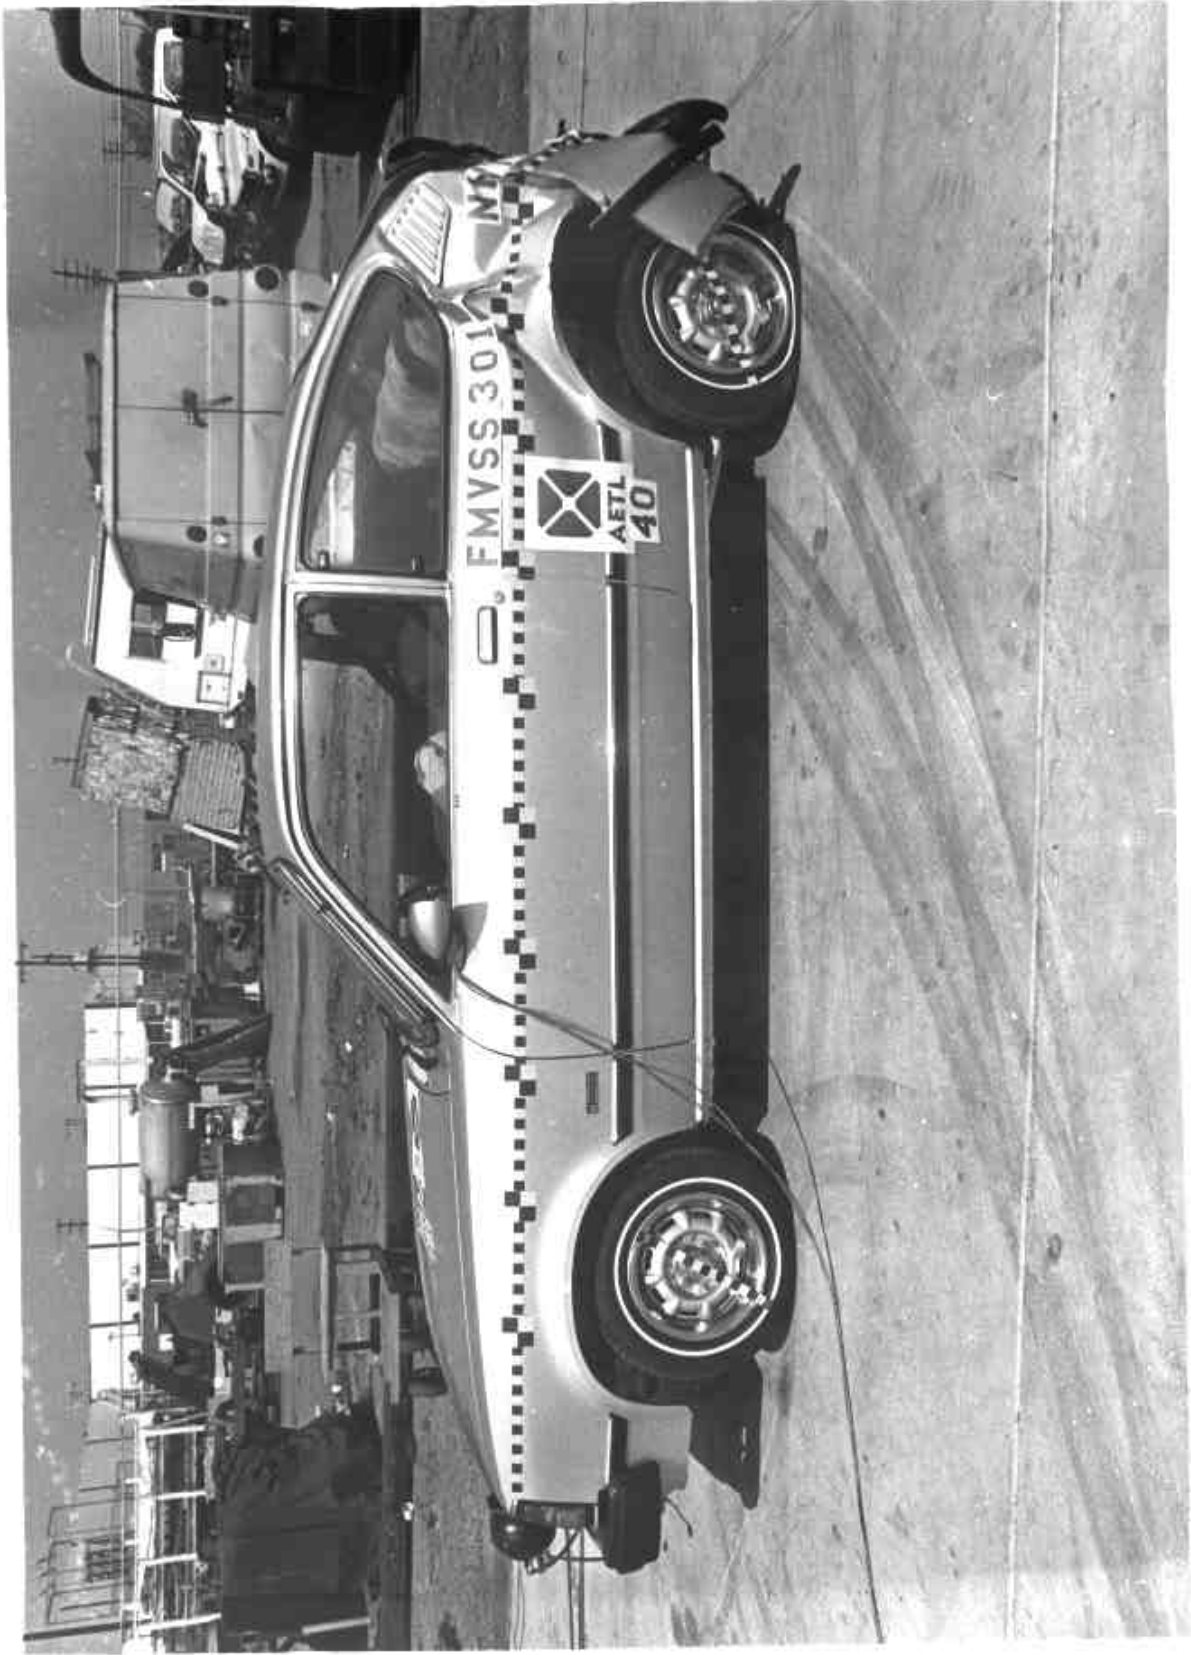
Figure 3-4

Post-impact inspection of the test vehicle revealed almost all crush occurred rearward of the front doors. The trunk floor pan collapsed to ground level and jammed both rear wheels. The left rear tire was flat and the rear window shattered. Both front seat backs bent backward and the passenger seat assembly twisted inward. The driver dummy head made contact with the rear seat back cushion, while the passenger dummy head made contact with the roof headliner and the rear seat back cushion.

Post-Impact, Left Side View

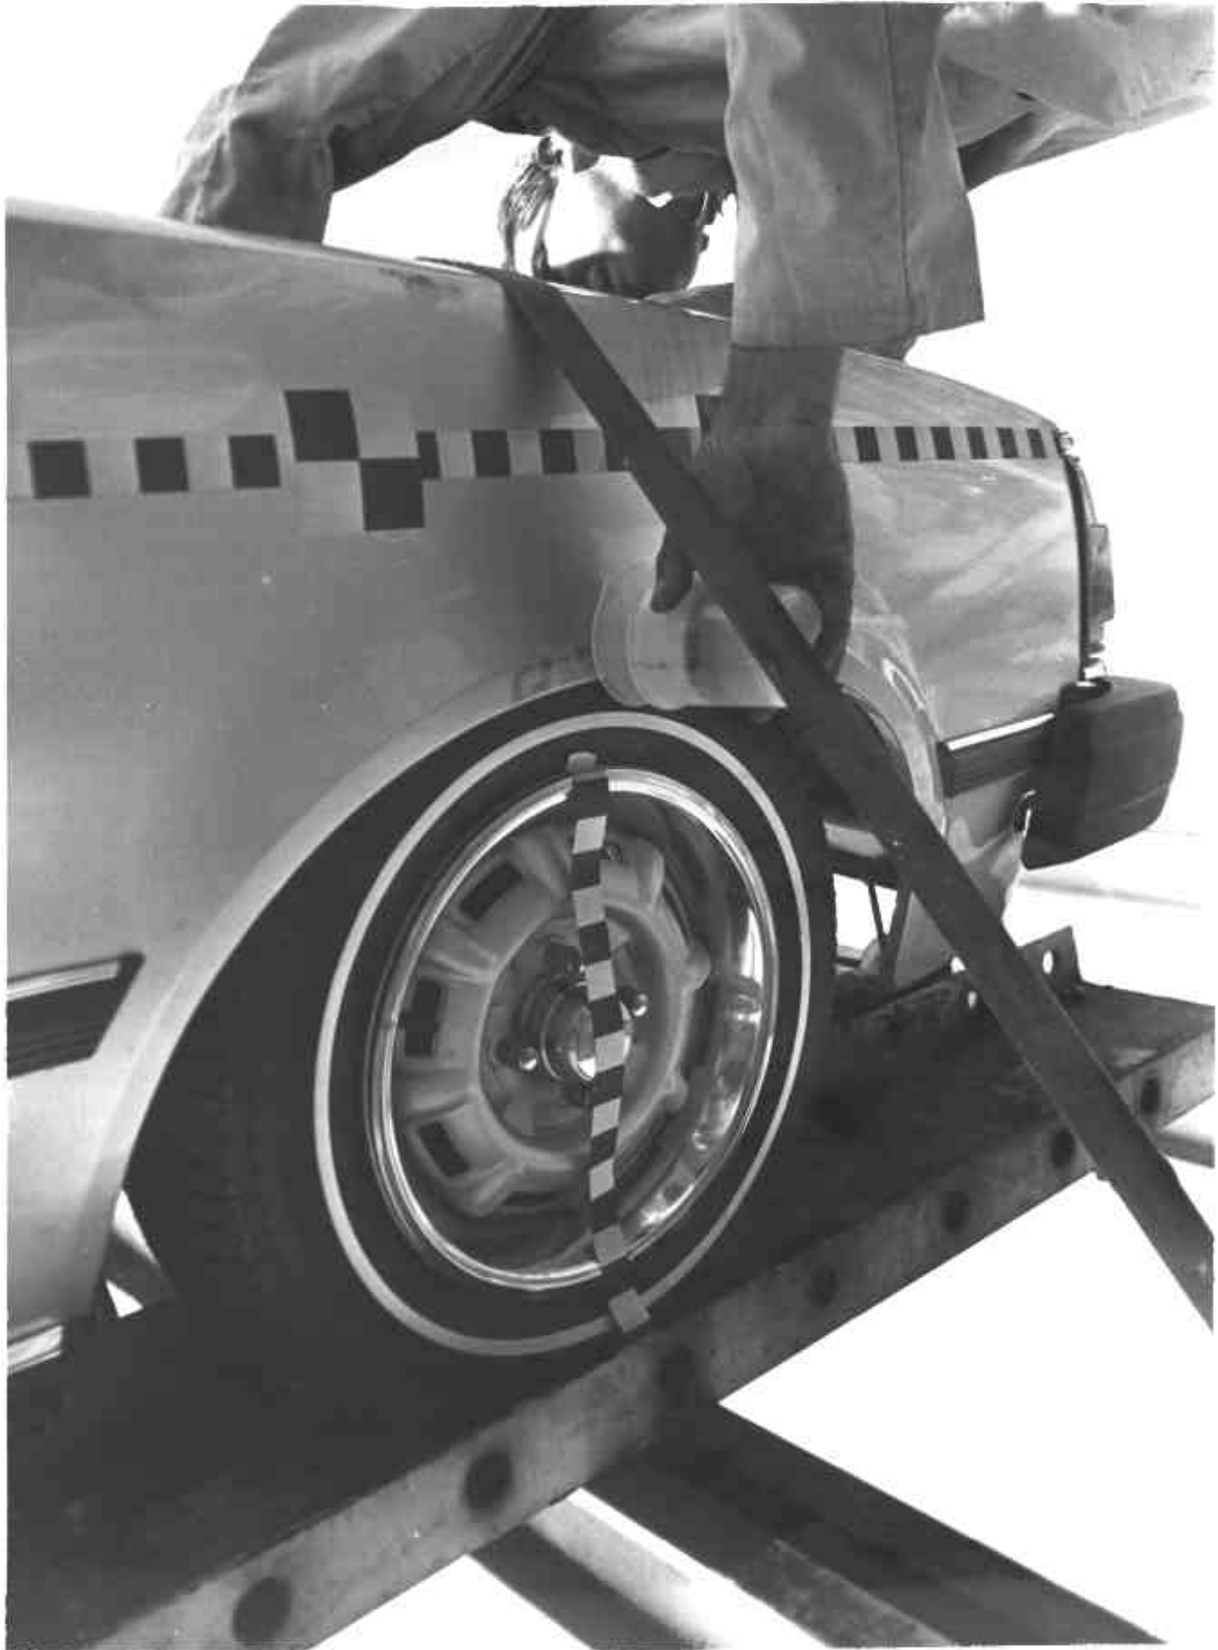
Figure 3-8
1981 Isuzu I-Mark Deluxe - 2 Door Coupe
NHTSA 810503
Post-Impact, Fuel Spillage, 90° Increment

Fuel Spillage Location: Emission canister in engine compartment.

No fuel spillage was noted following the moving barrier impact, nor during the time period before the start of the rollover test. However, fuel spillage was noted emitting from the emission canister, located in the engine compartment, after the vehicle had obtained the first 90° test increment (right side down). The fuel spillage continued during the 90° test increment time period, however, the fuel spillage from the emission canister ceased, after the onset of rotation to the 180°

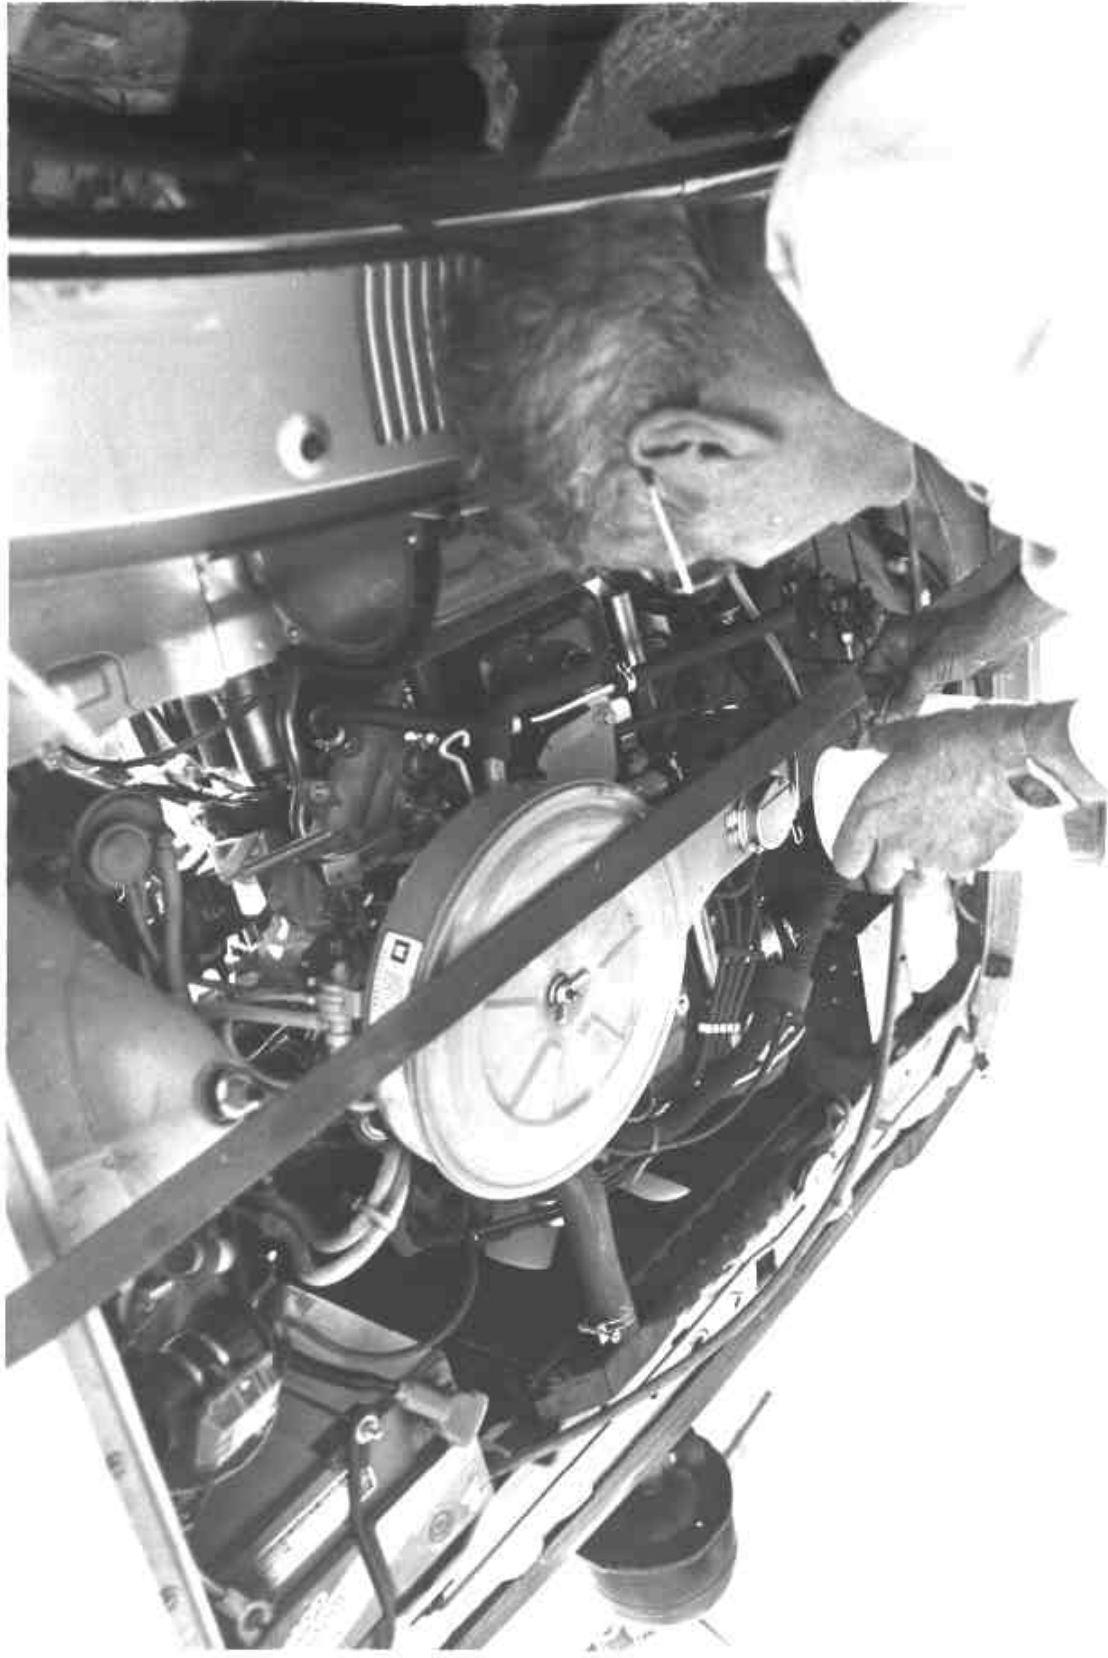
Figure 3-9

Fuel Spillage Location: Carburetor air cleaner assembly.

test increment, and fuel spillage appeared emitting from the carburetor air cleaner assembly. The fuel spillage continued as recorded during the remaining rollover test increment time periods.

Post-Impact, Fuel Spillage, 180° Increment

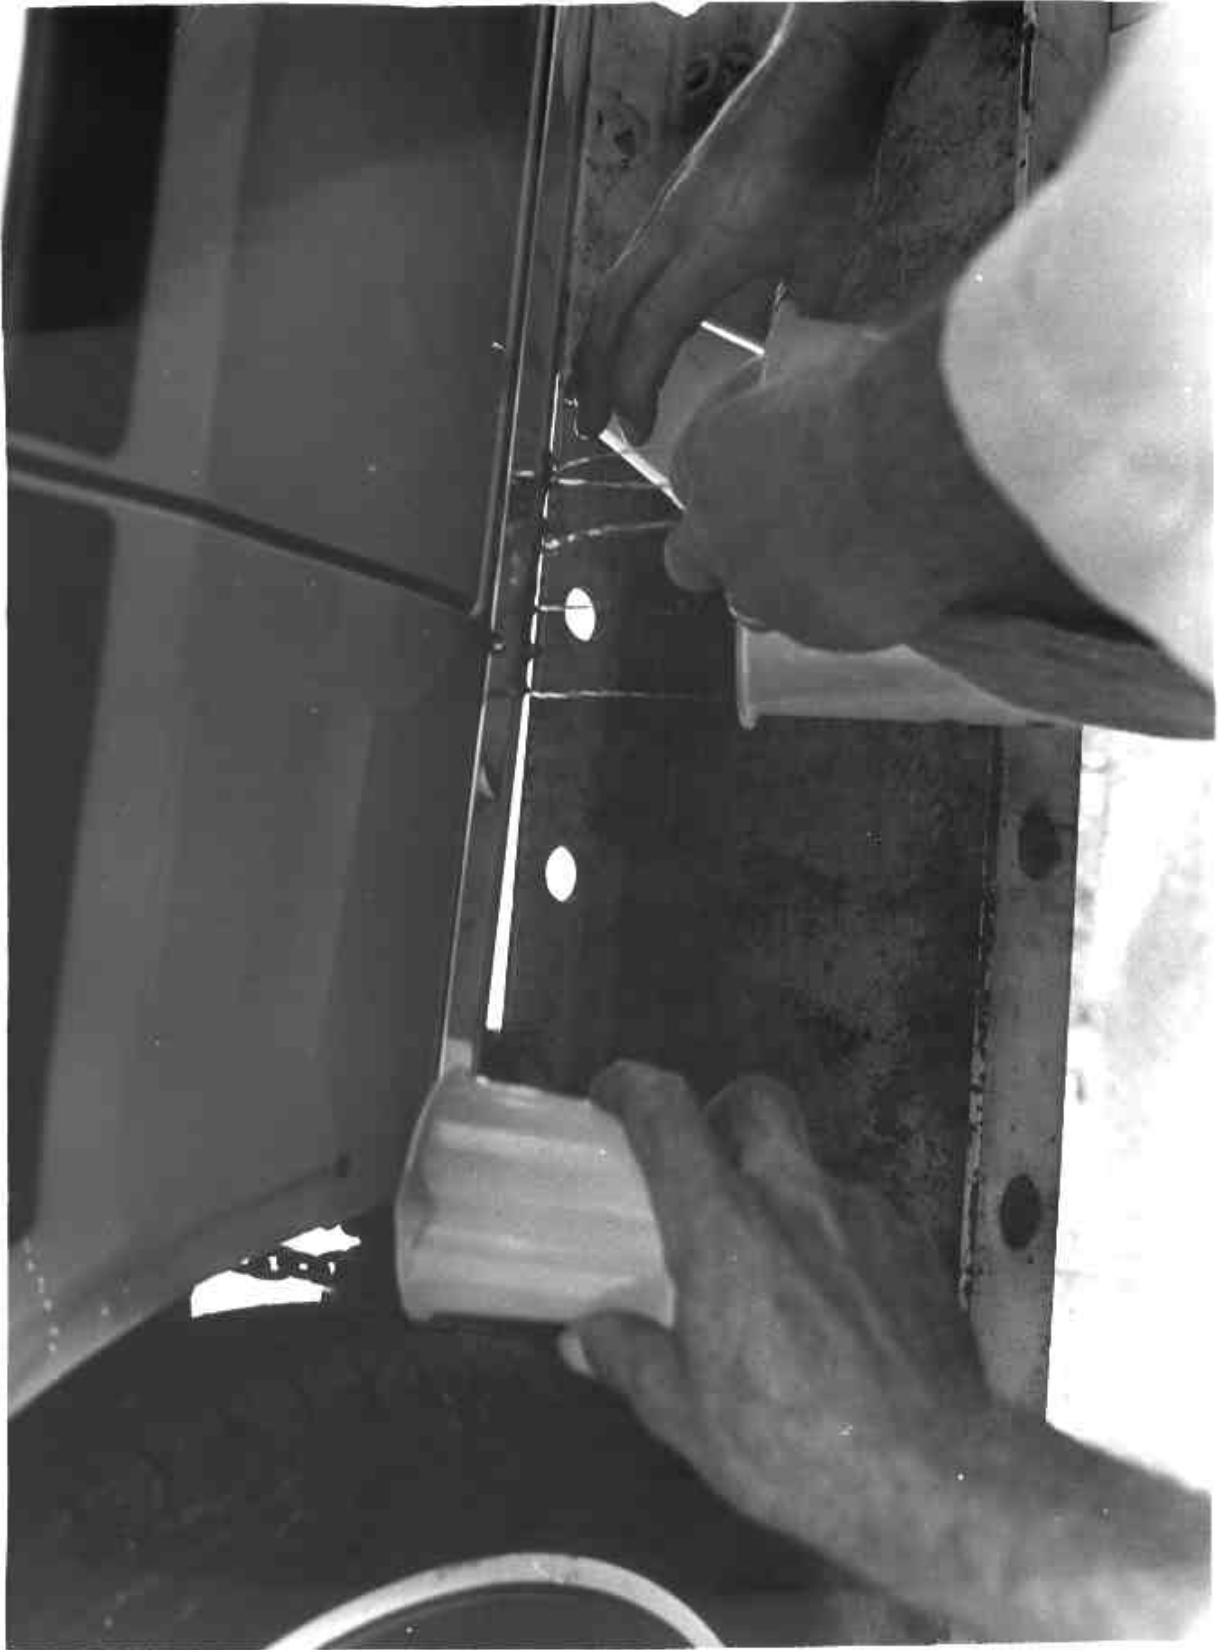
Fuel Spillage Location: Carburetor air cleaner assembly.

Post-Impact, Fuel Spillage, 270° Increment

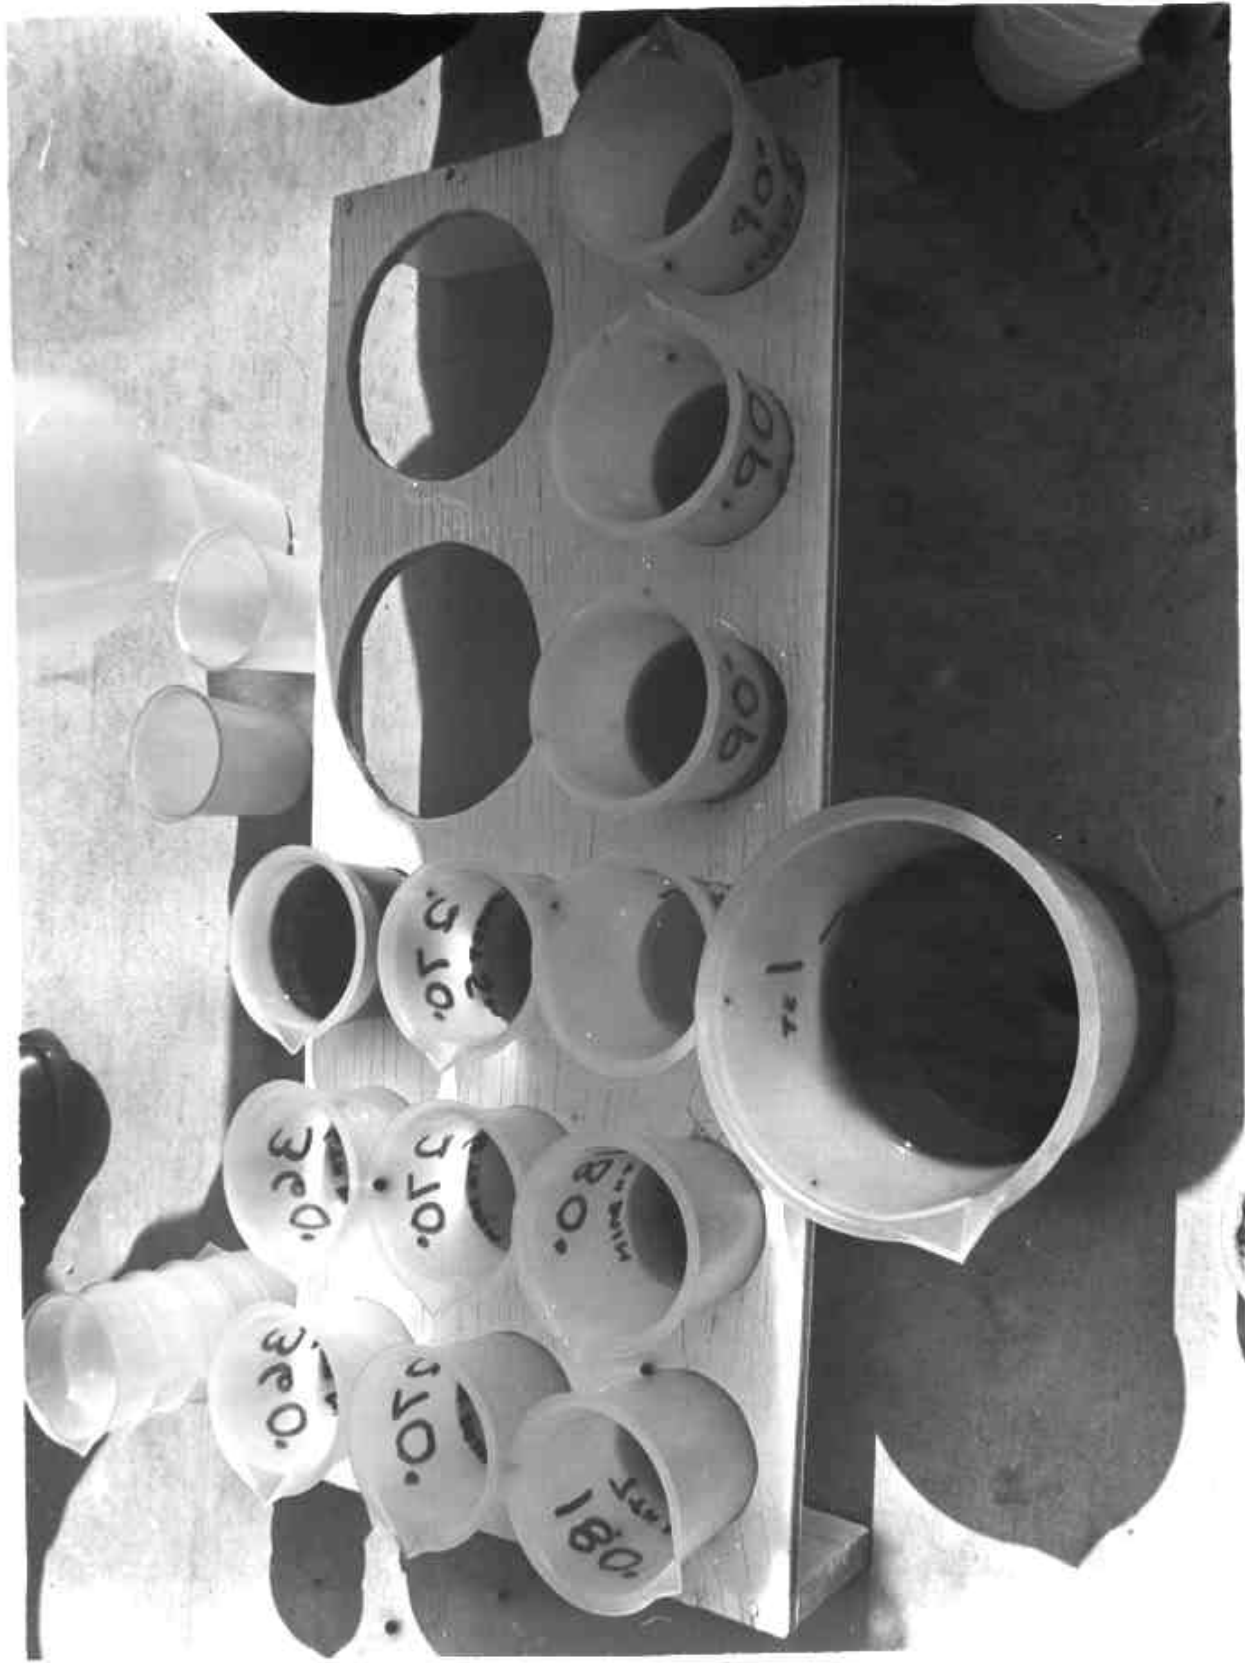
Post-Test, Fuel Spillage Collection
