# **CALSPAN ADVANCED TECHNOLOGY CENTER**

## *IMPROVED LIGHTWEIGHT SUBCOMPACT SIDE STRUCTURE TEST REPORT*

Calspan Report No. 6225-V-8

| <b>TEST:</b> | <b>TEST NO. 7</b> |

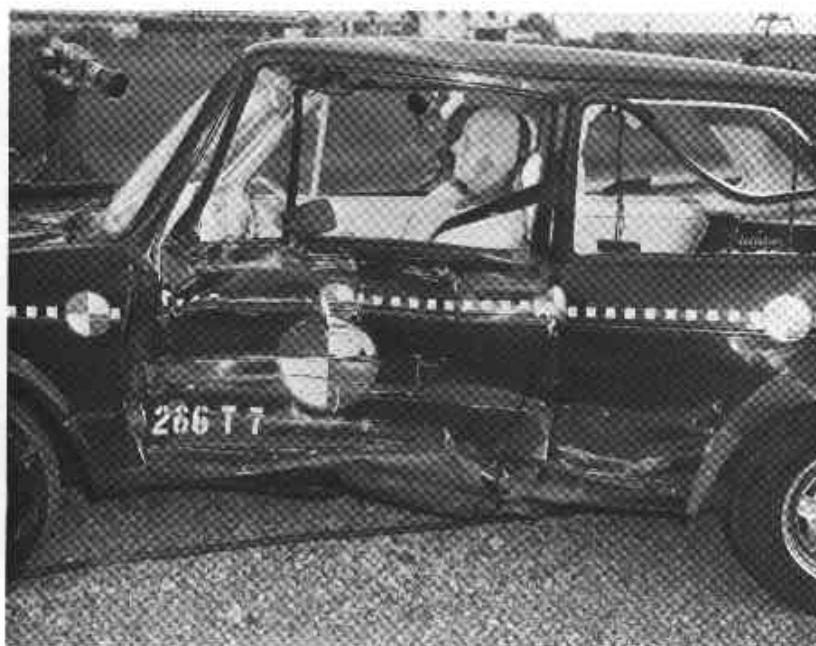
Figure 6 IMPACT AND POST IMPACT OF VW RABBIT

SIDE DAMAGE OF VW RABBIT
