TEST REPORT

SAFETY COMPLIANCE TEST FOR  
301-75  
REAR IMPACT

1988 FORD FESTIVA

NHTSA NO. CJ0201

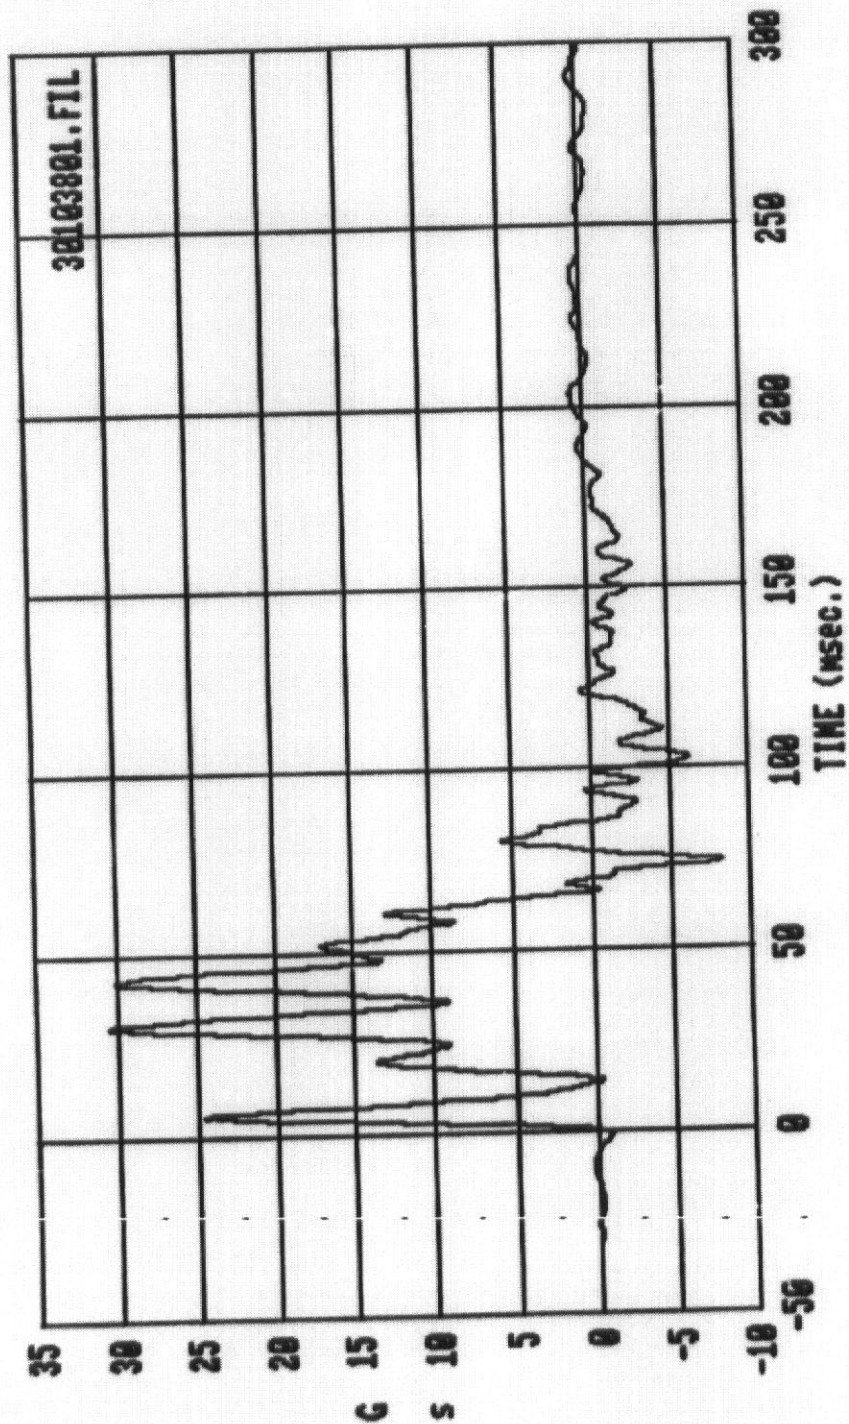
FIGURE 3-8

Max = 30.712 Min = -8.1737

MSE 10/06/86 -- 1988 Ford Festiva : C/G acceleration, X-axis (SAE CLASS 60)

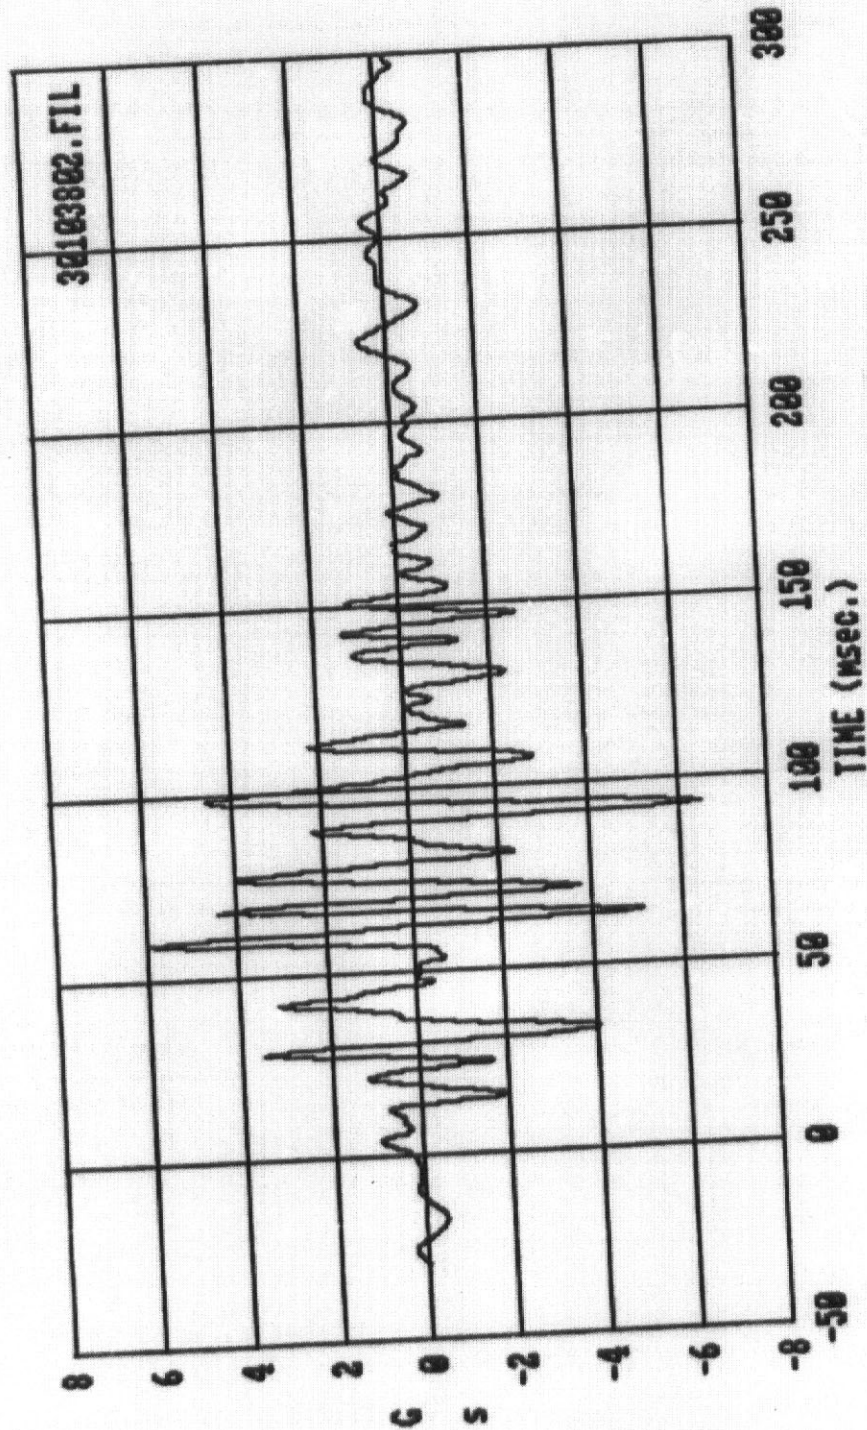
FIGURE 3-9

Max = 6.8541 Min = -6.5416

MSF .10/06/88 - 1988 Ford Festiva : C/G acceleration, Y-axis (SAE CLASS 60)

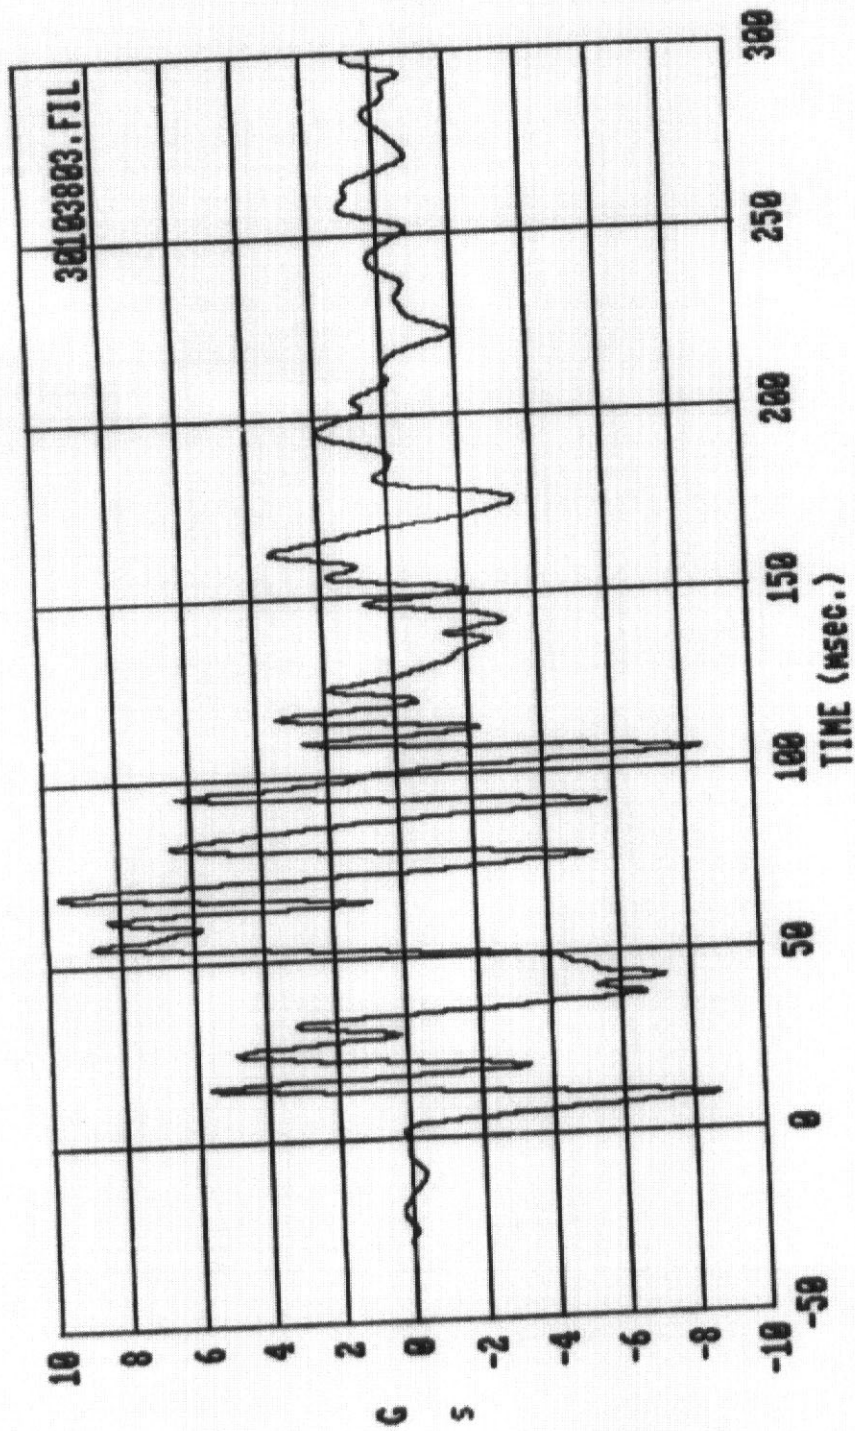
FIGURE 3-10

Max = 9.6748 Min = -8.7381

MSE 10/06/88 -- 1988 Ford Festiva : C/G acceleration, Z-axis (SAE CLASS 60)

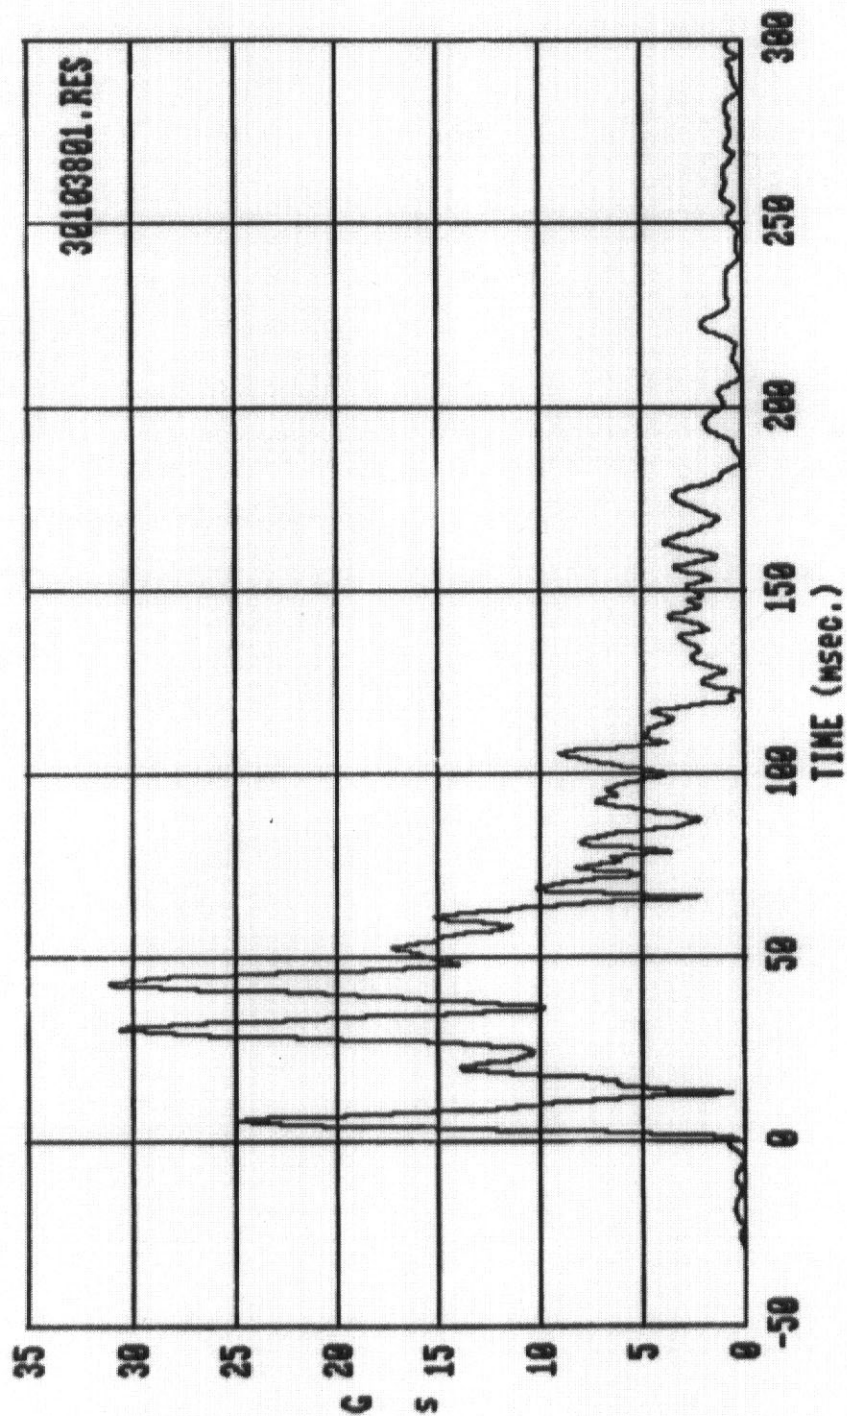
FIGURE 3-11

MSE 10/06/88 -- 1988 Ford Festiva : C/G resultant acceleration (SAE CLASS 60)
