**DYNAMIC IMPACT TEST OF
A SCHOOL BUS
WITH A 10,000 POUND MOVING BARRIER
WITH CONTOURED FRONT END**

1985 CARPENTER CADET SCHOOL BUS
24 PASSENGER

NHTSA NO. CF0902

FINAL REPORT

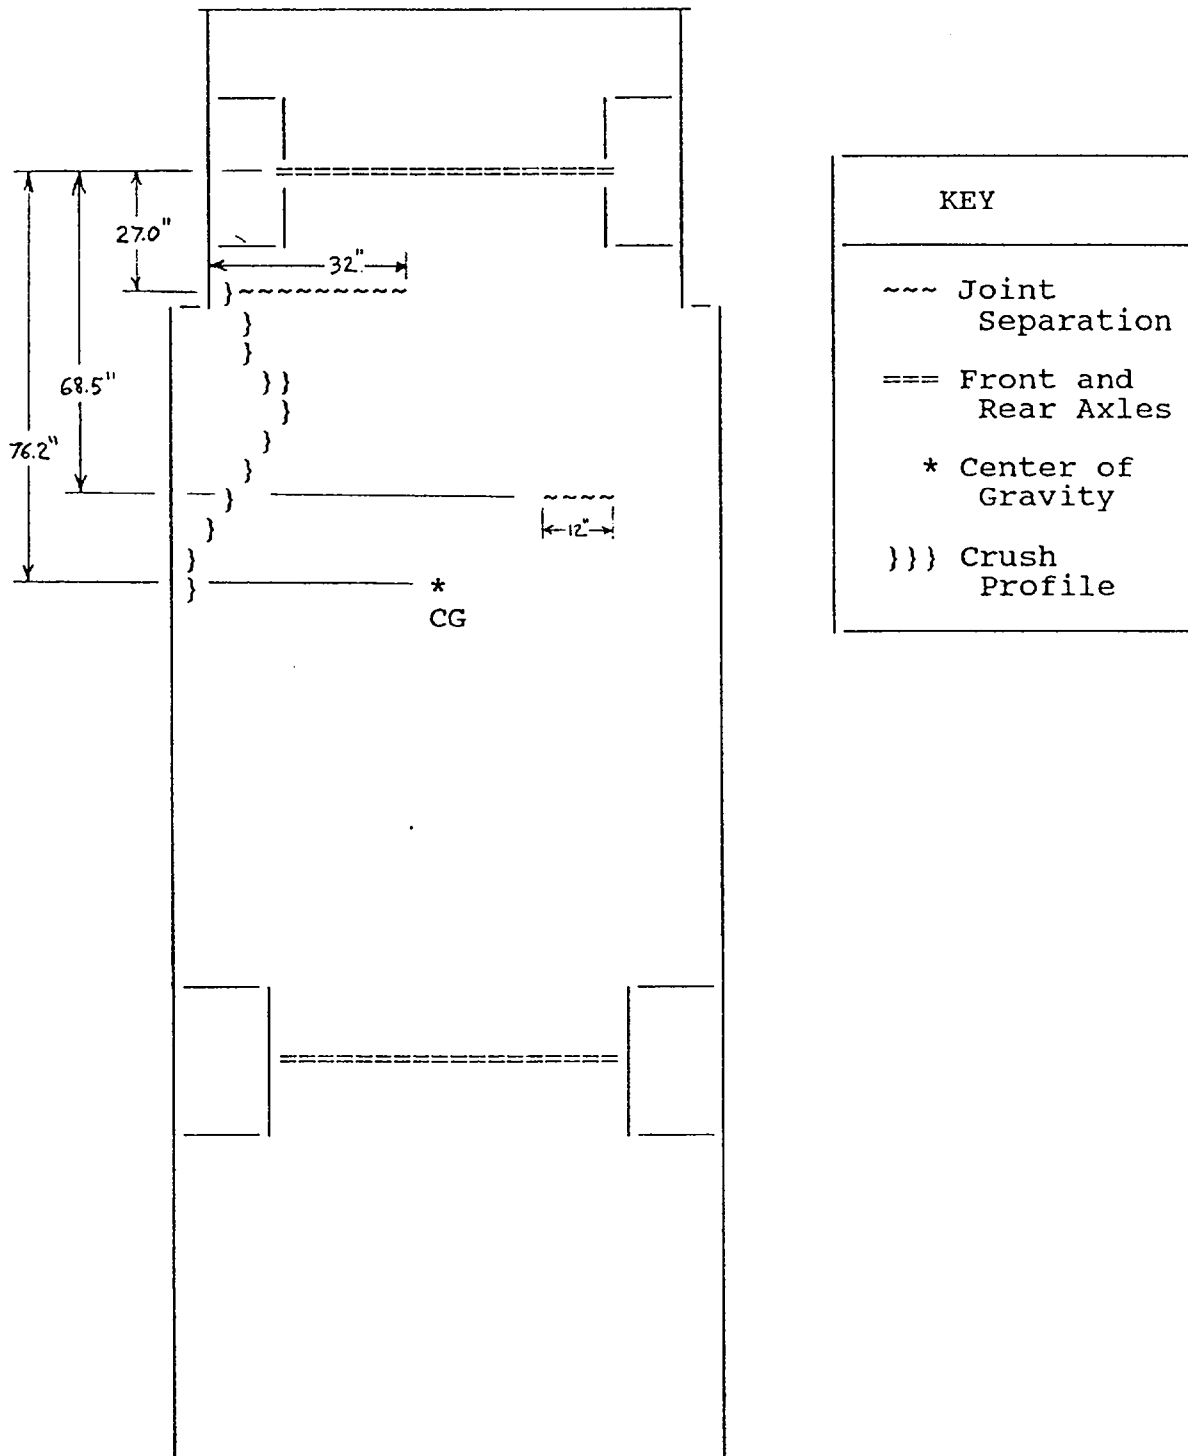
FIGURE 2-11 APPROXIMATE CRUSH AND JOINT SEPARATION PROFILES

JOINT SEPARATION SUMMARY: Two floor joints separated during the impact. The first joint was located 27 inches rearward of the front axle, just in front of the driver's seat. The joint separated laterally 32 inches inwards from the bus left side. The other separated joint was located 68.5 inches rearward of the front axle. It had a 12 inch length of separation located 53 inches from the bus left side, near the top of the stairway leading into the bus.

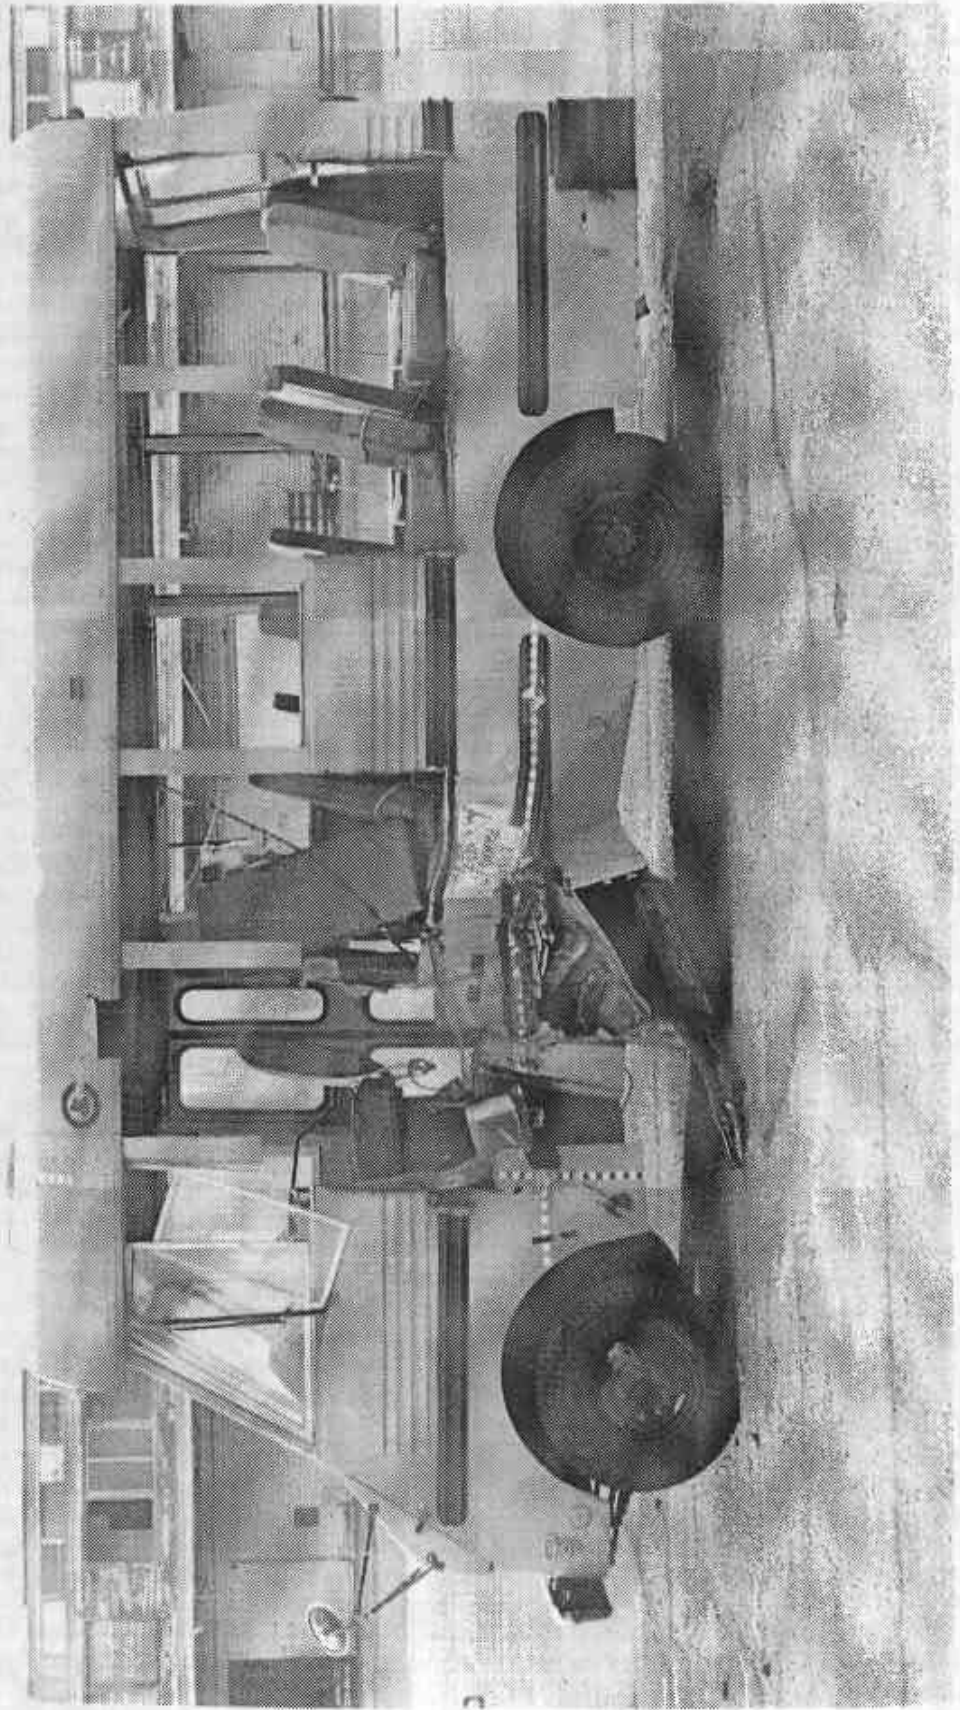
FIGURE 3-1 LEFT SIDE OVERALL VIEW - POSTTEST

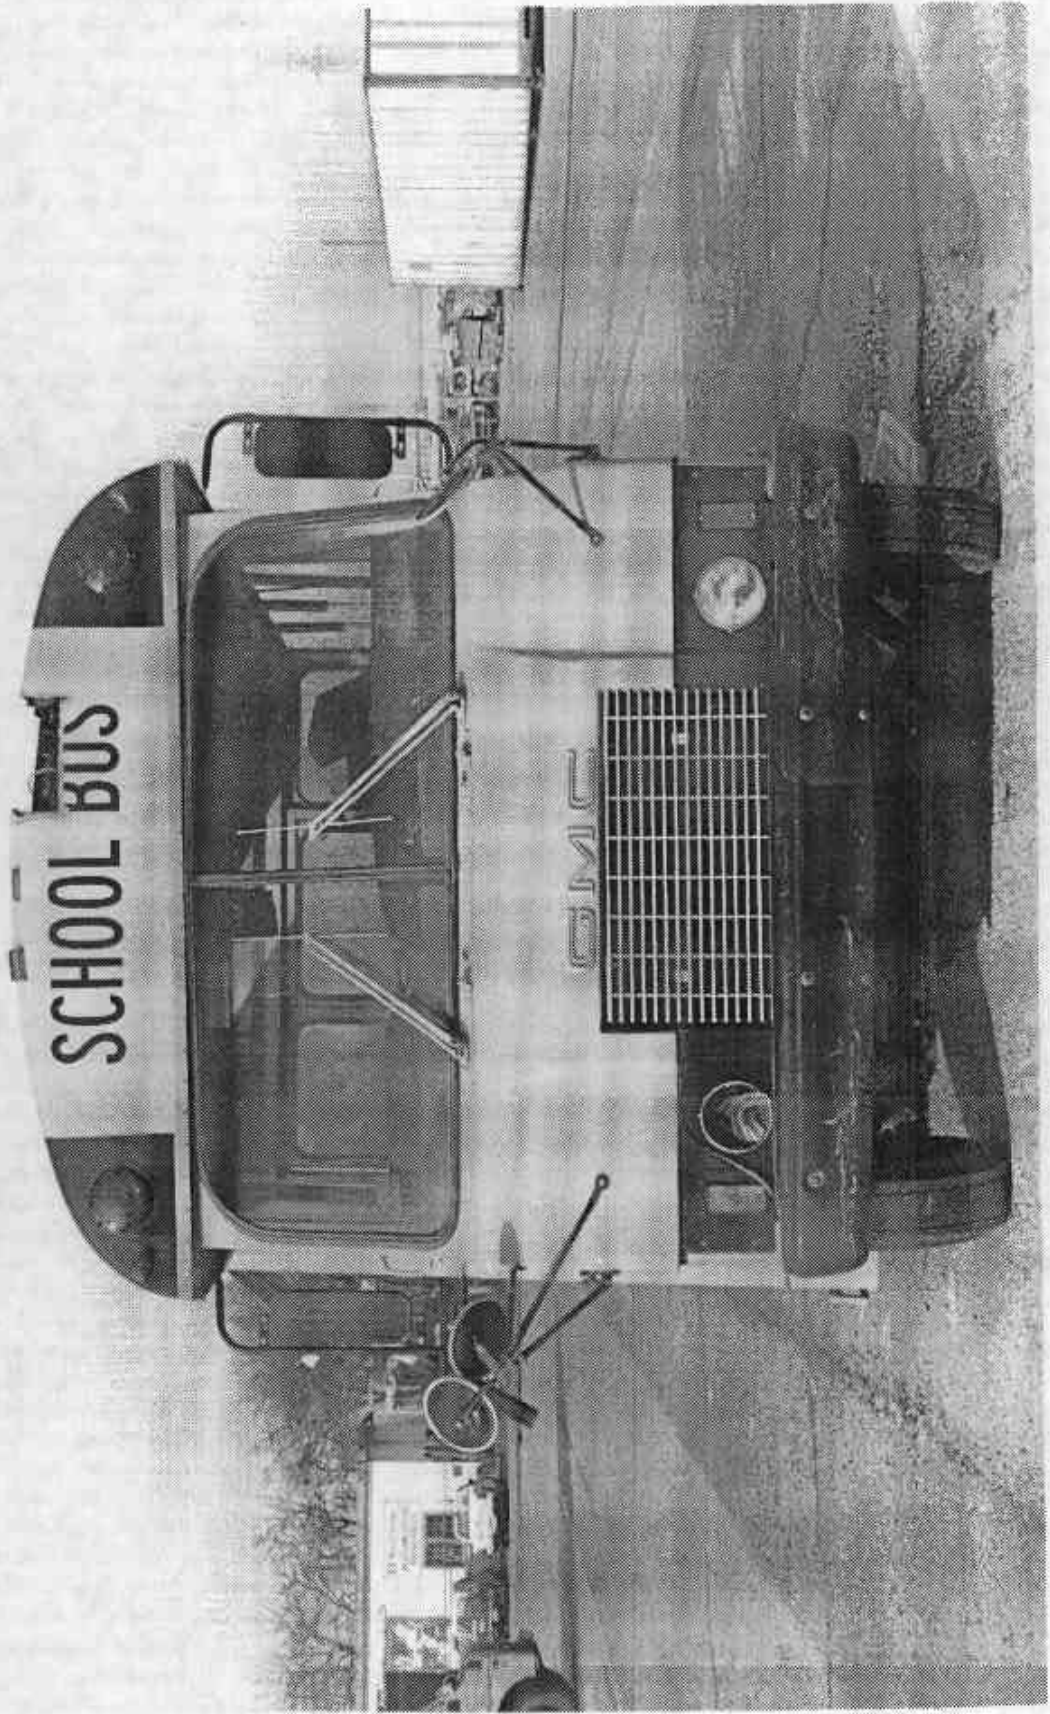
FIGURE 3-2 FRONT VIEW -- POSTTEST

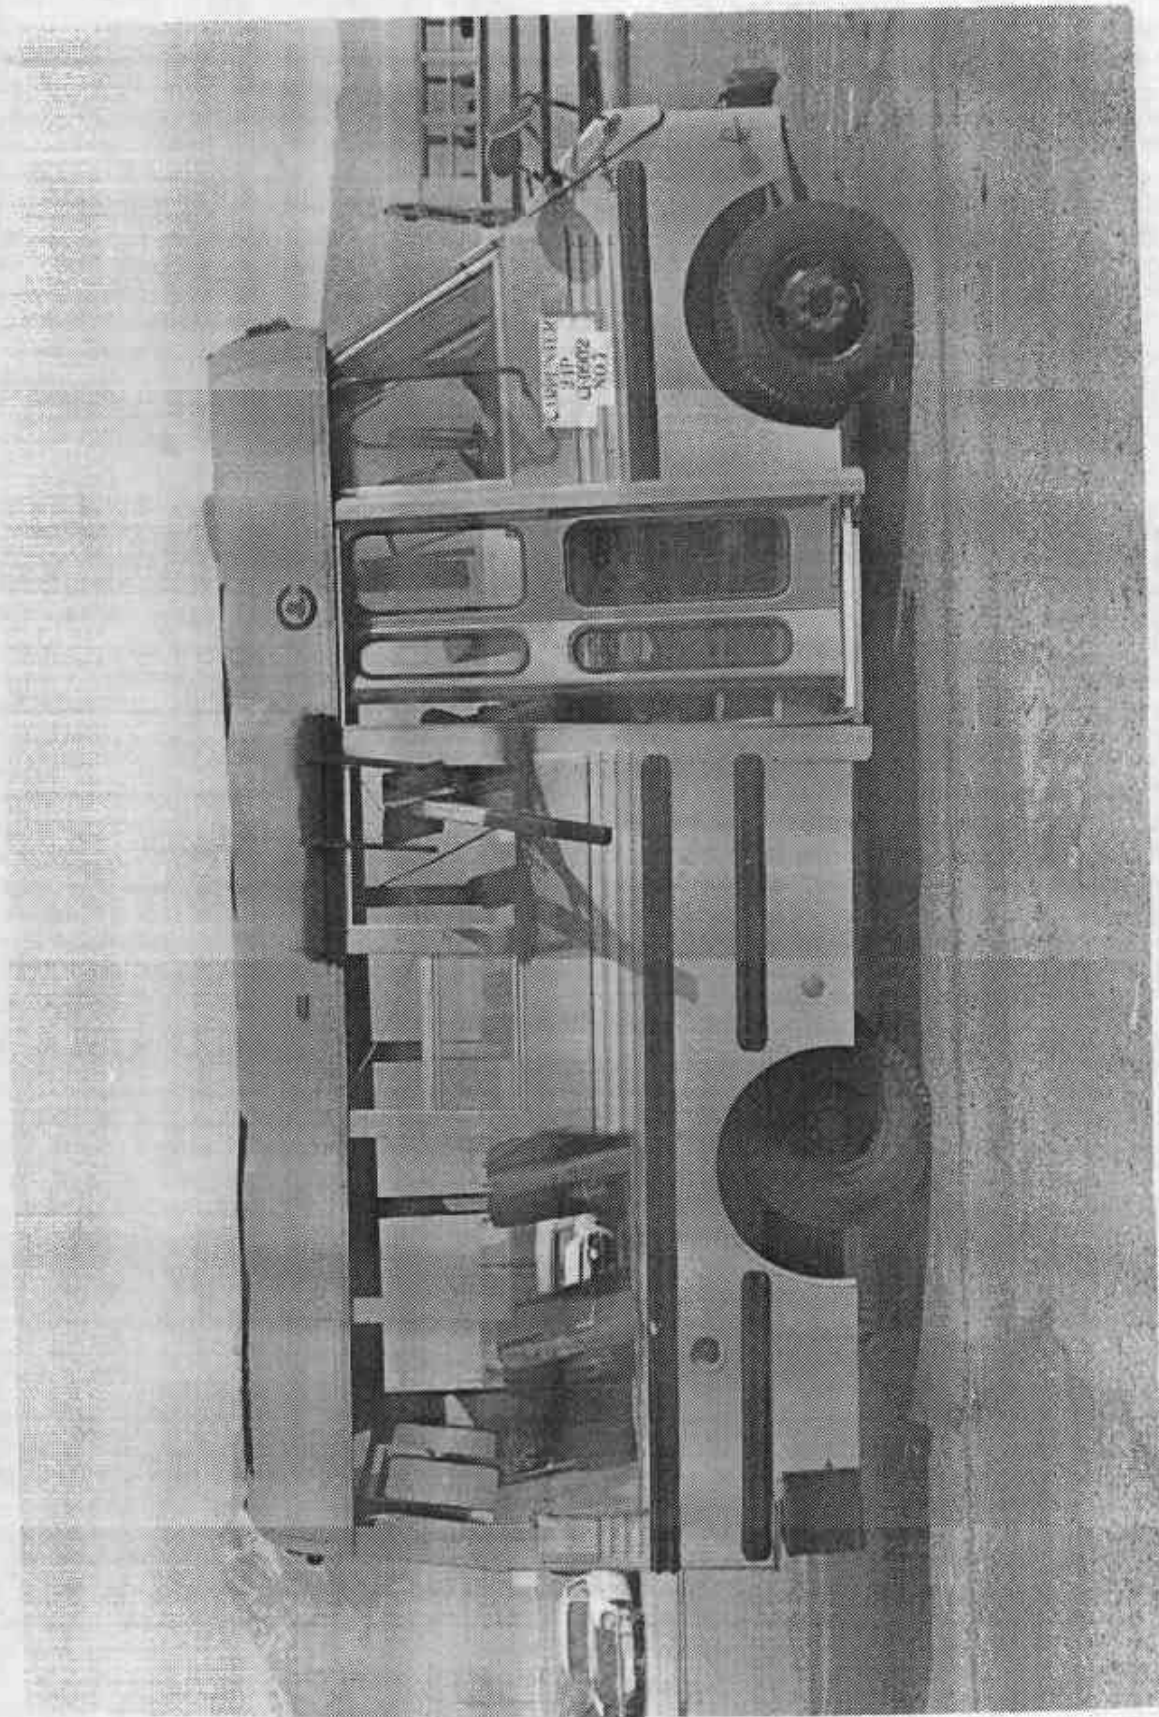
FIGURE 3-3 RIGHT SIDE OVERALL VIEW - POSTTEST

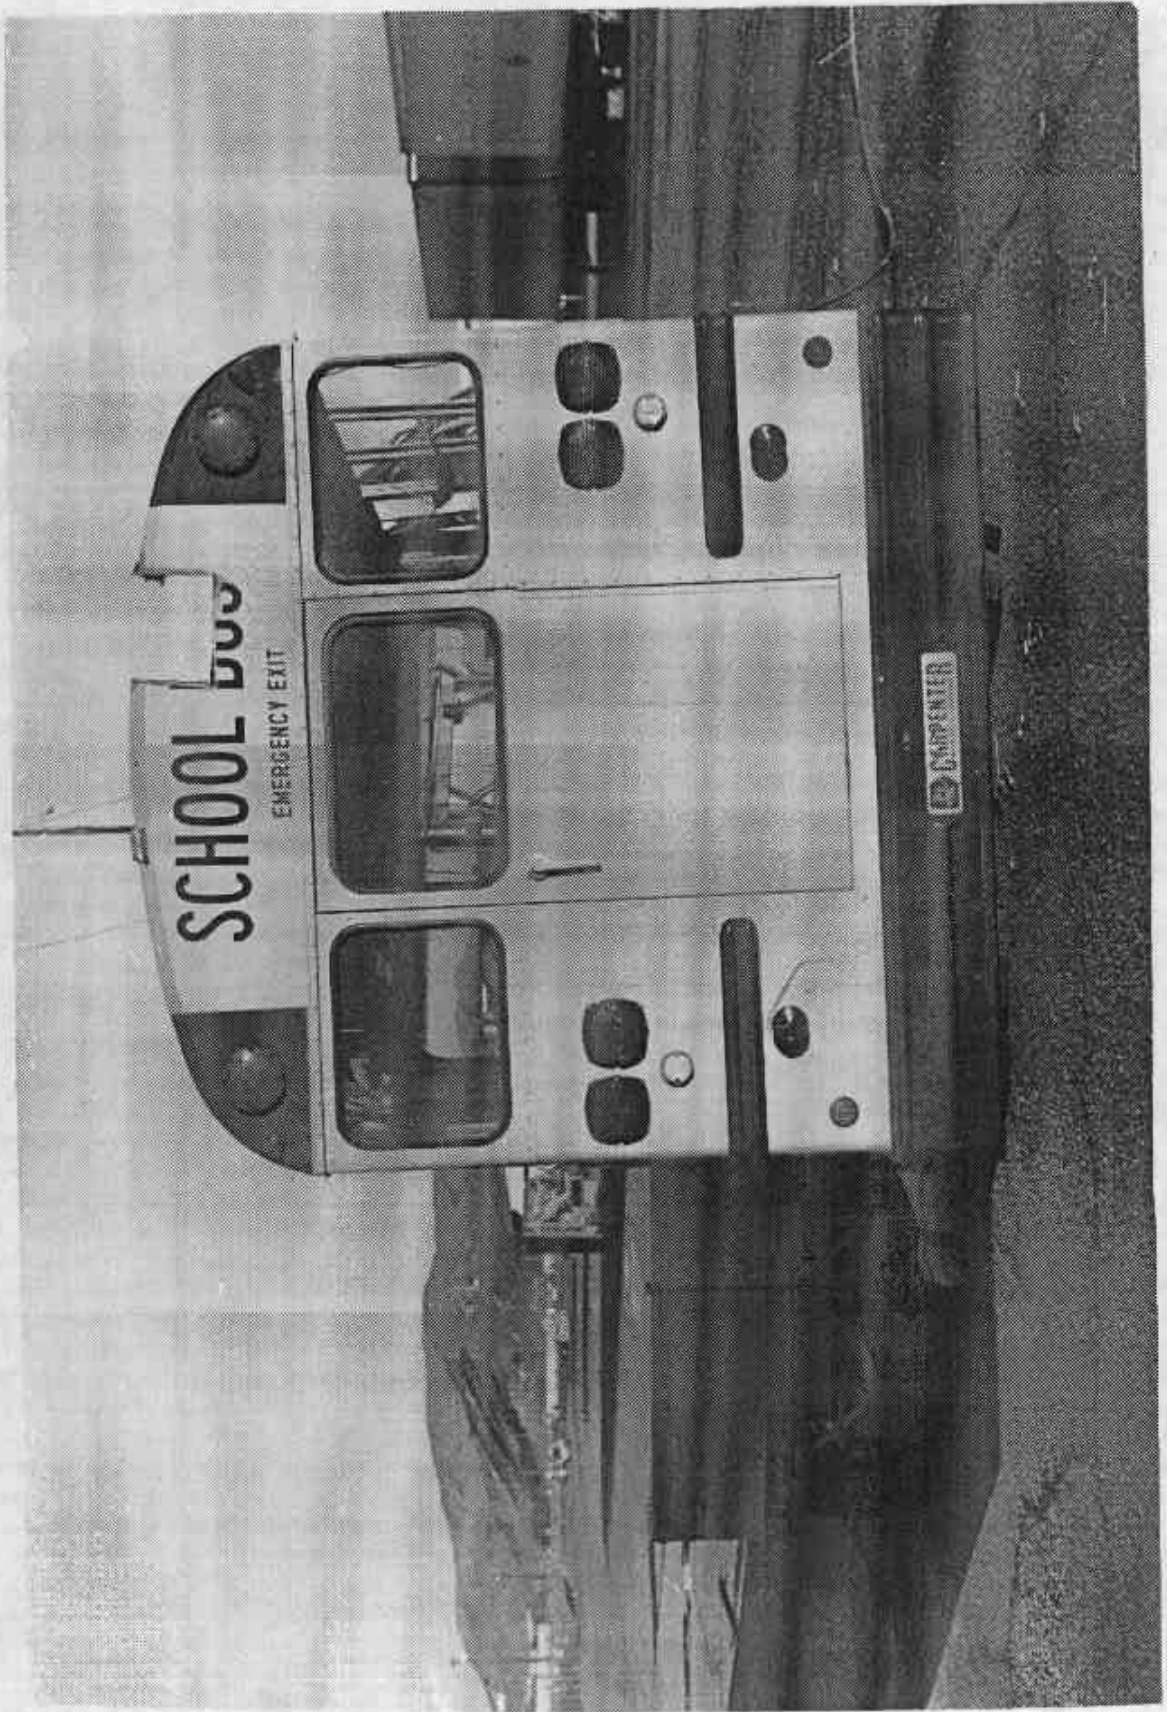
FIGURE 3-4 REAR VIEW - POSTTEST

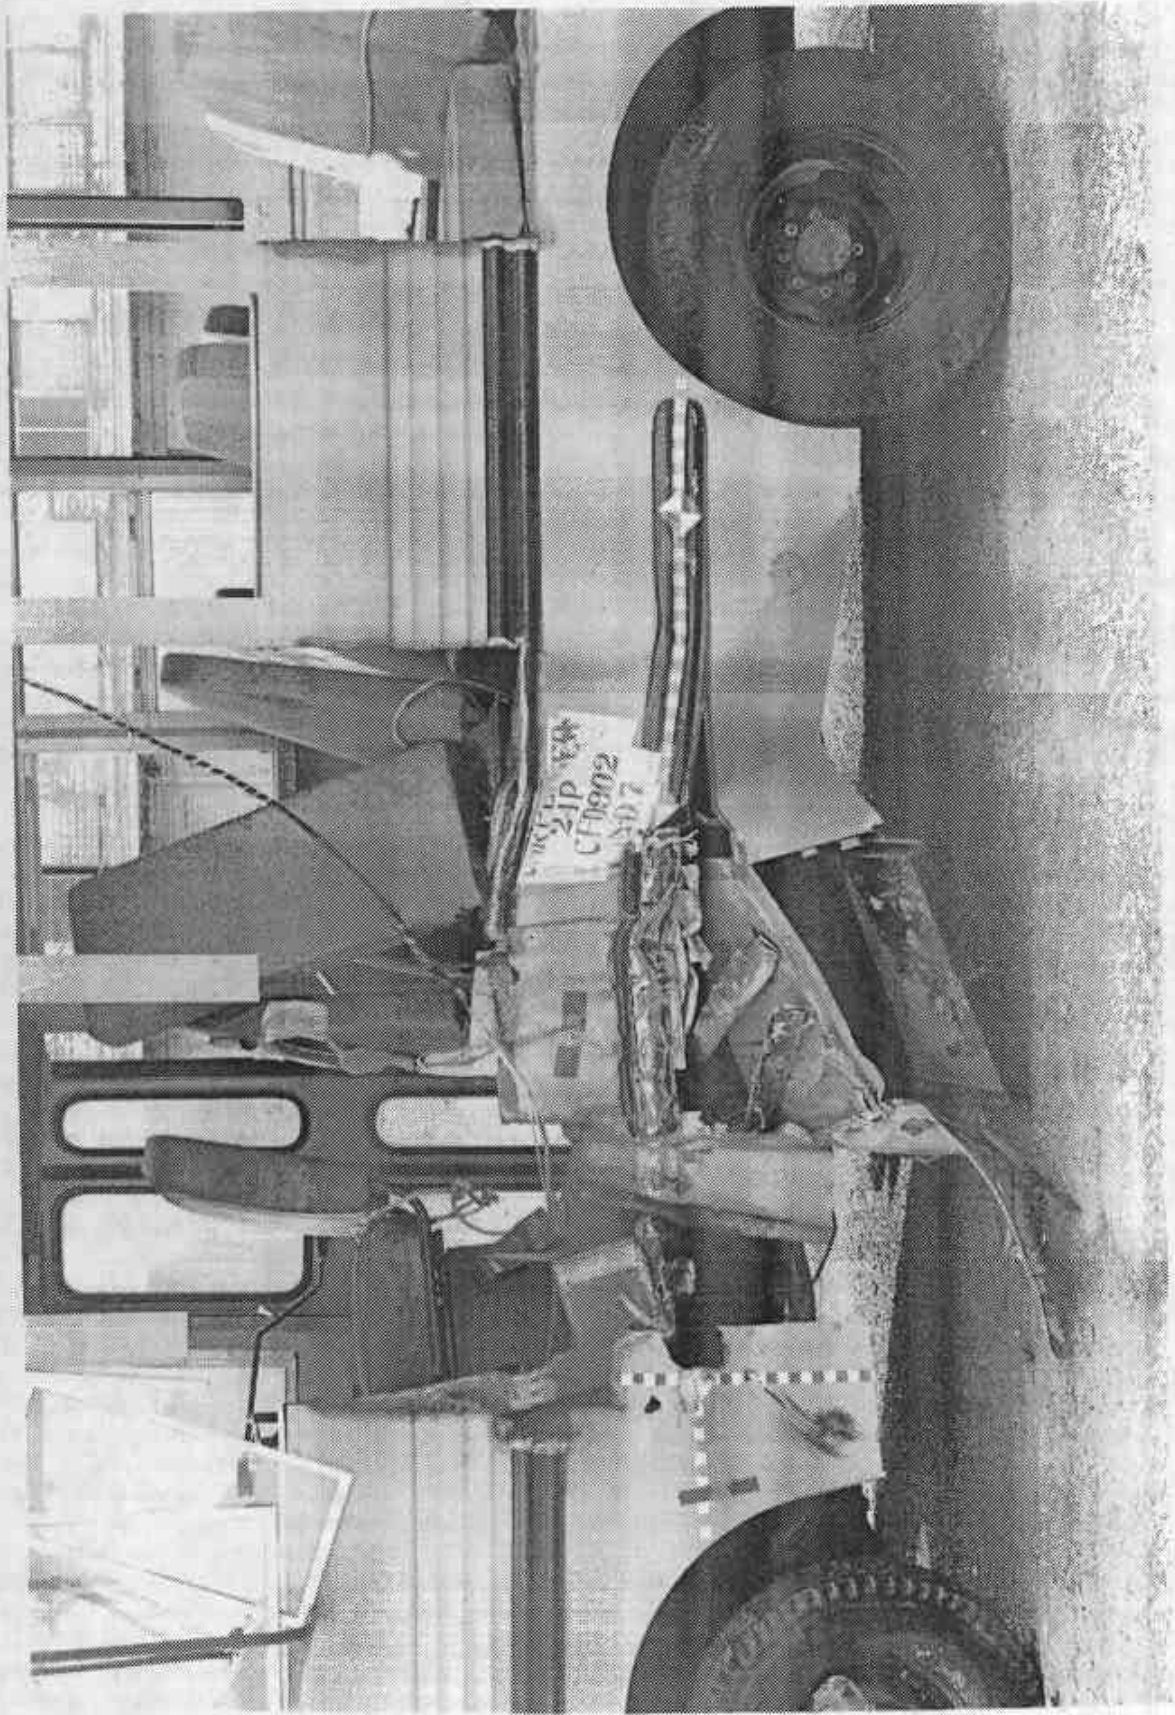
DAMAGE DETAILS: The 10,000 lb moving barrier contacted the bus just aft of the "B" pillar. Crush of the bus extended approximately 65 inches rearward from the impact point with a maximum lateral crush of 17.3 inches. The floor separated at a point 27 inches rearward of the front axle, directly in front of the driver's seat. The length of the separation was 32 inches, starting from the bus left side. The floor at this point did not have a normal U shaped joint. The main floor of the bus was connected to the driver toeboard at this point by only an overlapping piece of sheet metal secured with 1/4 inch machine screws.

FIGURE 3-5 CLOSEUP VIEW OF IMPACT AREA -- POSTTEST

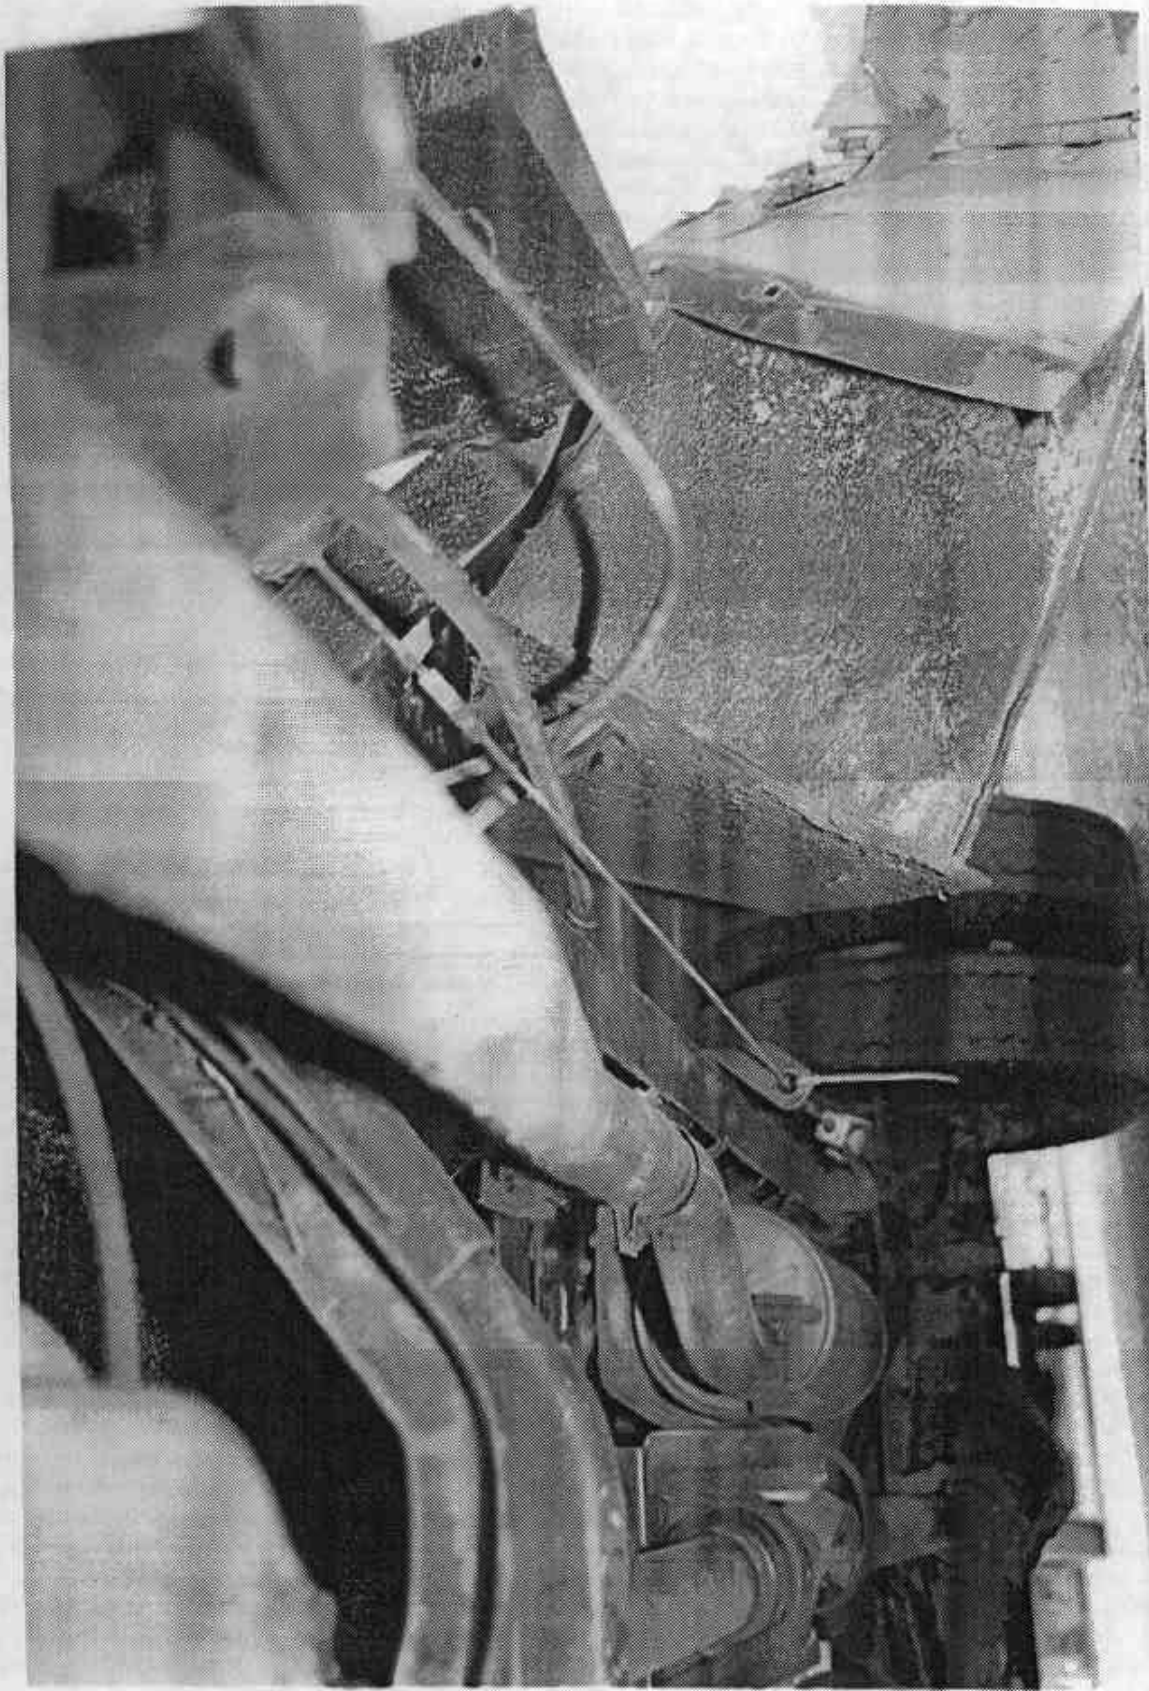
FIGURE 3-6 CLOSEUP UNDERNEATH VIEW OF IMPACT AREA LOOKING FRONT TO REAR -- POSTTEST

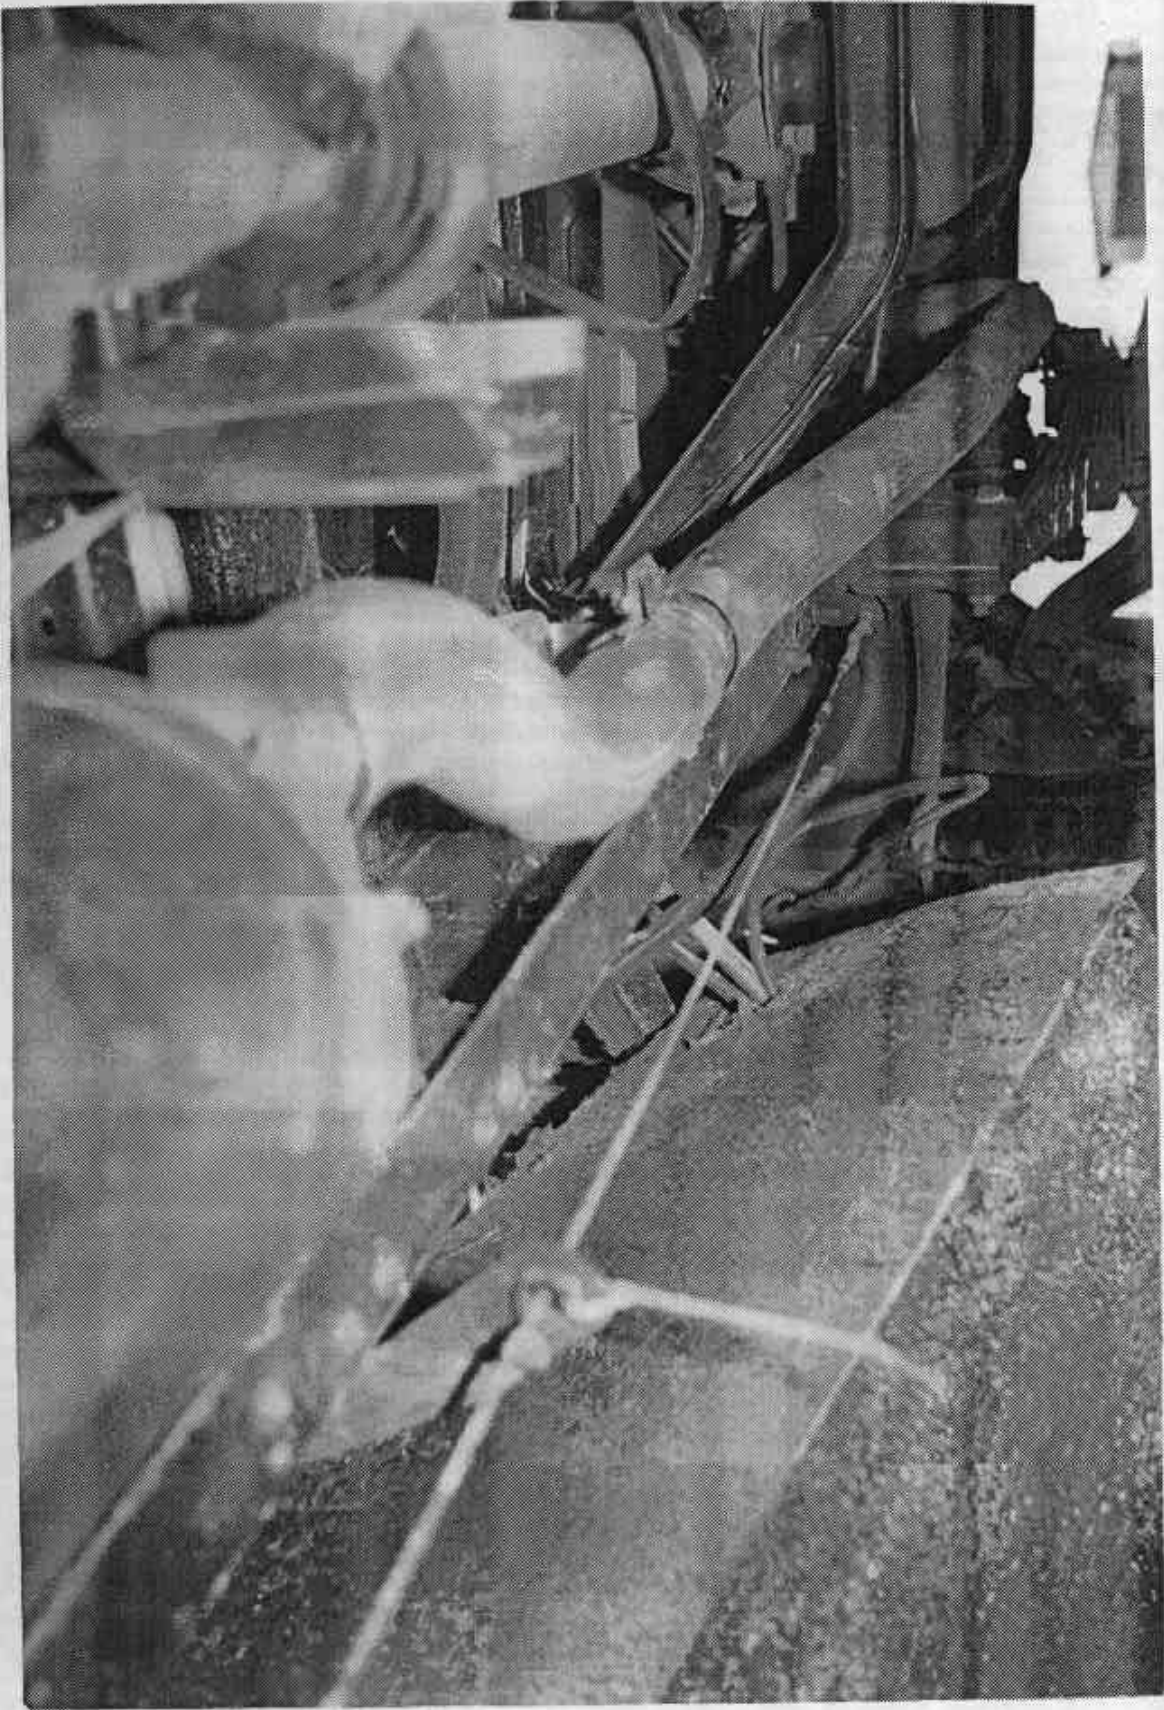
FIGURE 3-7 CLOSEUP UNDERNEATH VIEW OF IMPACT AREA LOOKING REAR TO FRONT - POSTTEST

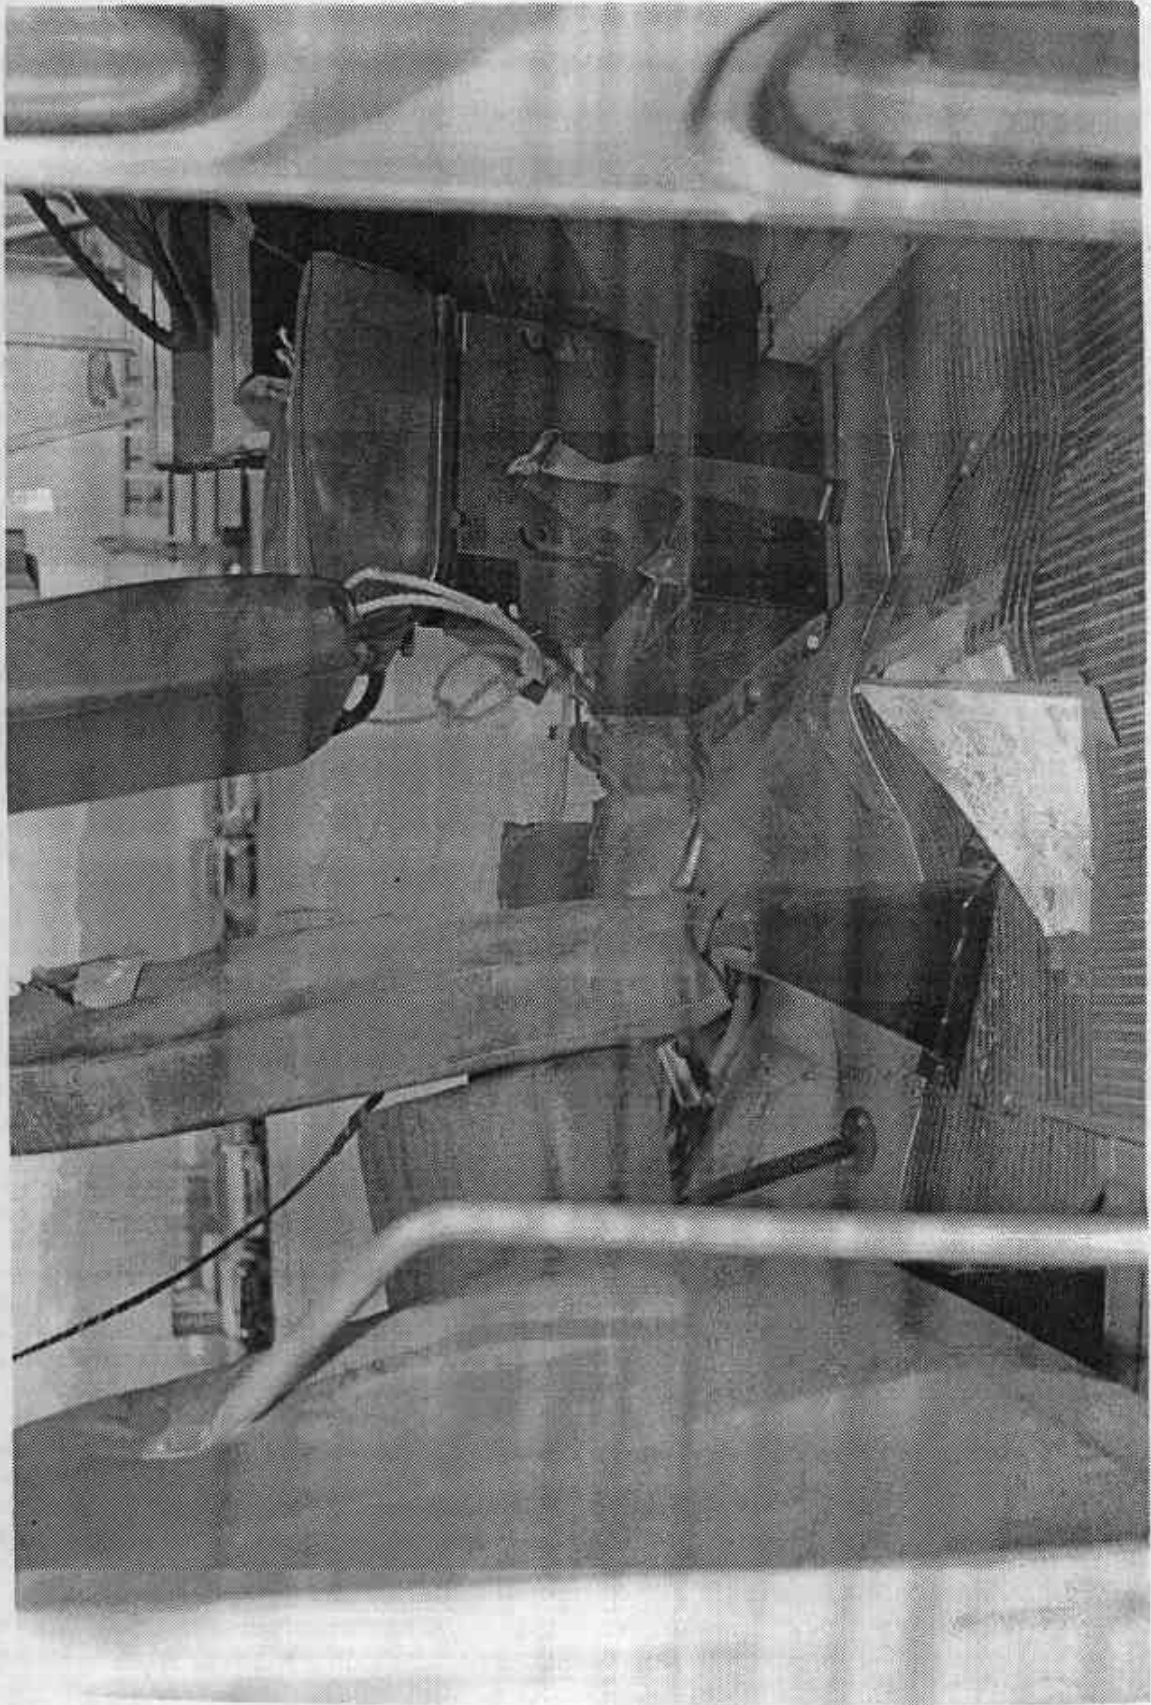
The only other separation occurred at a normal U shaped joint located 68.5 inches rearward of the front axle. The total length of the separation was 12 inches and occurred 53 inches from the bus left side, at the top, rear of the entrance stairway. It appears that one side of the joint was attached to the right frame rail at this point and was torn away from the other side of the joint due to the body distortion occurring during impact.

FIGURE 3-8 INTERIOR VIEW OF JOINT SEPARATION - POSTTEST
