**DYNAMIC IMPACT TEST OF
A SCHOOL BUS
WITH A 10,000 POUND MOVING BARRIER
WITH CONTOURED FRONT END**

1987 CARPENTER CONVENTIONAL SCHOOL BUS
65 PASSENGER

NHTSA NO. CH0902

FINAL REPORT

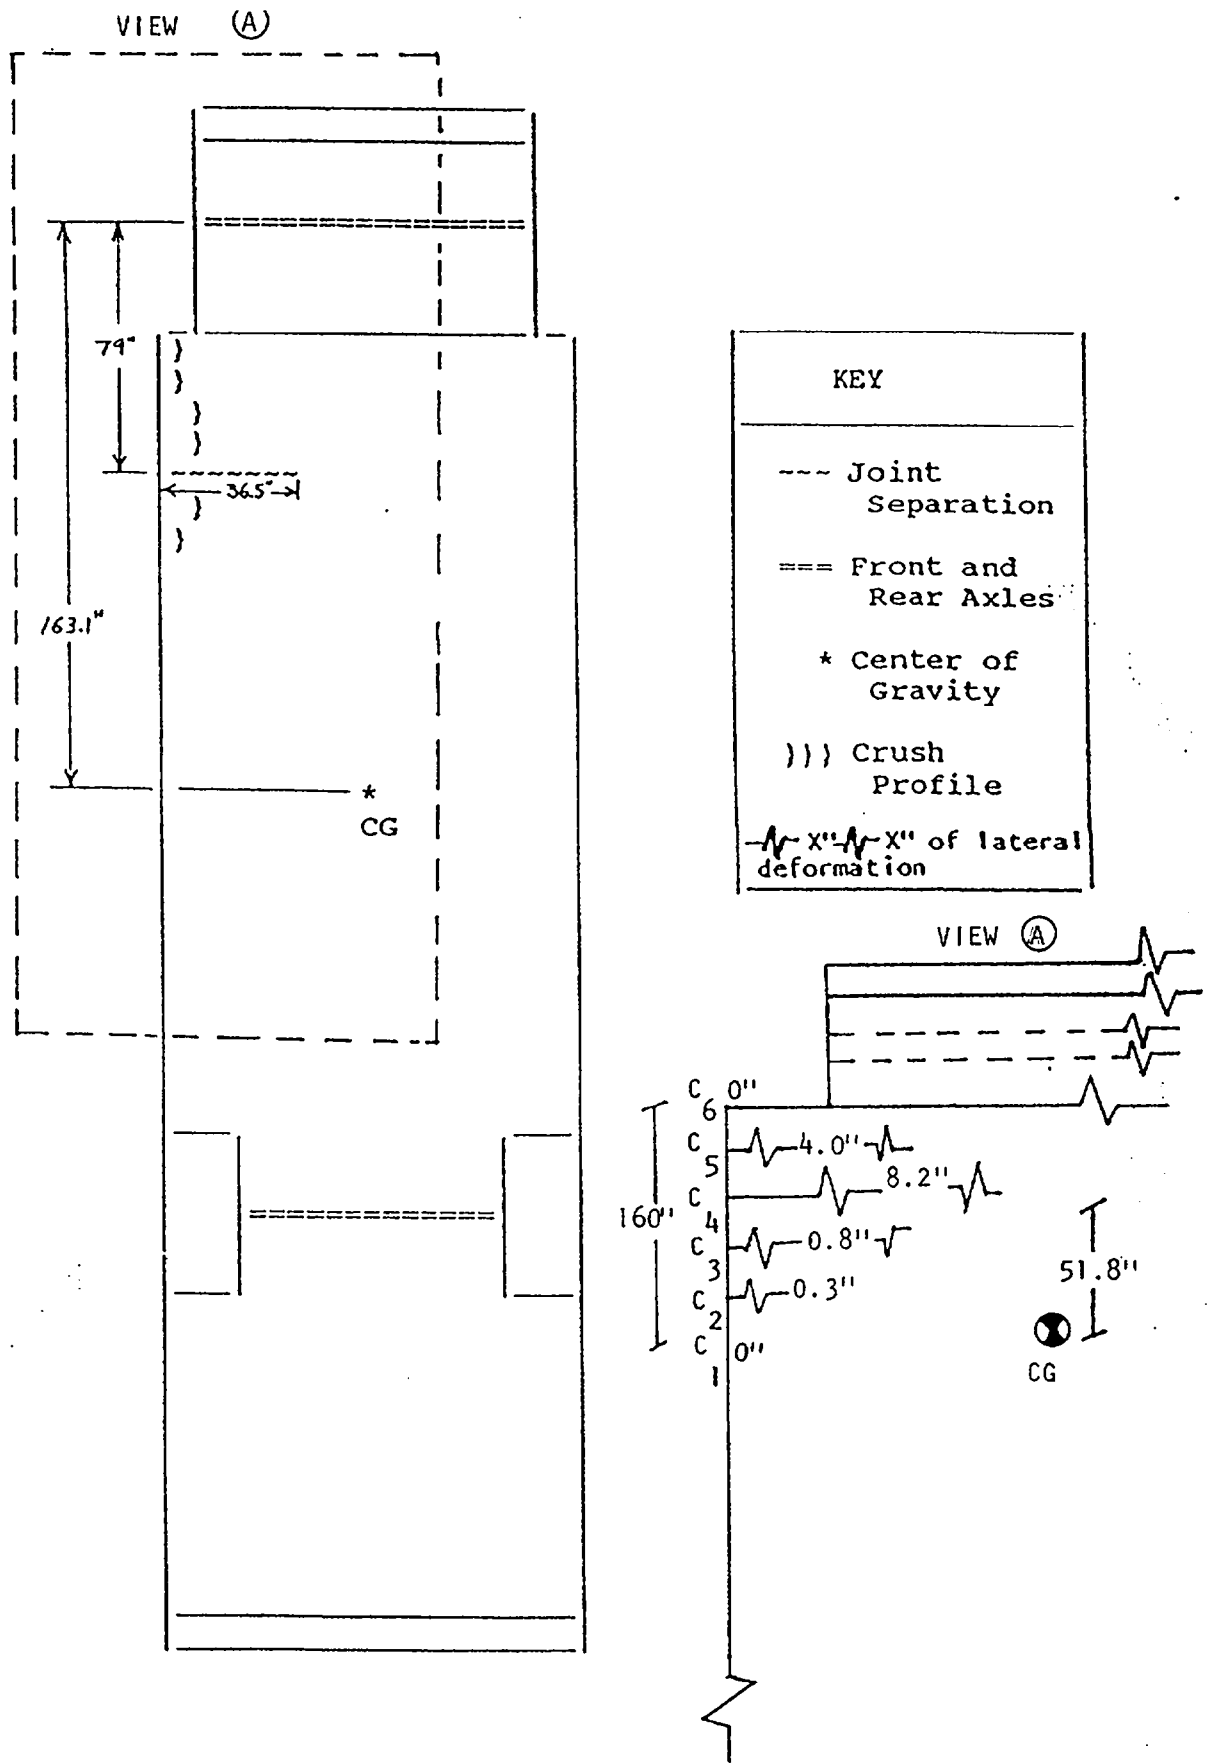
FIGURE 2-11 APPROXIMATE CRUSH AND JOINT SEPARATION PROFILES

JOINT SEPARATION SUMMARY: One floor joint separated during the impact.

The separated joint was located 79 inches rearward of the front axle,

behind the driver's seat. The joint separated 36.5 inches laterally

across the bus.

separation. View (A) of Figure 2-11 shows the deformation at six
different points along the 160" long crushed portion of the bus.

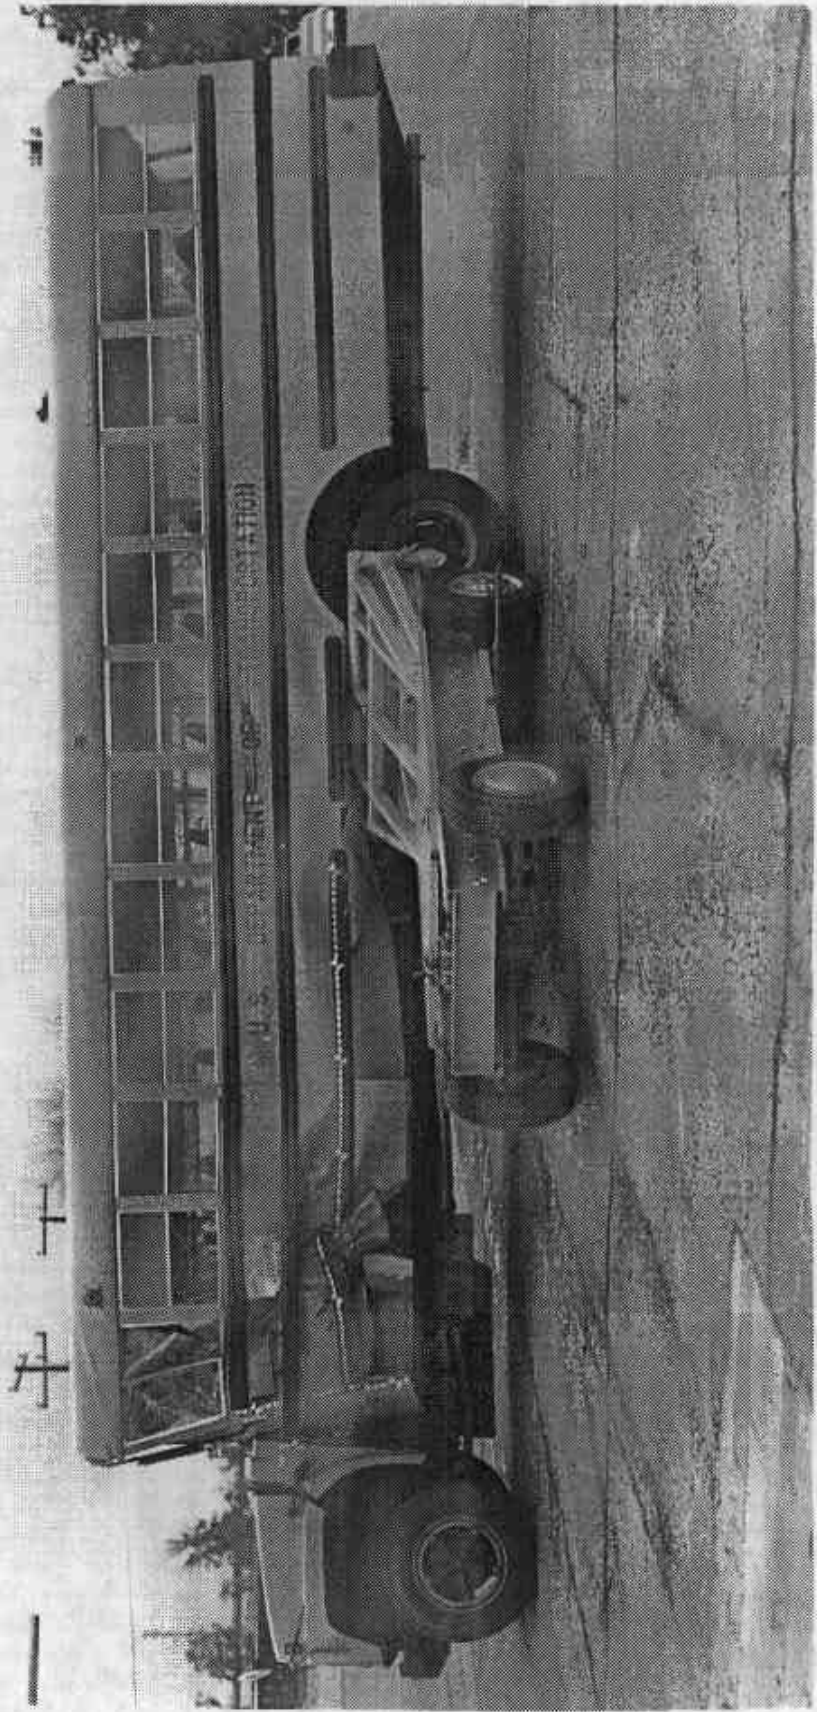
FIGURE 3-1 LEFT SIDE OVERALL VIEW - POSTTEST

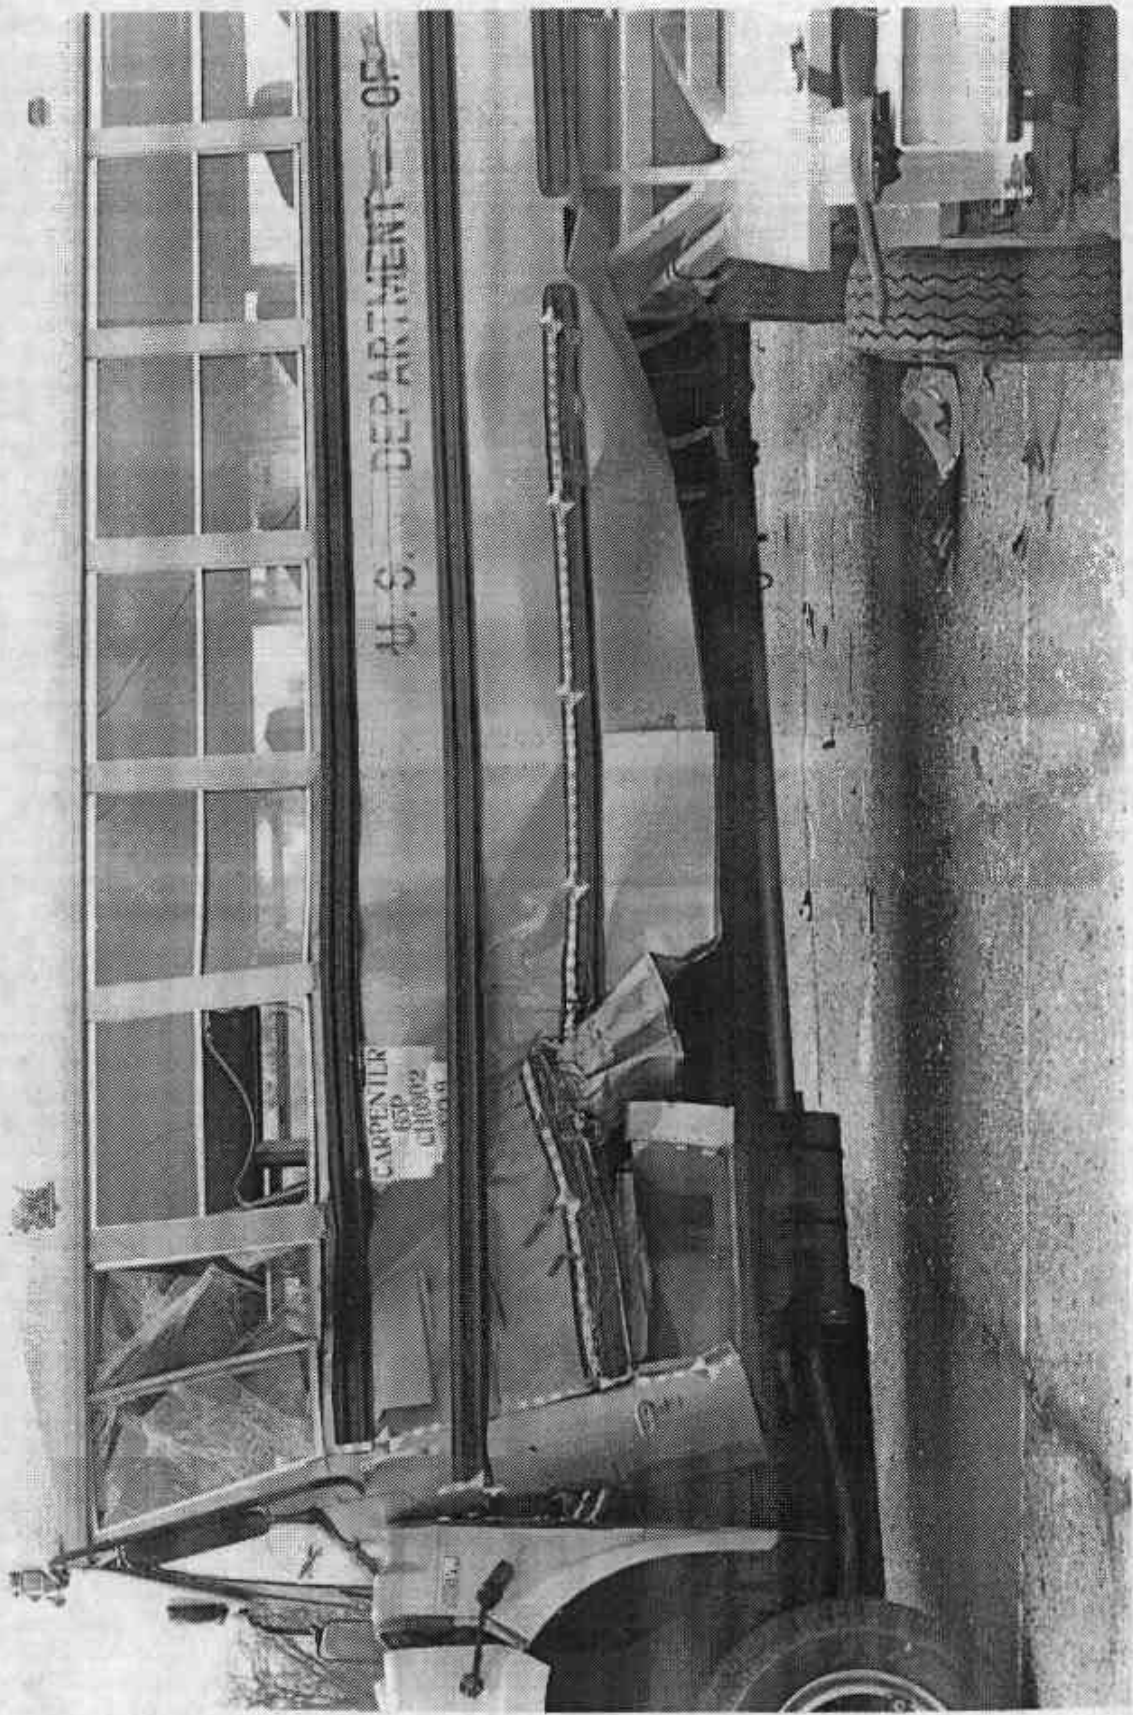
DAMAGE DETAILS: The 10,000 lb moving barrier contacted the bus just
aft of the "A" pillar. Crush of the bus left side extended
approximately 80 inches rearward of the impact point with a maximum
lateral crush of 8.2 inches. The floor joint, located behind the
driver's seat, 79 inches rearward of the front axle, separated 36.5
inches laterally across the bus. The floor immediately forward of
this joint was badly buckled. No other joint separation was detected.
The bus main body pulled away from the front engine compartment along
the left side pulling 4 secured bolts out of the sheet metal. A
second impact of the 10,000 lb sled occurred 160 inches rearward of
the front axle. this caused minor side and floor damage, but no joint
separation. Incidentally, the second impact occurred where the gas
tank and the cage would have been, if they were not removed. There
were no significant gaps created in the floor due to the joint

FIGURE 3-5 CLOSEUP VIEW OF IMPACT AREA - POSTTEST

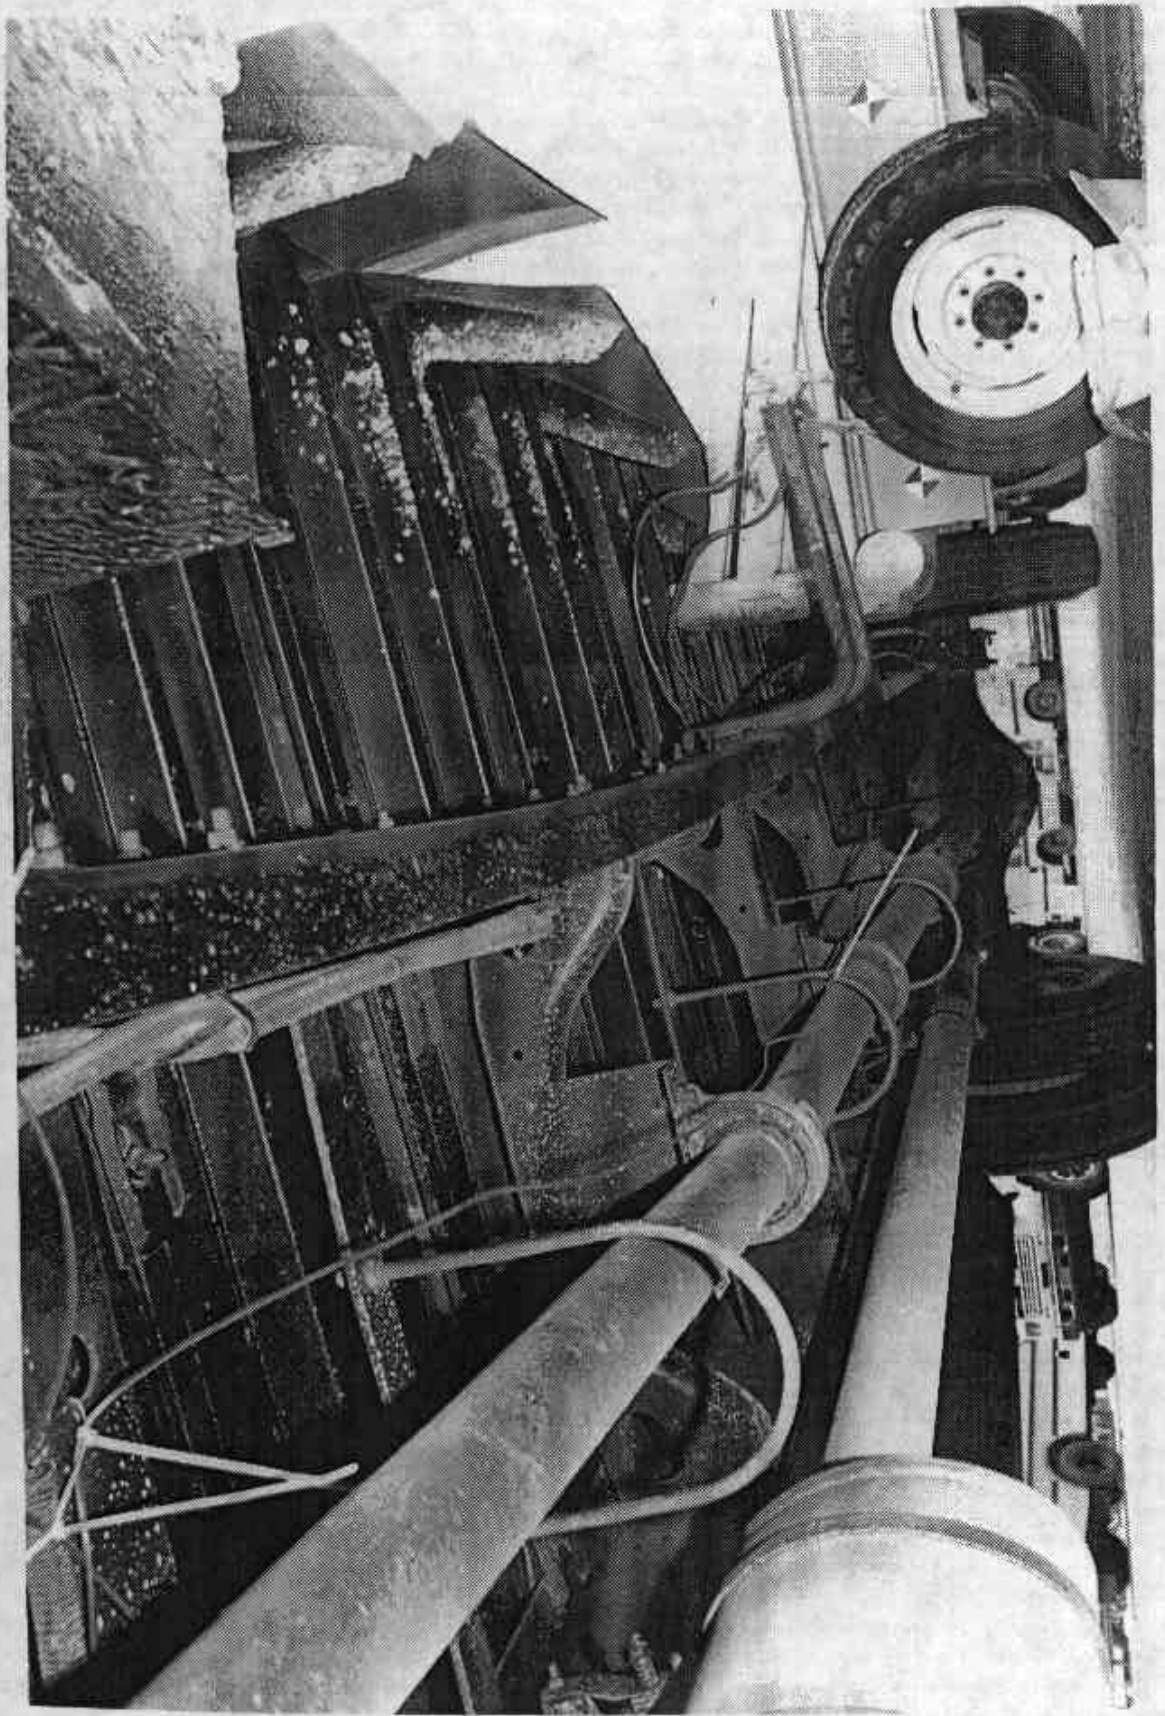
FIGURE 3-6 CLOSEUP UNDERNEATH VIEW OF IMPACT AREA LOOKING FRONT TO REAR - POSTTEST

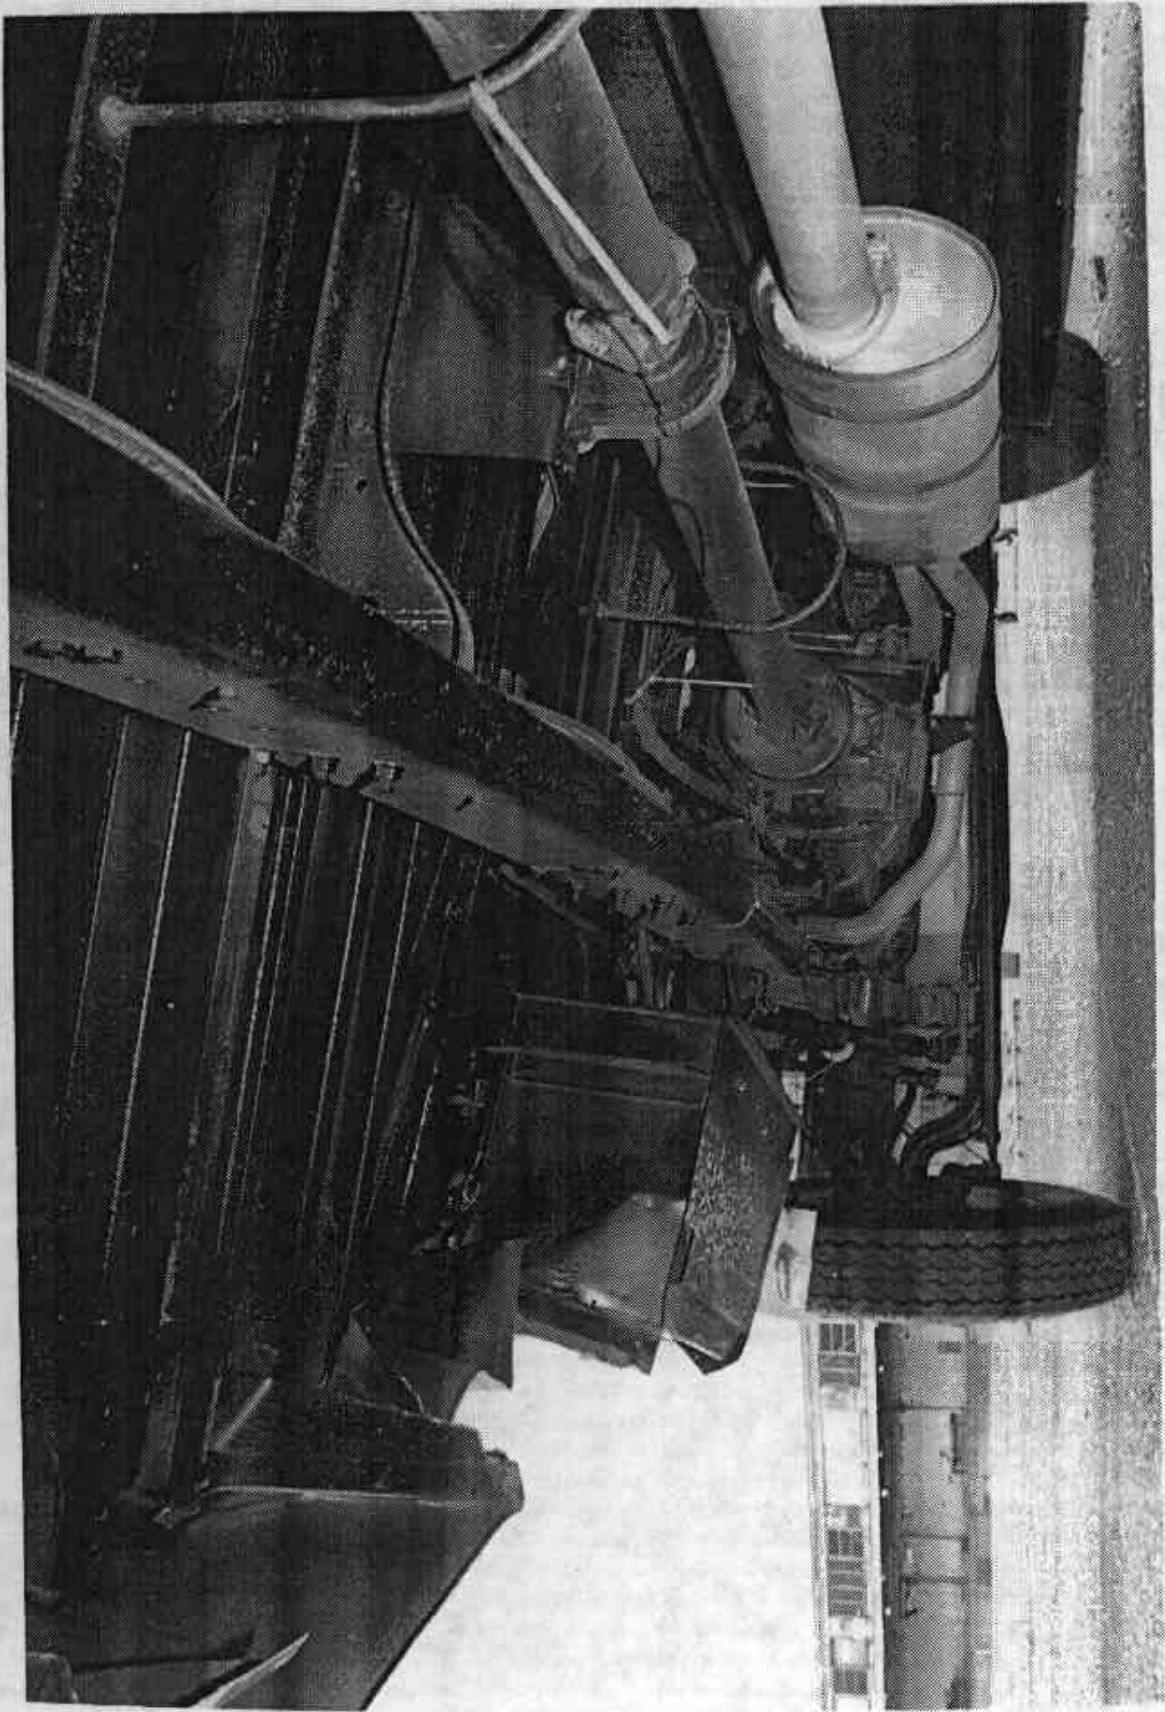
FIGURE 3-7 CLOSEUP UNDERNEATH VIEW OF IMPACT AREA LOOKING REAR TO FRONT - POSTTEST

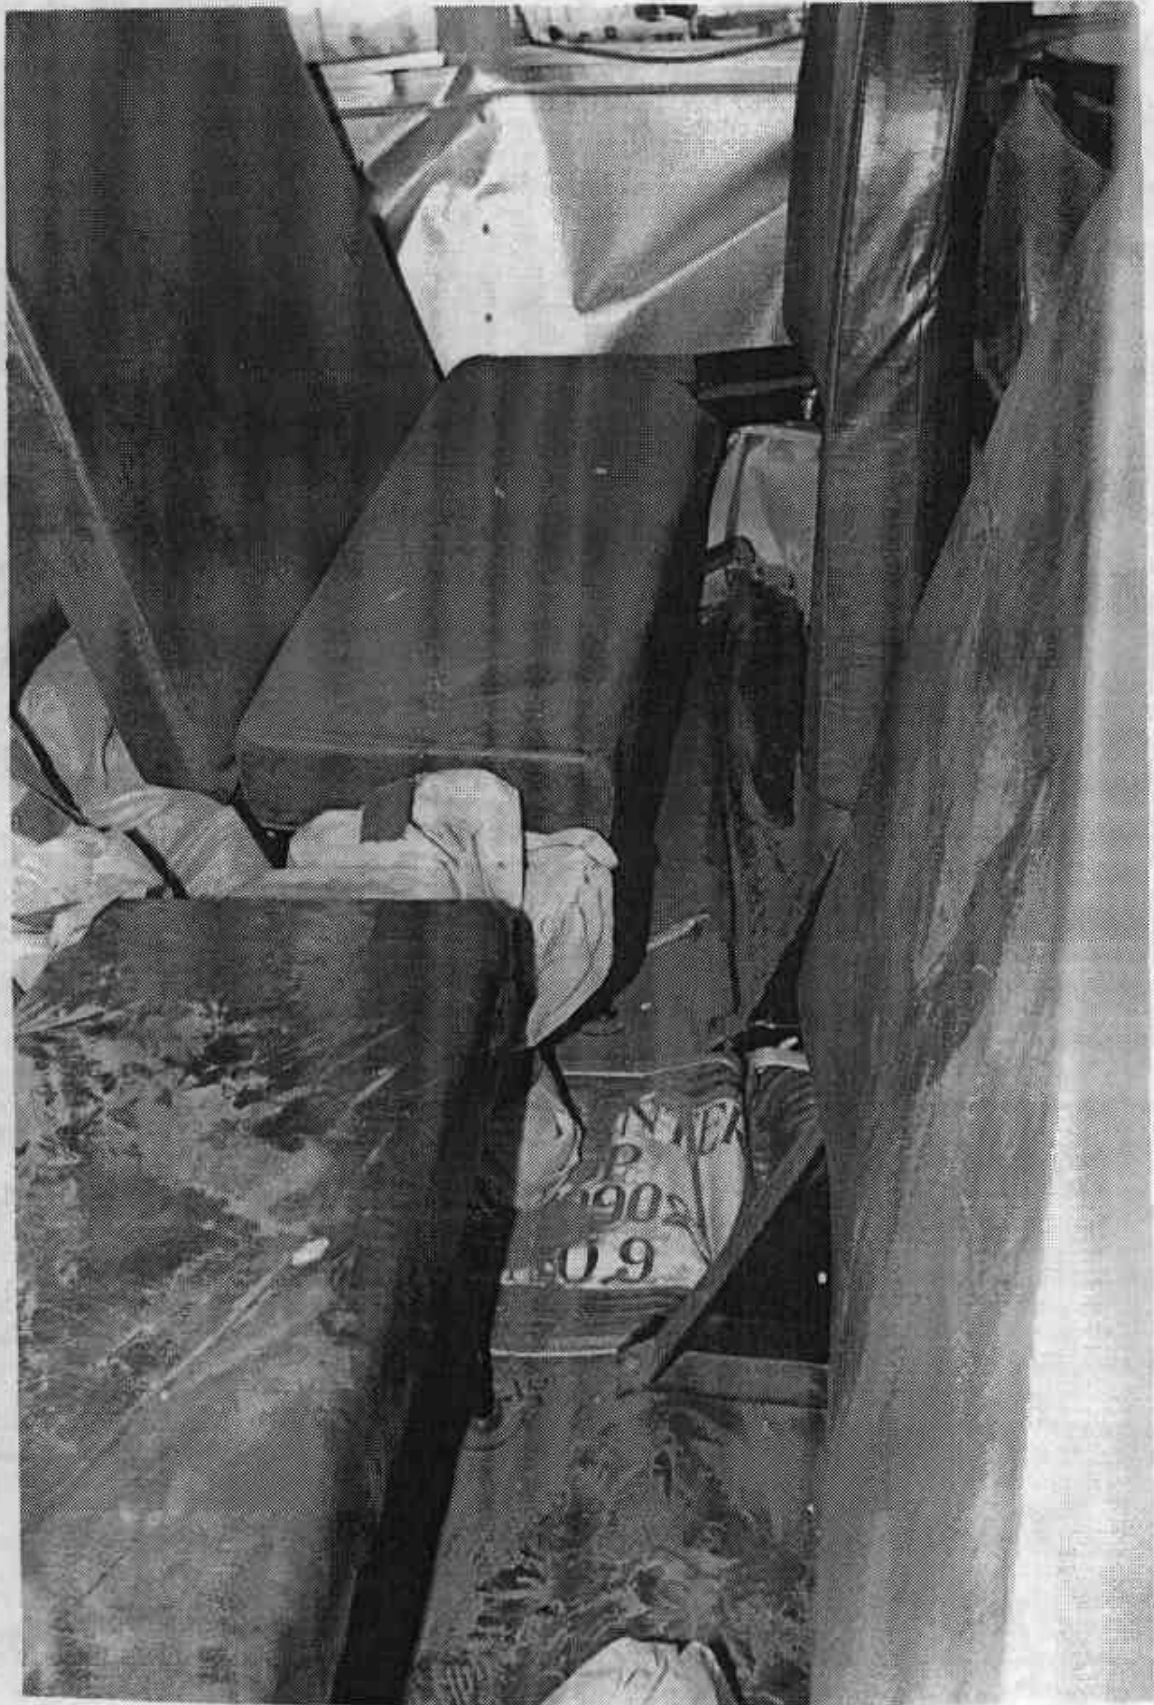
FIGURE 3-8 INTERIOR VIEW OF JOINT SEPARATION - POSTTEST
