CALSPAN REPORT NUMBER:: 8404-3

**VEHICLE-TO-VEHICLE  
28.2 kph FRONTAL IMPACT OF A  
1993 VOLVO 850 GLT 4-DOOR SEDAN INTO THE  
REAR OF A 1986 VOLKSWAGEN GOLF 4-DOOR HATCH BACK**

CALSPAN TEST NUMBER: A109 4-1655

December 5, 1996

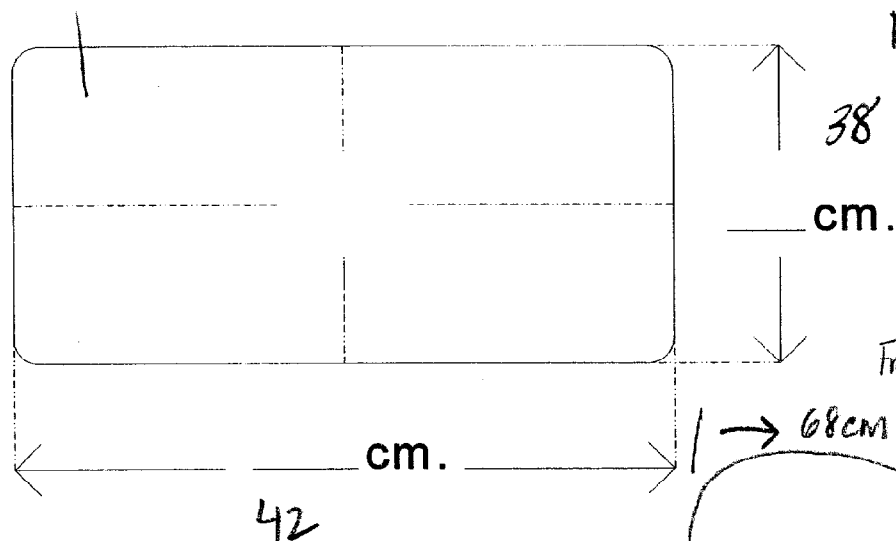
## 1. SKETCH DAMAGE AND CONTACT EVIDENCE ON PASSENGER AIR BAG (Front)

no transfers on face of bag.
