# Insurance Institute for Highway Safety Crashworthiness Evaluation

## Crash Test Report 1997 Mazda Protege (CF97017)

**Vehicle identification number:** JM1BC1413V0103946  
**Body style:** Four-door sedan  
**Engine/transmission:** Transverse 1.5-liter 4-cylinder, 4-speed automatic,  
front-wheel drive

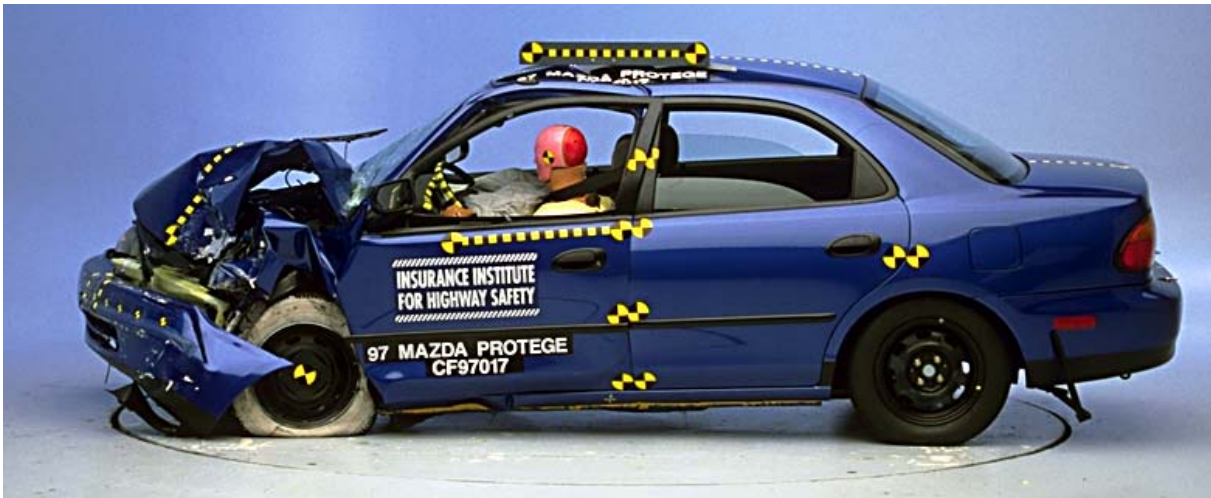
**Postcrash — 1997 Mazda Protege**

All doors remained closed during the crash. The driver door aperture shortened 7 cm as measured at the lower edge of the window. The driver and left rear doors opened with ease after the crash, but minor interference with the driver door prevented the left rear door from opening fully without slight additional effort. The right front and right rear doors opened with ease after the crash.

The welded seam between the driver door sill and adjacent floorpan was separated for 41 cm extending rearward from the base of the A-pillar.

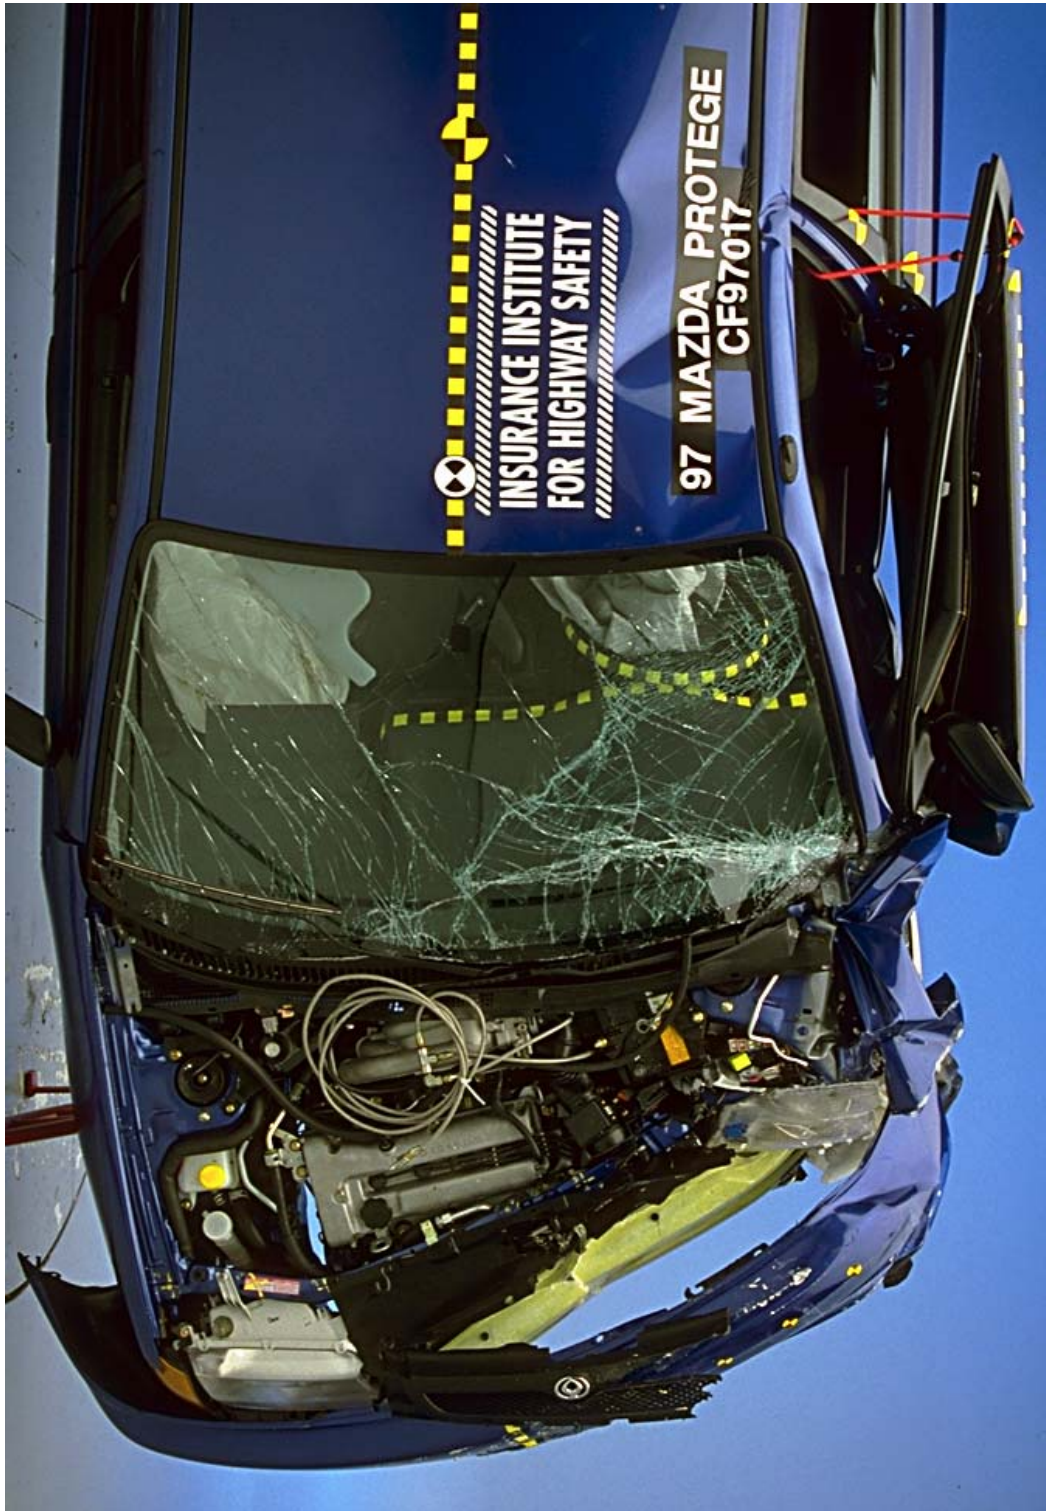
**Figure 1**  
**Overhead View of Crash Deformation — 1997 Mazda Protege**

Figure 1 shows the overhead view of the crash deformation. Figure 2A illustrates the precrash and postcrash contour measures of the front bumper cover profile and the resulting permanent crush. Figure 2B illustrates the corresponding measures of both the front bumper reinforcement bar and the upper crossmember of the radiator support. Figure 3 shows the precrash and postcrash views from below. Figure 4 illustrates the deformation of the frame rails, door sills, floor pan stiffeners, and longitudinal and transverse members beneath the engine, which are visible in Figure 3.

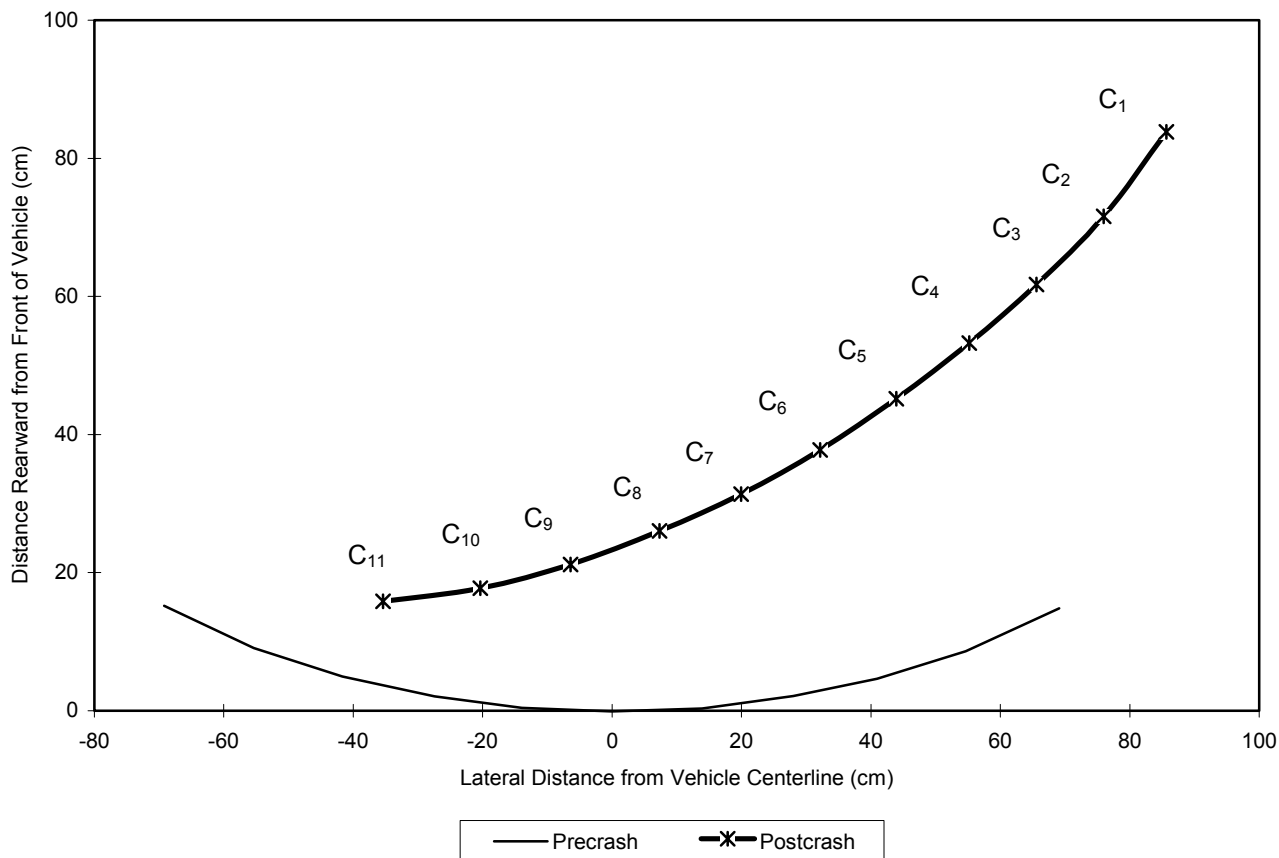
**a) Exterior Crush Contour at Bumper Height**

The bumper cover was torn completely off the vehicle during the crash. The postcrash contour represents the best attempt to fit the cover back onto the vehicle. The length of the reference line was 138 cm precrash and 121 cm postcrash.
