# Insurance Institute for Highway Safety Crashworthiness Evaluation

## Crash Test Report 1998 Volkswagen Passat (CF98002)

**Vehicle identification number:** WVVMA63B8WE114404  
**Body style:** Four-door sedan  
**Engine/transmission:** Longitudinal 1.8-liter turbocharged 4-cylinder,  
5-speed automatic, front-wheel drive

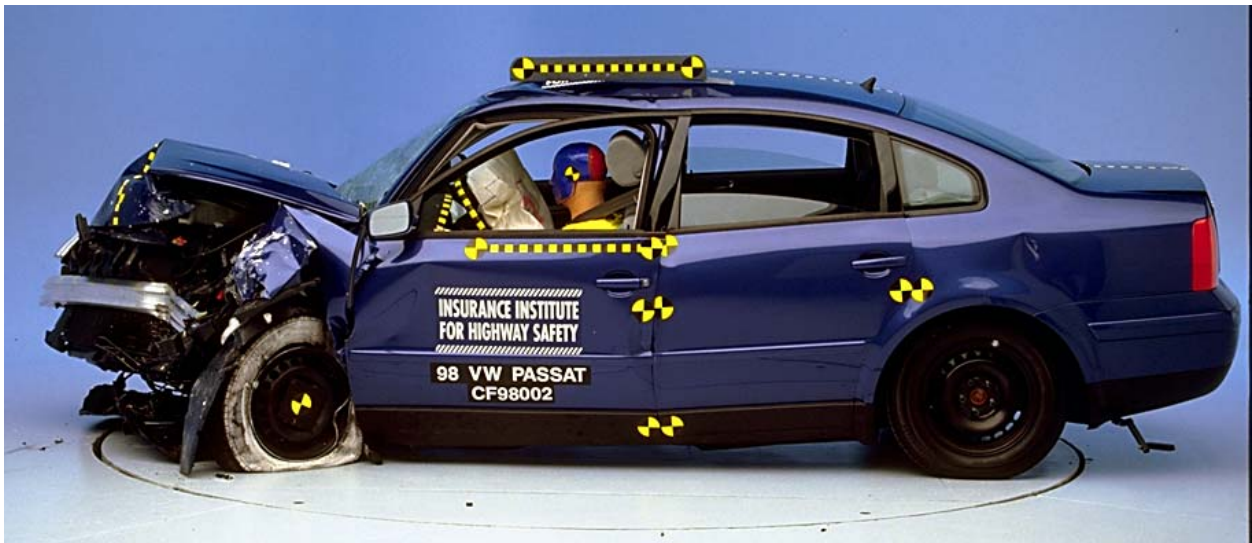
**Postcrash — 1998 Volkswagen Passat**

All doors remained closed during the crash. The driver door aperture shortened 4 cm as measured at the lower edge of the window. The driver and left rear doors required additional effort to open after the crash, but the right front and right rear doors opened with ease.

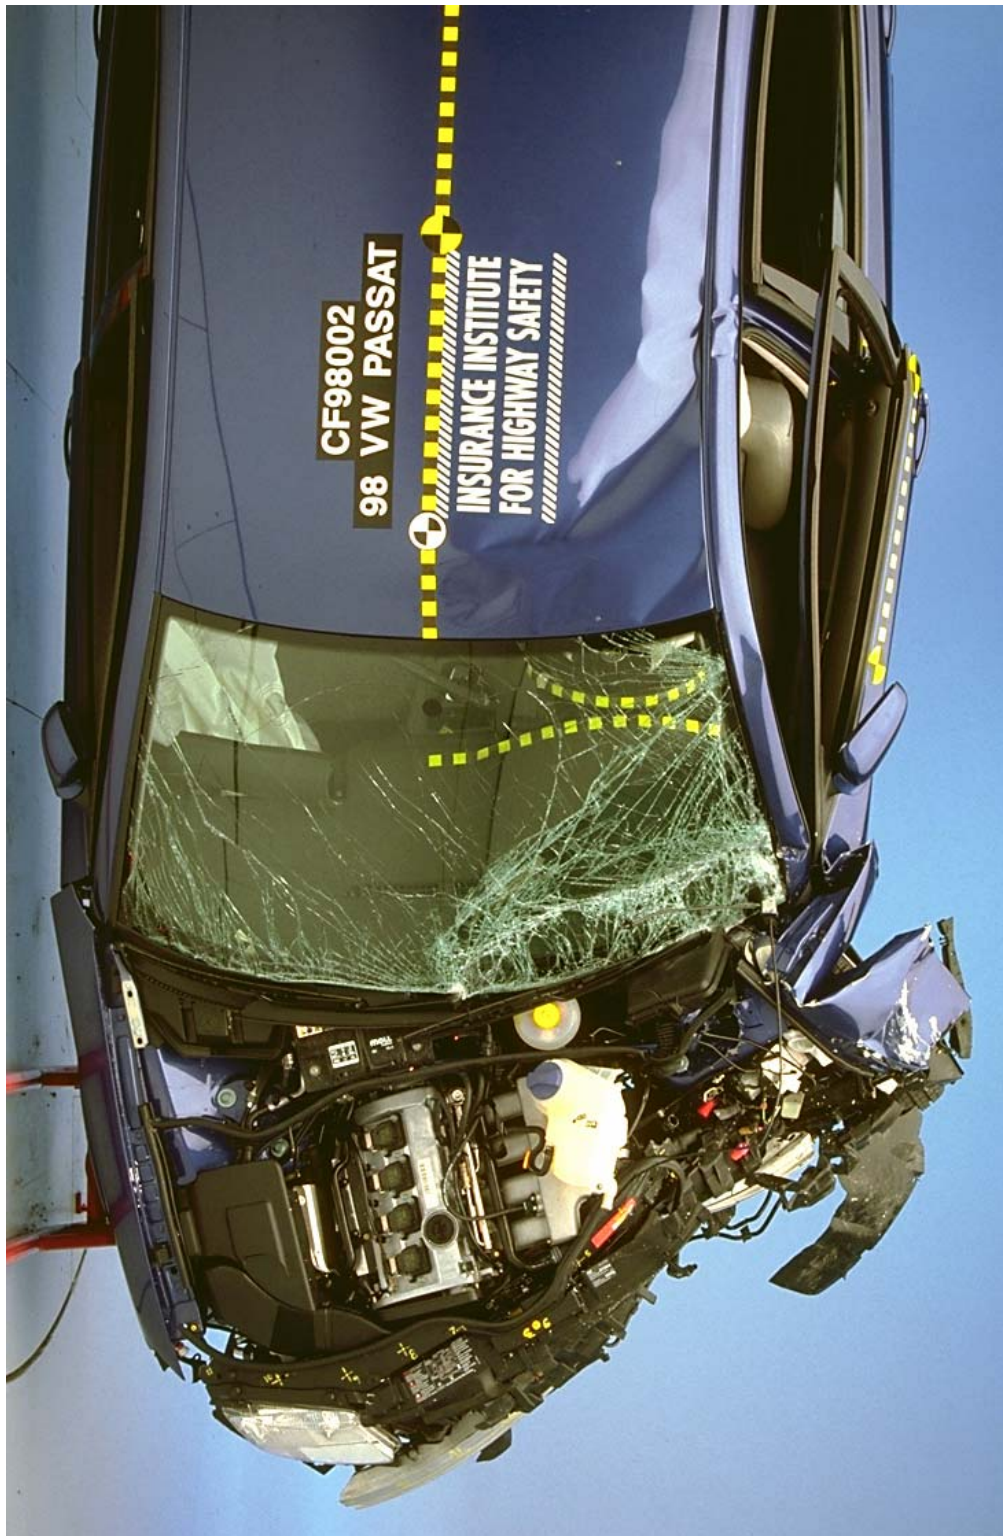
**Figure 1**  
**Overhead View of Crash Deformation — 1998 Volkswagen Passat**

Figure 1 shows the overhead view of the crash deformation. Figure 2A illustrates the precrash and postcrash contour measures of the front bumper cover profile and the resulting permanent crush. Figure 2B illustrates the corresponding measures of both the front bumper reinforcement bar and the upper crossmember of the radiator support. Figure 3 shows the precrash and postcrash views from below. Figure 4 illustrates the deformation of the side rails, floor rails, and engine cradle, which are visible in Figure 3.

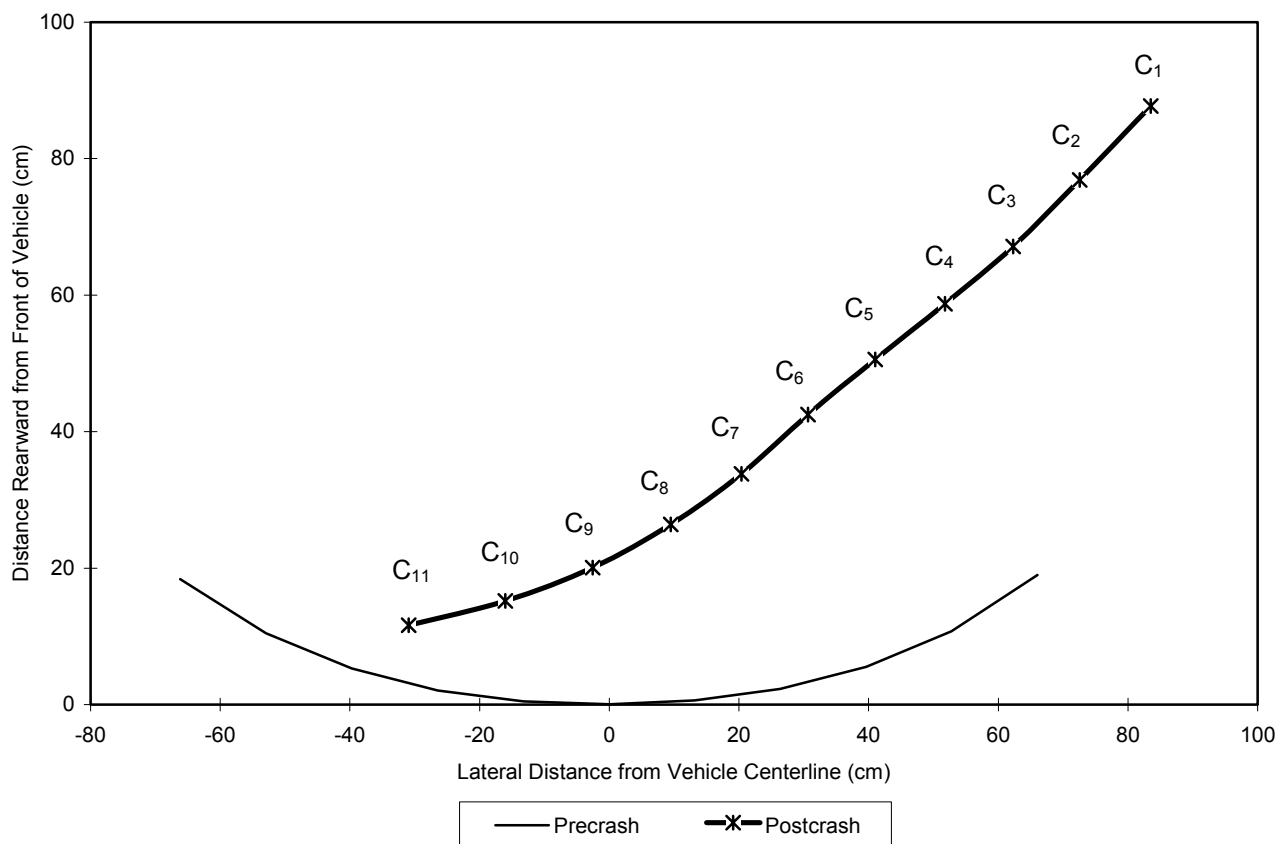
**a) Exterior Crush Contour at Bumper Height**

The bumper cover was torn completely off the vehicle during the crash. The postcrash contour represents the best attempt to fit the cover back onto the vehicle. The length of the reference line was 132 cm precrash and 114 cm postcrash.

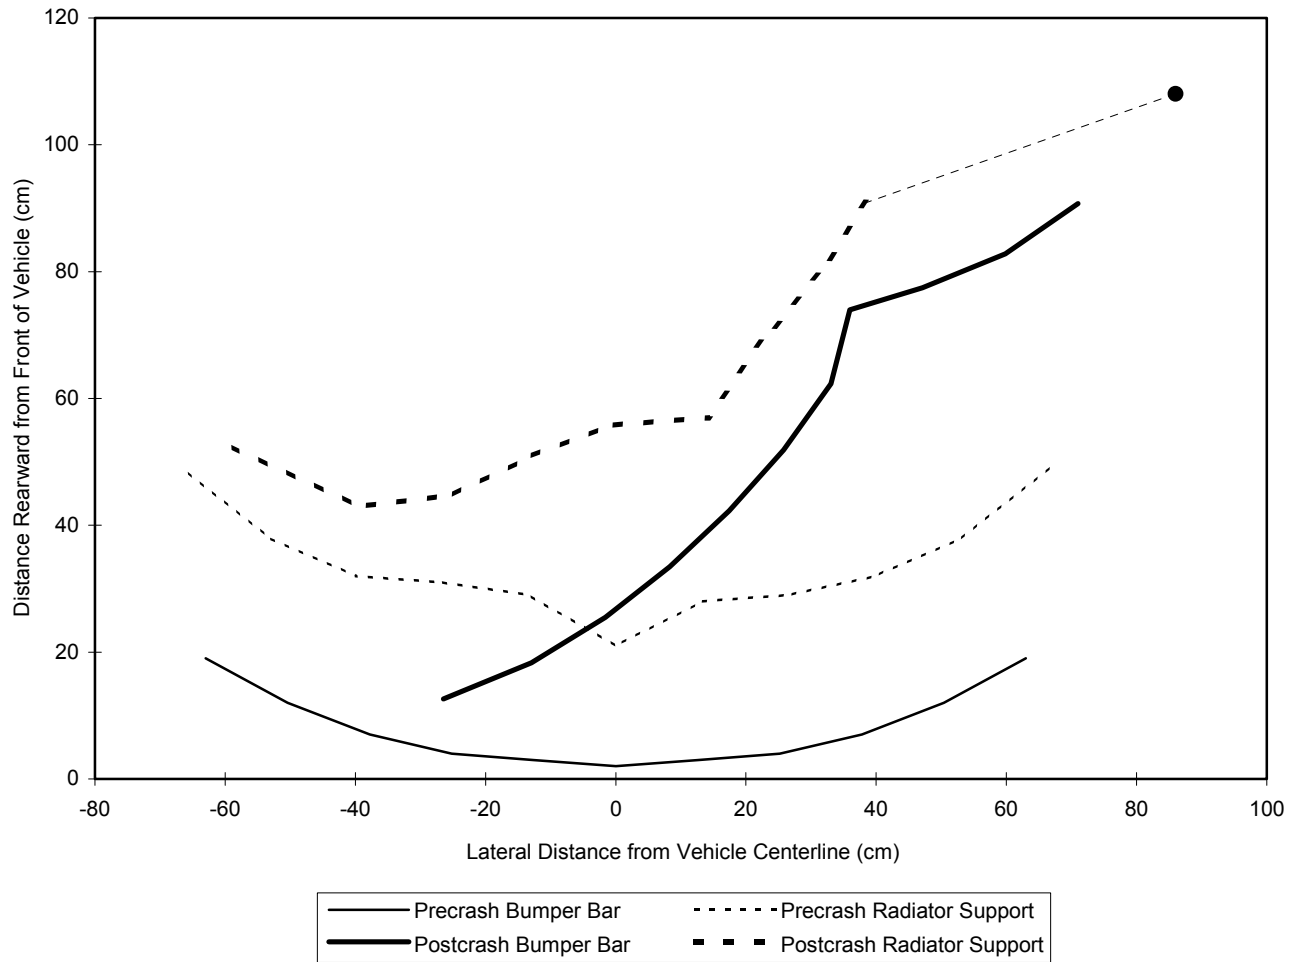
## b) Front Bumper Bar and Upper Radiator Support Crossmember Crush Contour

Upper radiator support crossmember (made of plastic) at driver side was broken off during the crash. Indicated endpoint represents junction of crossmember with fender.
