# Insurance Institute for Highway Safety Crashworthiness Evaluation

## Crash Test Report 1998 Nissan Sentra (CF97021)

**Vehicle identification number:** 1N4AB41D2WC709761  
**Body style:** Four-door sedan  
**Engine/transmission:** Transverse 1.6-liter 4-cylinder, 4-speed automatic, front-wheel drive

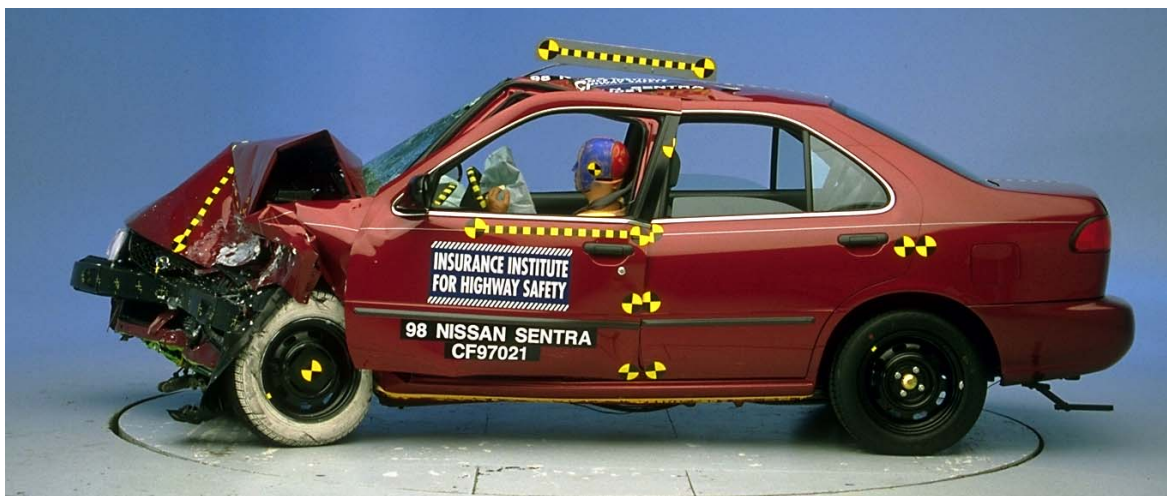
**Postcrash — 1998 Nissan Sentra**

All doors remained closed during the crash. The driver door aperture shortened 11 cm as measured at the lower edge of the window. The driver door required tools to open, and the left rear door required additional effort to open after the crash. The right front and right rear doors opened with ease after the crash.

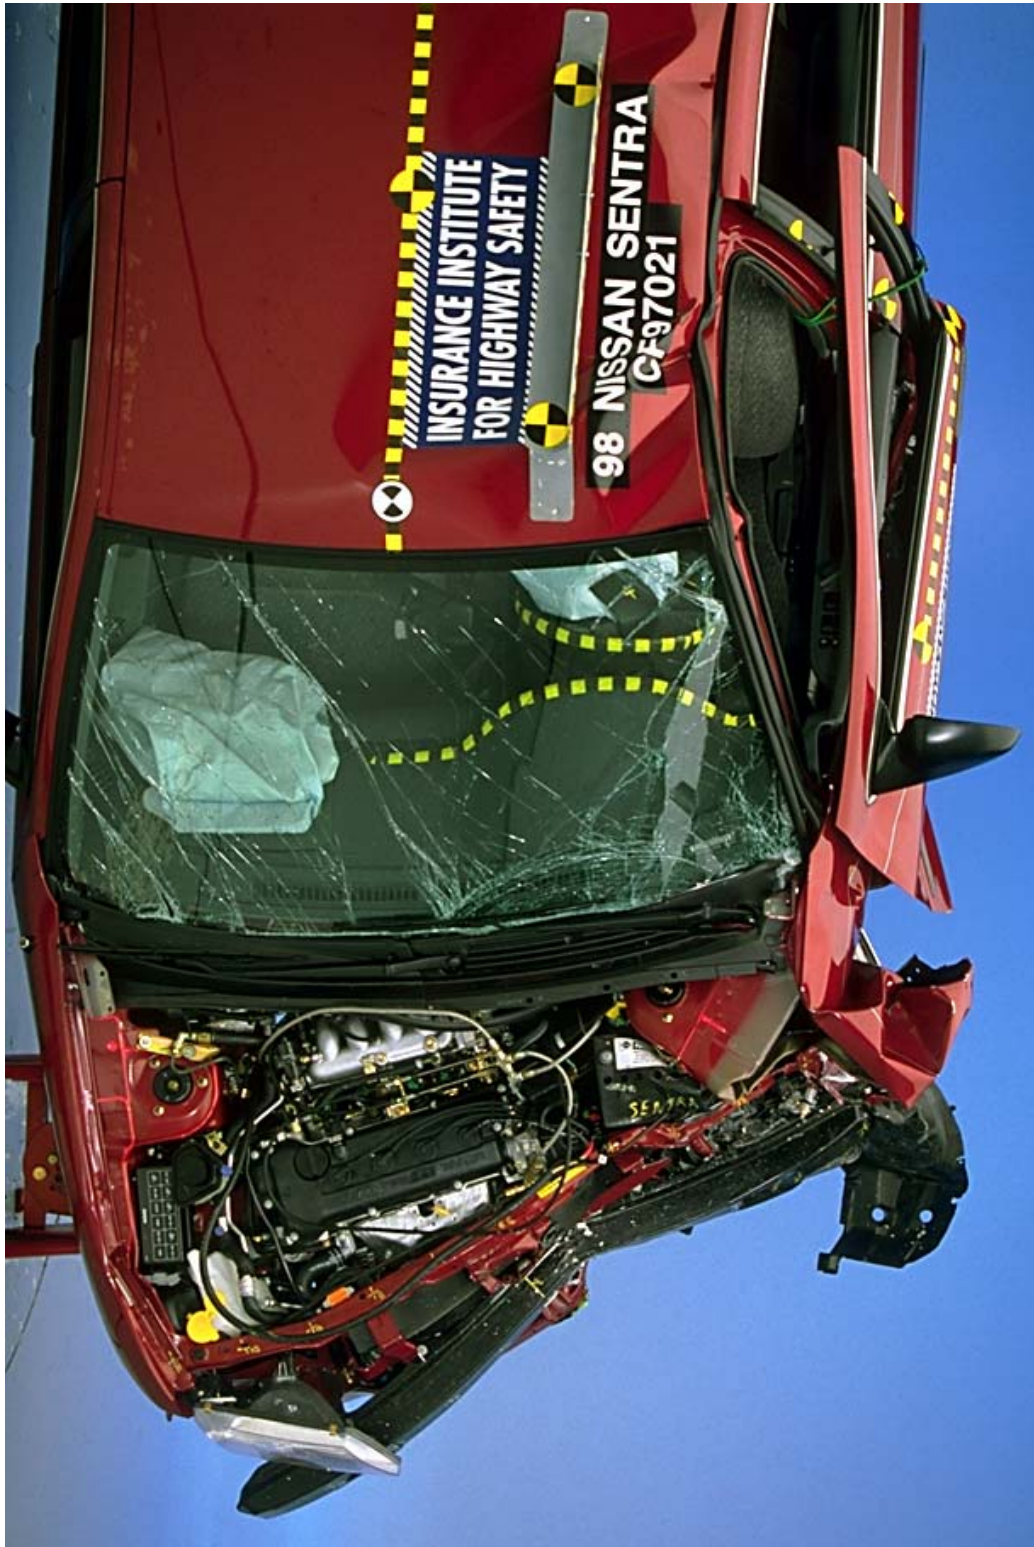
**Figure 1**  
**Overhead View of Crash Deformation — 1998 Nissan Sentra**

Figure 1 shows the overhead view of the crash deformation. Figure 2A illustrates the precrash and postcrash contour measures of the front bumper cover profile and the resulting permanent crush. Figure 2B illustrates the corresponding measures of both the front bumper reinforcement bar and the upper crossmember of the radiator support. Figure 3 shows the precrash and postcrash views from below. Figure 4 illustrates the deformation of the side rails, floor rails, and engine support members, which are visible in Figure 3.

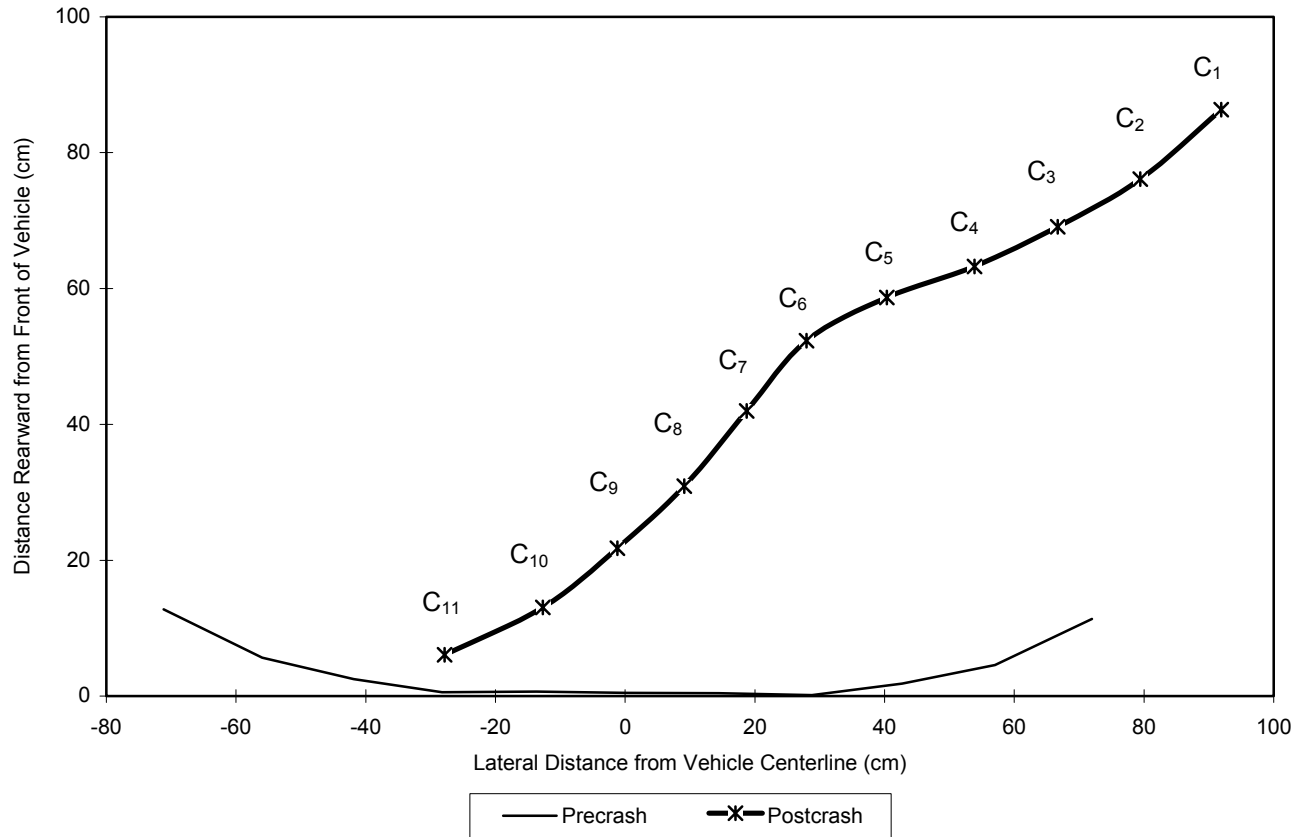
**a) Exterior Crush Contour at Bumper Height**

The bumper cover was torn completely off the vehicle during the crash. The postcrash contour represents the best attempt to fit the cover back onto the vehicle. The length of the reference line was 143 cm precrash and 120 cm postcrash.

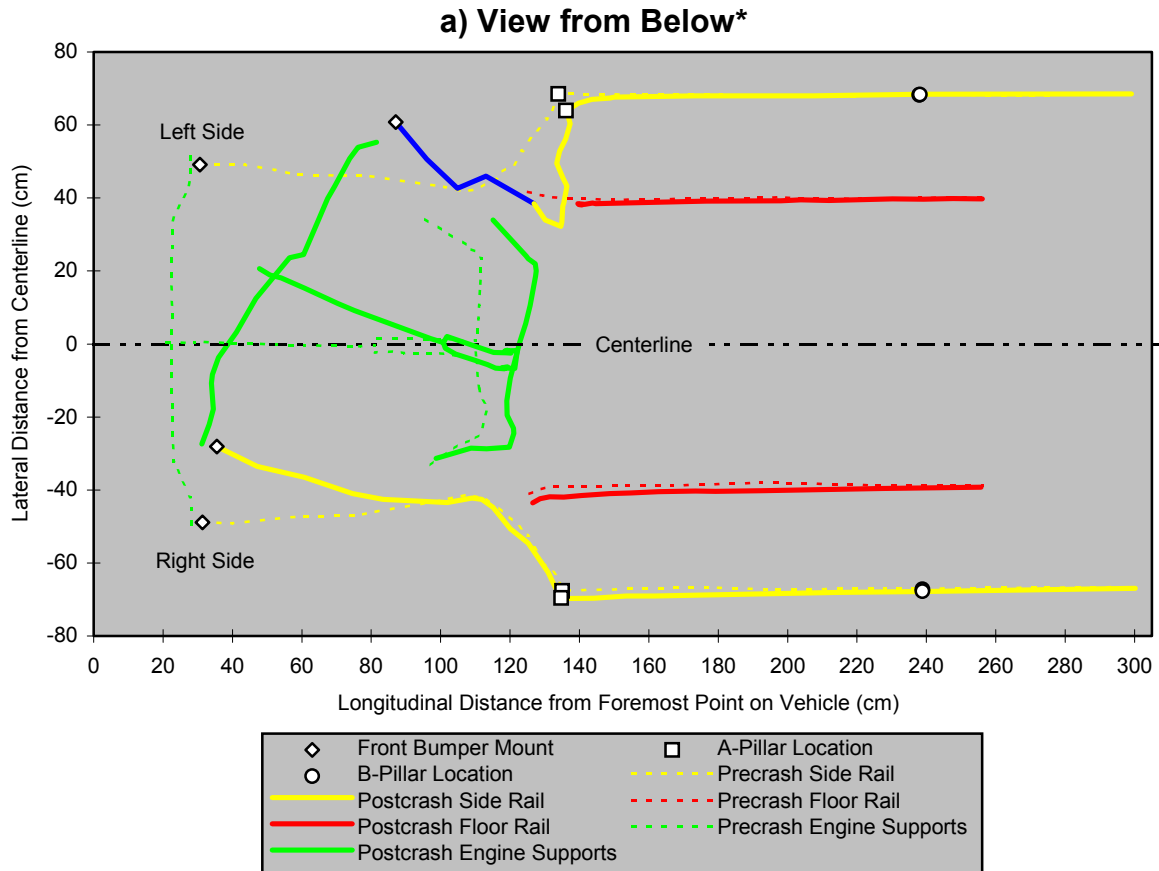
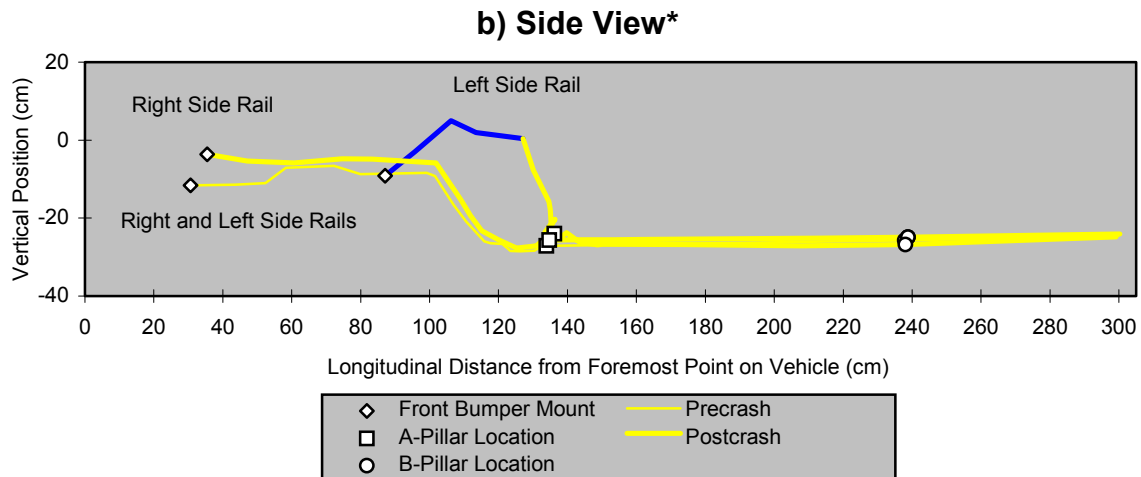
**Figure 4**  
**Frame Rail Deformation — 1998 Nissan Sentra**

\* After the crash, the position of the leading segment of the left side rail (indicated by — ) was approximated because this segment could not be adequately accessed due to the crush.
