# Insurance Institute for Highway Safety Crashworthiness Evaluation

## Crash Test Report 1997 Volkswagen Jetta (CF97018)

**Vehicle identification number:** 3VWRA81HXVM046024  
**Body style:** Four-door sedan  
**Engine/transmission:** Transverse 2.0-liter 4-cylinder, 4-speed automatic, front-wheel drive

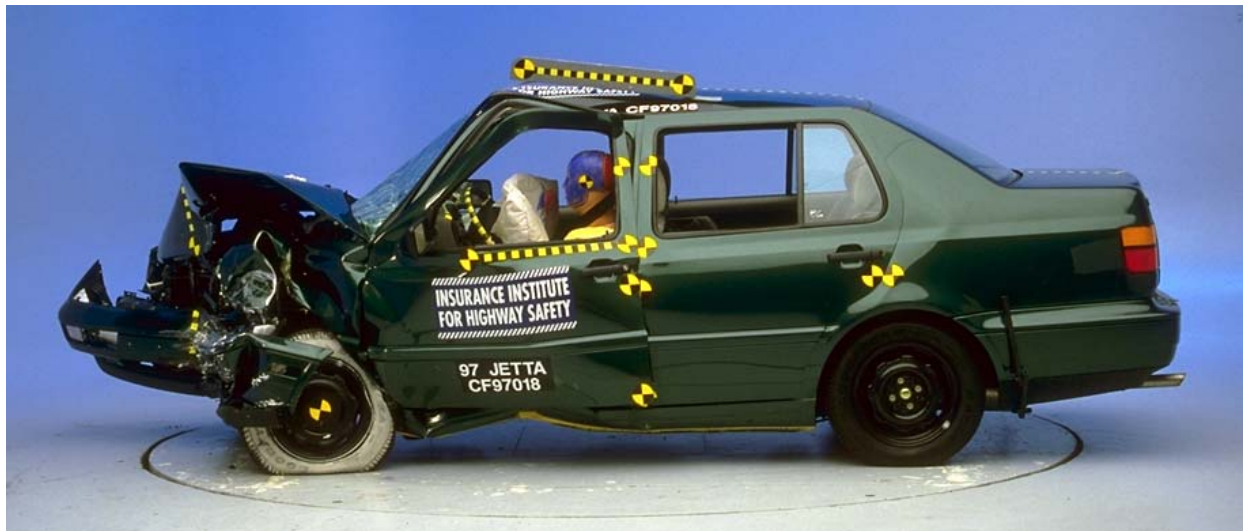
**Postcrash — 1997 Volkswagen Jetta**

Measures of intrusion taken after the crash indicated the lower instrument panel in front of the dummy moved rearward 7-9 cm. Resultant intrusion in the driver footwell measured 26 cm at the footrest and 20-34 cm at other places on the toepan. The upper end of the steering column moved upward 5 cm and rearward 7 cm. All doors remained closed during the crash. The driver and left rear doors required additional effort to open, but the right front and right rear doors opened with ease after the crash.

All doors remained closed during the crash. The driver door aperture shortened 10 cm as measured at the lower edge of the window. The driver door required additional effort to open, and the left rear door required considerable effort to open after the crash. The right front and right rear doors opened with ease after the crash.

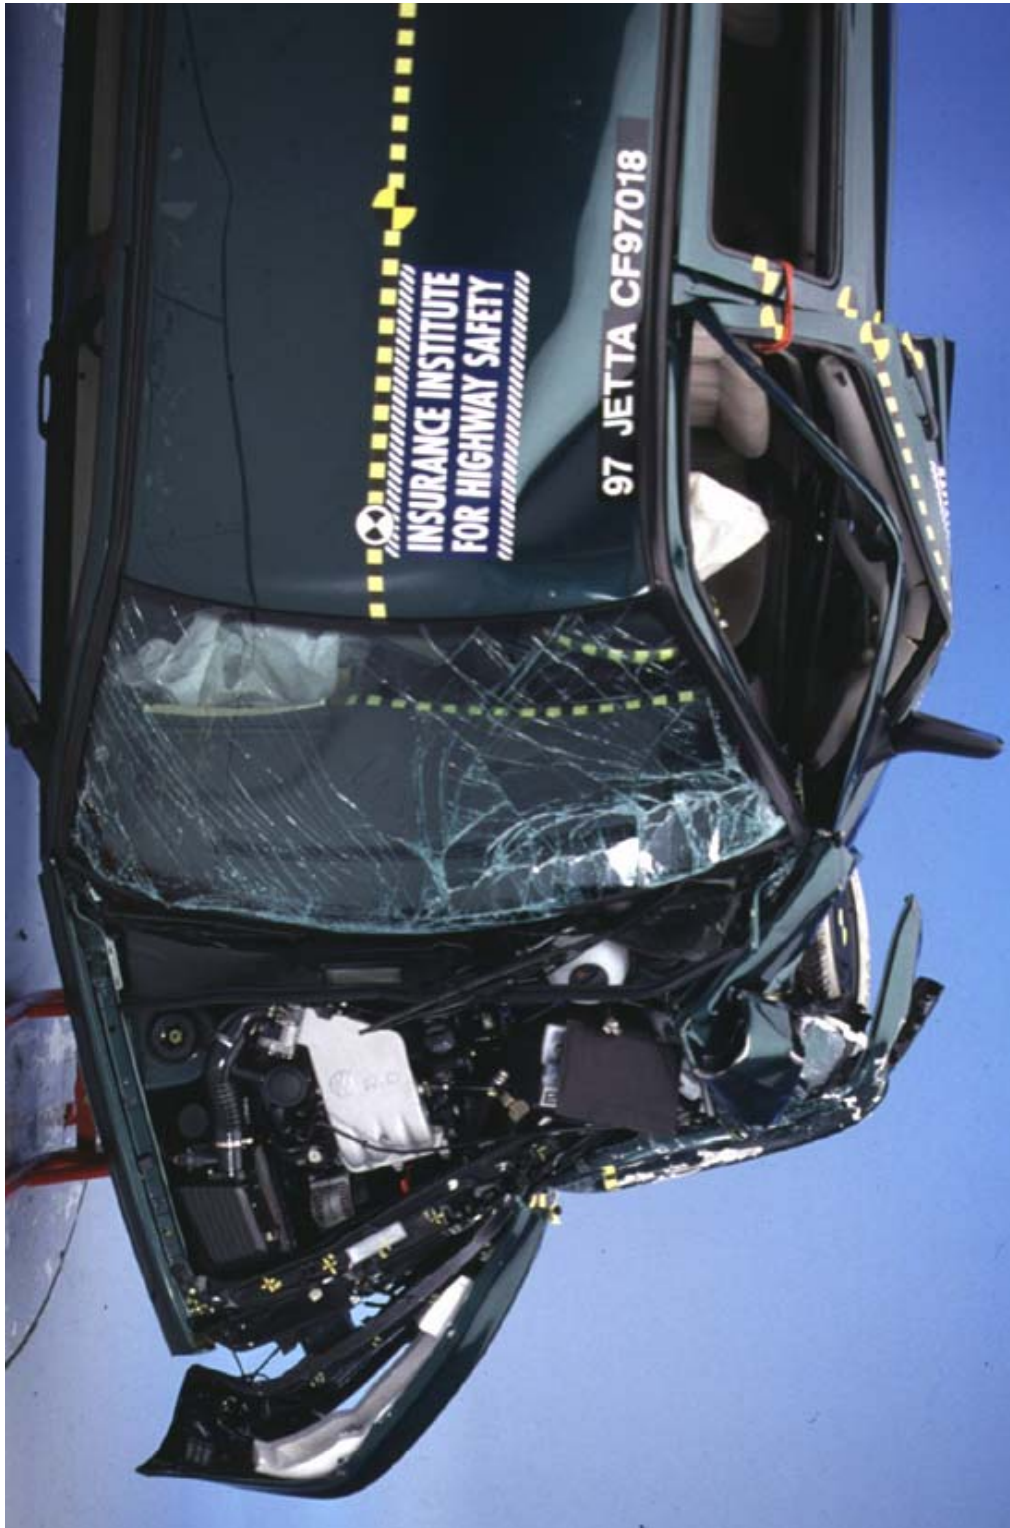
**Figure 1**  
**Overhead View of Crash Deformation — 1997 Volkswagen Jetta**

Figure 1 shows the overhead view of the crash deformation. Figure 2A illustrates the precrash and postcrash contour measures of the front bumper cover profile and the resulting permanent crush. Figure 2B illustrates the corresponding measures of both the front bumper reinforcement bar and the upper crossmember of the radiator support. Figure 3 shows the precrash and postcrash views from below. Figure 4 illustrates the deformation of the side rails, floor rails, and engine support members, which are visible in Figure 3.

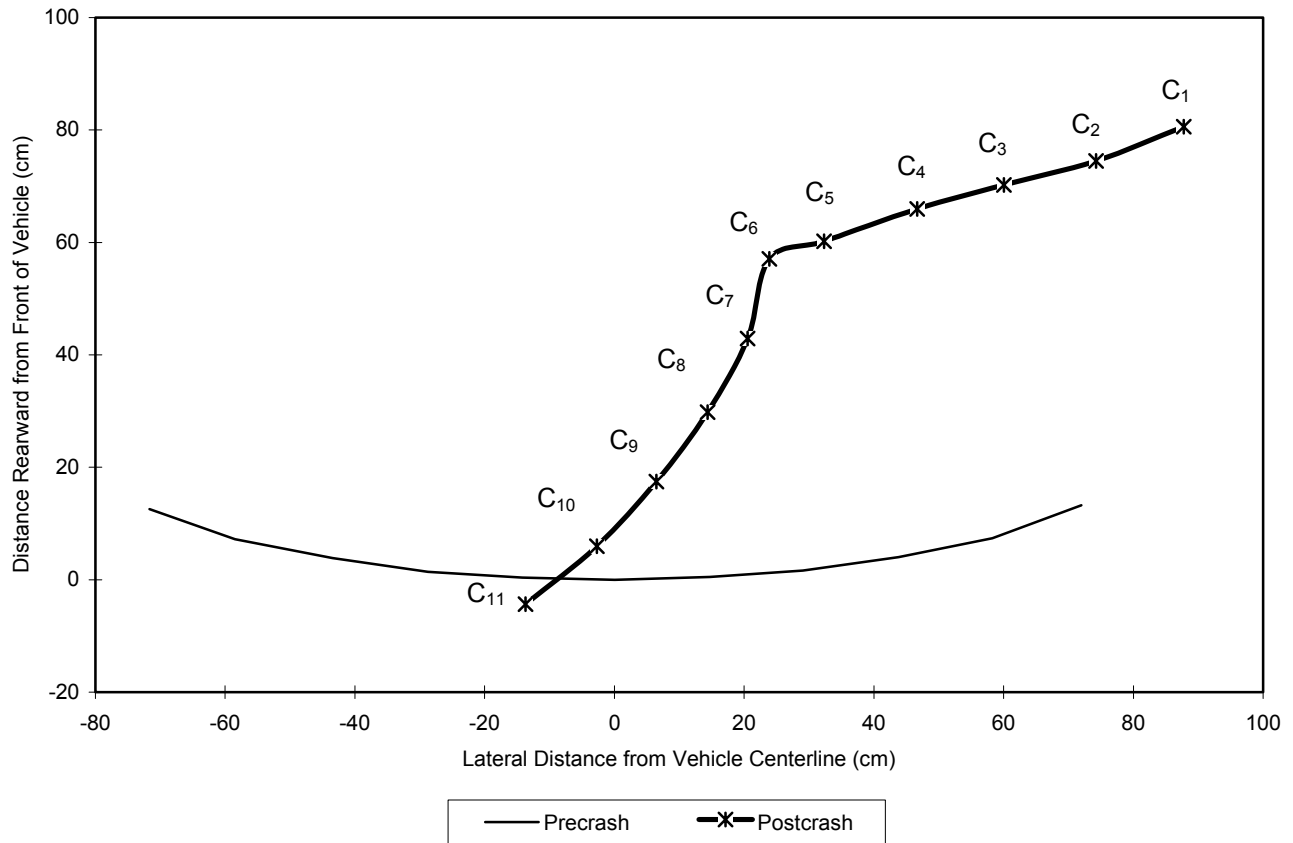
**a) Exterior Crush Contour at Bumper Height**

The length of the reference line was 144 cm precrash and 102 cm postcrash.
