# Insurance Institute for Highway Safety Crashworthiness Evaluation

## Crash Test Report 1999 Chevrolet Malibu (CF99025)

**Vehicle identification number:** 1G1ND52J3X6271101  
**Body style:** Midsize four-door sedan  
**Engine/transmission:** Transverse 3.1-liter V6, 4-speed automatic,  
front-wheel drive

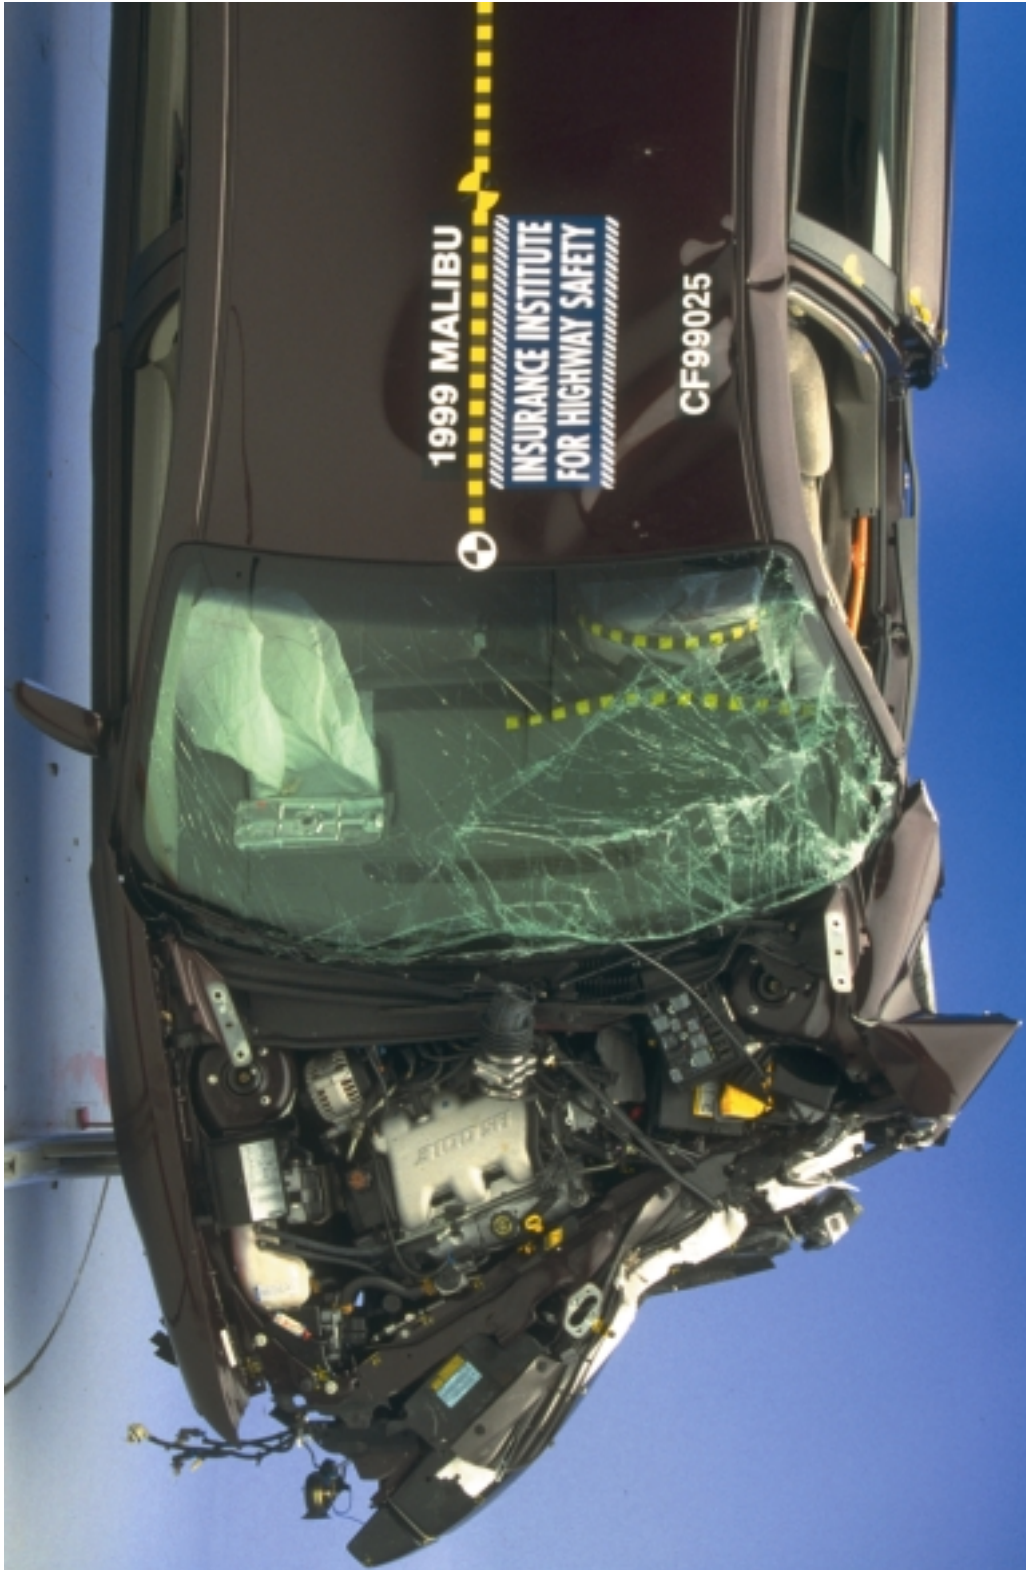
**Figure 2**  
**Overhead View of Crash Deformation — 1999 Chevrolet Malibu**

Figure 2 shows the overhead view of the crash deformation. Figure 3 illustrates the precrash and postcrash contour measures of the front bumper cover profile and the resulting permanent crush. Figure 4 shows the precrash and postcrash views from below. Figure 5 illustrates the deformation of the side rails, door sills, and engine cradle, which are visible in Figure 4.

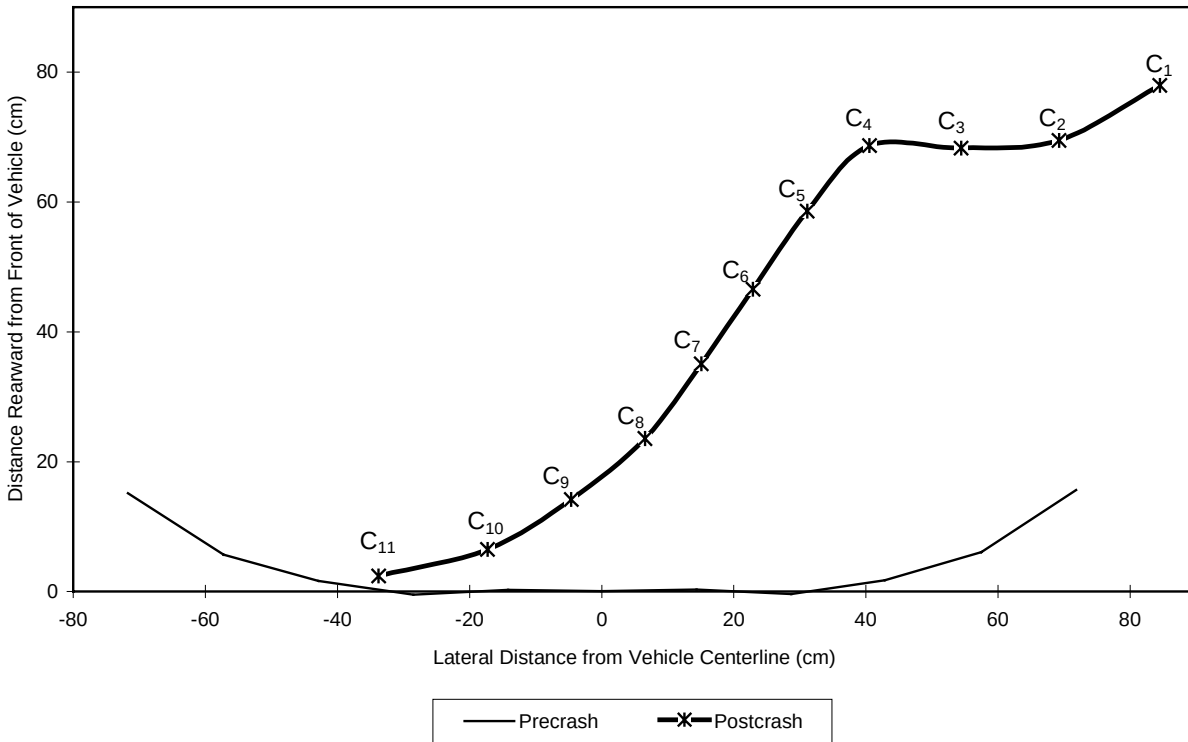
**Figure 3**  
**Front Bumper Cover Crush Contour — 1999 Chevrolet Malibu**

The bumper cover was torn completely off the vehicle during the crash. The postcrash contour represents the best attempt to fit the cover back onto the vehicle. The length of the reference line was 144 cm precrash and 118 cm postcrash.

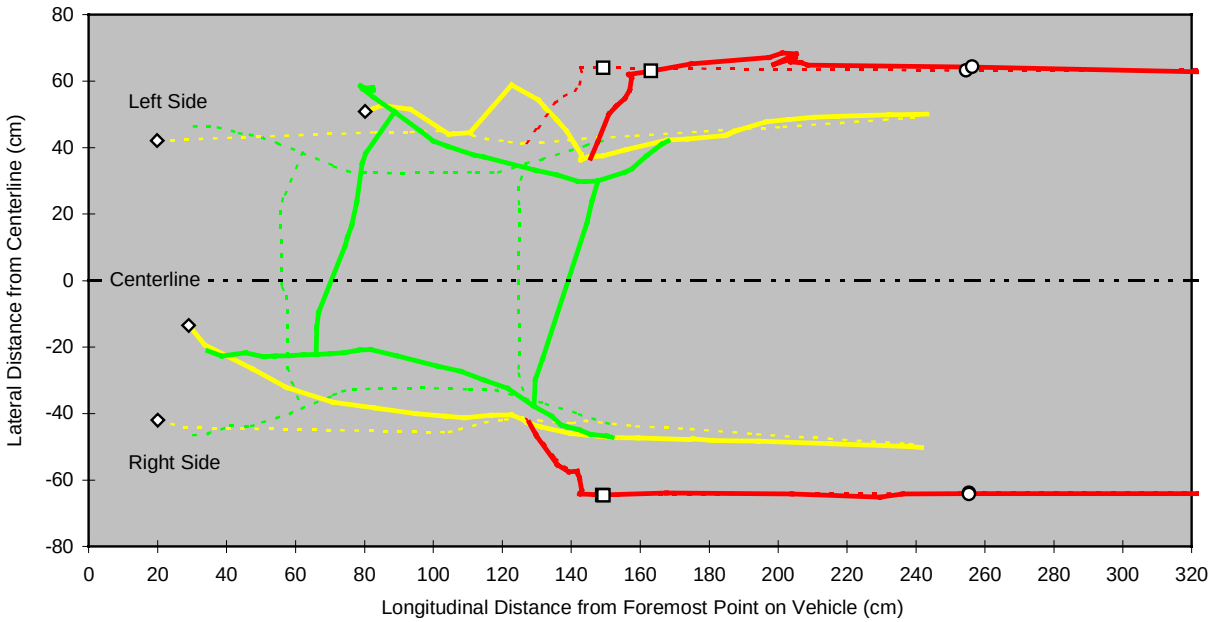
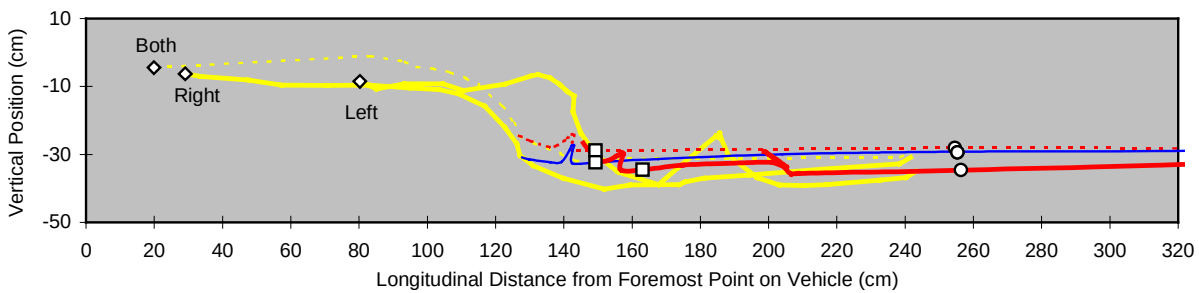
**Figure 5**  
**Structural Deformation, Views from Below and Side — 1999 Chevrolet Malibu**

The floorpan was buckled sharply upward just in front of the driver seat, and the welded seam joining the floorpan to the door sill was torn open. The tear was 22 cm long and had a maximum gap width of 11 cm.

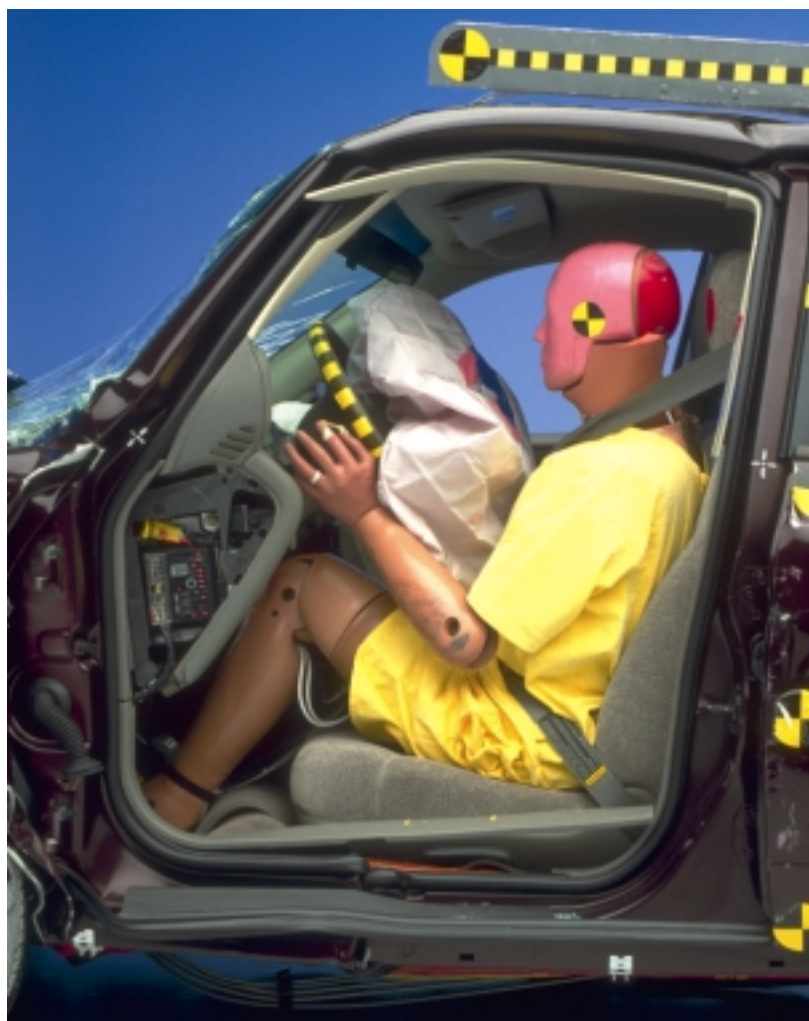
**Figure 6**  
**Dummy and Vehicle Interior, Postcrash — 1999 Chevrolet Malibu**

**Left leg and foot:** Paint transferred from the dummy's left knee indicated the knee primarily contacted the knee bolster 5 cm directly to the right of the left instrument panel intrusion reference point. The knee also contacted the left underside part of the steering column trim and the underside of the tilt adjustment lever. Paint transferred from the dummy's left shin indicated the shin contacted the bolster below and slightly to the left of the knee impact location on the bolster. The left foot was found fully dorsiflexed and considerably inverted, with the sole of the forefoot and heel against the intruded toepan and the back of the heel against a sharp downward buckle in the floorpan. The upper left corner of the brake pedal was lying on top of the medial forefoot.

**Right leg and foot:** Paint transferred from the dummy's right knee indicated the knee contacted the knee bolster about 4 cm below and 6 cm to the left of the right instrument panel intrusion reference point. Paint transferred from the dummy's right shin indicated the shin contacted the bolster directly below the knee impact location. The right foot was found almost fully dorsiflexed but neither inverted nor everted, with the back of the heel against a sharp downward buckle in the floormat/carpeting on the floorpan. The medial sole of the heel was pressed against the intruded toepan, and the lateral sole of the heel was pressed against the accelerator pedal, which had broken free of its mounting arm. The sole of the forefoot was pressed against the accelerator pedal arm, which in turn was pressed against the intruded toepan. The lateral edge of the sole near the toe was against a steel brace to the right of the accelerator pedal arm.
