# Insurance Institute for Highway Safety Crashworthiness Evaluation

## Crash Test Report 1999 Mazda 626 (CF99024)

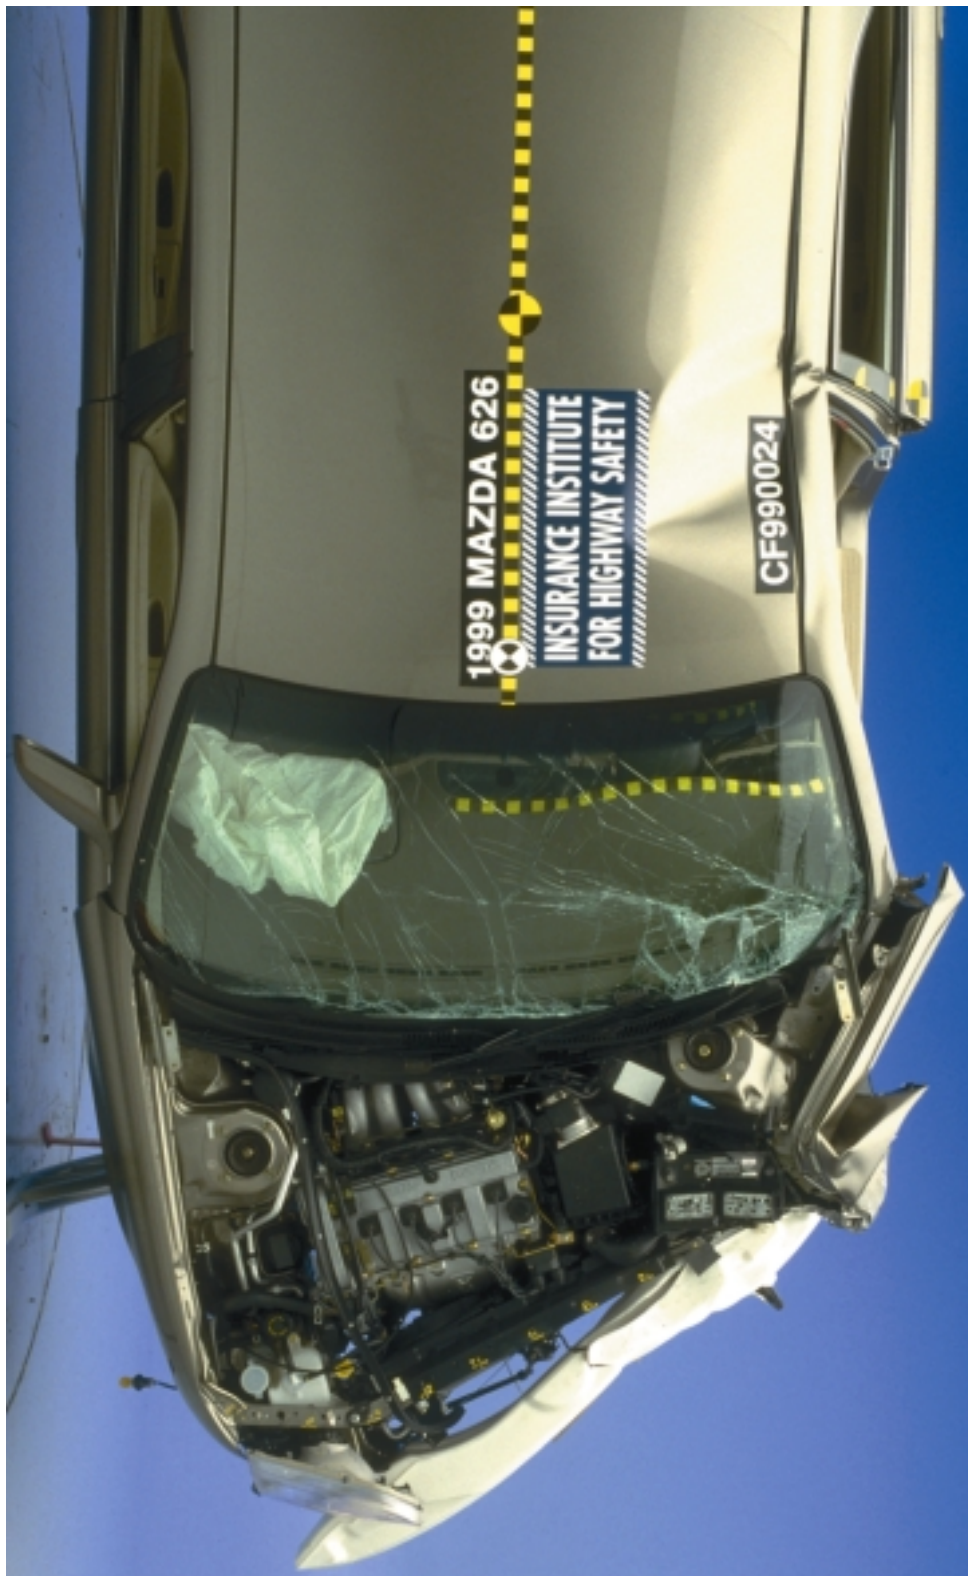
**Figure 2**  
**Overhead View of Crash Deformation — 1999 Mazda 626**

Figure 2 shows the overhead view of the crash deformation. Figure 3 illustrates the precrash and postcrash contour measures of the front bumper cover profile and the resulting permanent crush. Figure 4 shows the precrash and postcrash views from below. Figure 5 illustrates the deformation of the side rails, floor rails, and radiator and engine supports, which are visible in Figure 4.

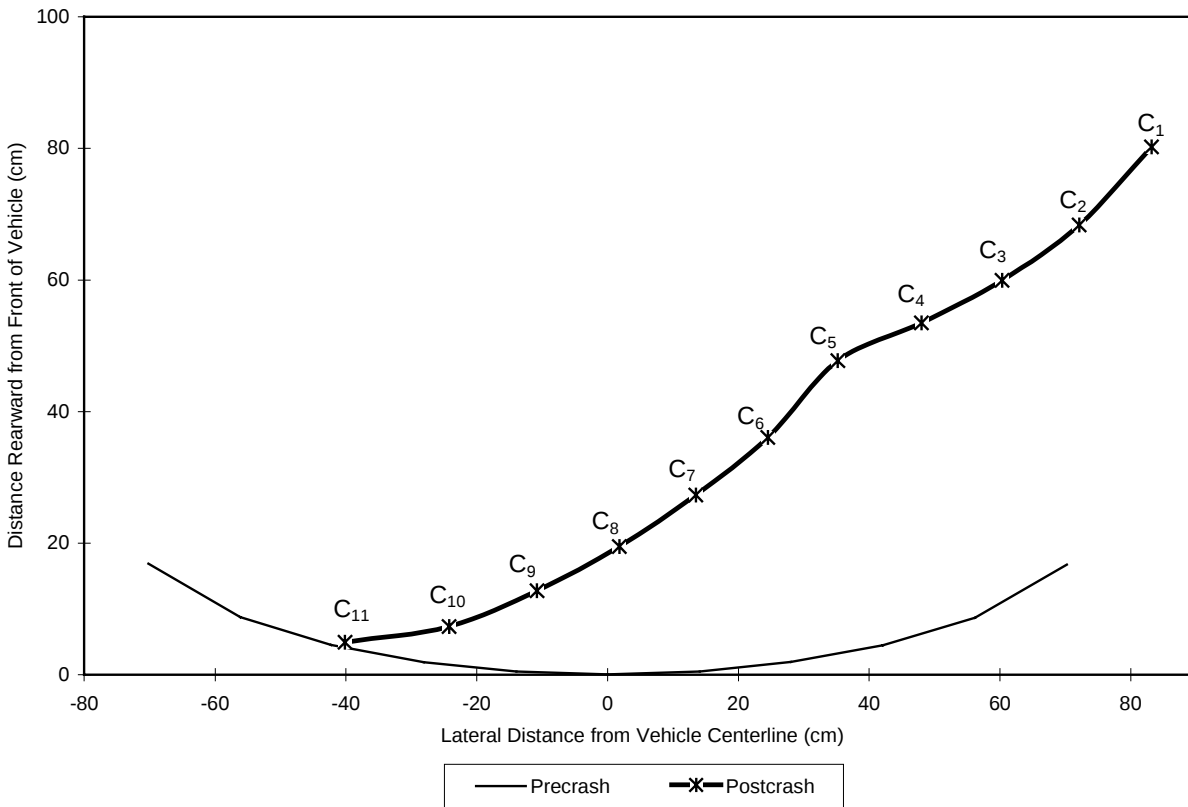
**Figure 3**  
**Front Bumper Cover Crush Contour — 1999 Mazda 626**

The bumper cover was torn completely off the vehicle during the crash. The postcrash contour represents the best attempt to fit the cover back onto the vehicle. The length of the reference line was 140 cm precrash and 123 cm postcrash.

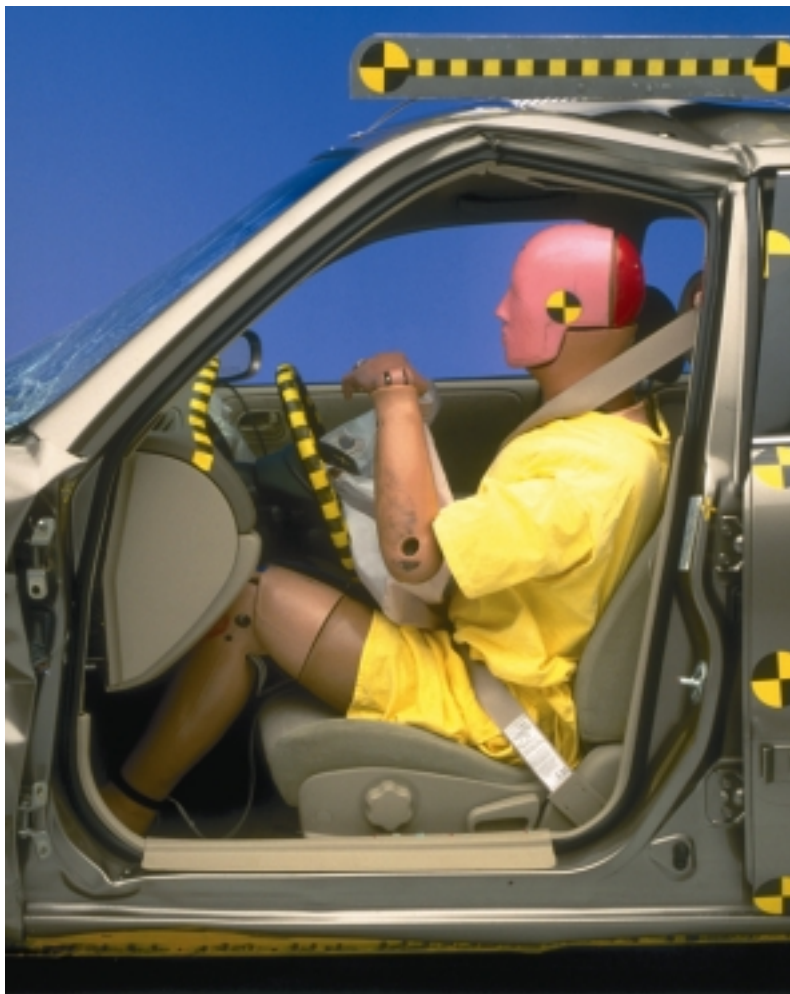
**Figure 6**  
**Dummy and Vehicle Interior, Postcrash — 1999 Mazda 626**

Postcrash examination of the driver seat rails indicated no discernible movement of the seat in its tracks during the crash. Deformation of the floor under the driver seat caused the seat to tip outward sufficiently for the head restraint to contact the shoulder belt upper anchorage D-ring.

The upper end of the steering column moved downward 4 cm and rearward 3 cm relative to the driver seat. Separation of the shear modules on the upper portion of the column was sufficient to completely separate the steering wheel and column from the instrument panel. As a result, the column dropped against the knee bolster plastic trim and extensively cracked the bolster on both sides of the column. When the bolster was removed later for inspection of the underlying steel bracing, it was found that the plastic bolster trim, although cracked, was the only part preventing the steering wheel and column from dropping even farther, onto the front seat.
