Insurance Institute for Highway Safety Crashworthiness Evaluation

Crash Test Report 2000 Isuzu Rodeo (CF00014)

Vehicle identification number: 4S2DM58W2Y4320411
Body style: Midsize utility vehicle
Engine/transmission: Longitudinal 3.2-liter V6, 4-speed automatic,
4-wheel drive

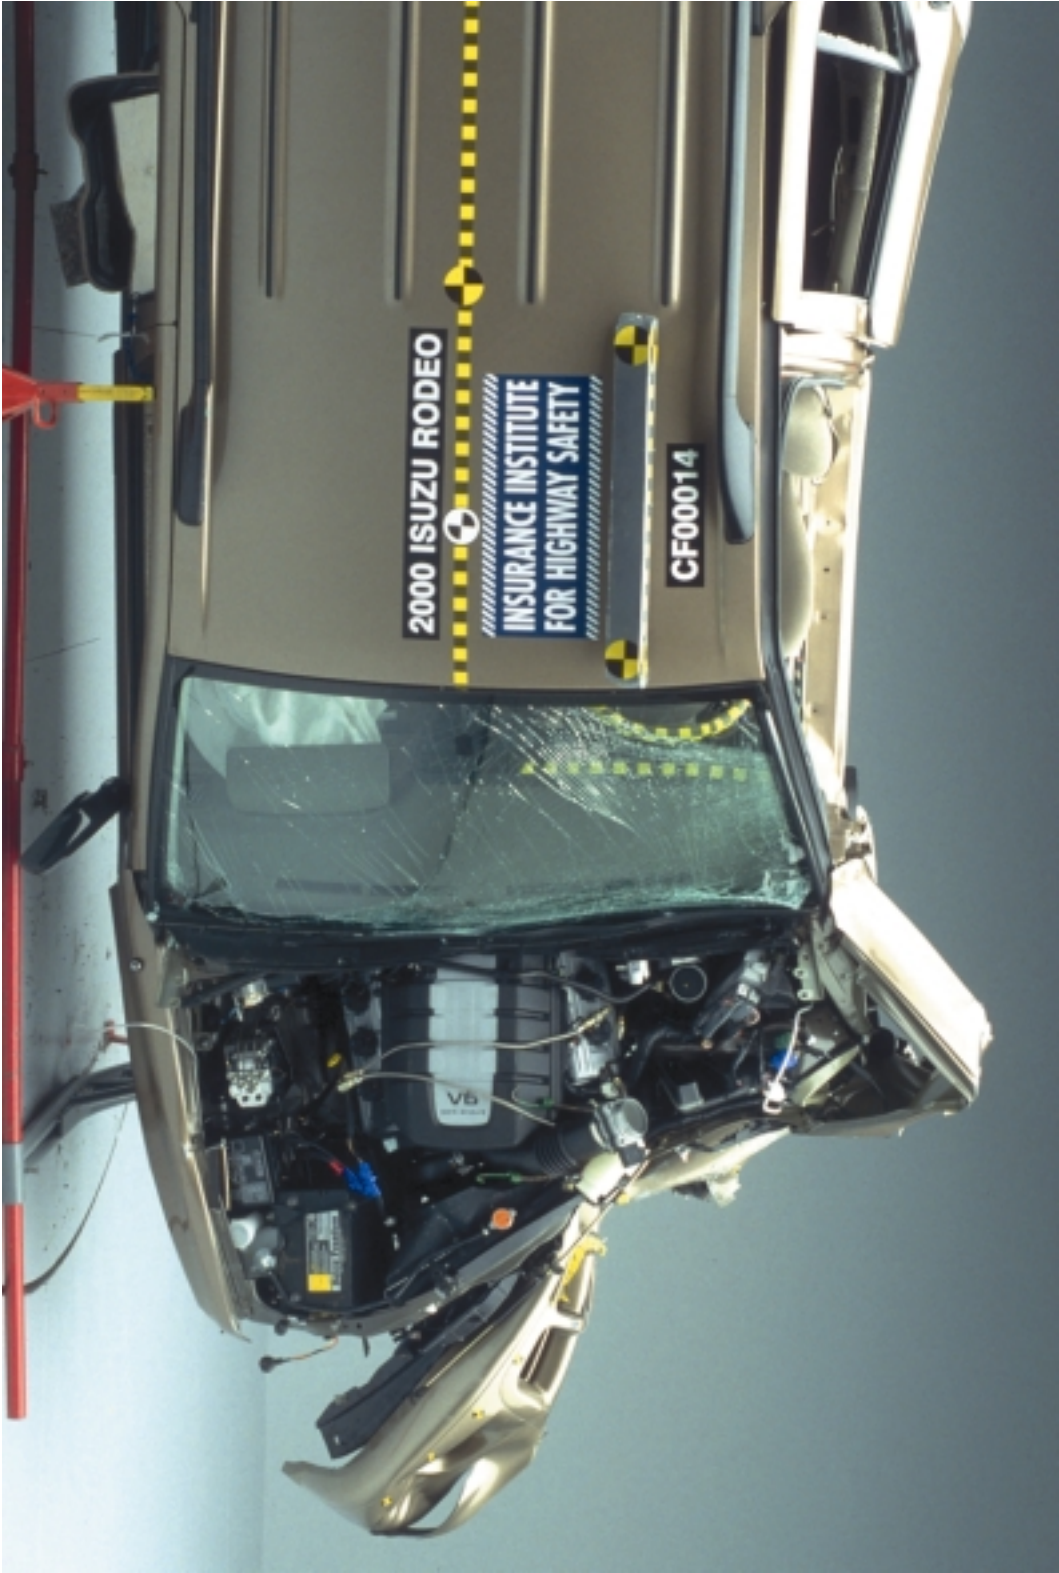
Figure 2
Overhead View of Crash Deformation – 2000 Isuzu Rodeo

Figure 2 shows the overhead view of the crash deformation. Figure 3 illustrates the precrash and postcrash contour measures of the front bumper cover profile and the resulting permanent crush. Figure 4 shows the precrash and postcrash views from below. Figure 5 illustrates the deformation of the frame rails, door sills, and crossmembers, which are visible in Figure 4.

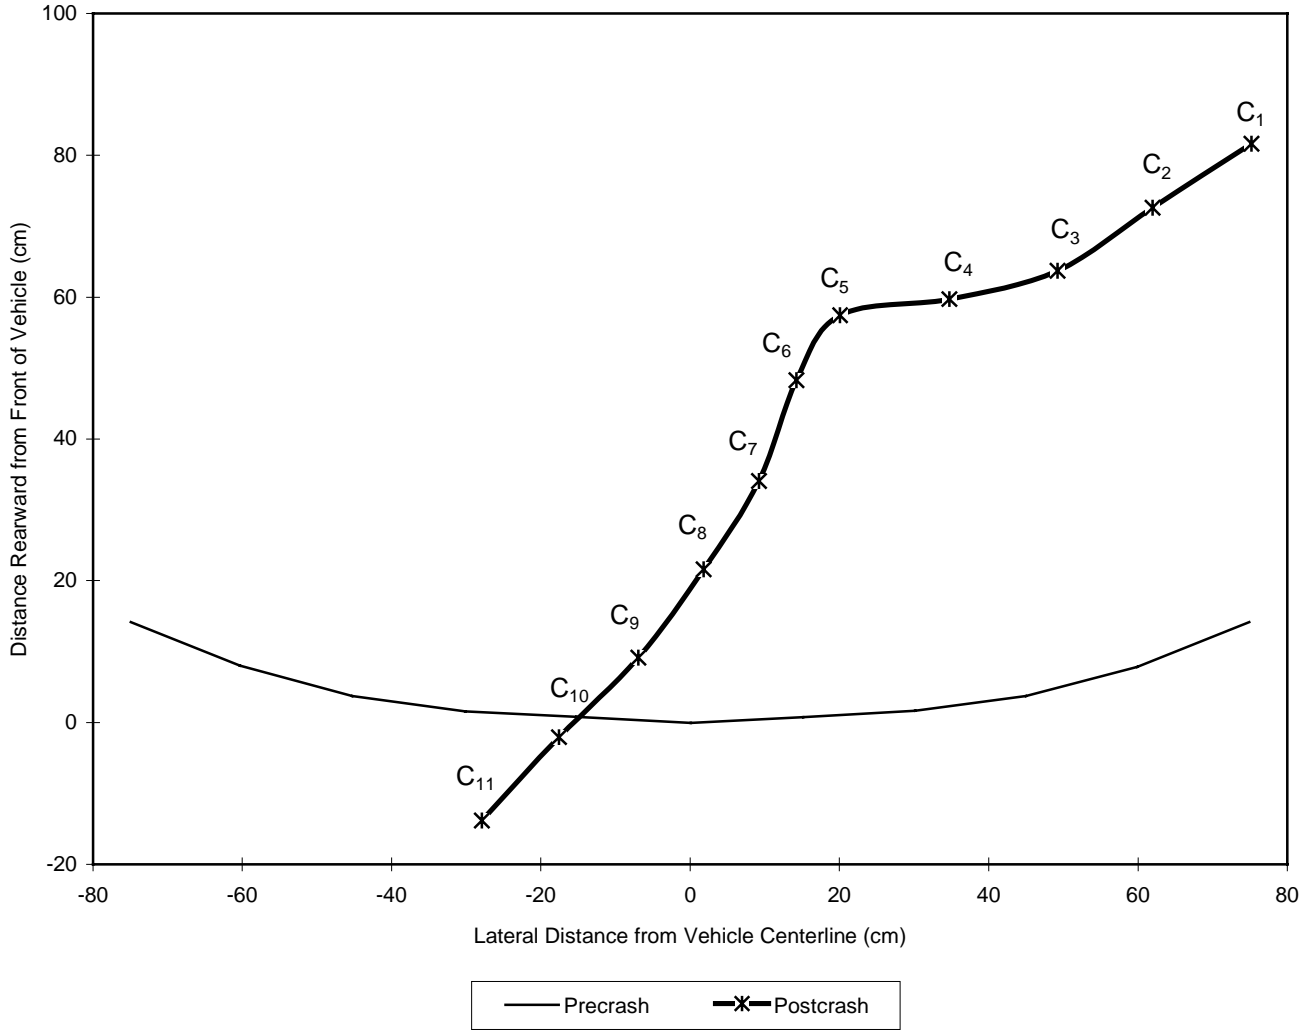
Figure 3
Front Bumper Cover Crush Contour – 2000 Isuzu Rodeo

C ₁	C ₂	C ₃	C ₄	C ₅	C ₆	C ₇	C ₈	C ₉	C ₁₀	C ₁₁
Postcrash Contour (cm)	82	73	64	60	57	48	34	22	9	-2	-14
Precrash Contour (cm)	14	8	4	2	1	0	1	2	4	8	14
Resulting Crush (cm)	68	65	60	58	56	48	33	20	5	-10	-28

The length of the reference line was 150 cm precrash and 103 cm postcrash.

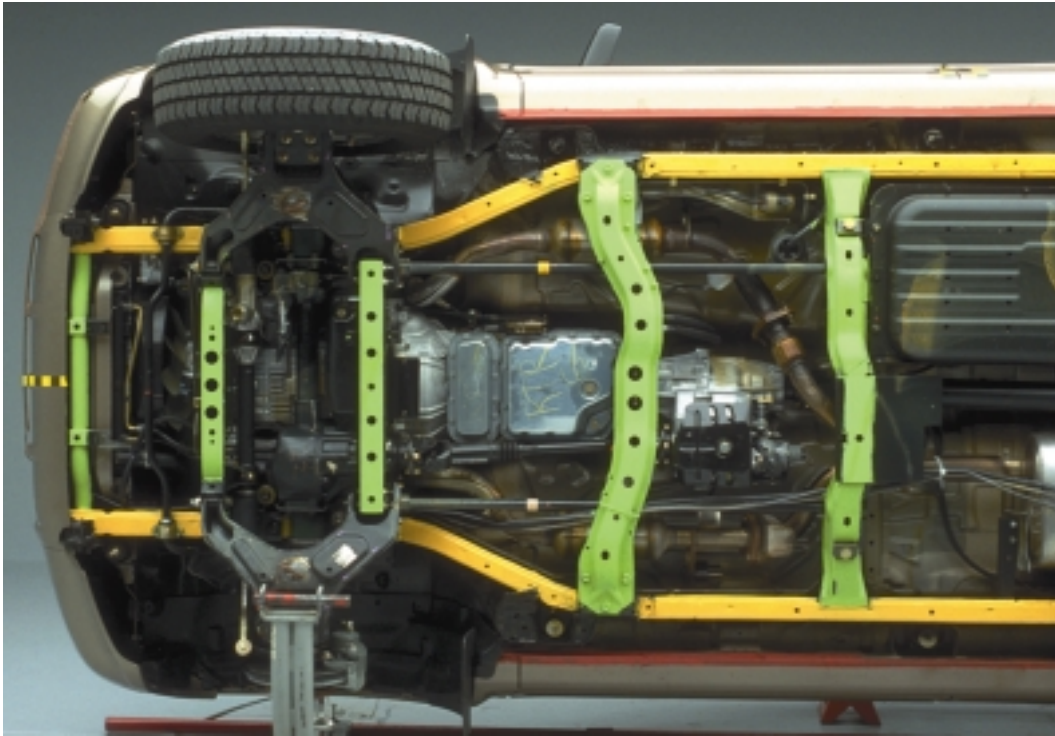
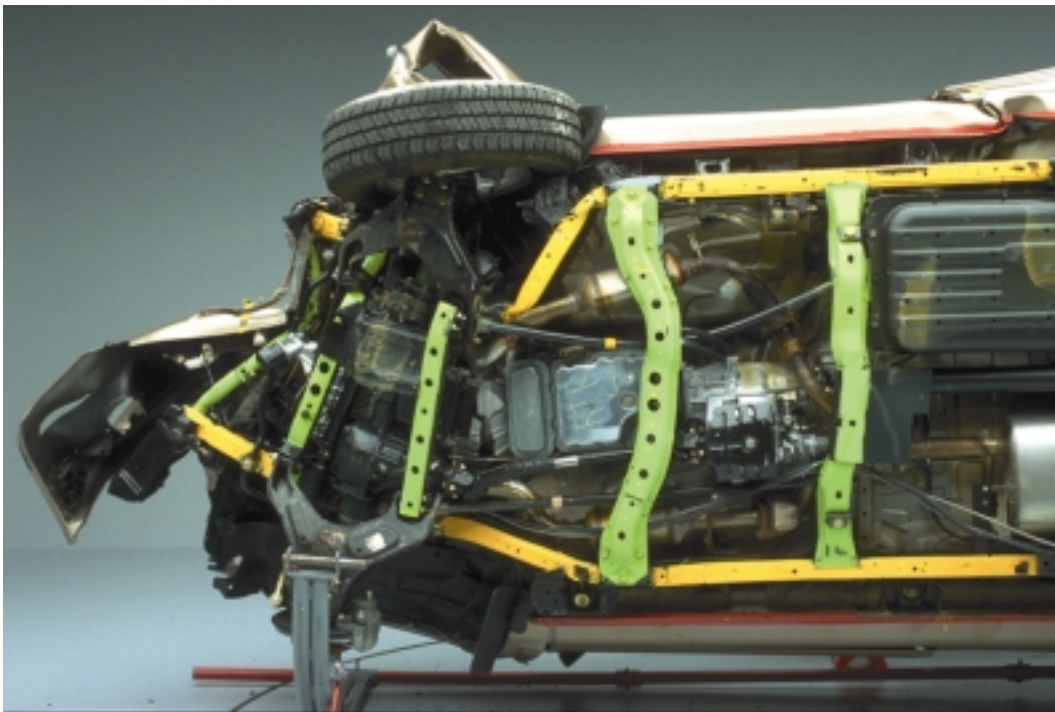
Figure 4
Precrash and Postcrash Views from Below – 2000 Isuzu Rodeo

Extensive floorpan buckling underneath and behind the driver seat caused the seat to pitch forward and to tip outward against the B-pillar.

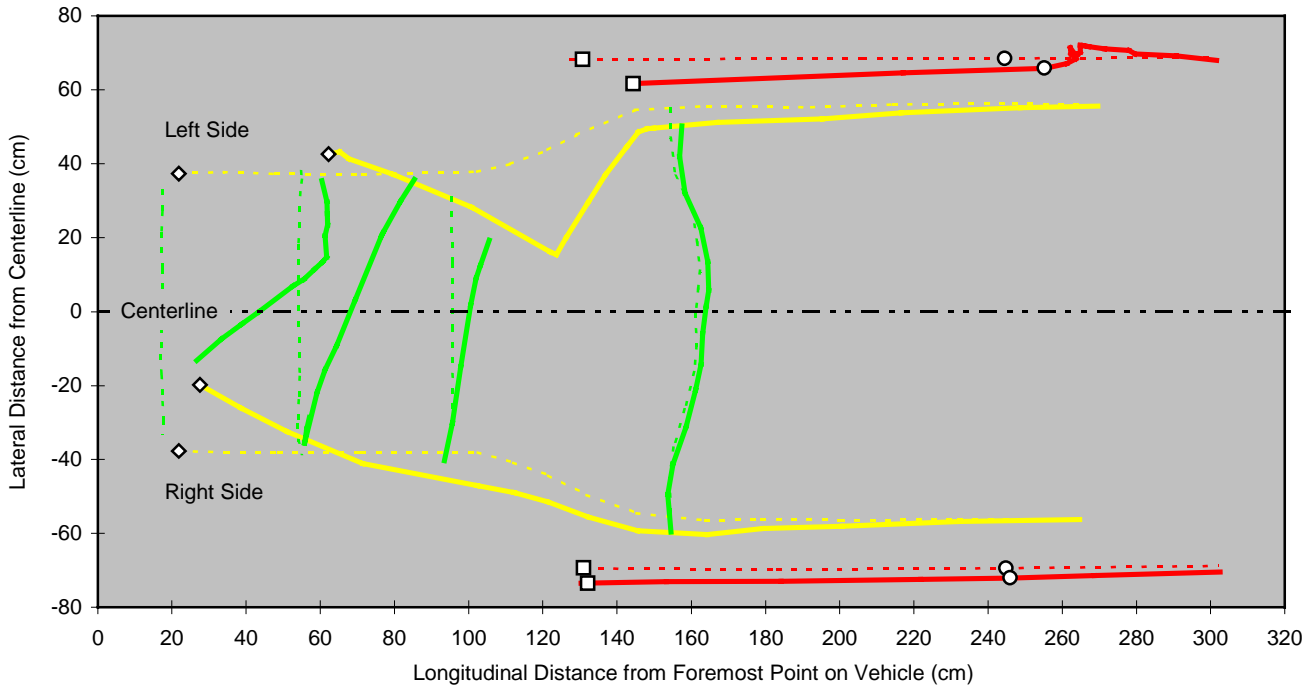
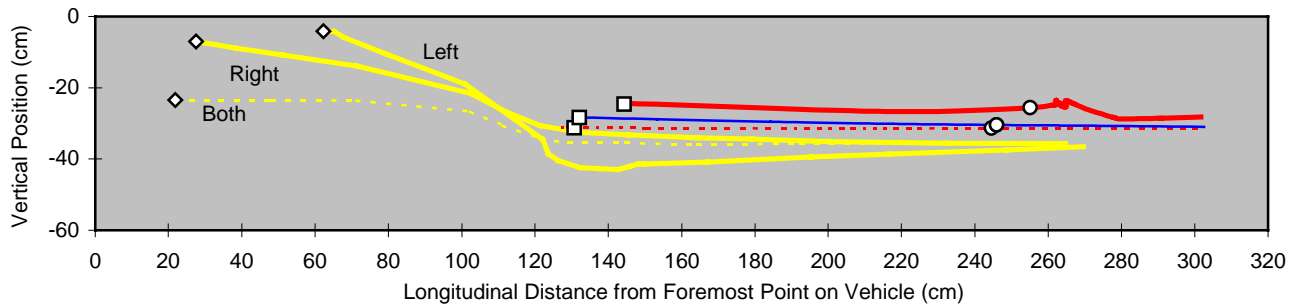
Figure 5
Structural Deformation, Views from Below and Side – 2000 Isuzu Rodeo

Postcrash examination of the driver seat rails indicated no discernible movement of the seat in its tracks during the crash. Extensive deformation of the floor underneath the inboard seat rail and behind the seat caused the seat to pitch forward and to tip outward into contact with the B-pillar.

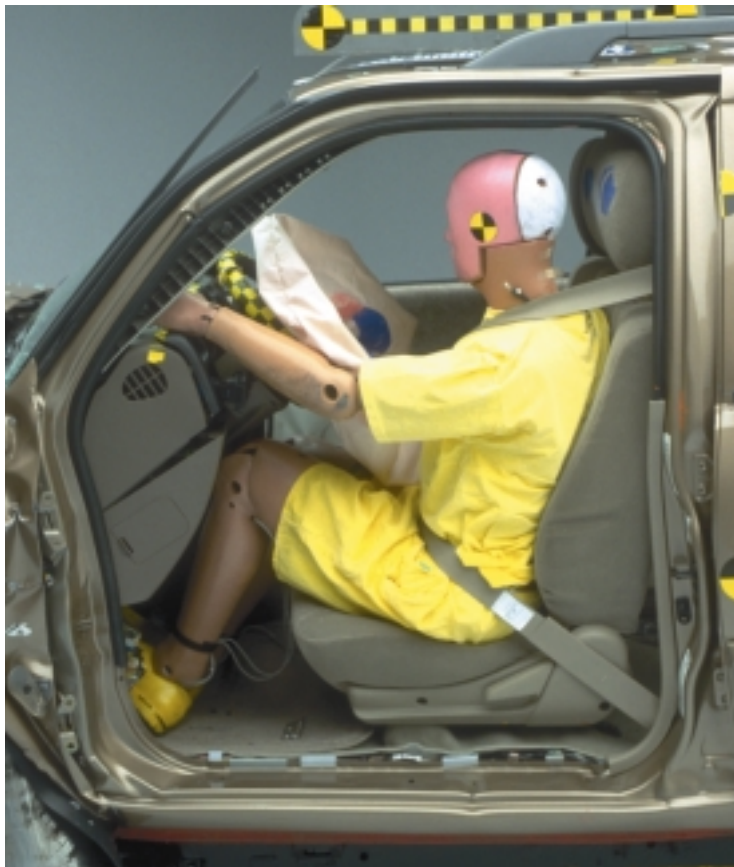
Figure 6
Dummy and Vehicle Interior, Postcrash – 2000 Isuzu Rodeo

Left leg and foot: Paint transferred from the dummy's left knee indicated the knee primarily contacted the knee bolster at the left instrument panel intrusion reference point. The knee then moved to the right and was found just below the left underside of the steering column trim, where a smaller paint transfer mark was noted. Paint transferred from the dummy's left shin indicated the shin contacted the bolster below the knee impact location on the bolster and then moved to the right and contacted the left edge of the bolster's protrusion around the steering column. The left foot was found slightly dorsiflexed, fully everted, and internally rotated about 40 degrees. The medial toe was resting against the accelerator pedal arm, and the medial back of the heel was on the flat floormat/carpeting on the floorpan. The sole of the forefoot was suspended behind and above the intruded toepan to the right of the footrest.

Right leg and foot: Paint transferred from the dummy's right knee indicated the knee contacted the knee bolster 2 cm below and 3 cm to the left of the right instrument panel intrusion reference point. Paint transferred from the dummy's right shin indicated the shin contacted the bolster directly below the knee impact location. There was also a small transfer mark from the shin on the right edge of the bolster's protrusion around the steering column. The right foot was found slightly dorsiflexed and somewhat inverted, with the back of the heel resting on the floormat/carpeting on the floorpan and the sole of the forefoot suspended behind and above the accelerator pedal.

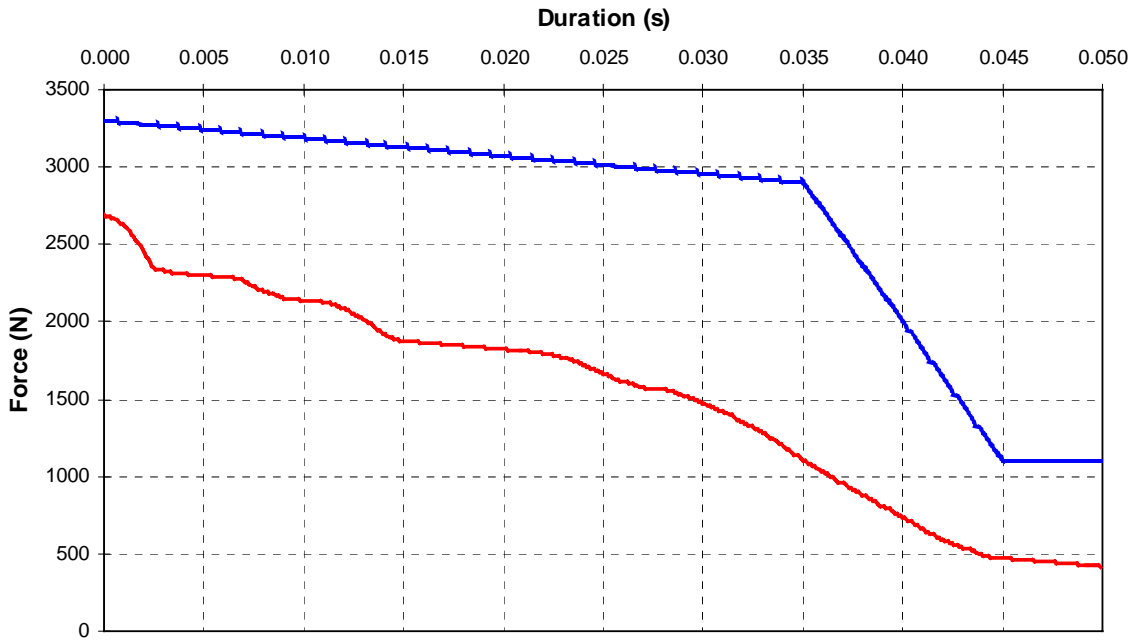
A- 13 CF00014 2000 Isuzu Rodeo Neck Tension Analysis

Table 4 provides a summary of the maximum neck injury measurements recorded during the crash. The maximum neck axial tension was 2.7 kN at 86 ms. None of the recorded neck force measures exceeded the magnitude-duration injury criteria (Figures A-13 to A-16).

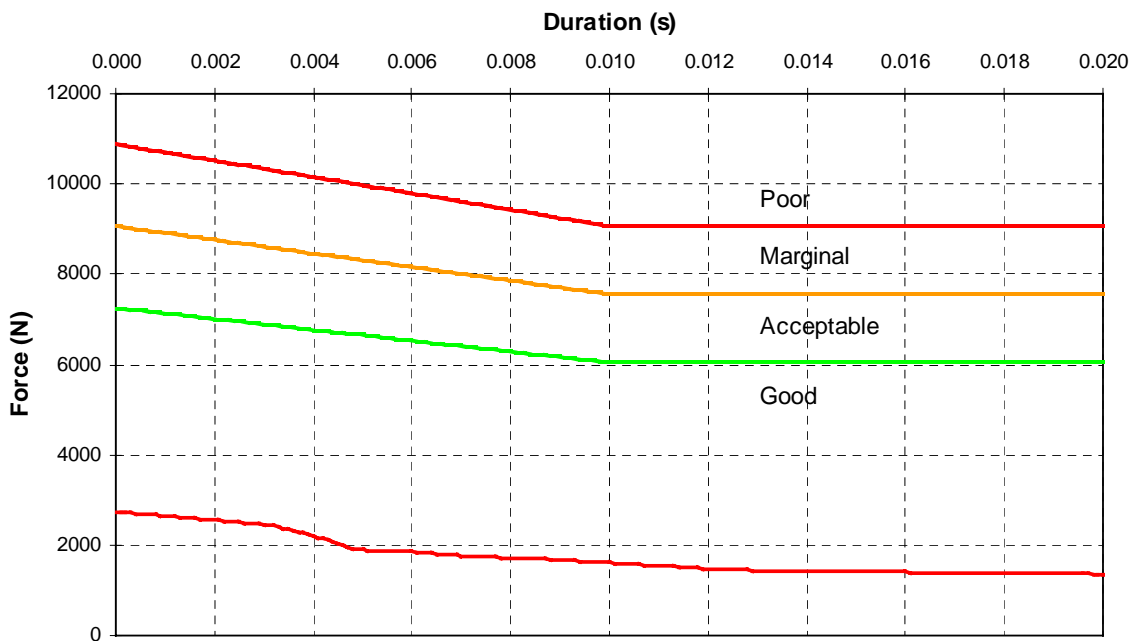
A- 24 CF00014 2000 Isuzu Rodeo Left Femur Axial Force Analysis

* This critical value is for instantaneous loading. Femur loads are compared with magnitude-duration injury criteria in Figures A-24 and A-37.

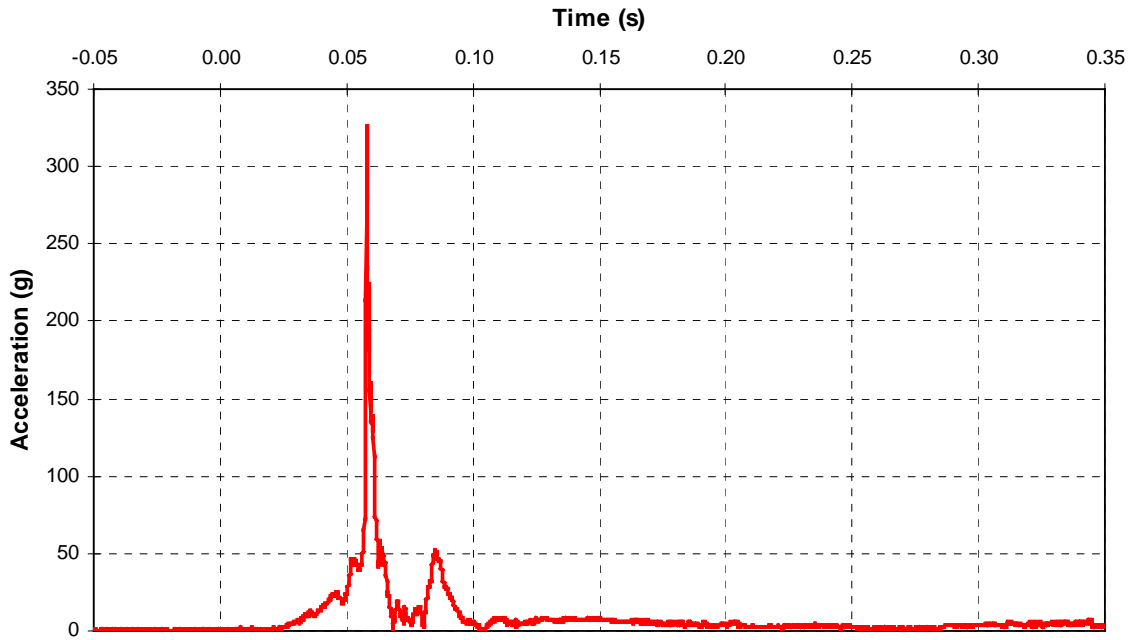
A- 33 CF00014 2000 Isuzu Rodeo Left Foot Vector Resultant Acceleration

Left leg and foot: The maximum left foot I-S acceleration was -304 g at 58 ms, and the maximum resultant left foot acceleration was 327 g at 58 ms.

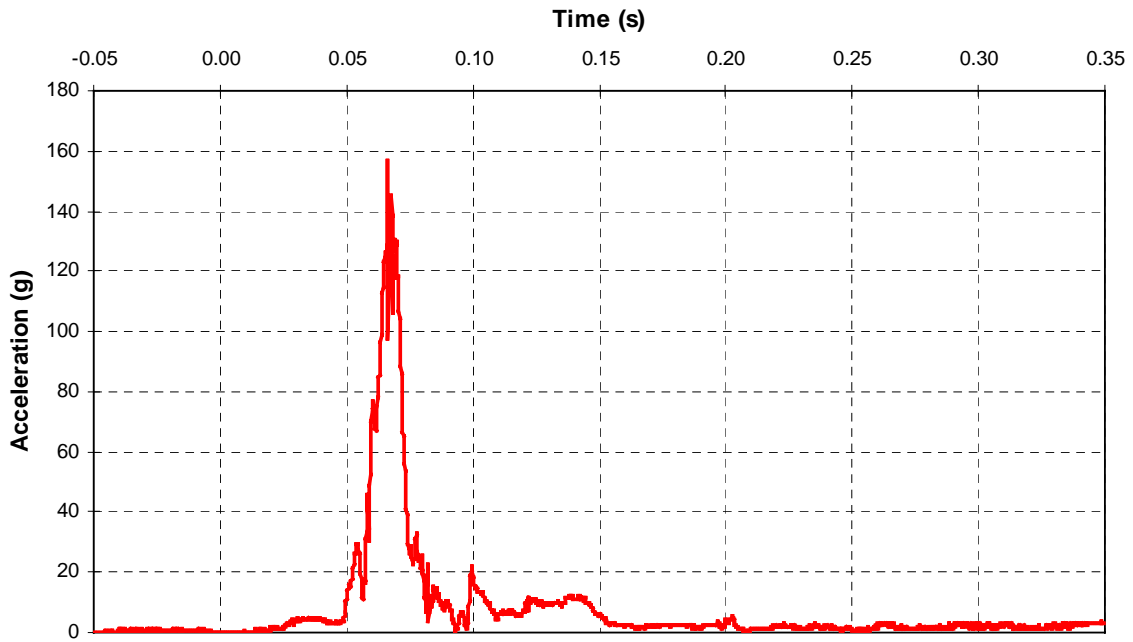
A- 46 CF00014 2000 Isuzu Rodeo Right Foot Vector Resultant Acceleration

Right leg and foot: The maximum resultant right foot acceleration was 157 g at 66 ms.
