Insurance Institute for Highway Safety Crashworthiness Evaluation

Crash Test Report 1998 Isuzu Amigo (CF98016)

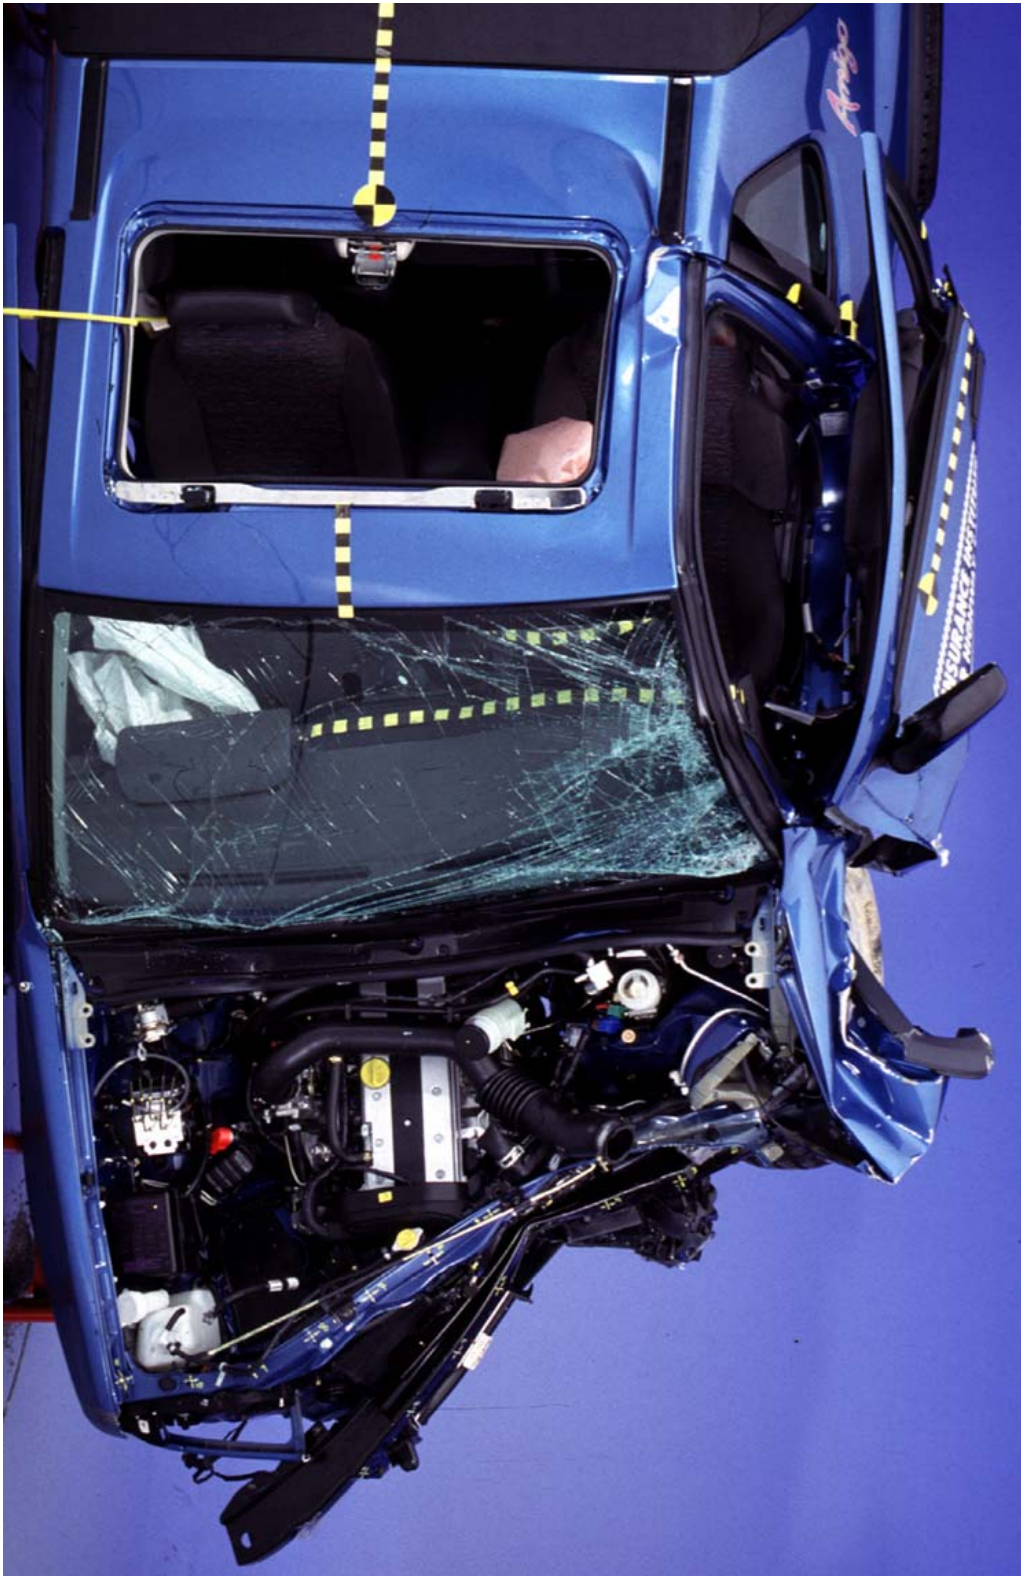
Figure 2
Overhead View of Crash Deformation — 1998 Isuzu Amigo

Figure 2 shows the overhead view of the crash deformation. Figure 3 illustrates the precrash and postcrash contour measures of the front bumper cover and the resulting permanent crush. Figure 4 illustrates the corresponding measures of both the front bumper reinforcement bar and upper crossmember of the radiator support. Figure 5 shows the precrash and postcrash views from below. Figure 6 illustrates the deformation of the frame rails, crossmembers, and door sills, which are visible in Figure 5.

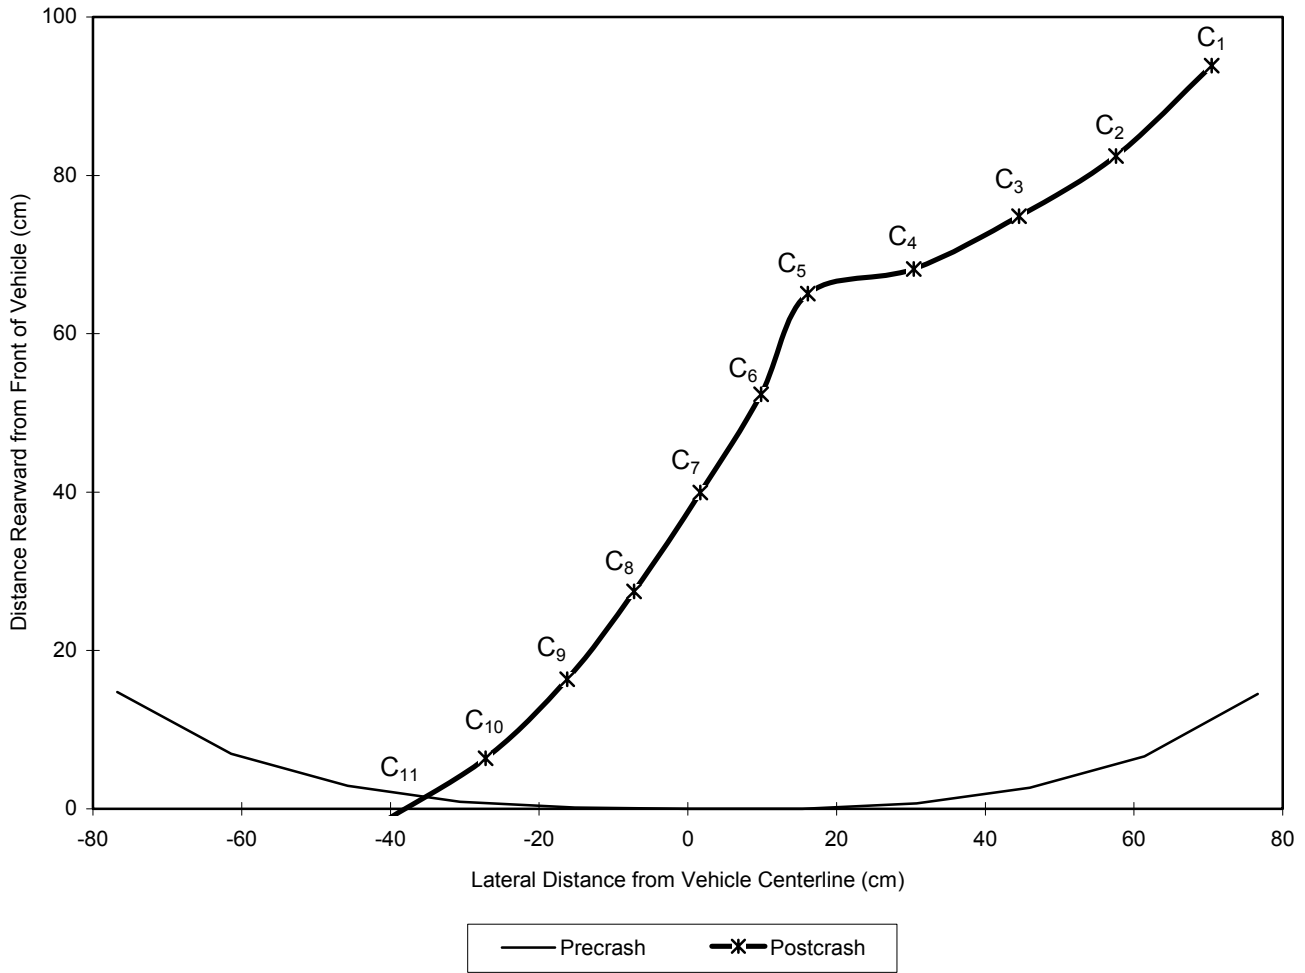
Figure 3
Front Bumper Cover Crush Contour — 1998 Isuzu Amigo

The bumper cover was torn completely off the vehicle and separated into multiple pieces during the crash. The postcrash contour of the cover was estimated by using the postcrash contour of the underlying bumper bar as a template and modifying it using the precrash longitudinal spacing between the cover and bar (under the assumption that the precrash spacing between cover and bar was maintained). The length of the reference line was 153 cm precrash and 111 cm postcrash, the latter taken from the bumper bar.

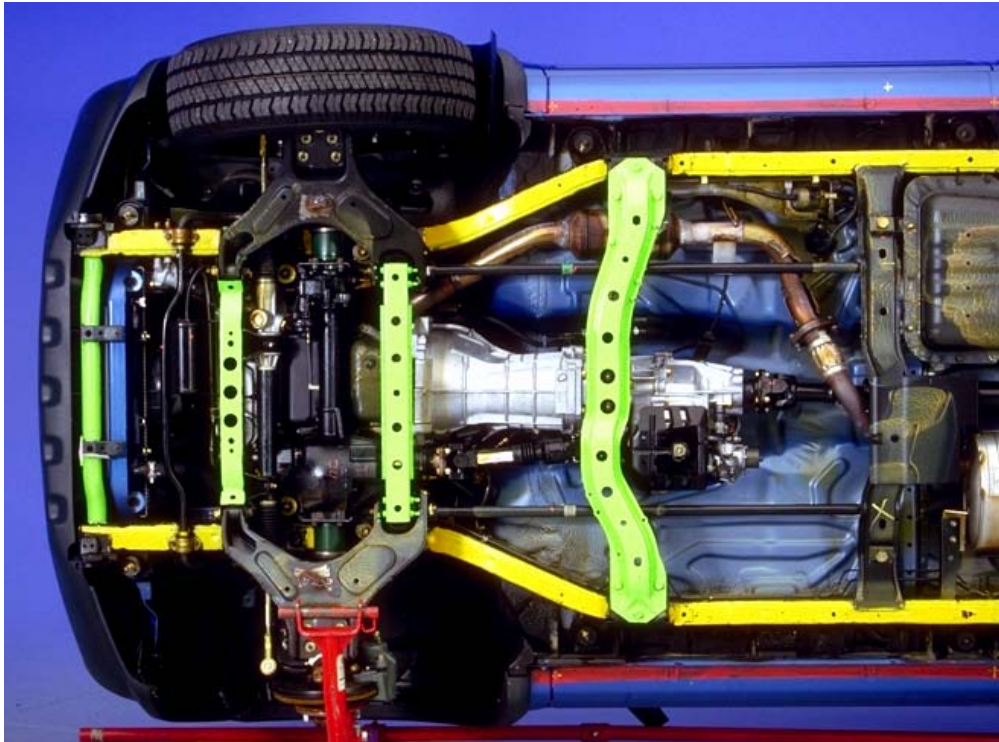
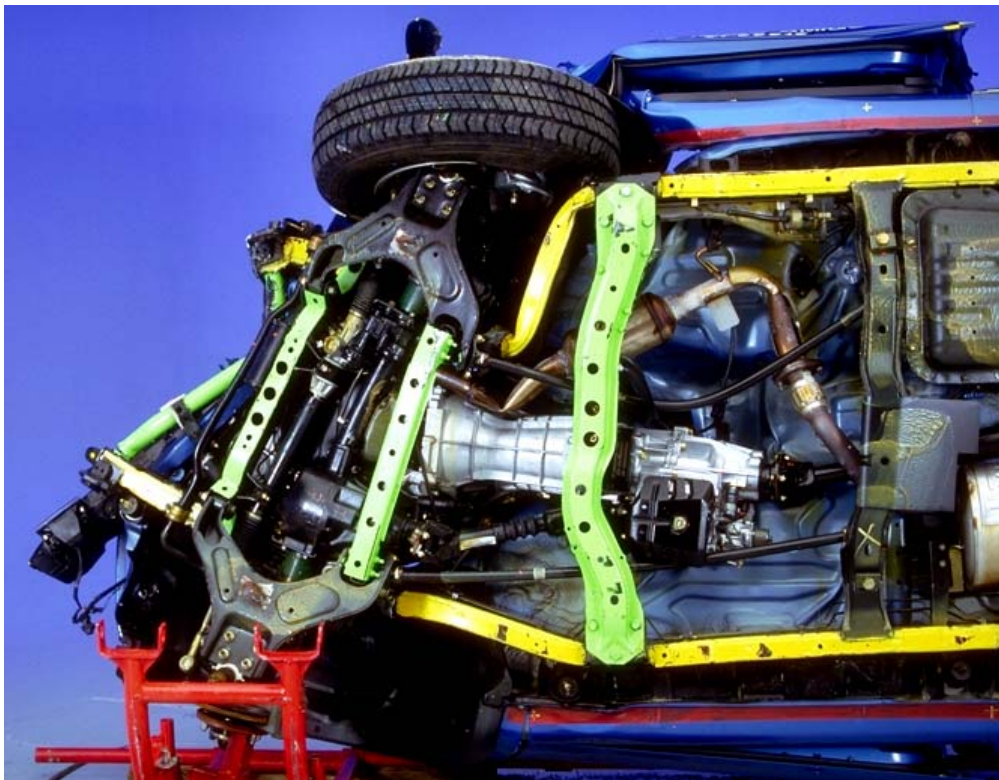
Figure 5
Precrash and Postcrash Views from Below — 1998 Isuzu Amigo

As the left front wheel was forced rearward during the crash, it loaded and deformed the driver door sill. The front portion of the sill and the lower half of the door hinge pillar were torn along the welded seam connecting them to the floorpan and toe-pan, respectively. The tear's length measured about 76 cm.

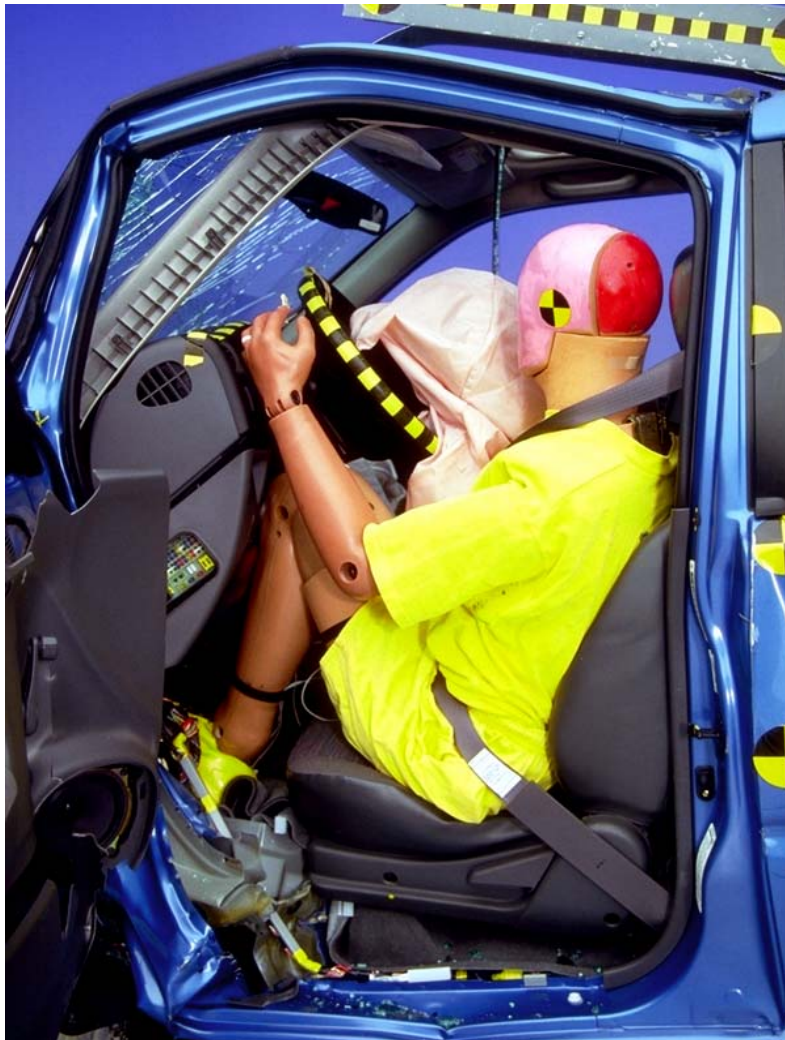
Figure 7
Dummy and Vehicle Interior, Postcrash — 1998 Isuzu Amigo

Postcrash examination of the driver seat rails indicated no discernible movement of the seat in its tracks during the crash. Deformation of the floor under the driver seat caused the seat back and head restraint to tip outward and contact the B-pillar.
