NHTSA - 98 - 3588 - 139

**Evaluation of Motor Vehicle Fire Initiation and Propagation
Part 8: Crash Tests on a Sport-Utility-Vehicle**

Jack L. Jensen, Jeffrey Santrock
General Motors Corporation

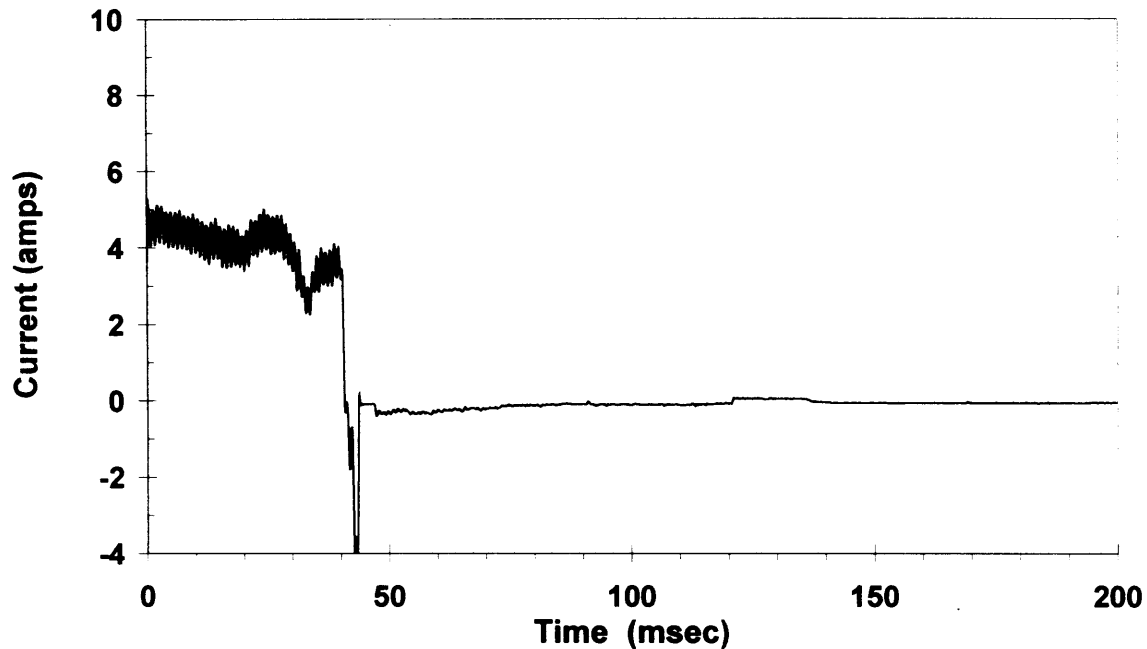
Figure 13
 Fuel Pump Current
 Test C11687

Figure 13 and plot 109 in Appendix B show the fuel pump current draw during the impact. The fuel pump was drawing about 4.5 amps while it was operating at impact. The current dropped to zero at about 40 msec after impact indicating the pump was off. This is consistent with the other frontal tests of this series in that, the fuel pumps have lost electrical power early (before 100 msec) in every test conducted. The fuel pump was likely stopped due to the drop in main vehicle voltage.

1. There were no fires observed during or after this crash test.
2. The electric fuel pump began stopping at 40 msec after impact due to the temporary loss of main vehicle system voltage. The fuel pump did not recover when the main electrical voltage temporarily returned from 120 msec to 140 msec.

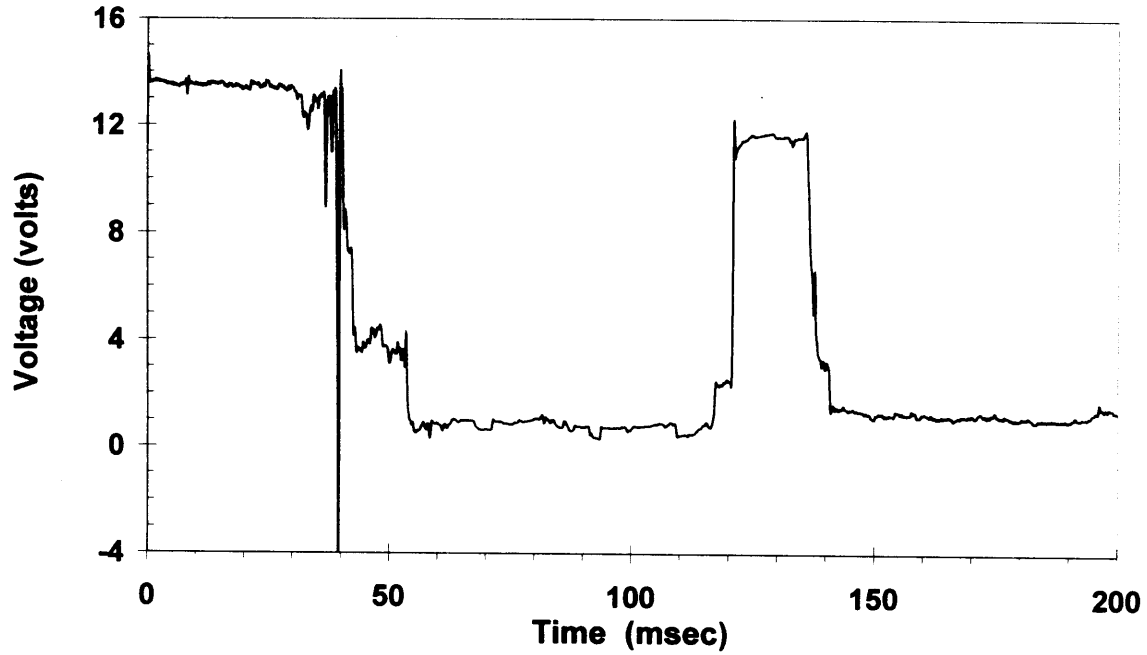
Figure 14
Ignition Voltage
Test C11687

From 40 msec to 60 msec, the ignition voltage dropped from 13 volts to near zero in a stepwise manner (Figure 14 and Plot 85 in Appendix B). The fuel pump voltage decayed from 13 volts to near zero from about 40 msec to 180 msec as shown in Figure 15 and Plot 81 (Appendix B). Bench-tests on fuel pumps for other vehicles in the project [2], [3] indicated a gradual decay in voltage (lasting 40-150 msec) when current flow was stopped to the motor. This is likely due to the windings of the motor producing a voltage drop as the motor stops. The decay shown in Figure 15 is consistent with the observations from other tests.

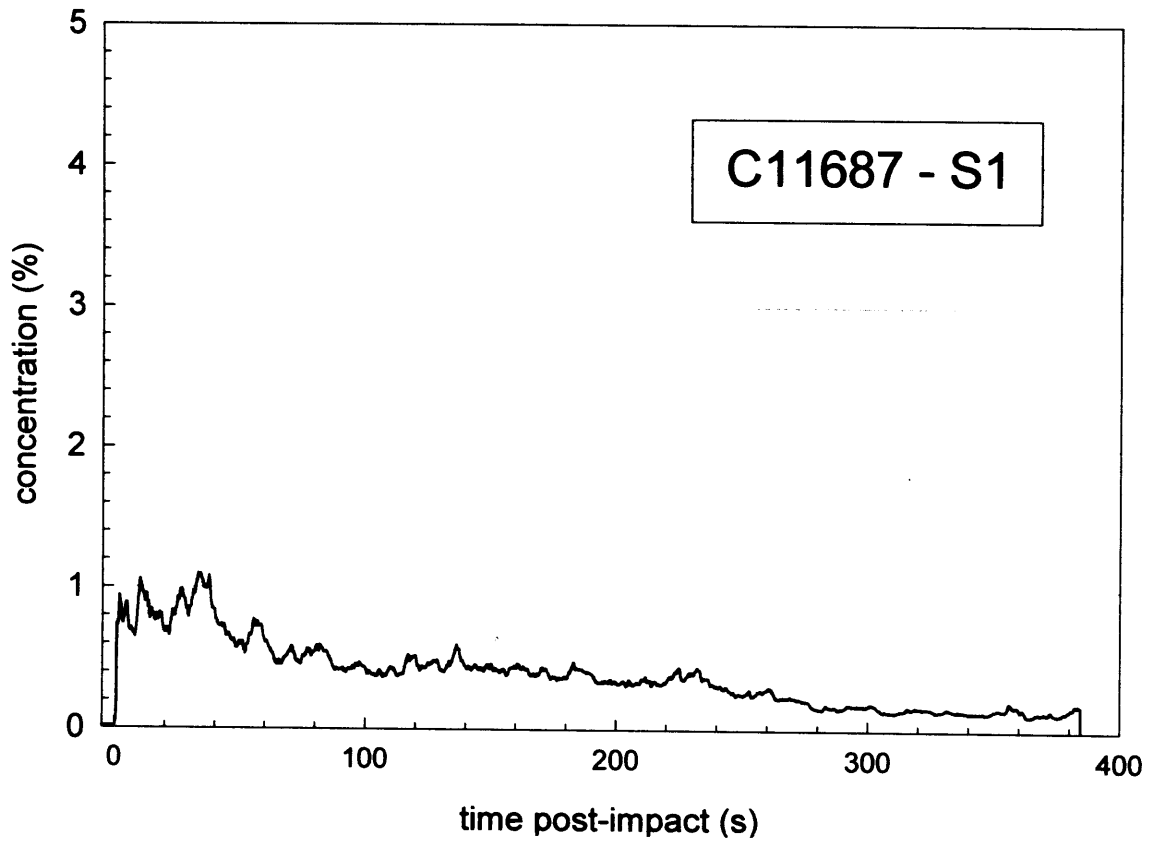
Figure 19
Concentration Of Hydrocarbon Vapors Measured Near Right Upper Engine (Location #1)
Test C11687

engine (location #3) was destroyed during the test. Of the remaining three locations, the right upper engine (location #1), and the left exhaust manifold (location #2) indicated the highest concentrations of hydrocarbon vapors. These two sensor outputs are recreated here as Figure 19 and Figure 20.

The vapor concentration at location #1 increased to slightly greater than 1% in the first 60 seconds following the impact, while the concentration at location #2 exceeded 3% during the first 60 seconds. The GCMS analysis was completed on the vapors collected from these same locations [1]. The results of the GCMS analysis for locations #1 and #2 were similar. The results of the GCMS analysis for location #2 is recreated here as Figure 21 and Figure 22. The GCMS analysis indicated the source of the vapors were gasoline, stoddard solvent and oils.

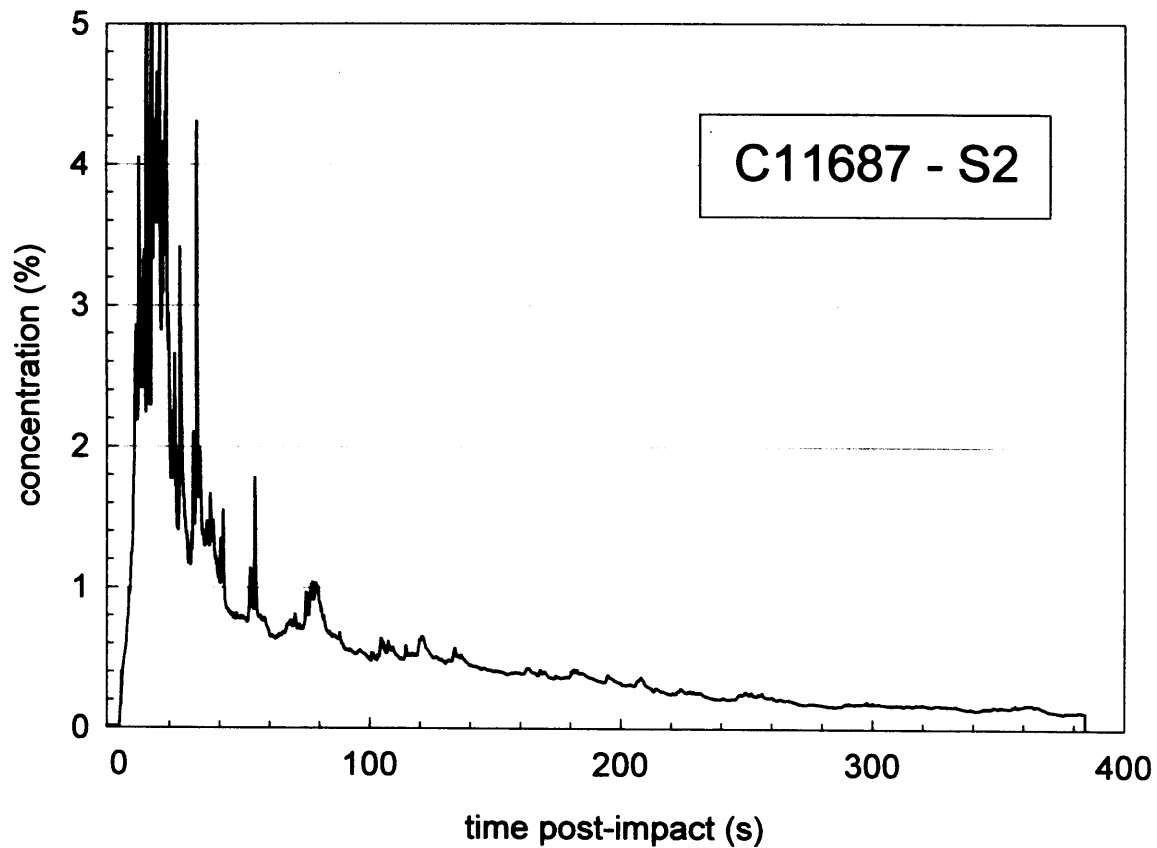
Figure 20
Concentration Of Hydrocarbon Vapors Measured Near Left Exhaust Manifold (Location #2)
Test C11687

10. The engine began slowing 40 msec after impact and was stopped by 110 msec.
11. Valid data was obtained from only 3 of the 5 vapor sensors. Of those three, the highest concentration of vapor was near the left exhaust manifold that exceeded 3% concentration for the first 60 seconds following the impact. The GCMS analysis indicated the source of the vapors was likely oils, Stoddard and gasoline. The source of the oils was likely transmission fluid or power steering fluid contacting a hot surface in the engine. The source of the Stoddard vapor was the leak in the fuel tank, and the source of the gasoline vapor was either an opening in the air/fuel intake path (releasing gasoline vapors and not necessarily liquid) or contamination of the Stoddard Solvent with gasoline.

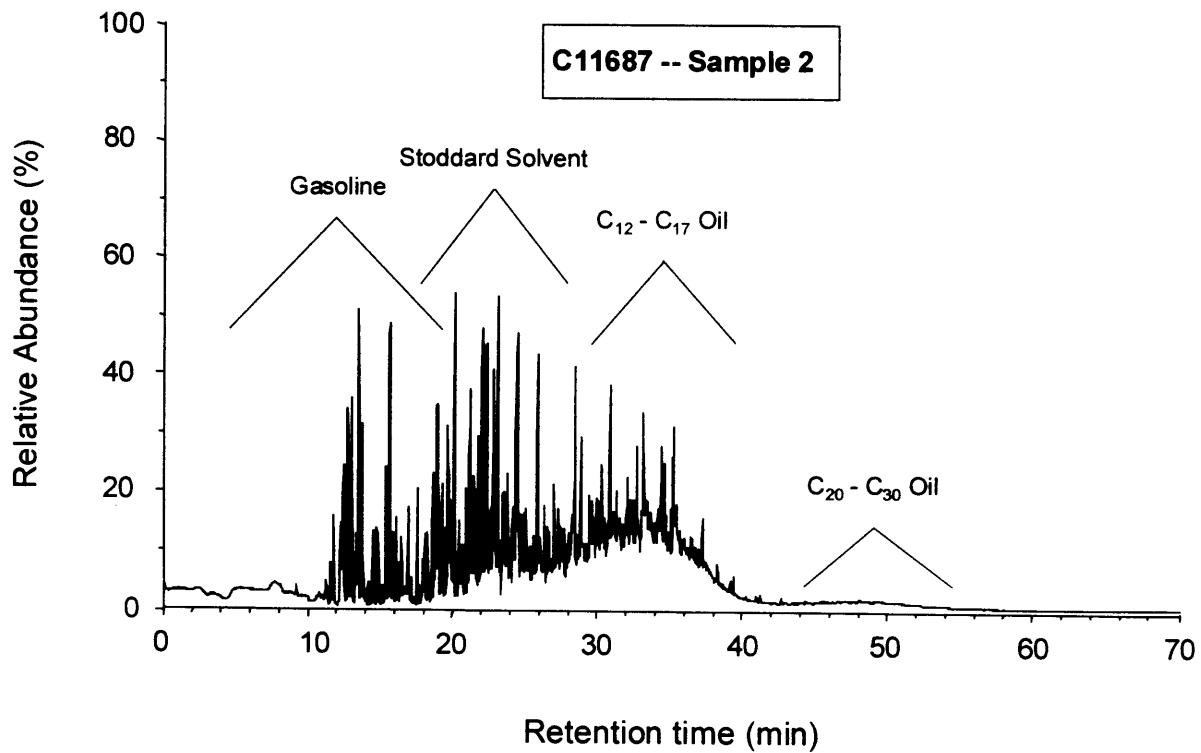
Figure 22
GCMS Analysis of Vapor Sample Collected near Left Exhaust Manifold (Location #2) Post-test, Test C11687

The source of the oil vapor observed in this test could not be positively identified through the GCMS analysis. The analysis does not distinguish vapors with similar molecular makeup. In this case, any of the heavy oils such as power steering fluid, transmission fluid, or motor oil could be the source of the vapor. Of these fluids, only transmission fluid and power steering systems leaked during the impact, so one of those two may have been the likely source. At ambient temperatures, these fluids do not vaporize, thus contact with a hot surface likely occurred vaporizing the fluid.

The source of the Stoddard vapor was likely the Stoddard that leaked out of the fuel tank during the impact. (Section 2.2.6.) Unlike the oils, Stoddard and gasoline will vaporize at ambient conditions, thus the presence of vapor does not necessarily indicate contact with a hot surface.

Gasoline vapor was also indicated in the GCMS analysis. However, there were no leaks identified in the pressurized fuel system (Section 2.2.5.) (The fuel tank contained Stoddard for the test, but the pressurized fuel system contained gasoline.) The source of the gasoline vapor could have been from a damaged (during the impact) air intake or manifold in which the air/fuel mixture could escape to the atmosphere from the normal flow to the engine. Since the fuel pump stopped early, this would result in only a small amount of gasoline vapor (not liquid gasoline) released and does not necessarily present an increased fire risk. An alternate source of the gasoline vapor could have been from contaminated Stoddard Solvent. To reduce the volume of hazardous waste generated in conducting full-vehicle crash tests, Stoddard Solvent is re-used in most crash test laboratories; that is, it is removed from fuel tanks from crash-tested vehicles and re-used for other tests. Thus the Stoddard, over time, can be contaminated with residual gasoline from fuel tanks.

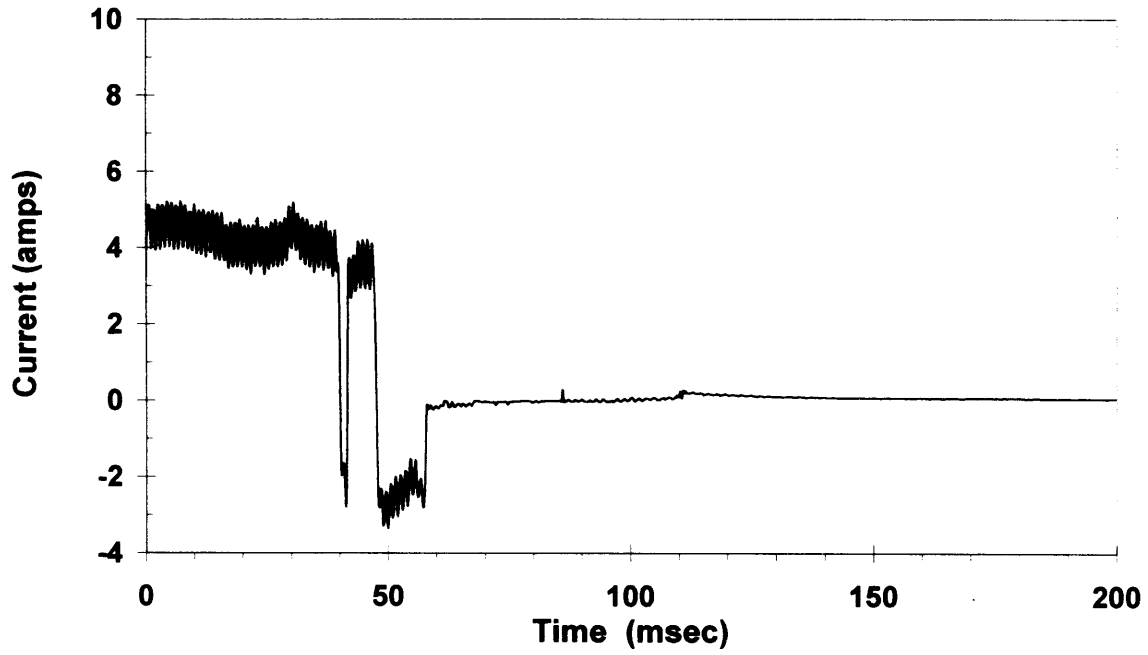
Figure 30
Fuel Pump Current
Test C11793

Figure 30 and Plot 99 shows the current measurement at the auxiliary fuel pump and indicates that the current stopped flowing to the pump at about 48 msec. This correlates with the time at which the main battery voltage dropped from 13 to 9 volts as shown in Plot 79 and Figure 31. Temporary and partial drops in main vehicle voltage have caused fuel pumps to consistently shut down early during the crash tests conducted for this project [2],[3]. In addition, an inertia activated fuel pump cutoff switch protected this fuel pump circuit. This switch activated at about 60 msec after impact. This can be determined by comparing the fuel pump voltage (Figure 32 and Plot 81) and the fuel inertia switch voltage (Figure 33 and Plot 85). These two measurements should be nearly equal after the switch activates as schematically shown in Figure 17. The measurements are indeed nearly identical after 60 msec. In addition, an independent electrical contact circuit was used to monitor the mechanical movement of the switch reset button (Plot 110) also indicated closure at about 60 msec.

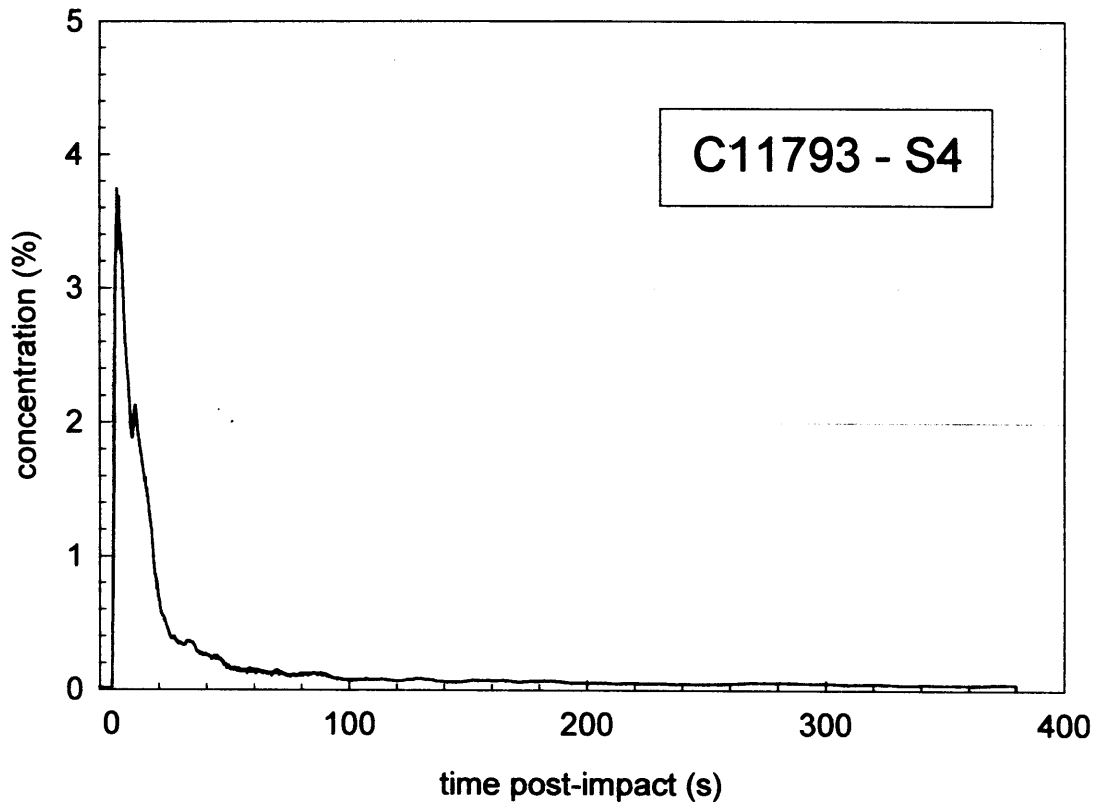
Figure 34
 Concentration Of Hydrocarbon Vapor Measured near the fuel pressure regulator (location #4)
 Test C11793

Similar to test C11687, gasoline vapor was identified in the engine compartment but no leaks in the pressurized fuel system were identified. Since there was no Stoddard leak in this case, the source of the gasoline vapor could not have been contamination of the Stoddard Solvent but was likely an opening in the air/fuel intake path resulting in gasoline vapors being released to atmosphere. Also similar to test C11687, the fuel pump stopped early during the impact, thus only a small amount of vapor was likely released.
