Insurance Institute for Highway Safety Crashworthiness Evaluation

Crash Test Report 2001 Mitsubishi Montero (CF00022)

Vehicle identification number: JA4MW51RA1J003130
Body style: Midsize 4-door utility vehicle
Engine/transmission: Longitudinal 3.5-liter V6, 5-speed automatic,
4-wheel drive

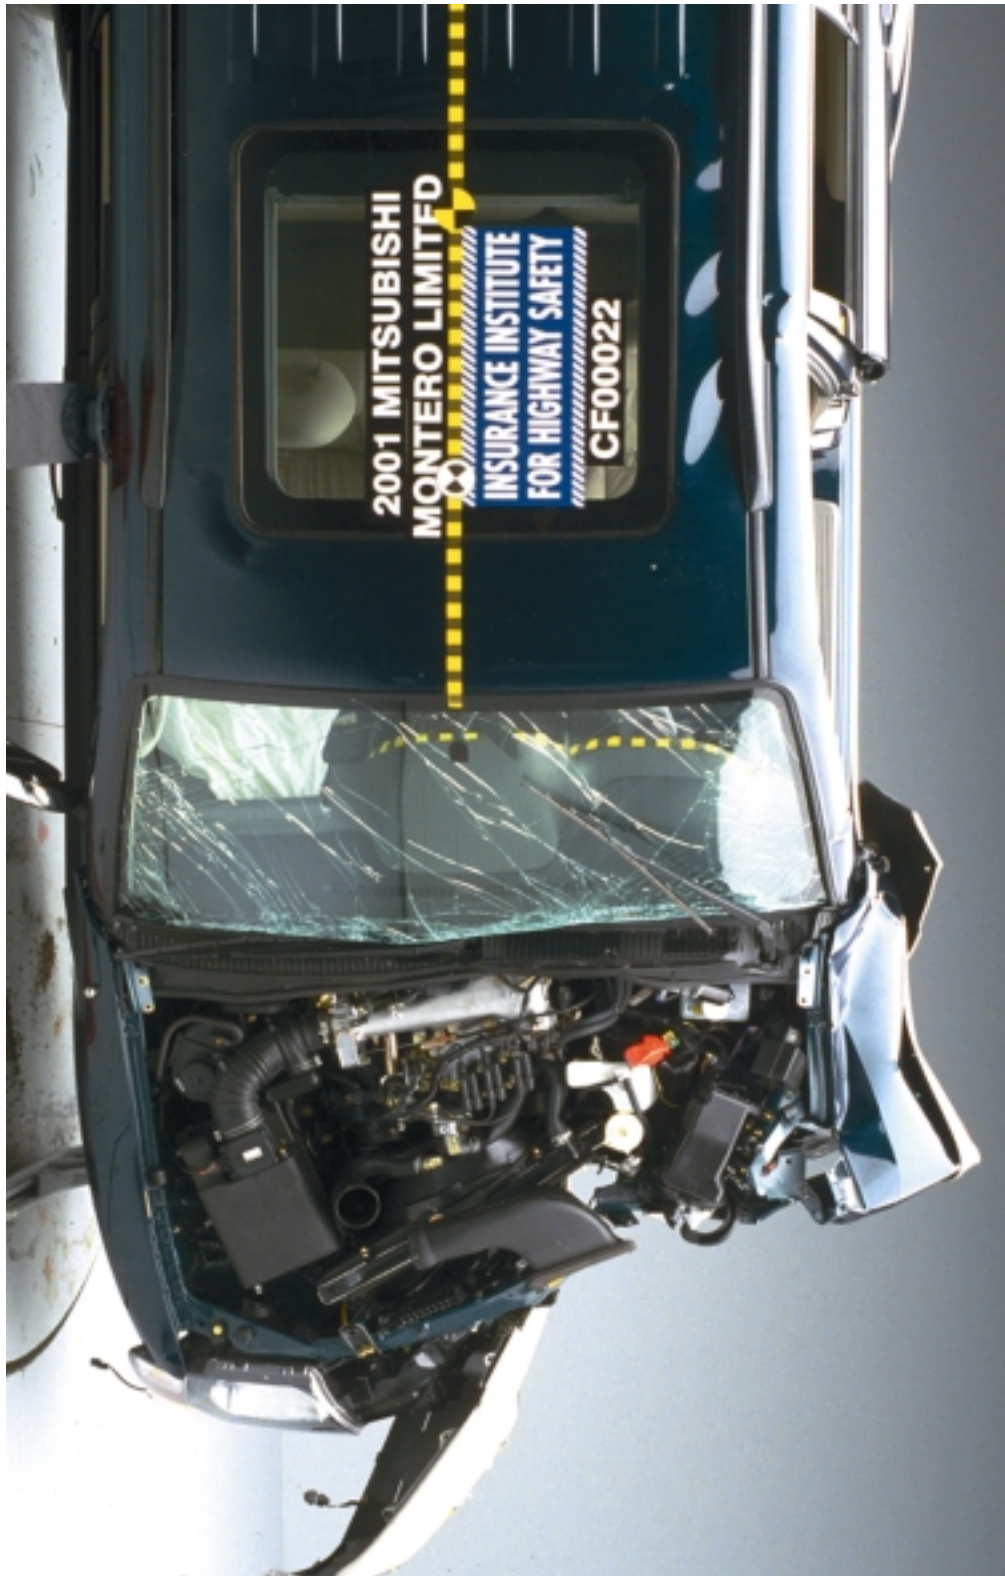
Figure 2
Overhead View of Crash Deformation — 2001 Mitsubishi Montero

Figure 2 shows the overhead view of the crash deformation. Figure 3 illustrates the precrash and postcrash contour measures of the front bumper cover profile and the resulting permanent crush. Figure 4 shows the precrash and postcrash views from below. Figure 5 illustrates the deformation of the side rails, door sills, and crossmembers, which are visible in Figure 4.

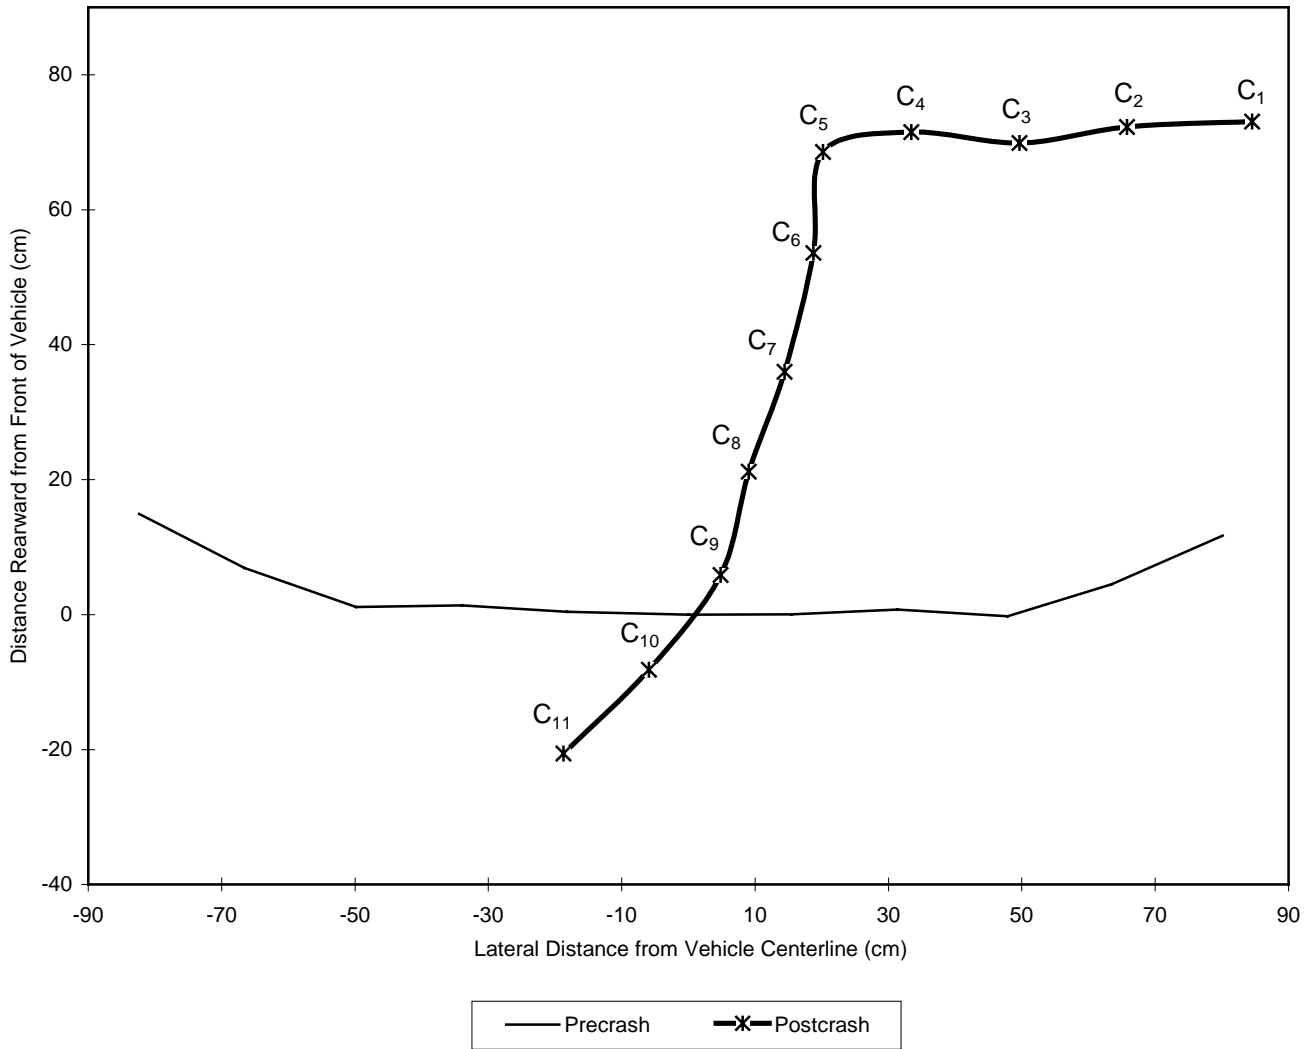
Figure 3
Front Bumper Cover Crush Contour — 2001 Mitsubishi Montero

C ₁	C ₂	C ₃	C ₄	C ₅	C ₆	C ₇	C ₈	C ₉	C ₁₀	C ₁₁
Postcrash Contour (cm)	73	72	70	72	69	54	36	21	6	-8	-21
Precrash Contour (cm)	12	5	0	1	0	0	0	1	1	7	15
Resulting Crush (cm)	61	67	70	71	69	54	36	20	5	-15	-36

The bumper cover at C₁ was torn off the vehicle during the crash. The postcrash measurement for C₁ represents the best attempt to fit the cover back onto the vehicle. The length of the reference line was 162 cm precrash and 103 cm postcrash.

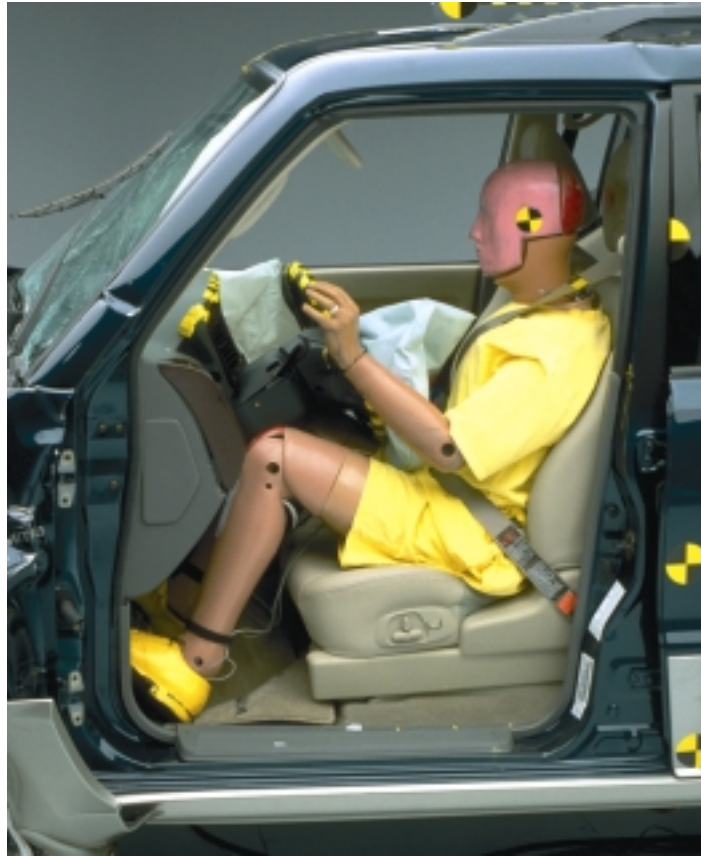
Figure 6
Dummy and Vehicle Interior, Postcrash — 2001 Mitsubishi Montero

Left leg and foot: Paint transferred from the dummy's left knee indicated the knee contacted the instrument panel just to the left of the steering column and just above the knee bolster. Paint transferred from the dummy's left shin indicated the shin contacted the bolster below and slightly to the left of the knee impact location. The left foot was found slightly dorsiflexed and fully everted. The medial back of the heel was found resting on the floormat/carpeting, and the medial toe was touching the intruded toepan to the right of the footrest.

Right leg and foot: Paint transferred from the dummy's right knee indicated the knee contacted the instrument panel just to the right of the steering column and above the knee bolster. The knee also contacted the ignition key, which was bent forward. Paint transferred from the dummy's right shin indicated the shin contacted the bolster just below the knee impact location. The right foot was found somewhat dorsiflexed and fully everted. The sole of the instep and forefoot was pressed against the fully depressed accelerator pedal and pedal arm. The lateral back of the heel was pressed against a downward buckle of the floormat/carpeting, and the medial side of the foot was pressed against the inboard edge of the brake pedal.
