Insurance Institute for Highway Safety Crashworthiness Evaluation

Crash Test Report 2000 Isuzu Trooper (CF00021)

Vehicle identification number: JACDJ58X1Y7J07010
Body style: Midsize 4-door utility vehicle
Engine/transmission: Longitudinal 3.5-liter V6, 4-speed automatic,
4-wheel drive

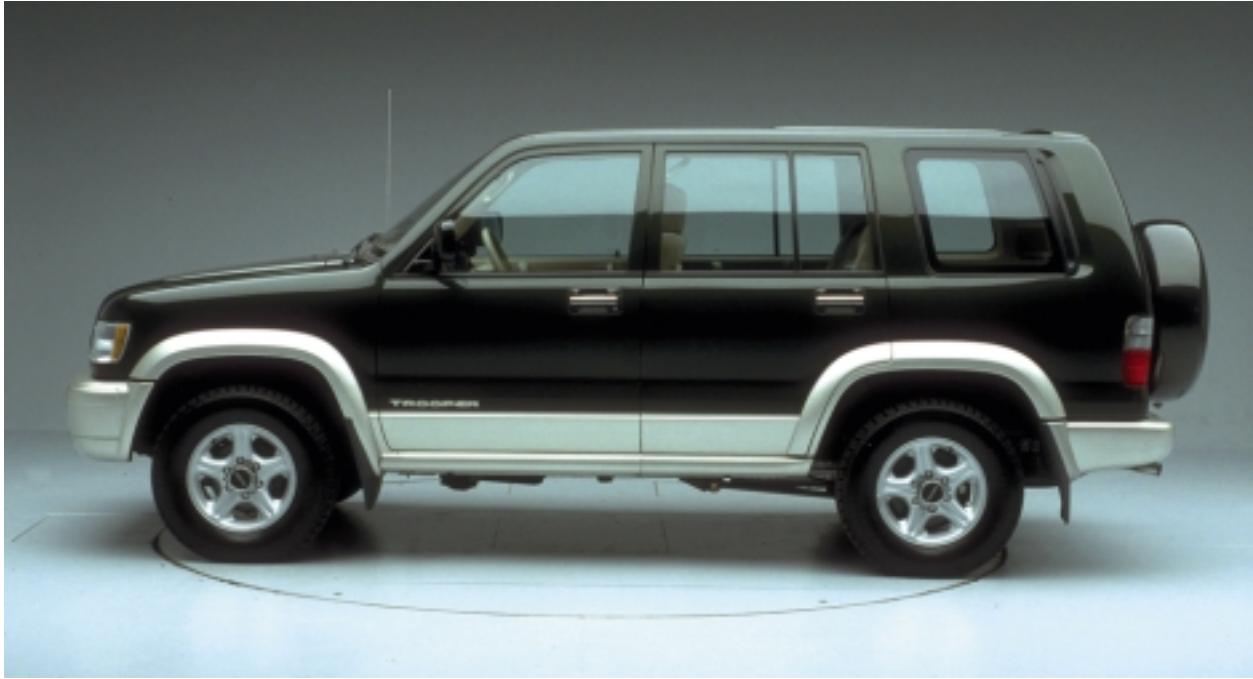
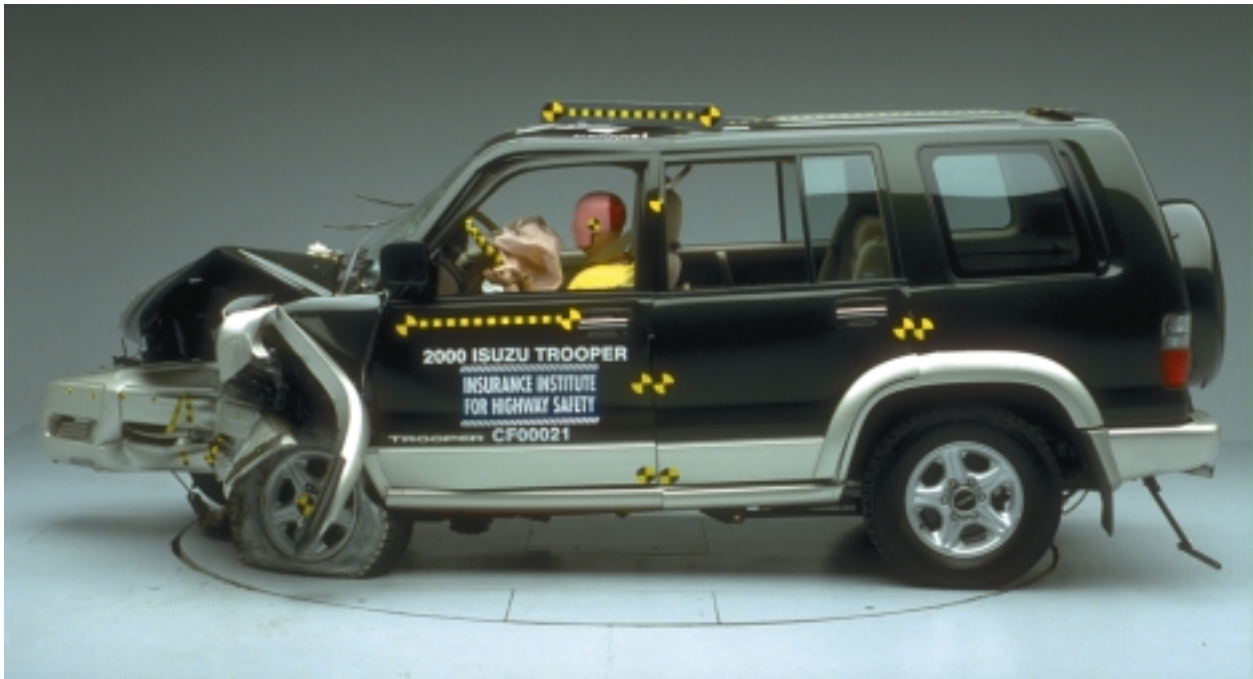
Figure 1
Pre-crash and Post-crash Side Views — 2000 Isuzu Trooper

Measures of intrusion taken after the crash indicated the lower instrument panel in front of the dummy moved rearward 3 cm. Resultant intrusion in the driver footwell measured 17 cm at the footrest and 19-21 cm at other places on the toepan. All doors remained closed during the crash. After the crash, the driver door and the right front and left rear doors required additional effort but no tools to open, and the right rear door opened with ease.

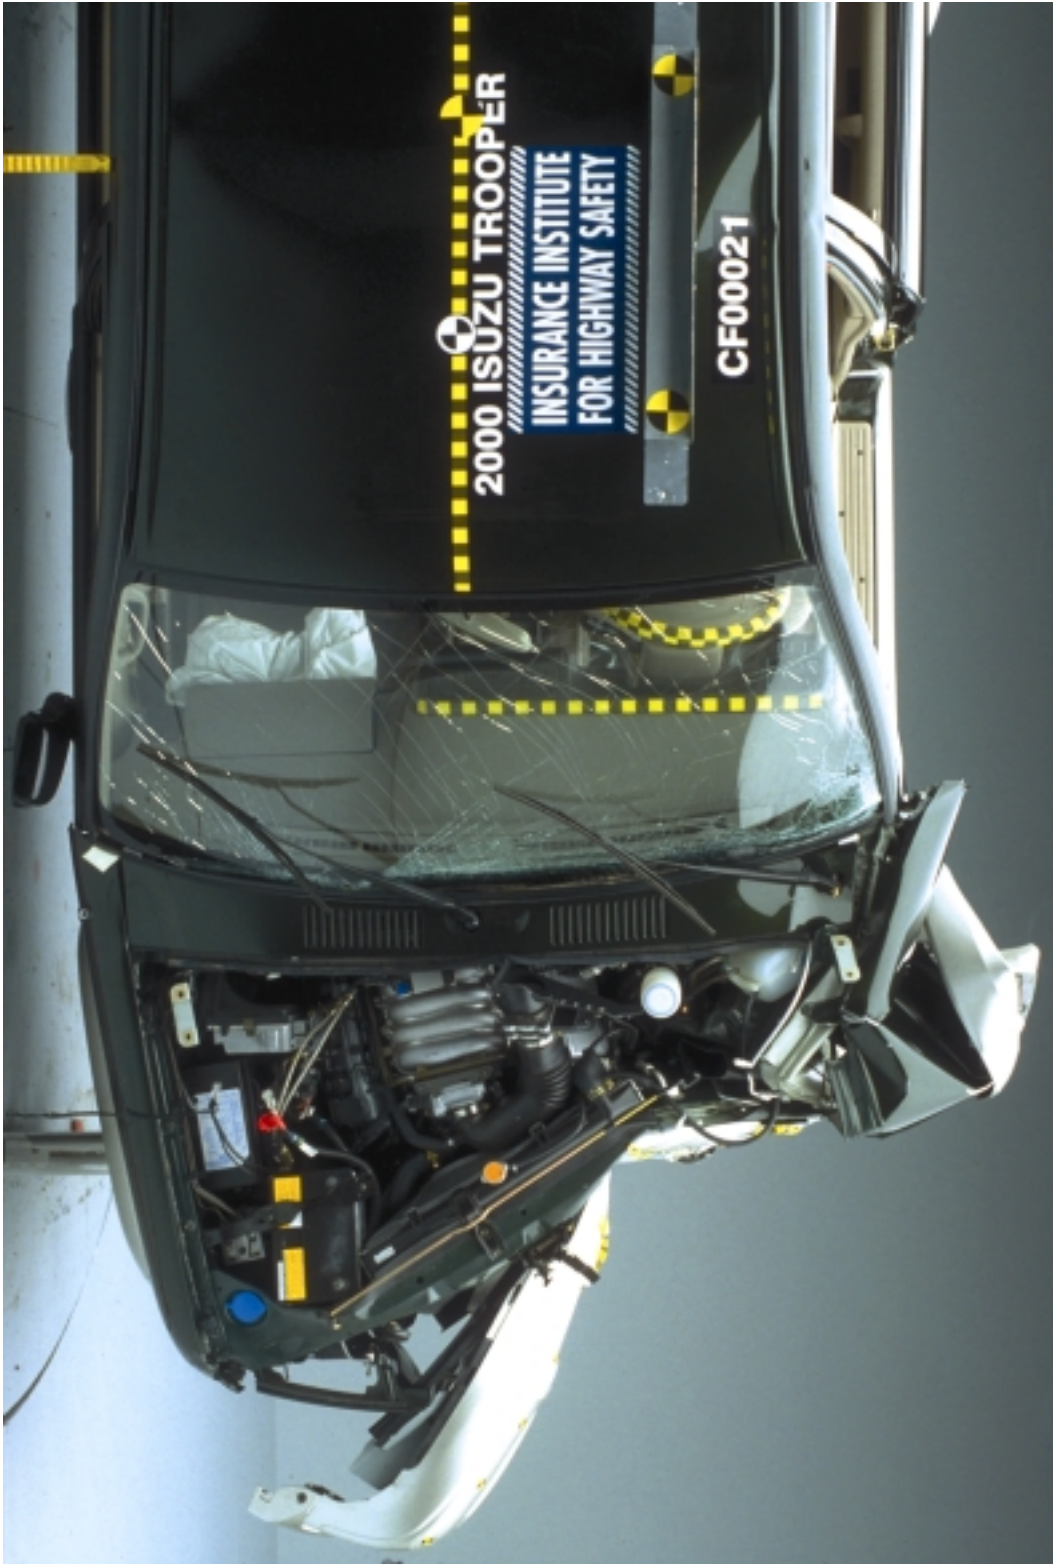
Figure 2
Overhead View of Crash Deformation — 2000 Isuzu Trooper

Figure 2 shows the overhead view of the crash deformation. Figure 3 illustrates the precrash and postcrash contour measures of the front bumper cover profile and the resulting permanent crush. Figure 4 shows the precrash and postcrash views from below. The marked area of the postcrash view in Figure 4 shows the location of the fuel line leak; Figure 5 shows this area enlarged with the affected fuel line and hose. Figure 6 illustrates the deformation of the frame rails, door sills, and crossmembers, which are visible in Figure 4.

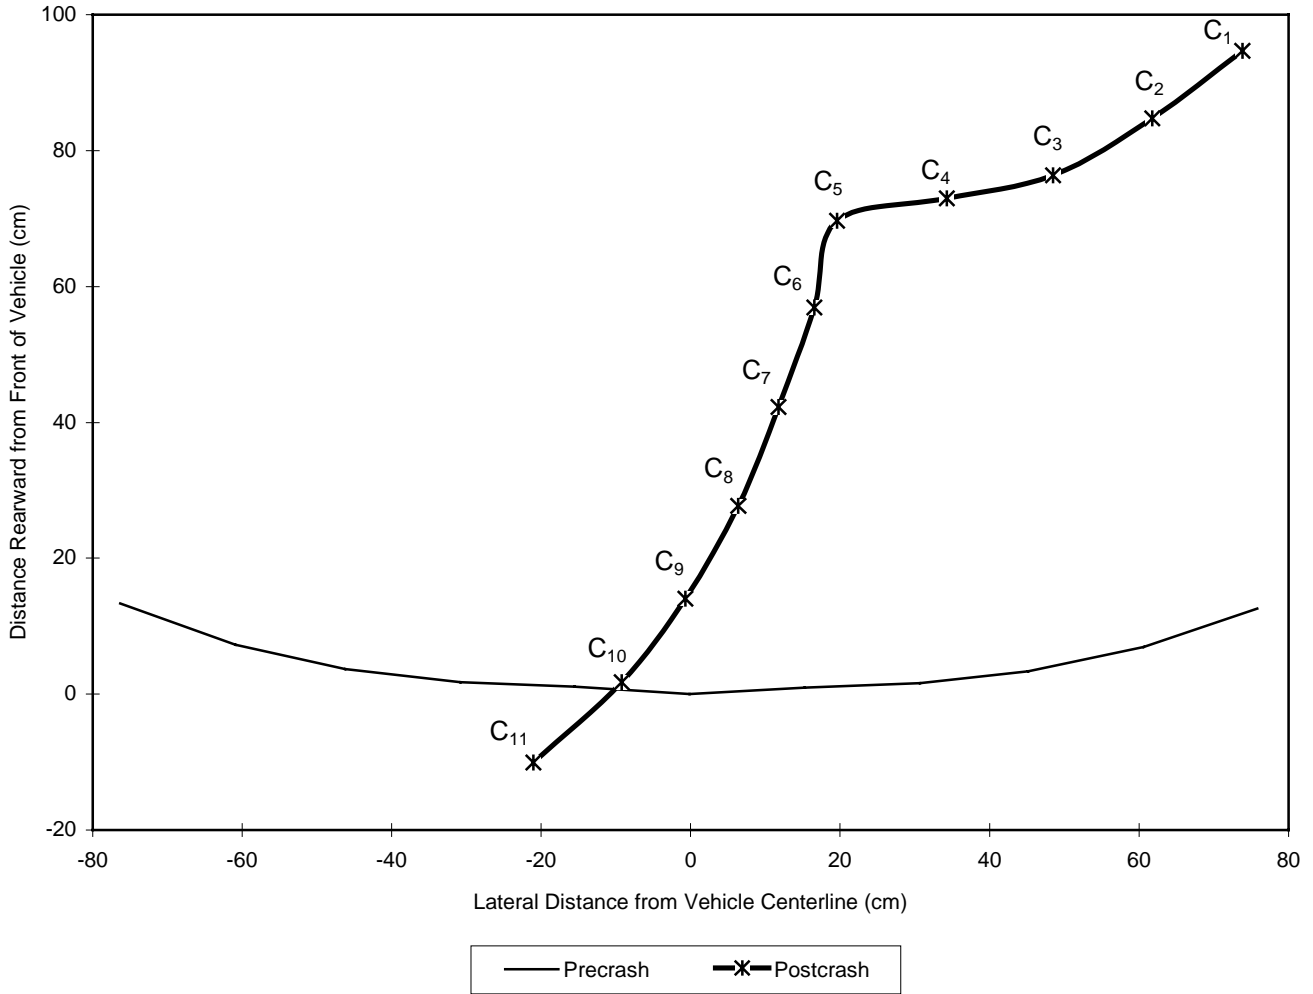
Figure 3
Front Bumper Cover Crush Contour — 2000 Isuzu Trooper

C ₁	C ₂	C ₃	C ₄	C ₅	C ₆	C ₇	C ₈	C ₉	C ₁₀	C ₁₁
Postcrash Contour (cm)	95	85	76	73	70	57	42	28	14	2	-10
Precrash Contour (cm)	13	7	3	2	1	0	1	2	4	7	13
Resulting Crush (cm)	82	78	73	71	69	57	41	26	10	-5	-23

The length of the reference line was 152 cm precrash and 95 cm postcrash.

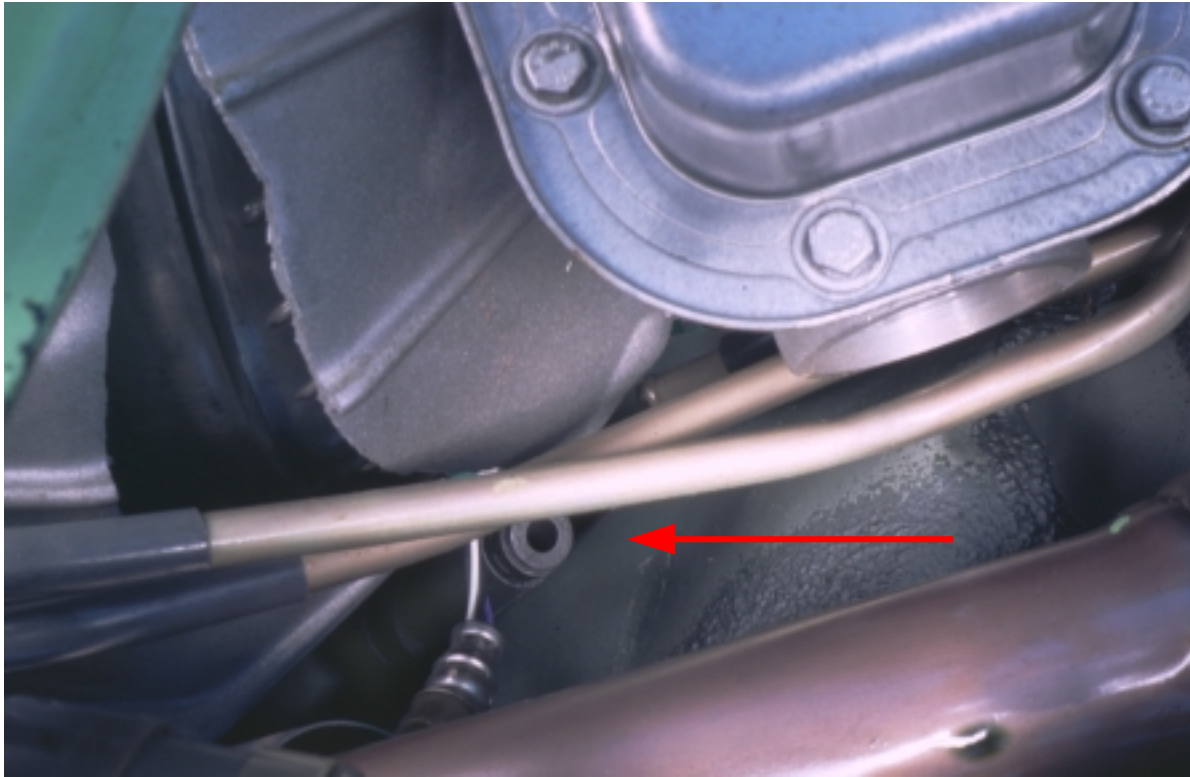
Figure 5
Postcrash Location of Separation of Fuel Hose from Fuel Line

Just after the crash, 1.5 gallons of Stoddard solvent was collected that was leaking from a fuel line that runs next to the transmission along the vehicle centerline. The leaking fluid was collected below the vehicle for 10 minutes, at which time the leak did not appear to slow. The fuel line was then clamped upstream of the leak. In addition to the 1.5 gallons of Stoddard solvent that was collected, there was a large, unmeasured amount of solvent that initially leaked onto the floor at a higher rate. It is likely that the fuel line would have continued to leak had it not been clamped. When the vehicle was rotated onto its right side for postcrash underbody photography, the fuel line clamps were removed, which allowed the Stoddard solvent to immediately flow freely. The solvent leak was observed coming from a separation between a flexible fuel hose running along the front part of the transmission and a metal fuel line running along the rear part of the transmission. During the crash, the longitudinal frame rails were bent, forcing the engine and front portion (torque converter) of the transmission toward the passenger side of the vehicle while the rear end of the transmission stayed closer to the vehicle centerline. This caused the flexible fuel hose to pull away and disconnect from the metal fuel line.

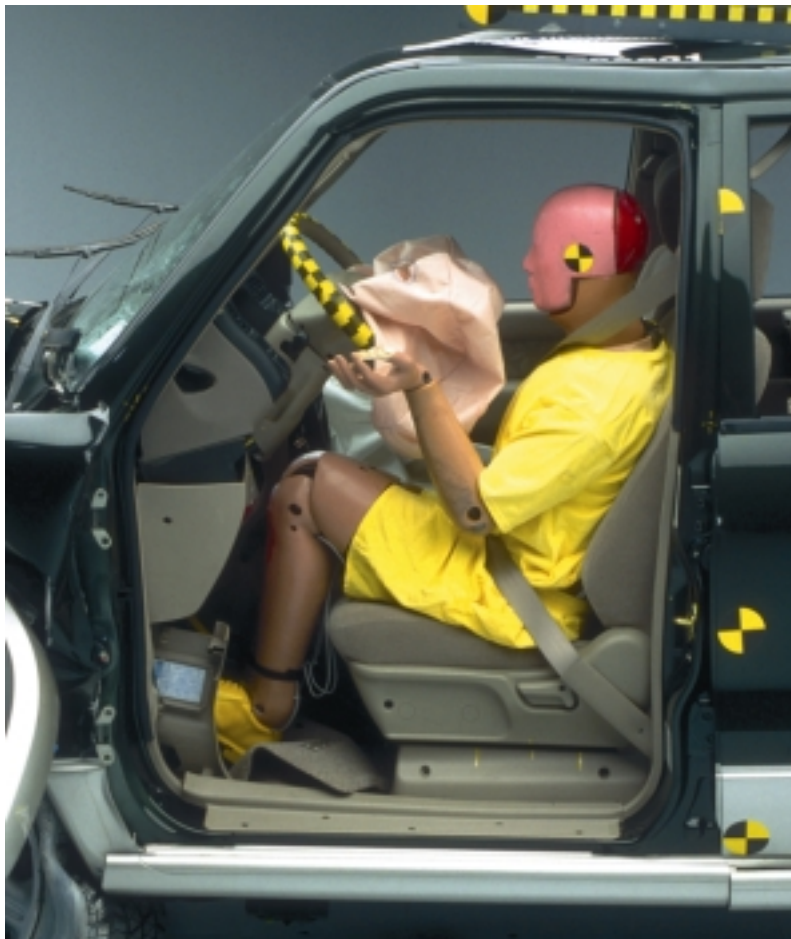
Figure 7
Dummy and Vehicle Interior, Postcrash — 2000 Isuzu Trooper

Left leg and foot: Paint transferred from the dummy's left knee indicated the knee contacted the knee bolster 7 cm directly above the left instrument panel intrusion reference point. The knee also contacted the underside portion of the steering column trim. Paint transferred from the dummy's left shin indicated the shin contacted the bolster directly below the knee impact location, extending to the base of the bolster. The top of the metal-backed bolster was dislodged and shifted rearward slightly. The left shin also contacted the center of the bolster protrusion below the steering column. The left foot was found slightly dorsiflexed and slightly everted, with the outboard half of the forefoot's sole resting on the raised carpeted footrest hump. The back of the heel was resting on a raised area on the floormat/carpeting.

Right leg and foot: Paint transferred from the dummy's right knee indicated the knee contacted the knee bolster 2 cm above and 4 cm to left of the right instrument panel intrusion reference point. The right knee also contacted the lower right portion of the steering column. Paint transferred from the dummy's right shin indicated the shin contacted the bolster on and below the knee contact, extending to the base of the bolster. The top right portion of the metal-backed knee bolster was dislodged and shifted rearward. The right foot was found fully dorsiflexed and fully inverted, with the sole at the instep on the fully depressed accelerator pedal and the back of the whole foot resting on a downward buckle of the floormat/carpeting. The lateral edge of the forefoot was pressed against the plastic side trim of the center console.
