# Insurance Institute for Highway Safety Crashworthiness Evaluation

## Crash Test Report 2001 Isuzu Trooper (CF00024)

**Vehicle identification number:** JACDJ58X017J00085  
**Body style:** Midsize 4-door utility vehicle  
**Engine/transmission:** Longitudinal 3.5-liter V6, 4-speed automatic,  
4-wheel drive

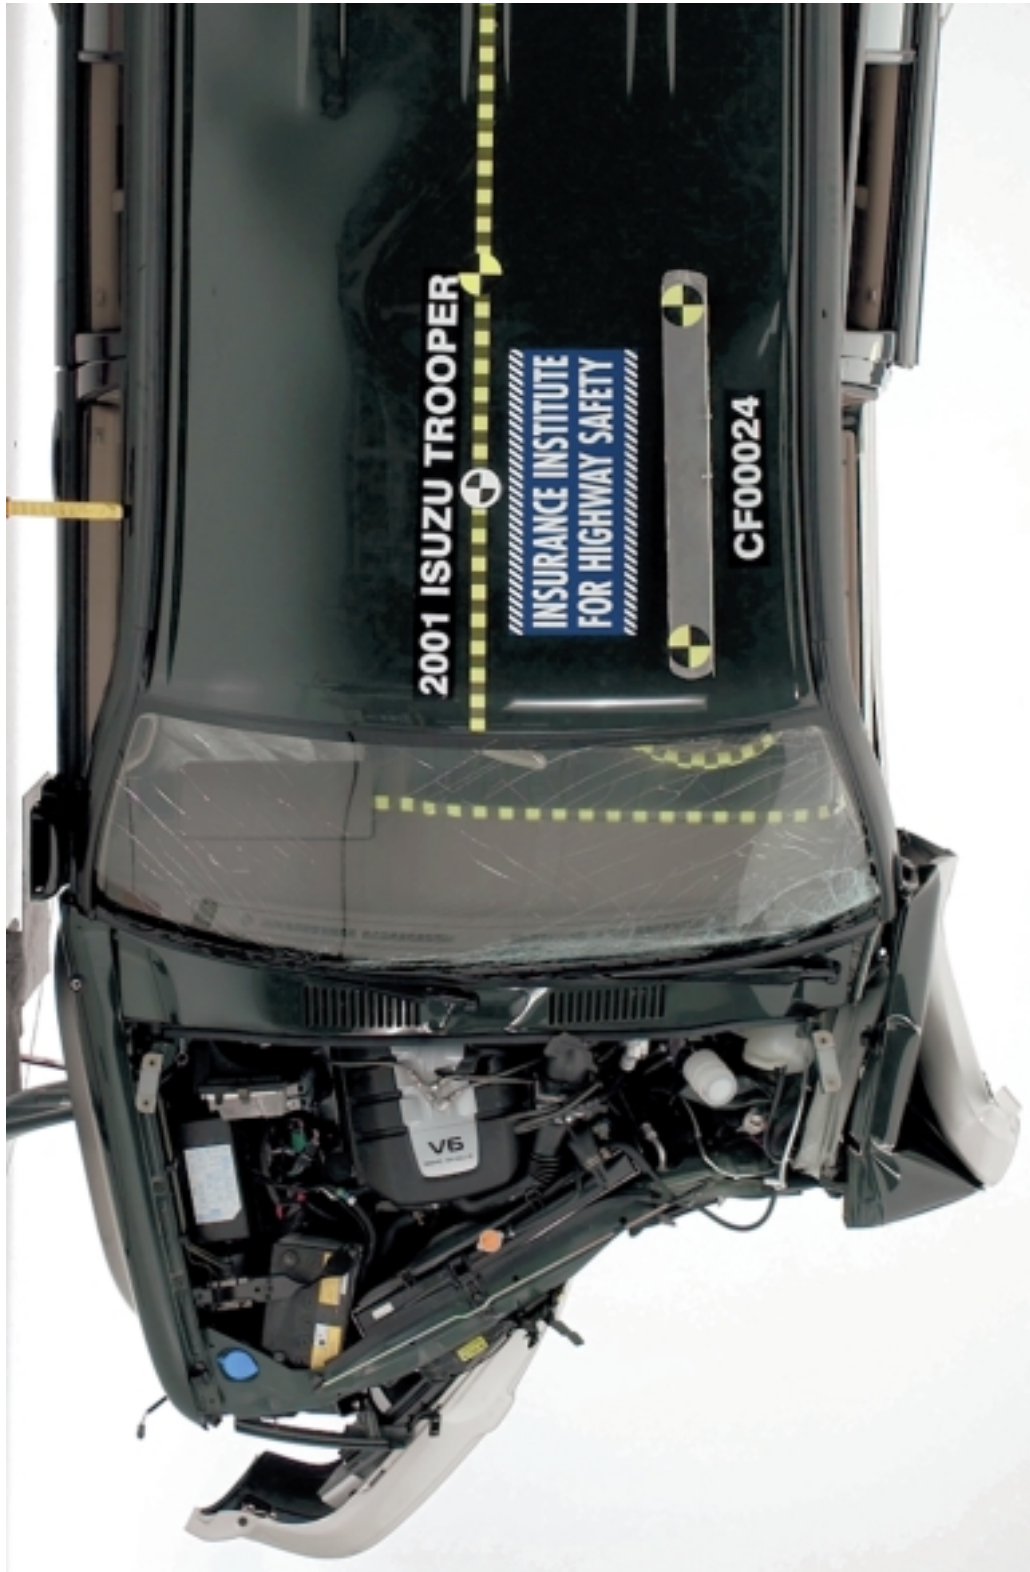
**Figure 2**  
**Overhead View of Crash Deformation — 2001 Isuzu Trooper**

Figure 2 shows the overhead view of the crash deformation. Figure 3 illustrates the precrash and postcrash contour measures of the front bumper cover profile and the resulting permanent crush. Figure 4 shows the precrash and postcrash views from below. Figure 5 shows the location of the fuel hose tear; Figure 6 shows this area enlarged with the affected fuel hose. Figure 7 illustrates the deformation of the frame rails, door sills, and crossmembers, which are visible in Figure 4.

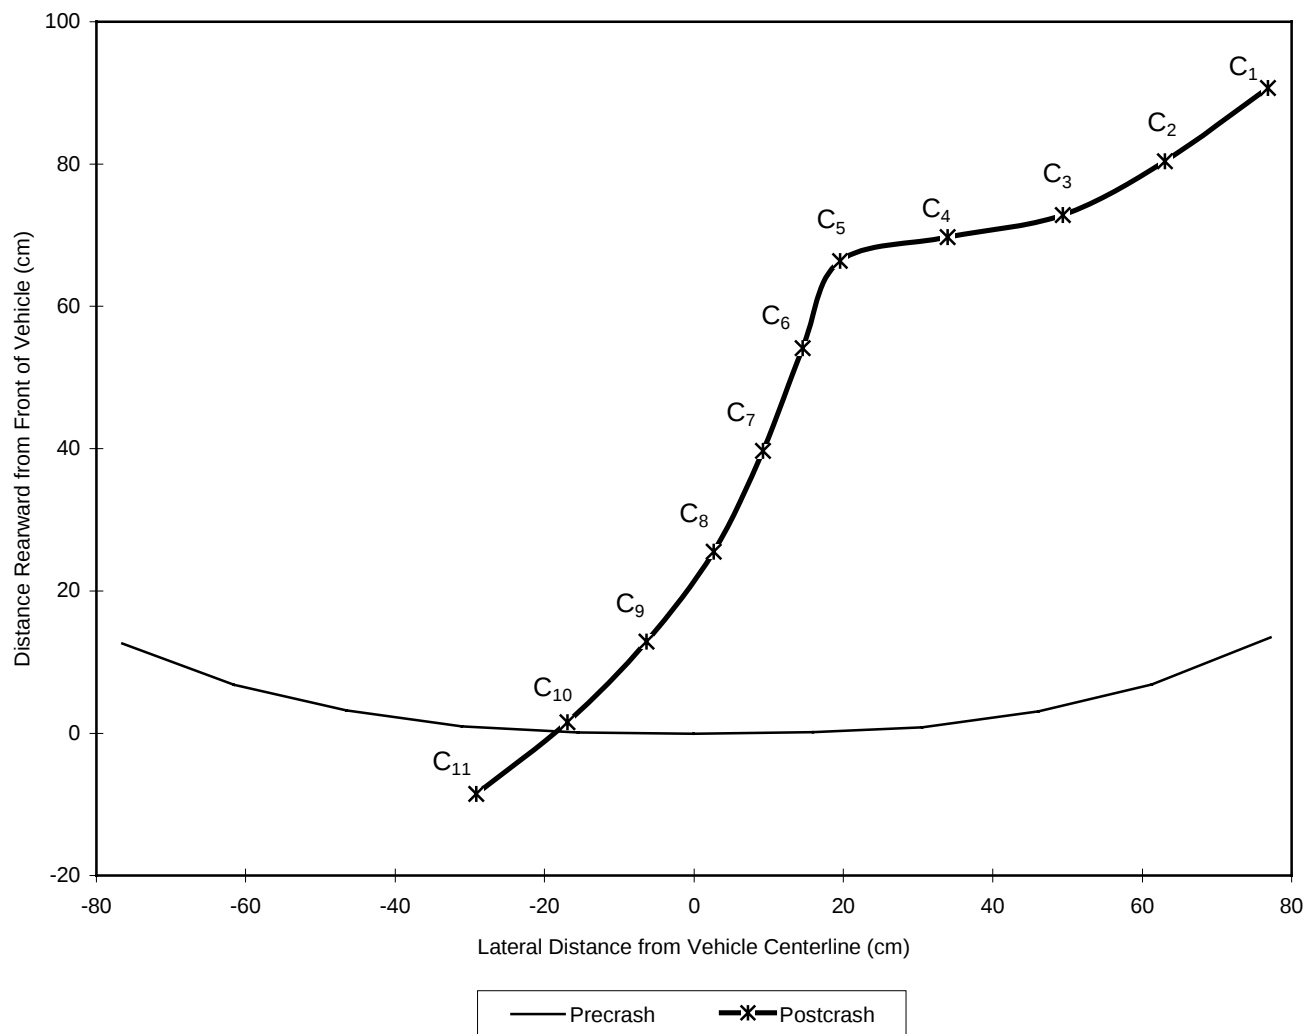
**Figure 3**  
**Front Bumper Cover Crush Contour — 2001 Isuzu Trooper**

The length of the reference line was 154 cm precrash and 106 cm postcrash.

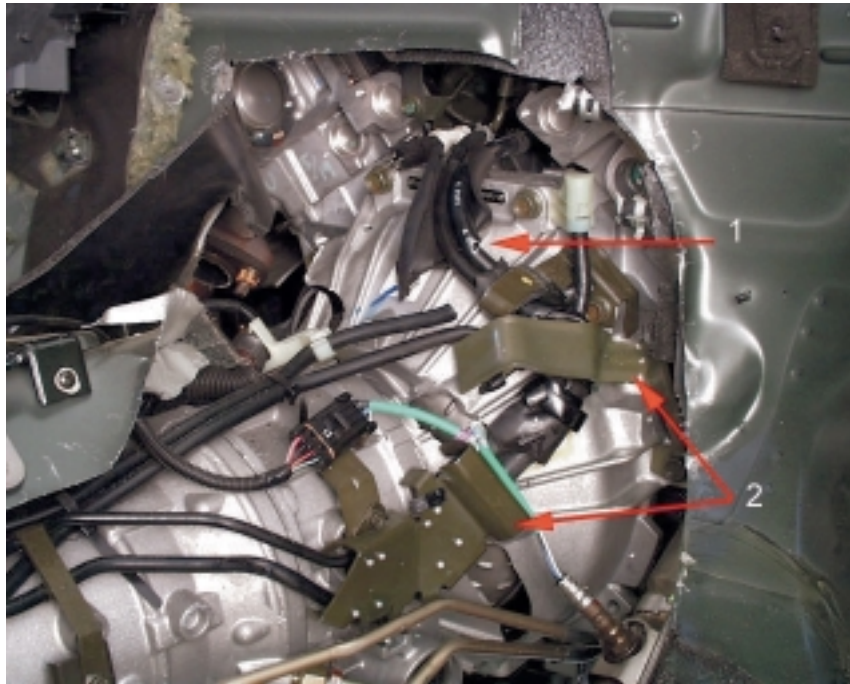
**Figure 5**  
**Postcrash Location of Tear in Fuel Hose — 2001 Isuzu Trooper**  
**(View from Right Front Seat with Firewall Cut Away)**

Within 8 minutes after the crash, 1.6 ounces of Stoddard solvent was collected that had leaked from a rubber fuel hose that is routed between the transmission housing and the firewall to the right of the vehicle centerline. (The leak had slowed to occasional drips by 5 minutes after the crash.) However, when the vehicle was later rotated onto its right side for postcrash underbody photography, the solvent leaked freely from the same location. The leak came from a tear in the hose as it was apparently pinched between the firewall and a rib on the aluminum transmission housing during the crash.

Just after the crash, Stoddard solvent was observed leaking from the right underside of the vehicle near the firewall. There was an initial stream of solvent onto the floor, and then the flow subsided. By 5 minutes after the test, only occasional drips were observed. At 8 minutes after the test, the total spillage was collected and measured to be 1.6 ounces of solvent. However, when the vehicle was rotated onto its right side for postcrash underbody photography, the Stoddard solvent immediately began to flow freely again. The flow was observed coming from a tear in a rubber fuel hose that is routed between the transmission housing and the firewall to the right of the vehicle's centerline. The flow continued from the tear and was stopped only by clamping the fuel lines near the fuel tank. During the crash, the hose apparently was pinched between the firewall and a rib on the aluminum transmission housing, causing the hose to tear.

Arrow 1 points to location of leak in 2001 Trooper; Arrow 2 points to retrofit brackets added to protect fuel lines/hoses.

The vehicle was equipped with brackets added to protect fuel lines and hoses routed along the right side of the transmission housing (see Figure 5). These brackets were retrofitted onto certain Troopers as part of a safety-related recall announced by Isuzu in September 2000 to minimize the possibility of fuel leakage in high-speed crashes.

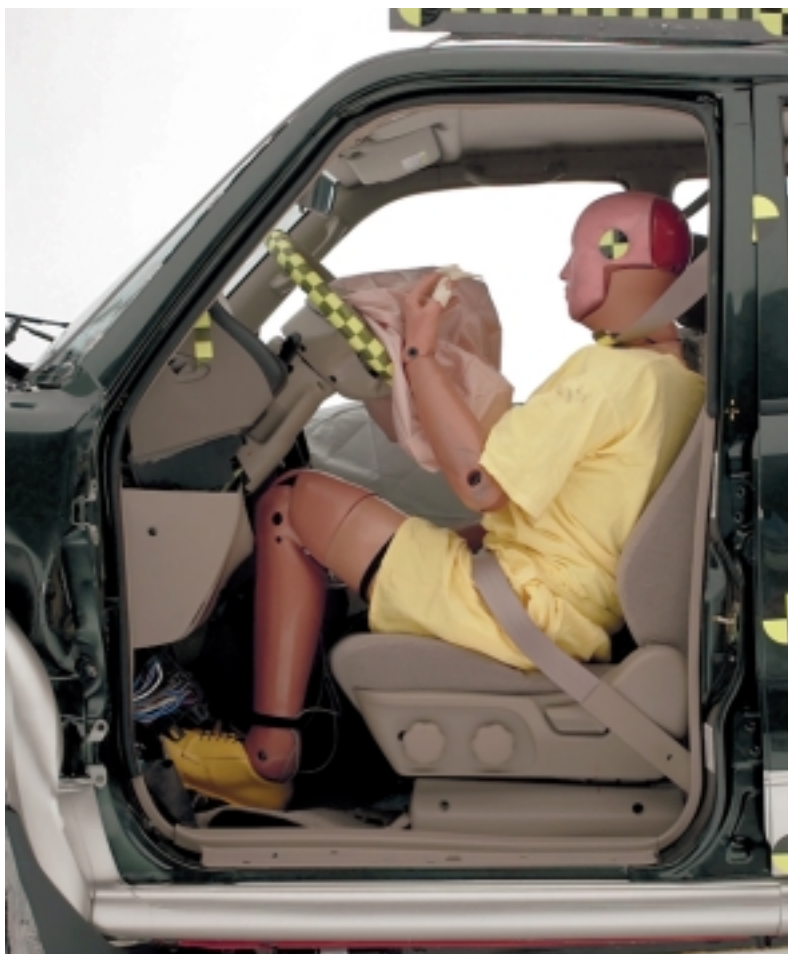
**Figure 8**  
**Dummy and Vehicle Interior, Postcrash — 2001 Isuzu Trooper**

Analysis of the high-speed film taken from camera position E indicated the deploying airbag contacted the dummy's face at 56 ms into the crash and then receded by 64 ms. The face began to load the almost fully inflated airbag at 72 ms. Paint transferred from the dummy's face indicated the nose loaded the airbag 4 cm above and 3 cm to the left of its center. As the dummy's face continued to move forward, the steering column tilted upward, causing the lower end of the steering wheel rim to move close to the dummy's chin. Although the airbag fabric obscured the dummy's face and steering wheel, the dummy's chin appeared to approach the lower center (6 o'clock) portion of the steering wheel. Sudden increases in the rearward head acceleration and neck tension and a decrease in the neck A-P bending moment, all occurring at the same time (97 ms), were consistent with contact between the dummy's chin and the steering wheel. A subsequent decrease in the neck A-P shear force suggested that the rim then contacted the dummy's neck. On rebound from the steering wheel, the head moved upward and rearward, and the right upper rear of the head contacted the outboard half of the head restraint at about 270 ms. Table 2 provides the timing of these events.
