# Insurance Institute for Highway Safety Crashworthiness Evaluation

## Crash Test Report 2001 Hyundai Elantra (CF00034)

**Vehicle identification number:** KMHDN45D61U032852  
**Body style:** Small 4-door sedan  
**Engine/transmission:** Transverse 2.0-liter 4-cylinder, 4-speed automatic, front-wheel drive

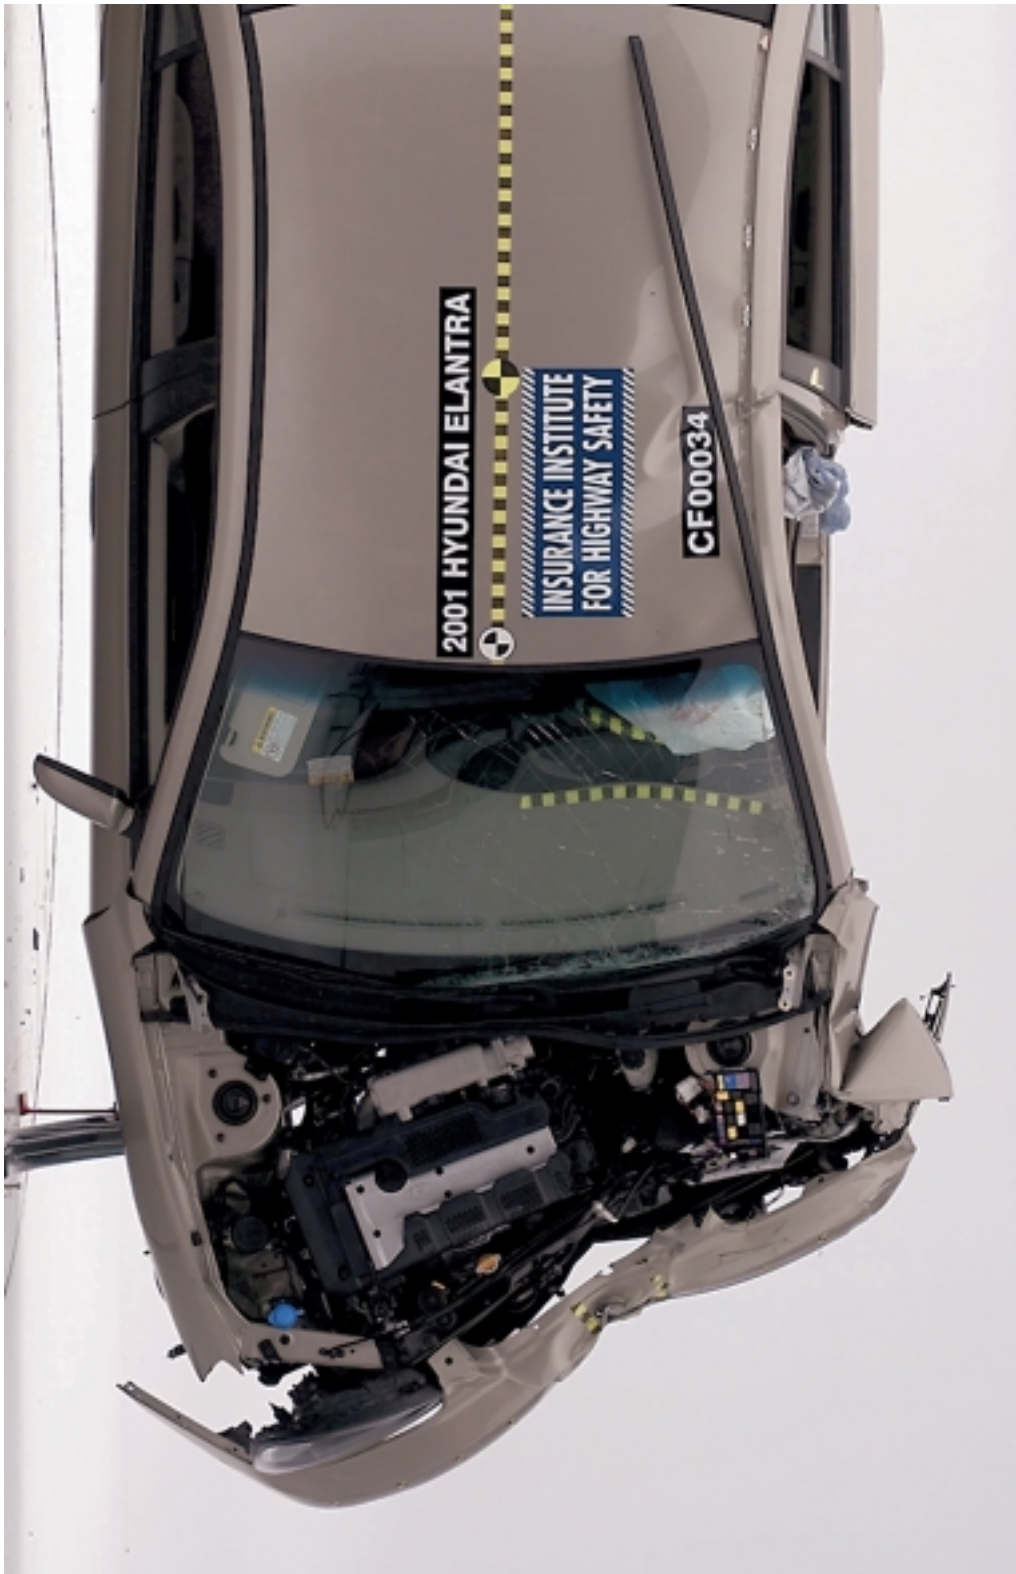
**Figure 2**  
**Overhead View of Crash Deformation — 2001 Hyundai Elantra**

Figure 2 shows the overhead view of the crash deformation. Figure 3 illustrates the precrash and postcrash contour measures of the front bumper cover profile and the resulting permanent crush. Figure 4 shows the precrash and postcrash views from below. Figure 5 illustrates the deformation of the side rails, door sills, and engine cradle, which are visible in Figure 4.

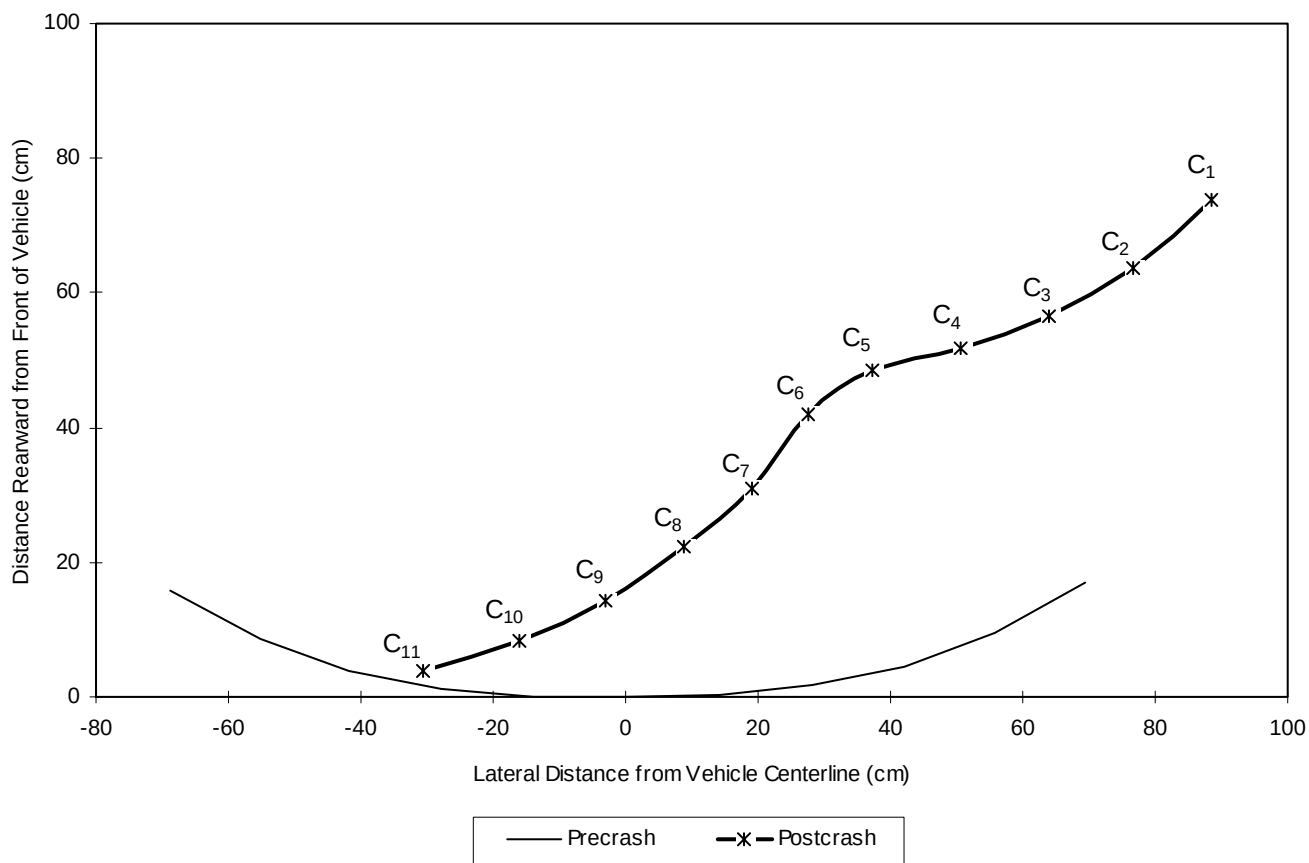
**Figure 3**  
**Front Bumper Cover Crush Contour — 2001 Hyundai Elantra**

The length of the reference line was 138 cm precrash and 119 cm postcrash.

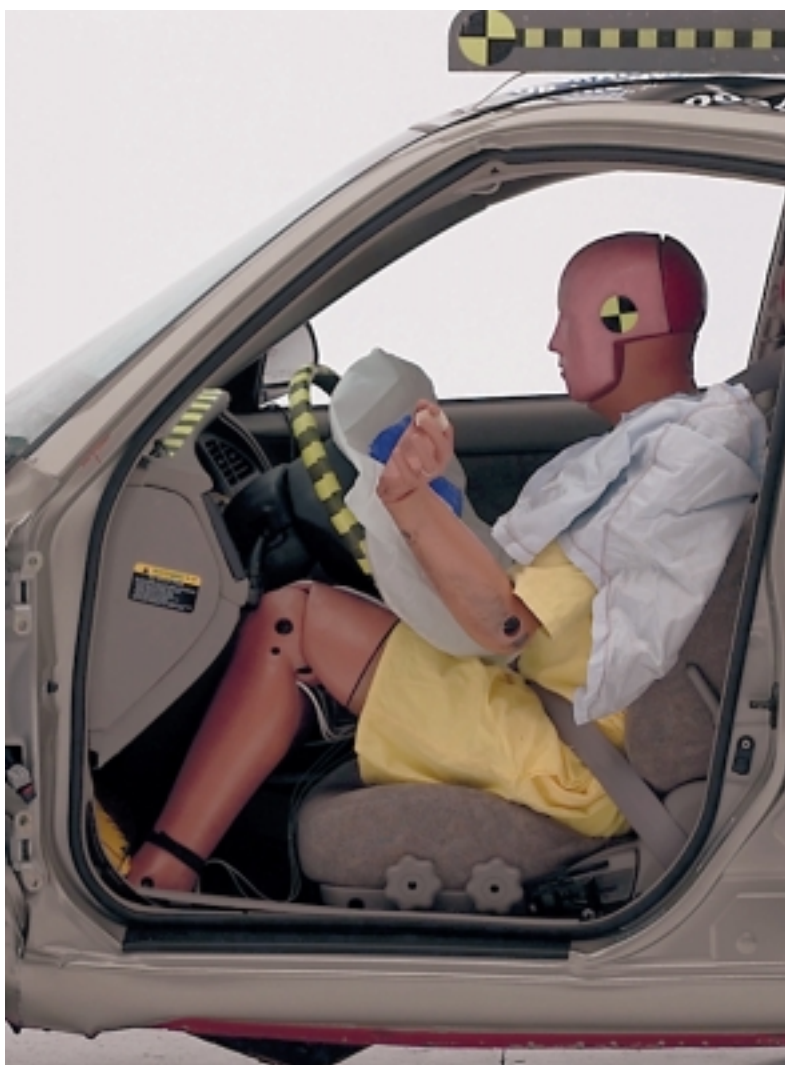
**Figure 6**  
**Dummy and Vehicle Interior, Postcrash — 2001 Hyundai Elantra**

Postcrash examination of the driver seat rails indicated no discernible movement of the seat in its tracks during the crash. Deformation of the floor under the driver seat caused the seat to pitch slightly forward.

Paint transferred from the dummy's left knee indicated the knee primarily contacted the instrument panel just above the knee bolster, about 5 cm above and 2 cm to the left of the left instrument panel intrusion reference point. The knee also contacted the lower left corner of the steering column trim and broke off the turn signal stalk. Paint transferred from the dummy's left shin indicated the shin contacted the knee bolster directly below the knee contact location on the instrument panel. The knee bolster, made of hard plastic, was found intact. The left foot was found fully dorsiflexed and fully inverted, with the lateral forefoot's sole pressed against the inboard edge of the footrest and the medial sole at the heel also pressed against the footrest. The back of the foot was pressed against a downward buckle in the floorpan/carpeting over the floorpan.

Paint transferred from the dummy's right knee indicated the knee primarily contacted and broke the right underside portion of the steering column trim. The knee also contacted the knee bolster directly below the contact location on the column. Paint transferred from the dummy's right shin indicated the shin contacted the bolster below the knee contact locations. The right foot was found somewhat dorsiflexed but neither inverted nor everted, with the lateral forefoot's sole touching the accelerator pedal, which had been torn off its mounting arm. The sole of the heel was pressed against the intruded toepan, and the back of the foot was pressed against a downward buckle in the floormat/carpeting.
