FMVSS 301-FUEL SYSTEM INTEGRITY

VOLKSWAGEN DO BRAZIL LTDA  
2005 VOLKSWAGEN GOLF  
4-DOOR HATCHBACK

NHTSA NUMBER: C55801

FINAL REPORT

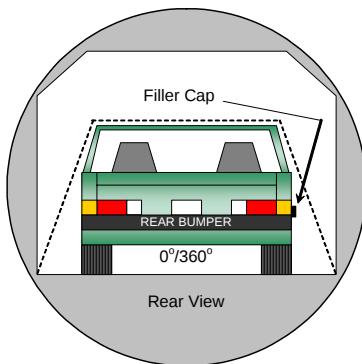
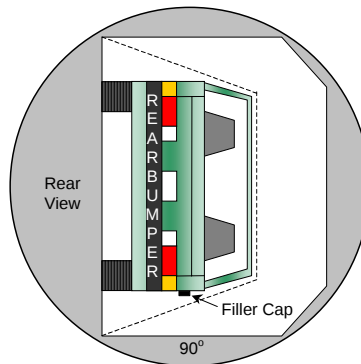
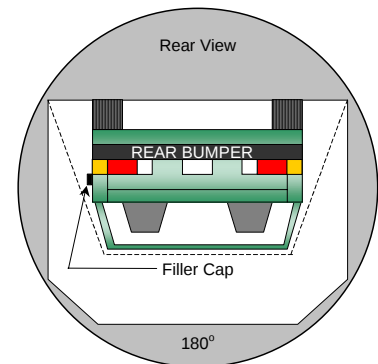
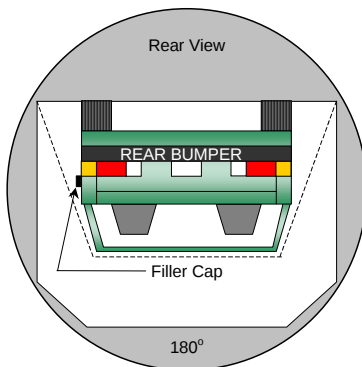
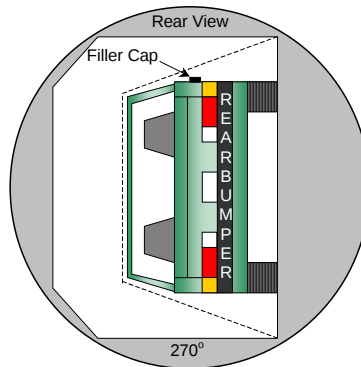
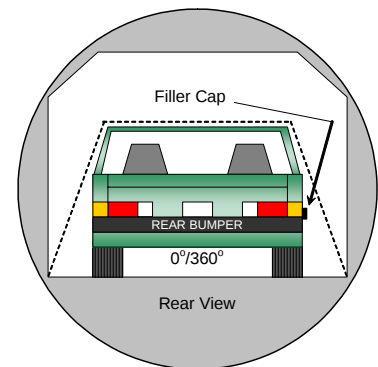
1. The specified fixture rollover rate for each 90° of rotation is 60 to 120 seconds.
2. The position hold time at each position is 300 seconds (minimum).
3. No solvent leakage occurred during rollover.

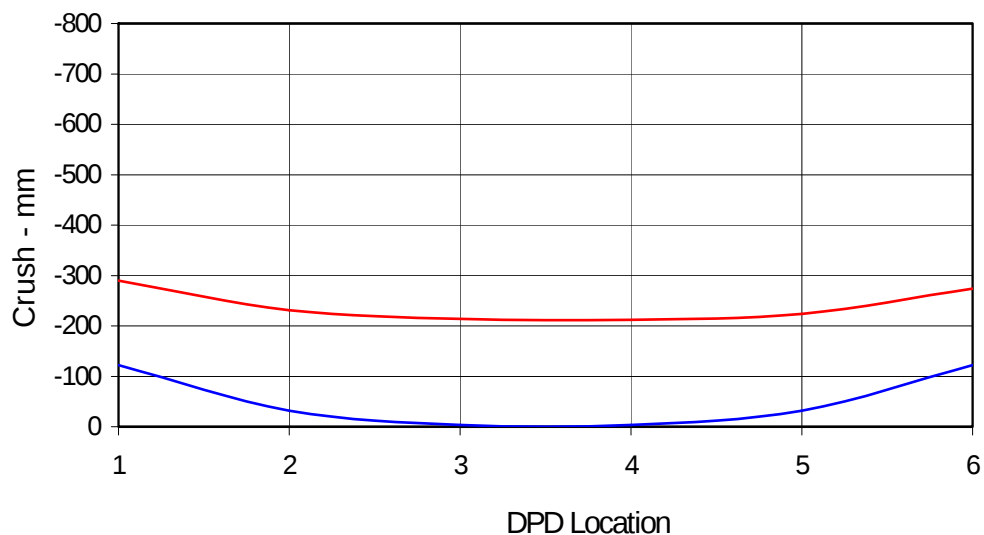
Damage Region Length (mm): 1371      Midpoint of Damage: Centerline  
 Impact Mode: Rear Impact (0 Deg.)

| No. | Measurement Description | Units | Pre-Test | Post-Test | Difference |
|---|---|---|---|---|---|
| C1 | Crush zone 1 at left side | mm | -122 | -290 | 168 |
| C2 | Crush zone 2 on left side | mm | -32 | -231 | 199 |
| C3 | Crush zone 3 on left side | mm | -3 | -214 | 211 |
| C4 | Crush zone 4 on right side | mm | -3 | -212 | 209 |
| C5 | Crush zone 5 on right side | mm | -32 | -224 | 192 |
| C6 | Crush zone 6 at right side | mm | -122 | -274 | 152 |
