FMVSS 301-FUEL SYSTEM INTEGRITY

GM DAEWOO AUTO & TECHNOLOGY COMPANY  
2005 SUZUKI RENO  
4-DOOR SEDAN

NHTSA NUMBER: C50507

FINAL REPORT

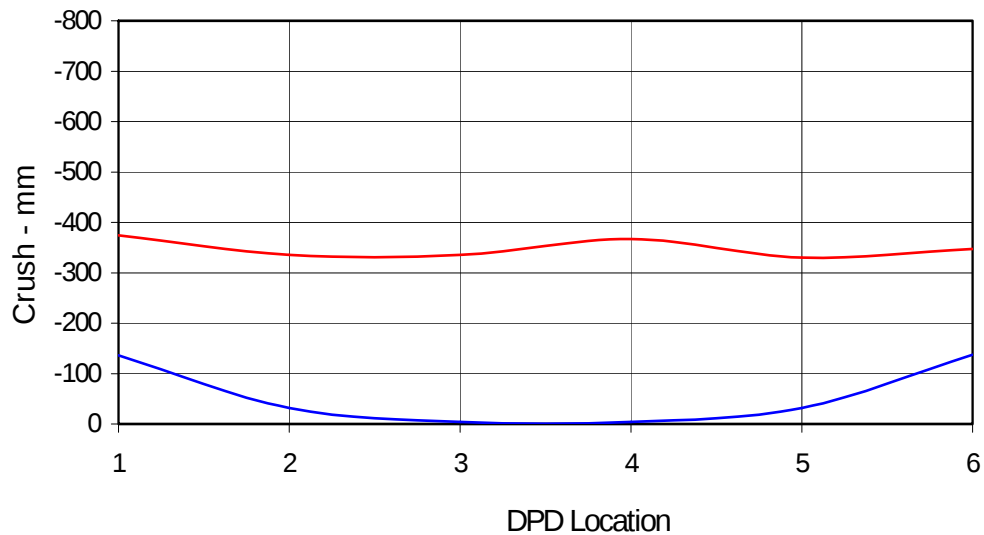
**CRUSH PROFILE**

Damage Region Length (mm): 1316      Midpoint of Damage: Centerline  
 Impact Mode: Rear Impact (0 Deg.)

| No. | Measurement Description | Units | Pre-Test | Post-Test | Difference |
|---|---|---|---|---|---|
| C4 | Crush zone 4 on right side | mm | -4 | -367 | 363 |

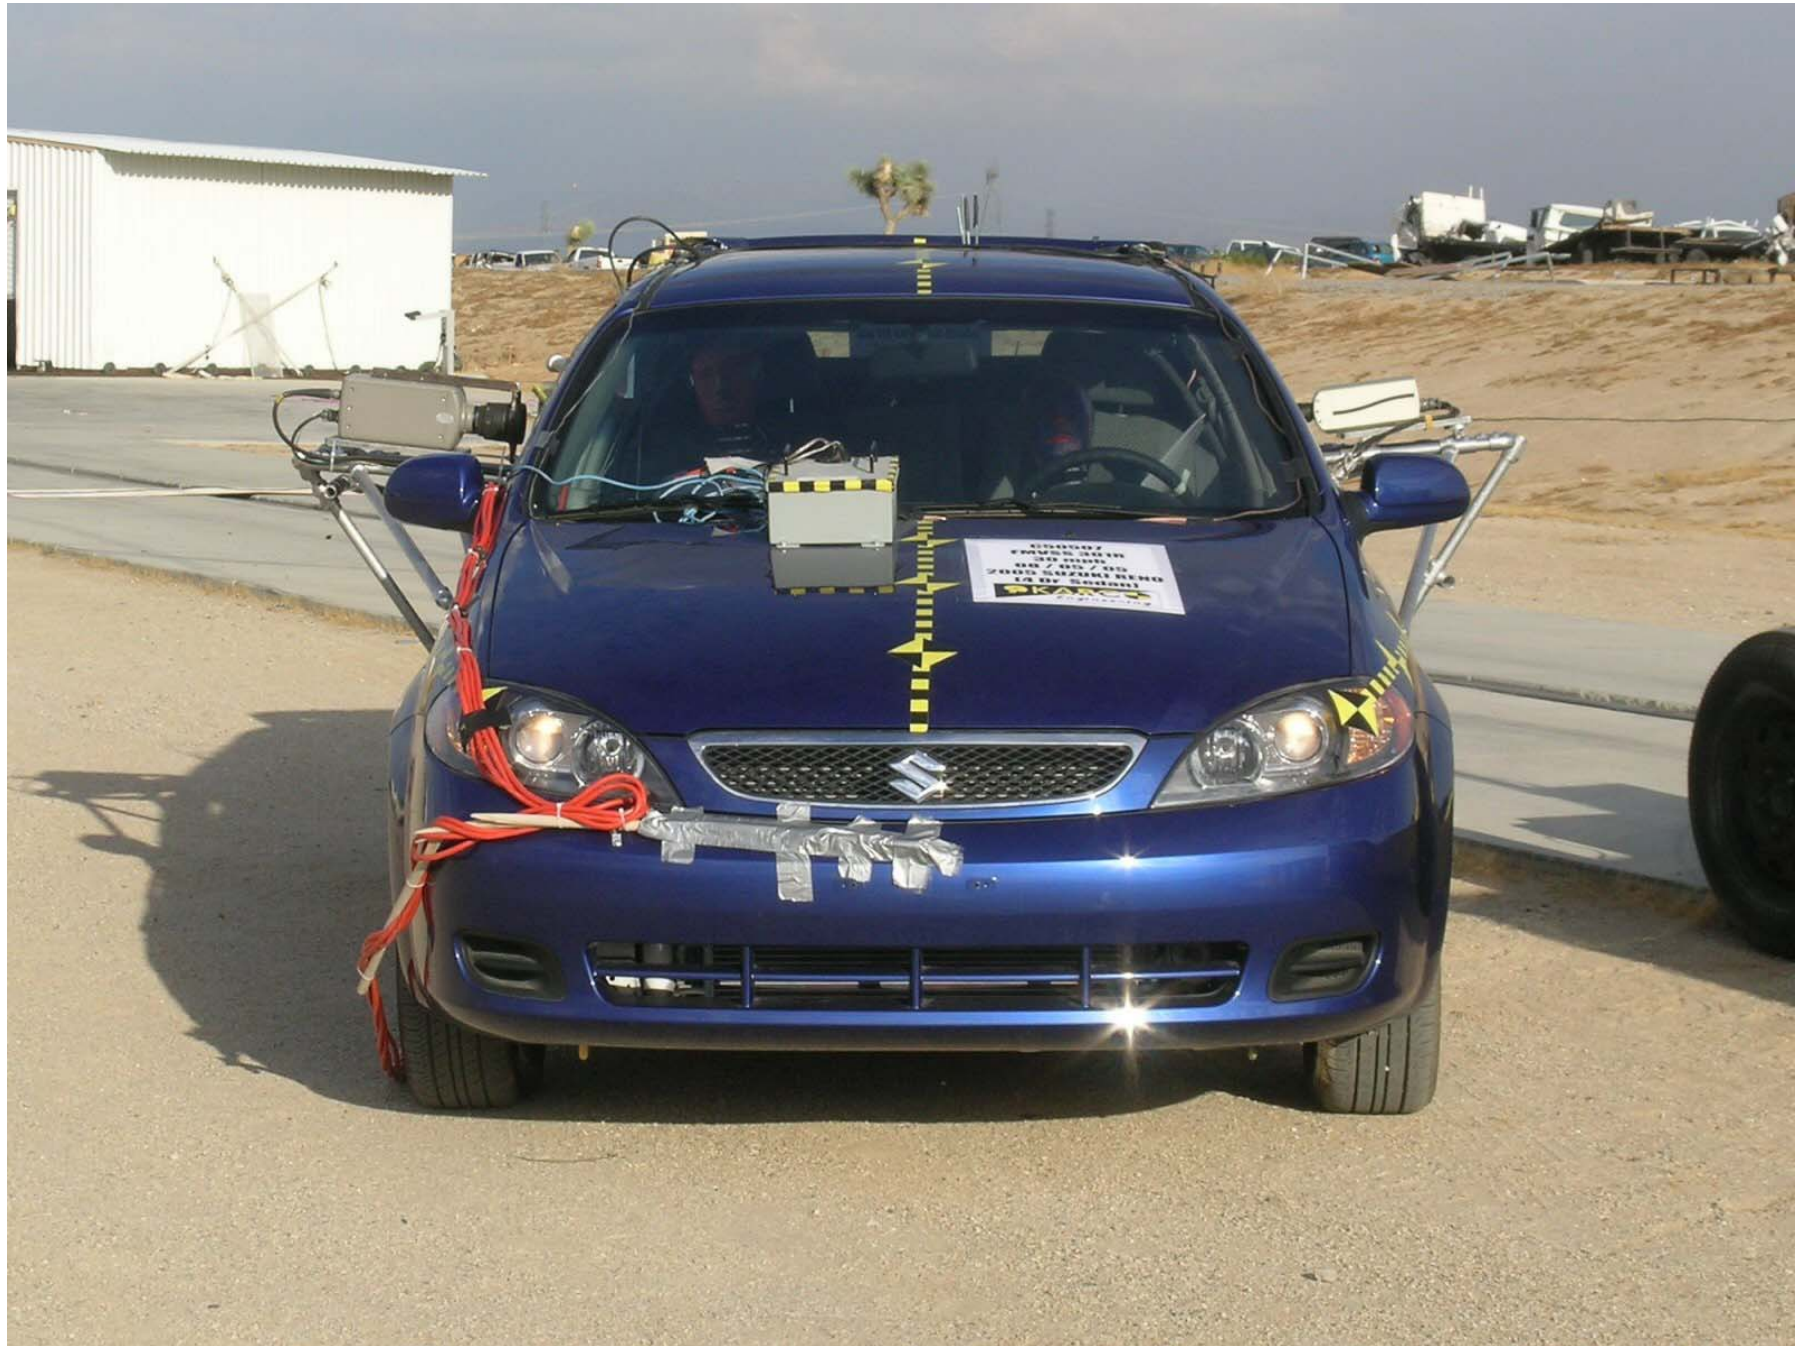
Figure A-6: Post-Test Front View

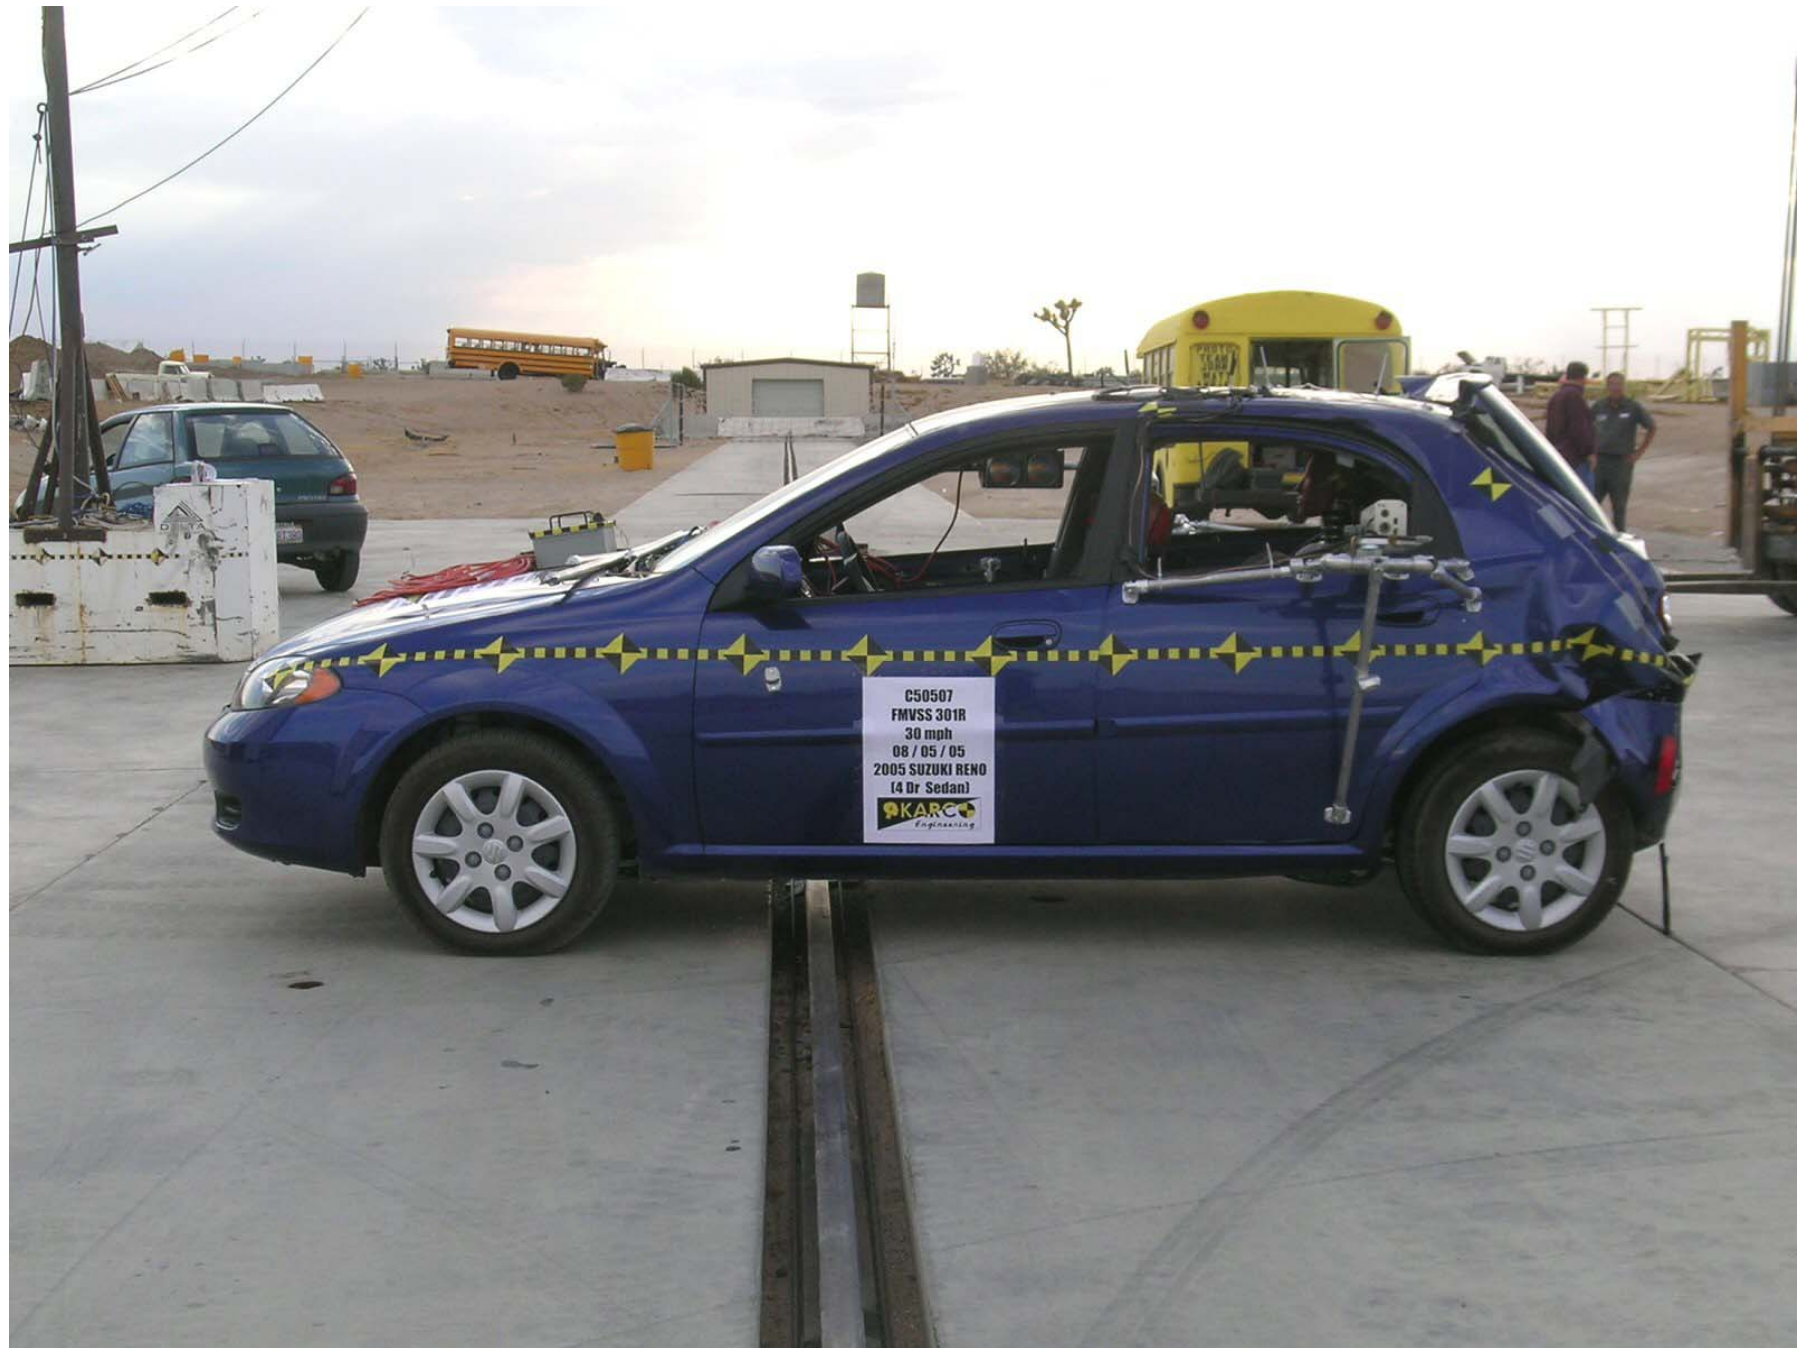
Figure A-8: Post-Test Left Side View

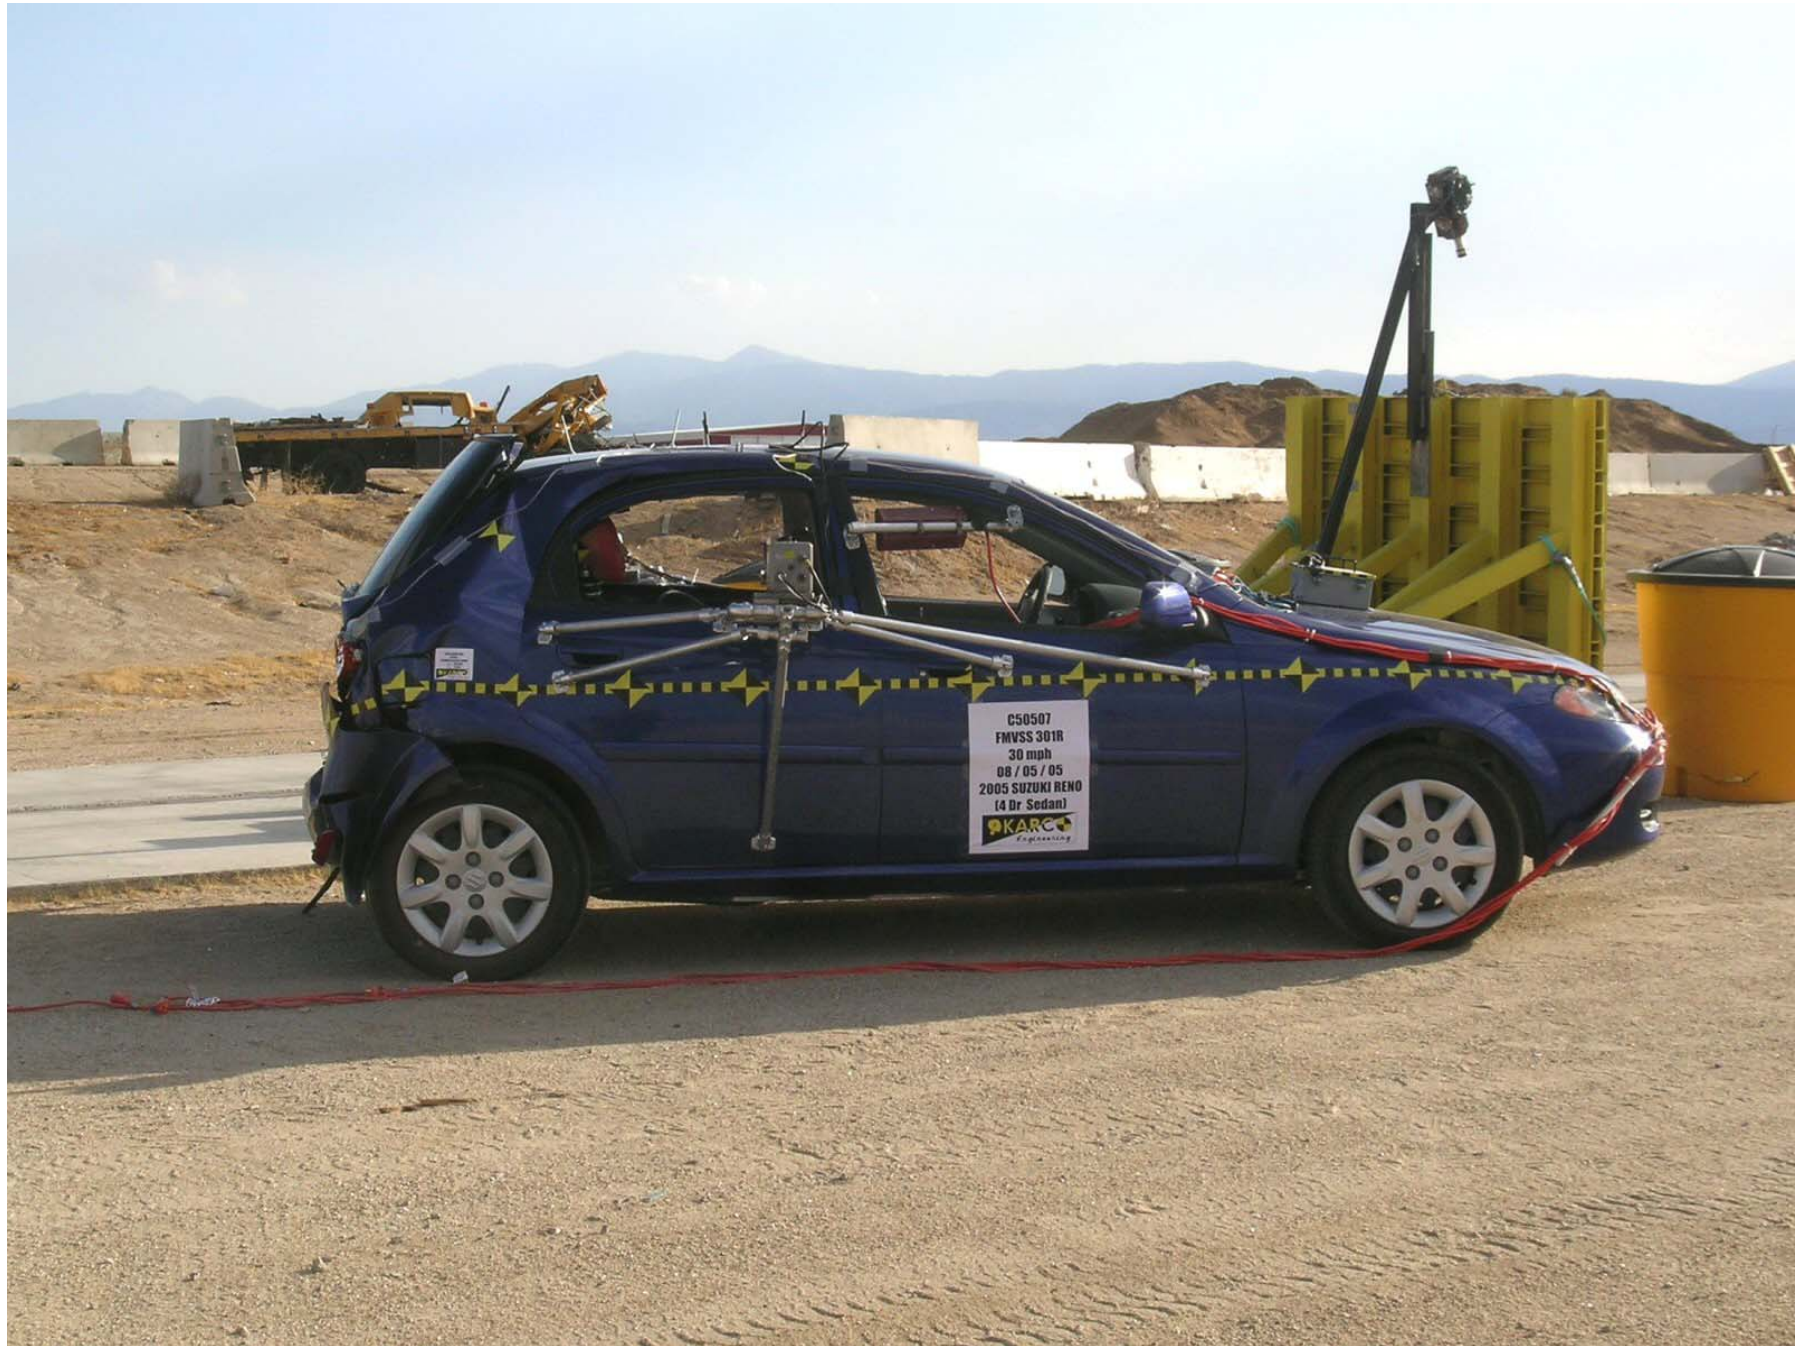
Figure A-10: Post-Test Right Side View

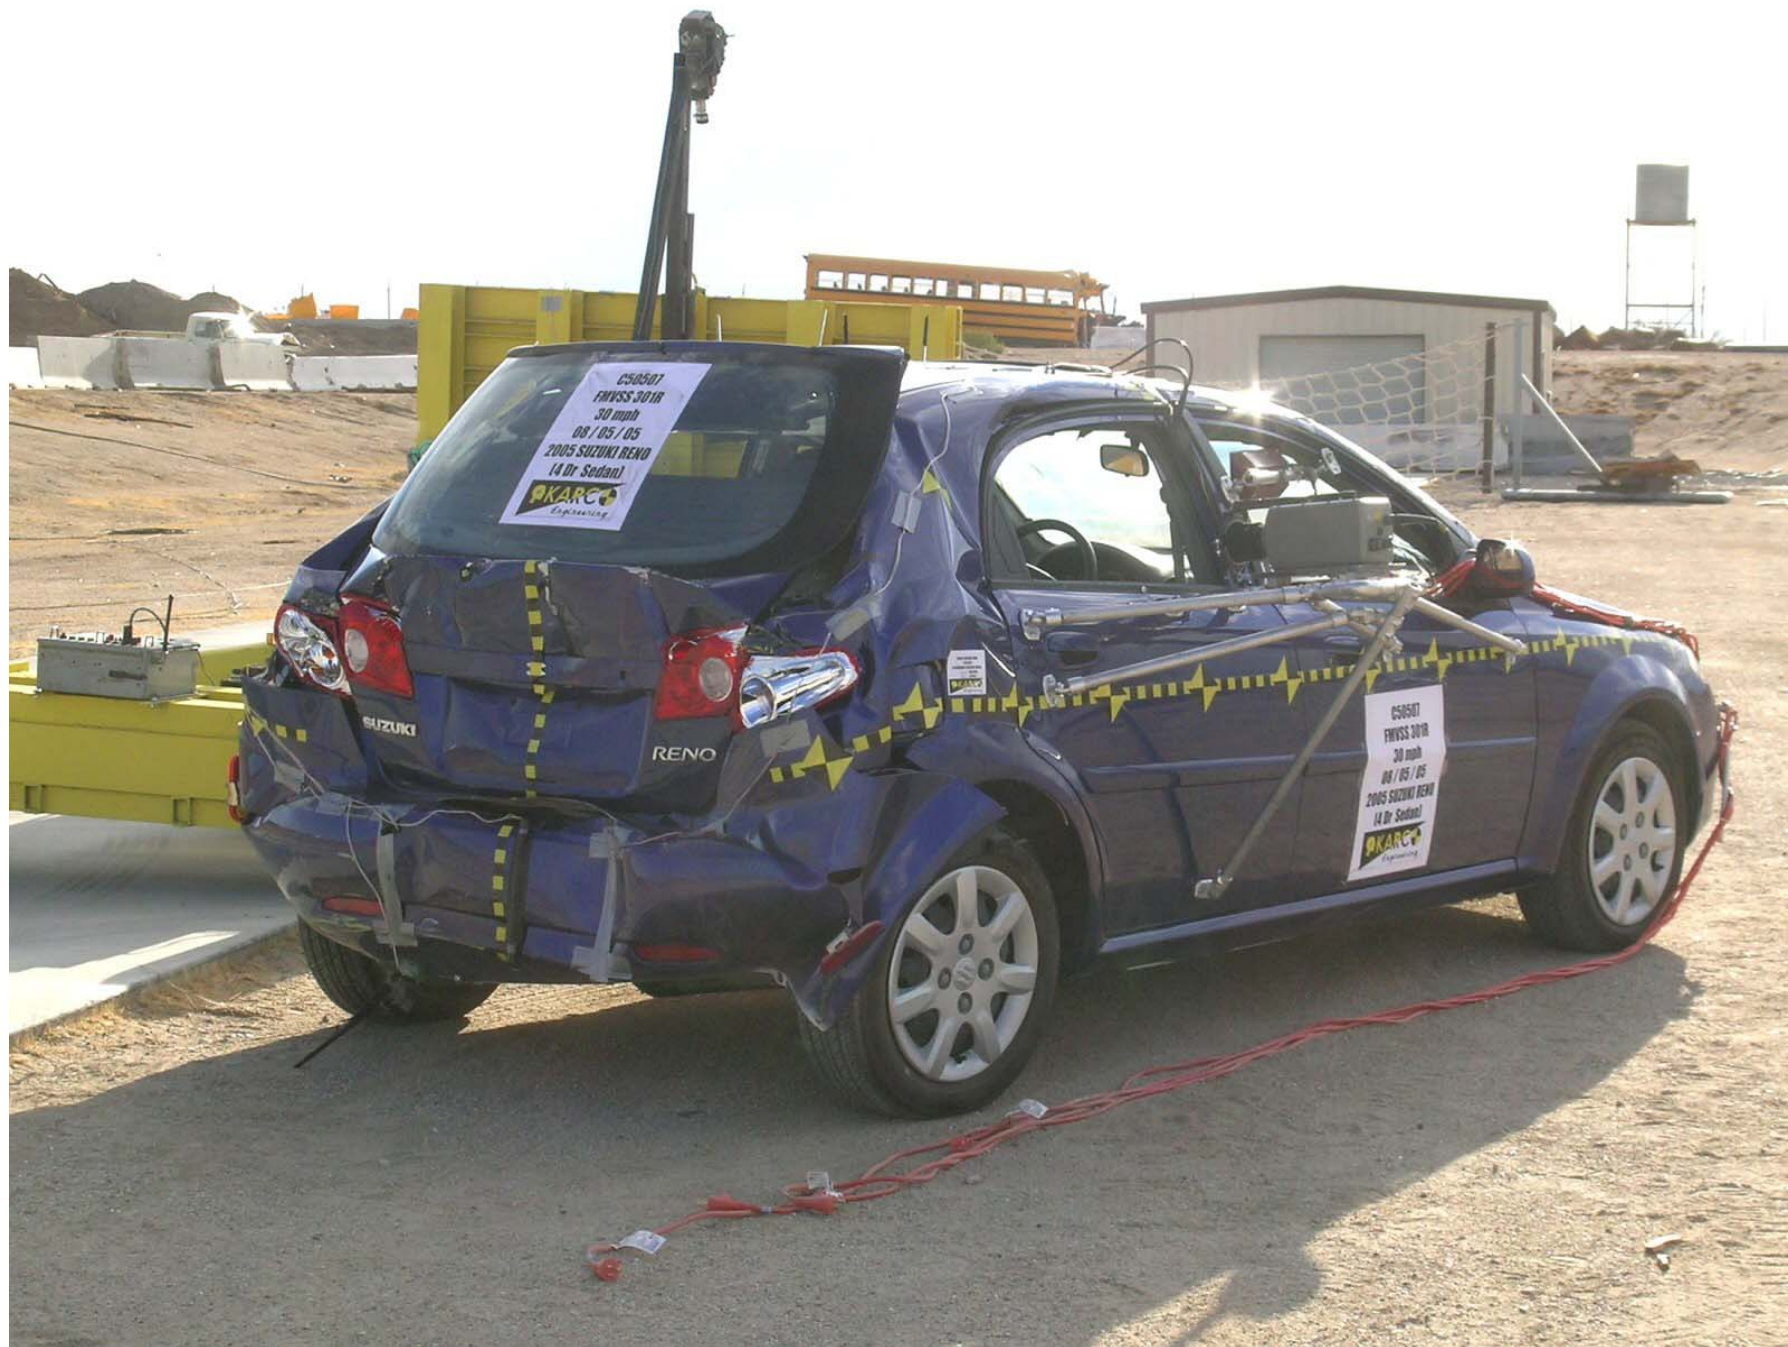
There was no fuel system fluid spillage following the impact event or during any portion of the static rollover test. The maximum longitudinal crush was 363 millimeters. The vehicle appeared to comply with all the requirements of FMVSS No. 301 "Fuel System Integrity."

Figure A-14: Post-Test Right Rear  $\frac{3}{4}$  View

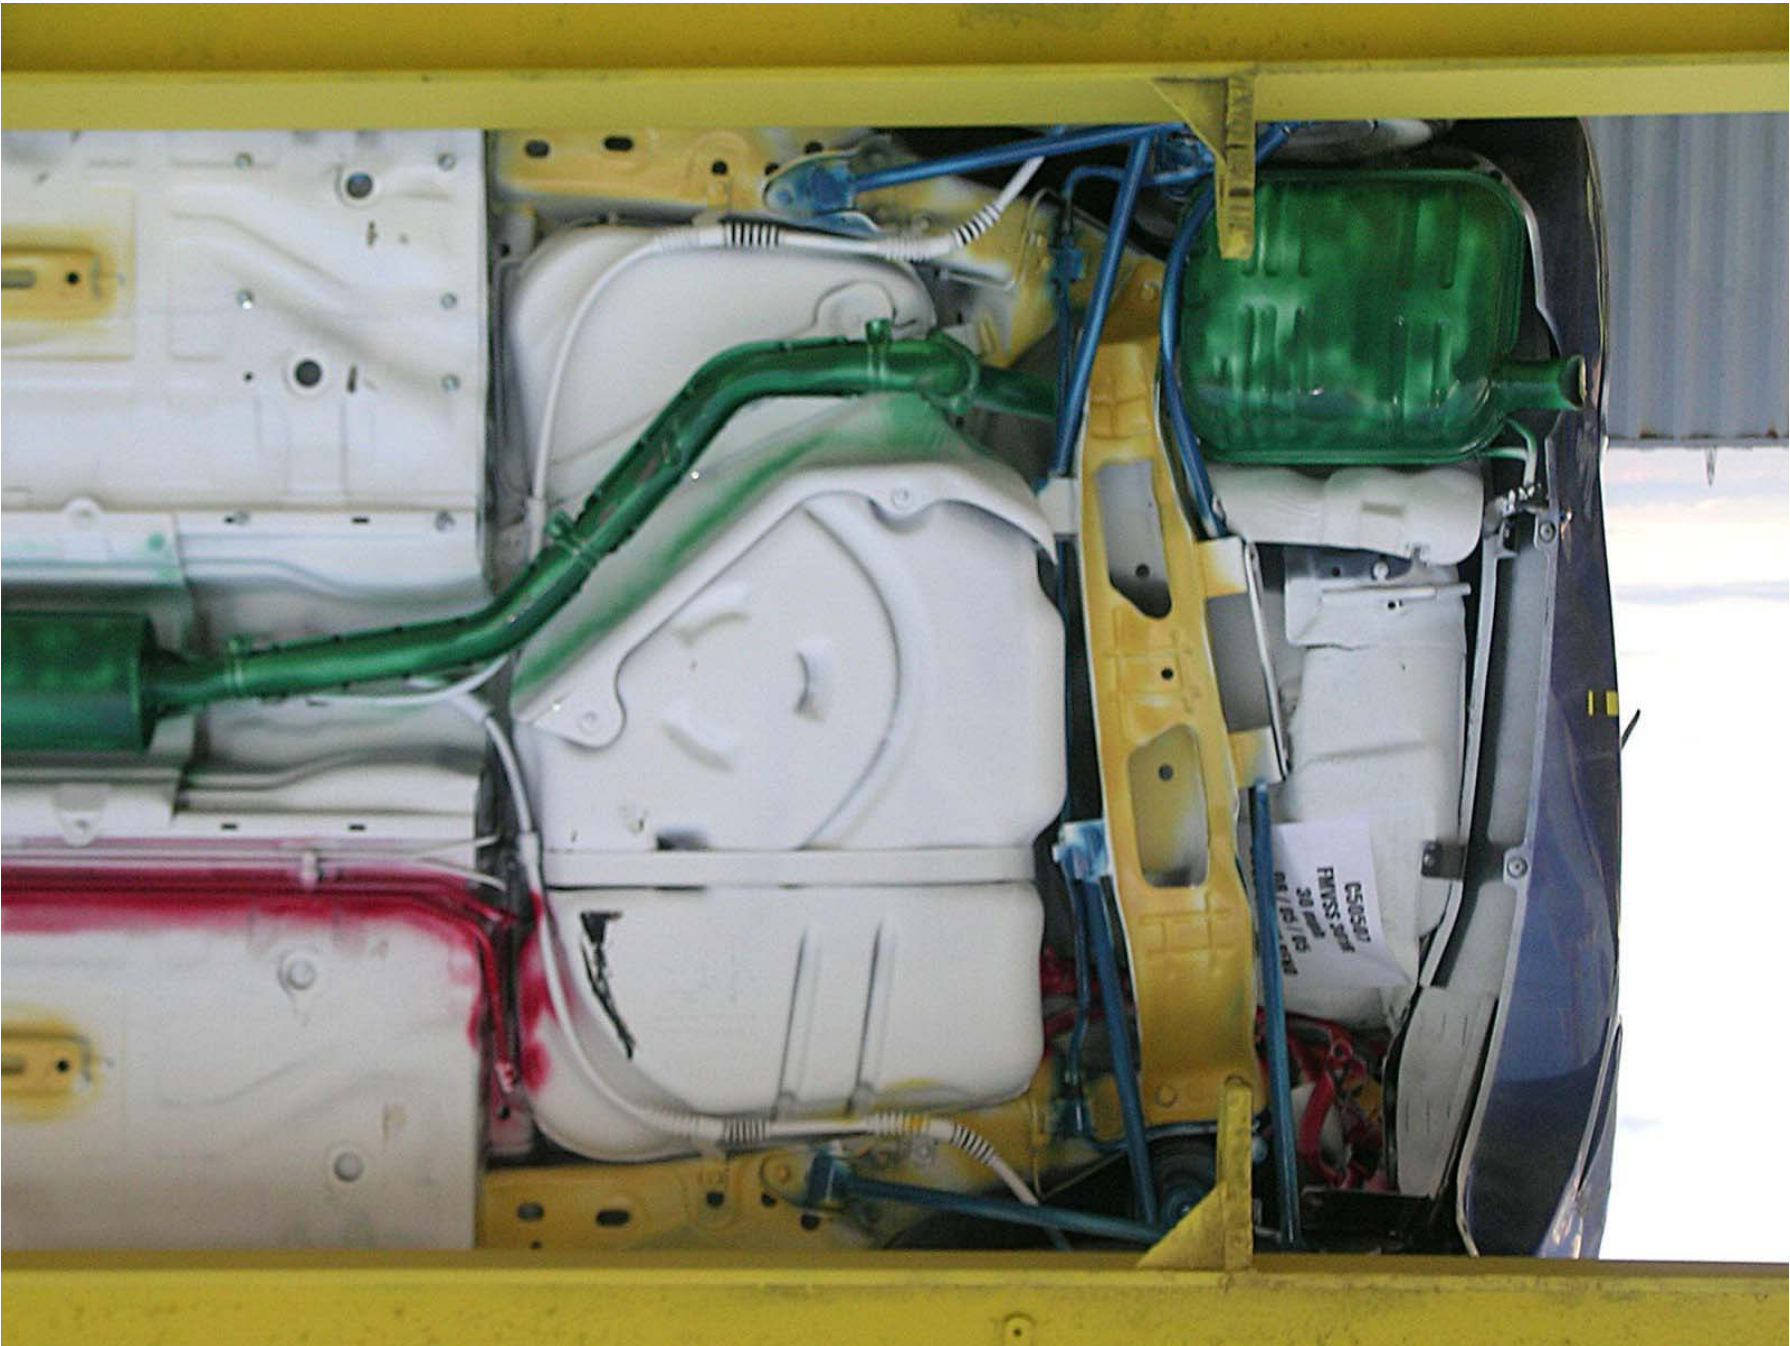
D. Spillage Location Details: No leakage occurred

Figure A-20: Post-Test Rear Underbody
