REPORT NUMBER TR-P28003-10-NC

**NEW CAR ASSESSMENT PROGRAM
SIDE IMPACT TEST**

**FORD MOTOR CO.
2009 FORD FLEX SE
5-DOOR MPV**

NHTSA NUMBER: M90201

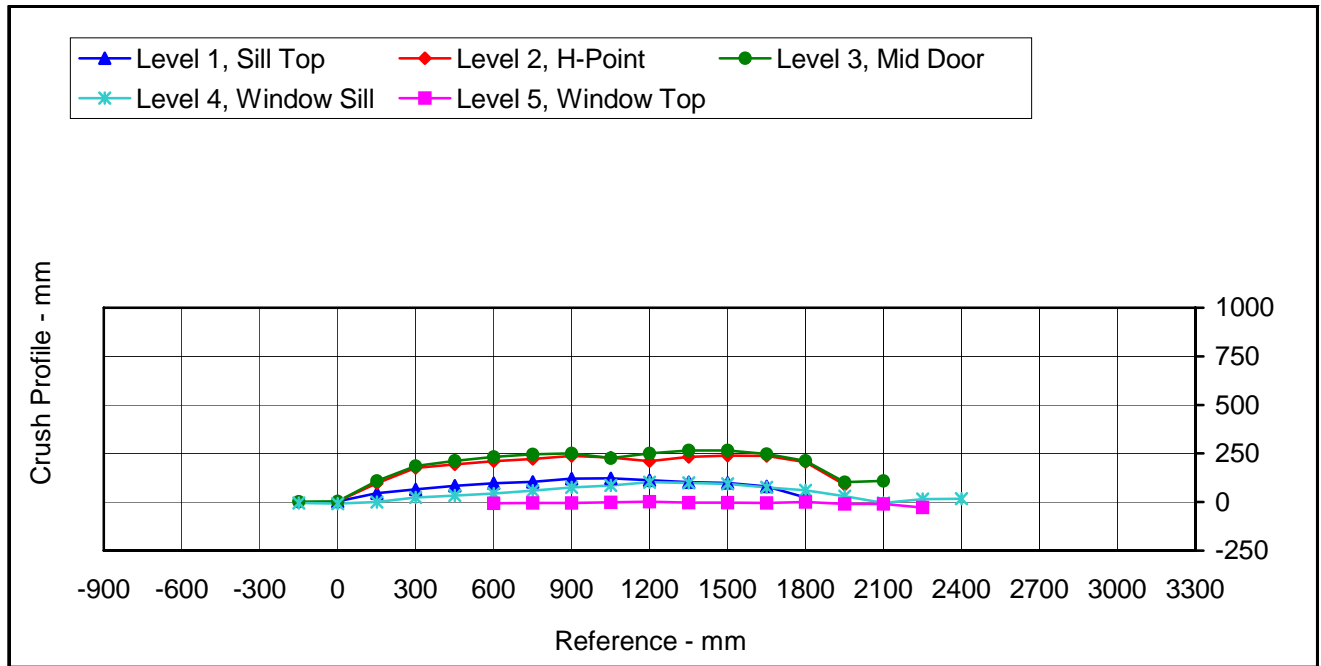
| | Units | Level 1 | Level 2 | Level 3 | Level 4 | Level 5 |
| Maximum Crush | mm | 122 | 239 | 265 | 102 | 2 |

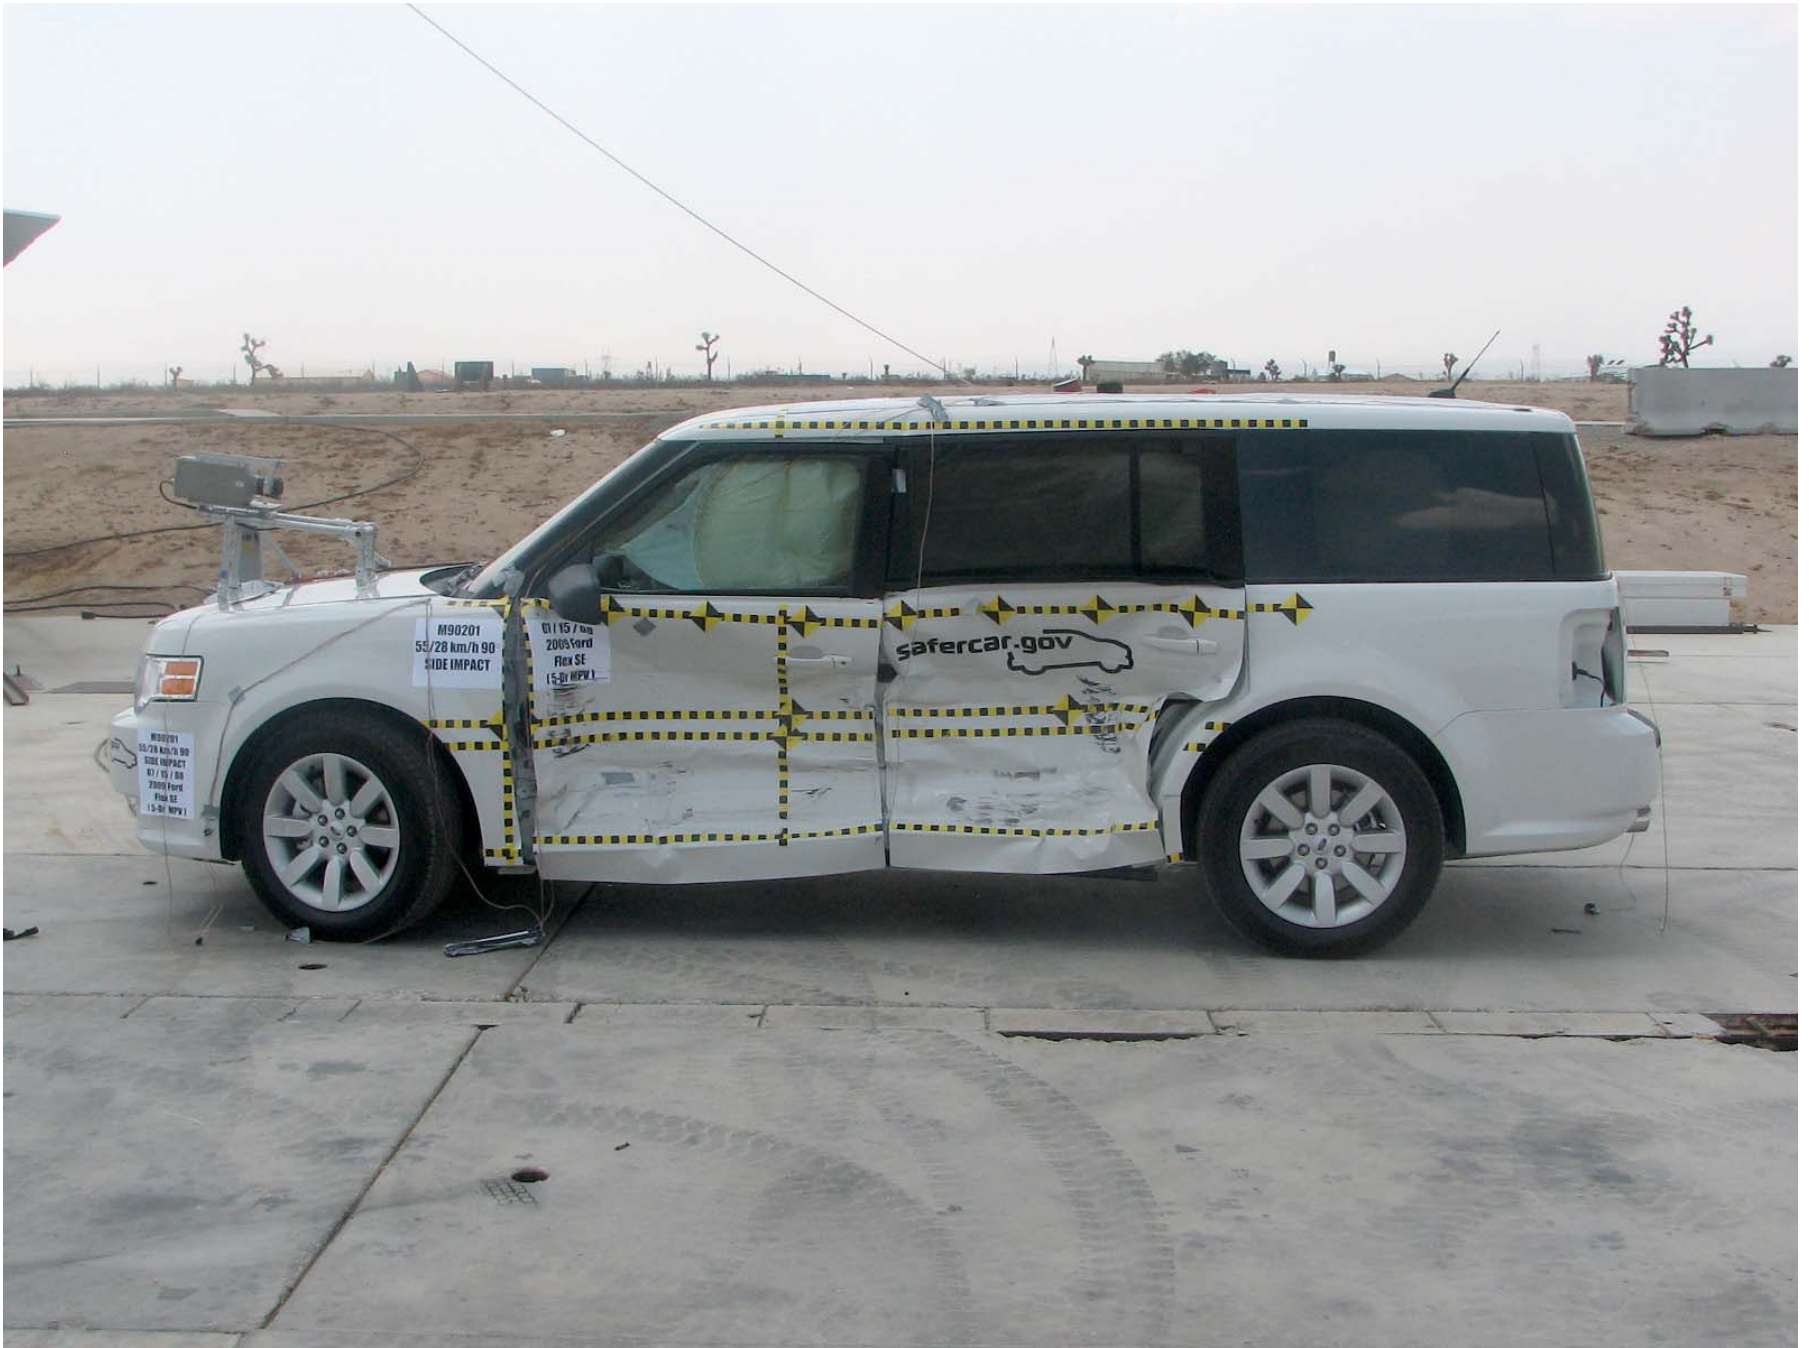
Figure A-10: Post-Test Left Side View

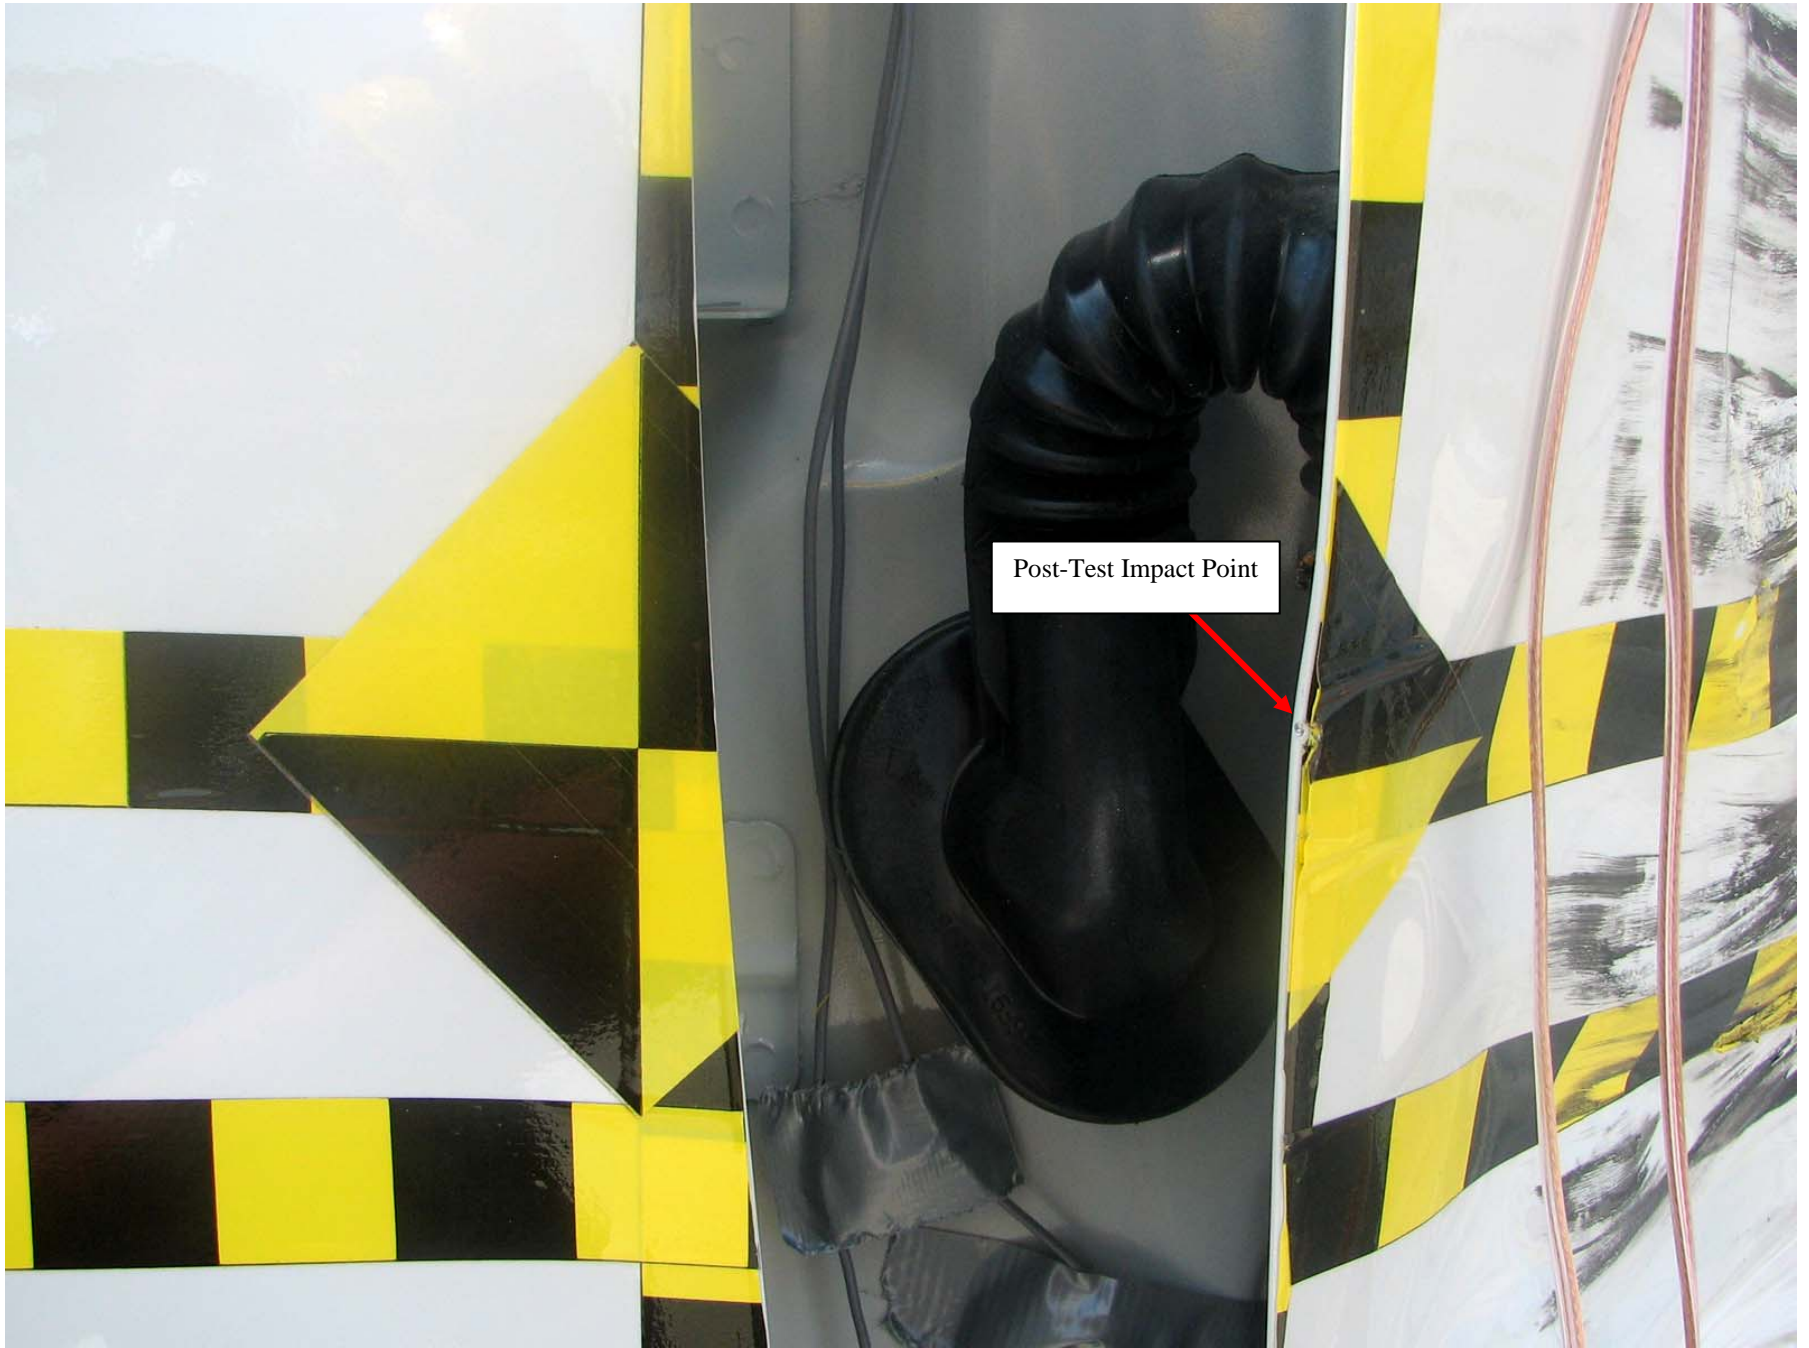
Figure A-26: Post-Test Left Impact Point

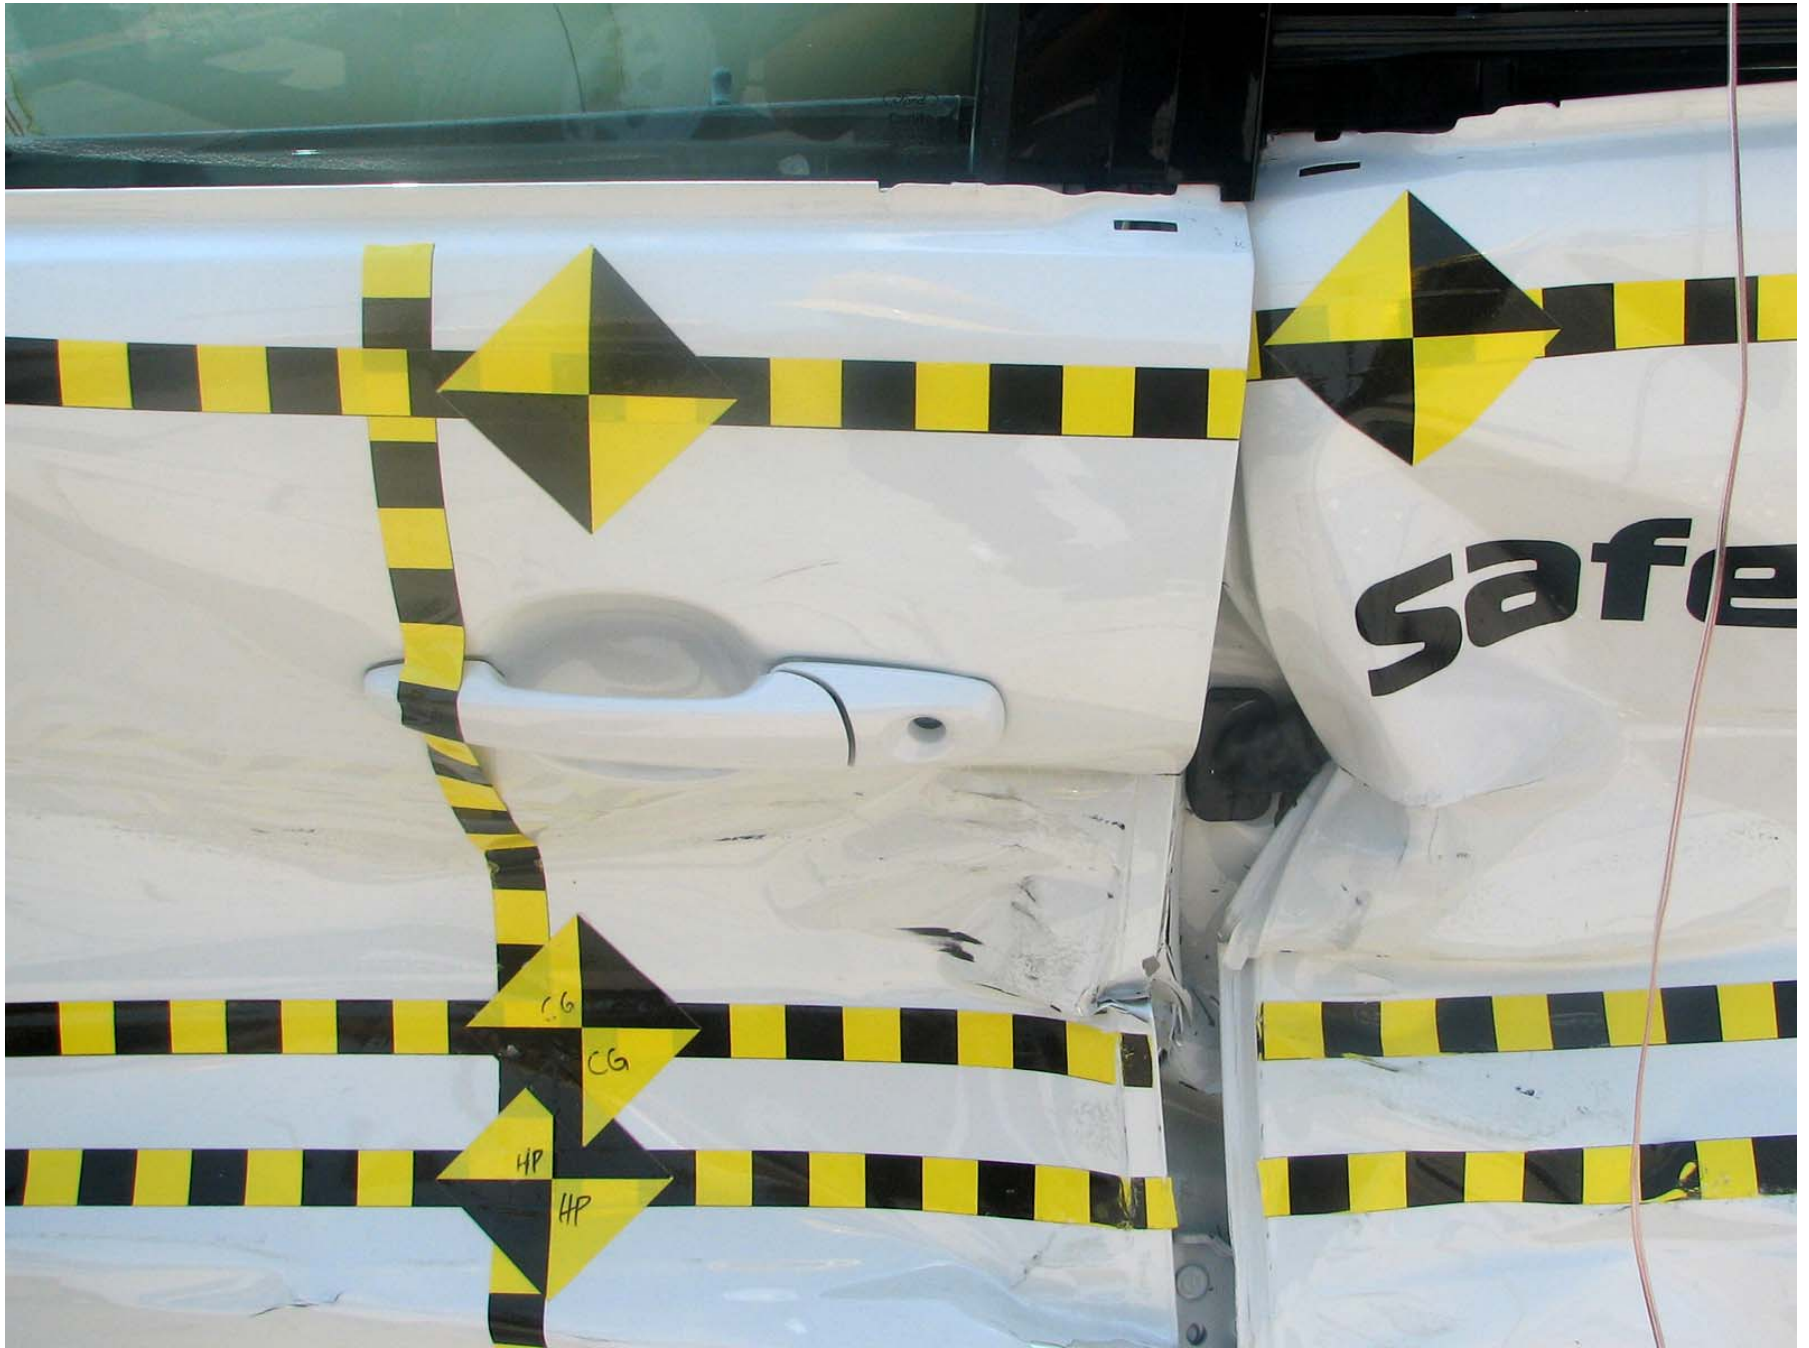
Figure A-32: Post-Test Left Front Door

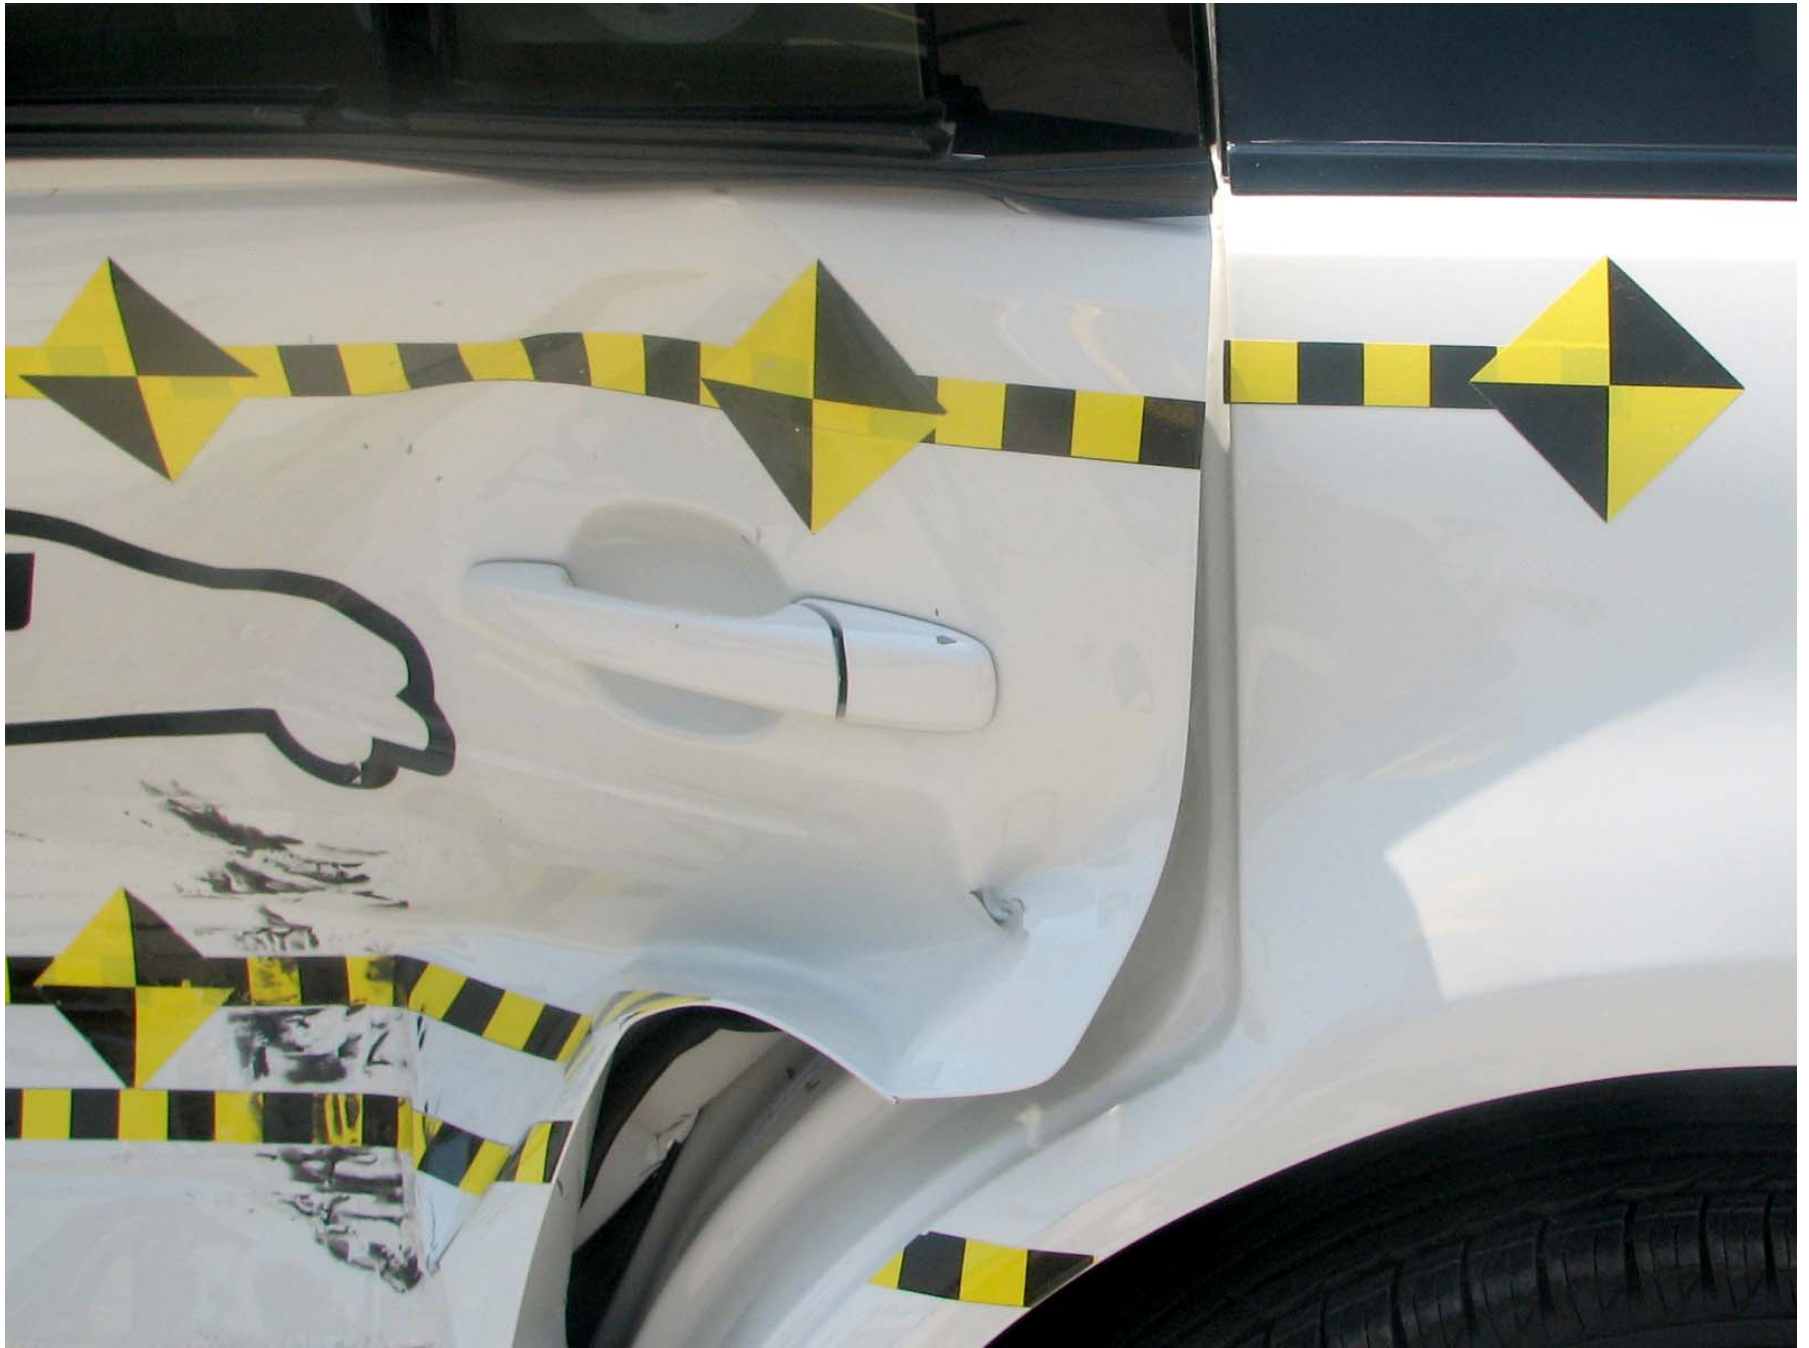
Figure A-34: Post-Test Left Rear Door
