REPORT NUMBER: NCAP305I-CAL-12-024

NEW CAR ASSESSMENT PROGRAM (NCAP)
FMVSS No. 305 Indicant Test

Honda Motor Co., LTD
2012 Honda CR-Z 3DR Base
Two-Door Coupe

NHTSA No: MC5319

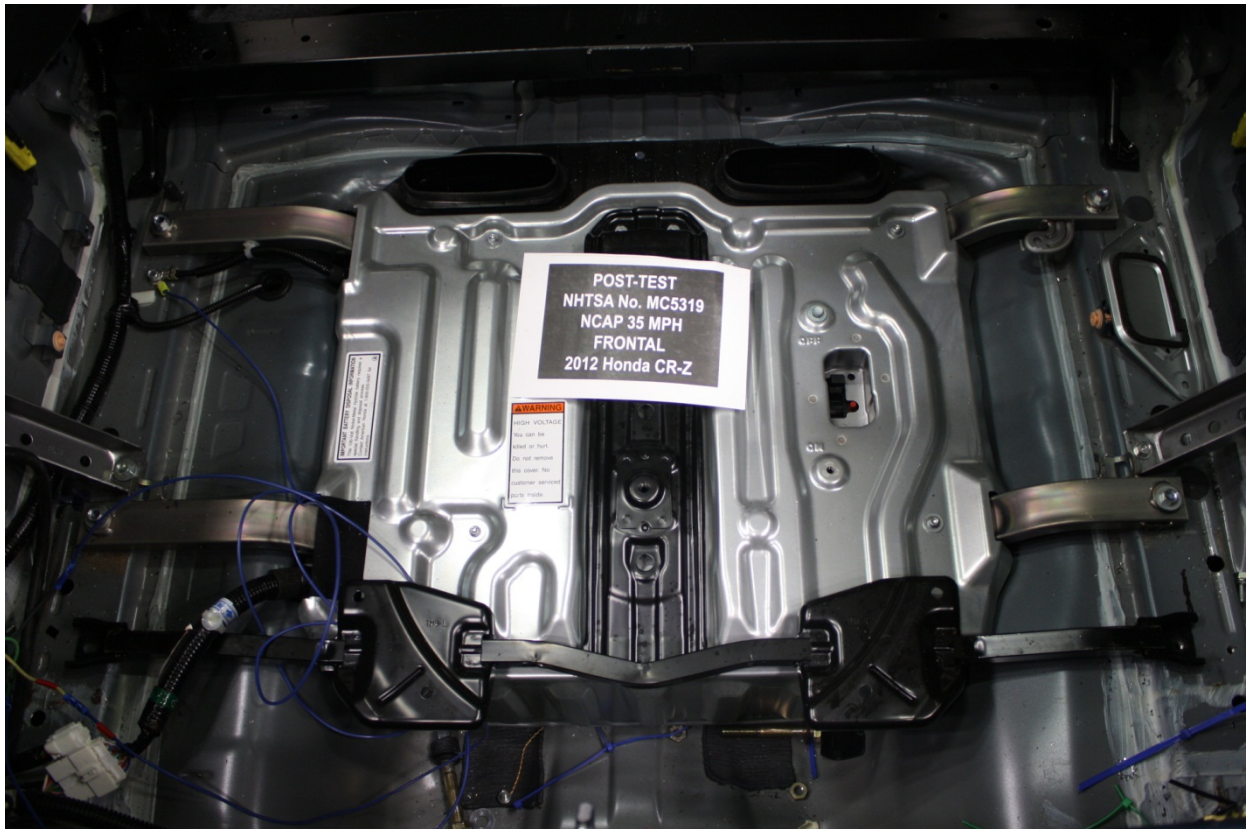
Figure A-15: Post-Impact View of Propulsion Battery Module(s)

none

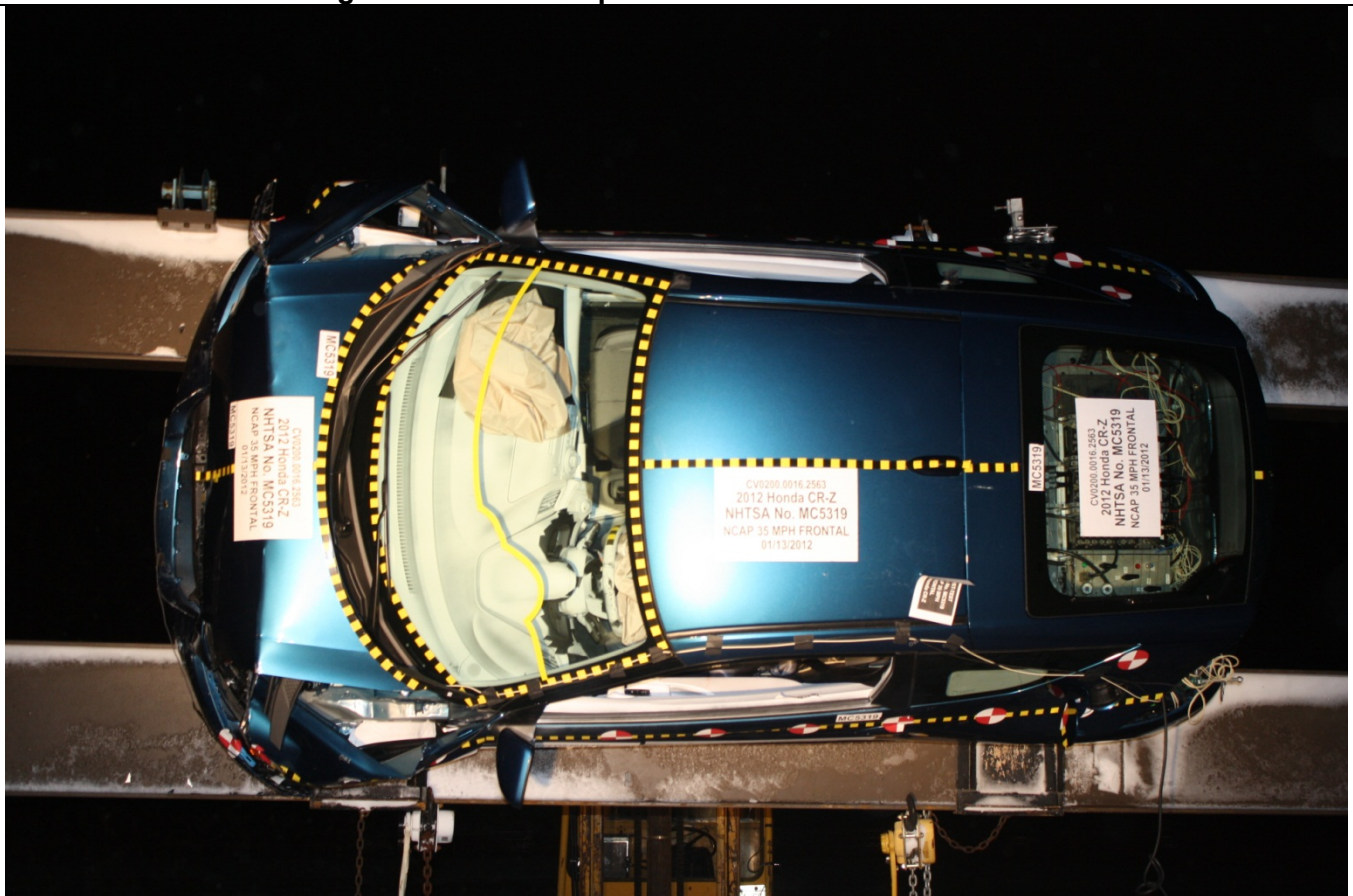
Figure A-28: FMVSS No. 305 Static Rollover at 90°

Rollover Stage	Propulsion Battery Electrolyte Spillage (L)	Spillage Location
0-90°	0	
90-180°	0	
180-270°	0	
270-360°	0

$$Ri/Vb = \underline{266134} \ \Omega/V \ @ \ 90^\circ$$

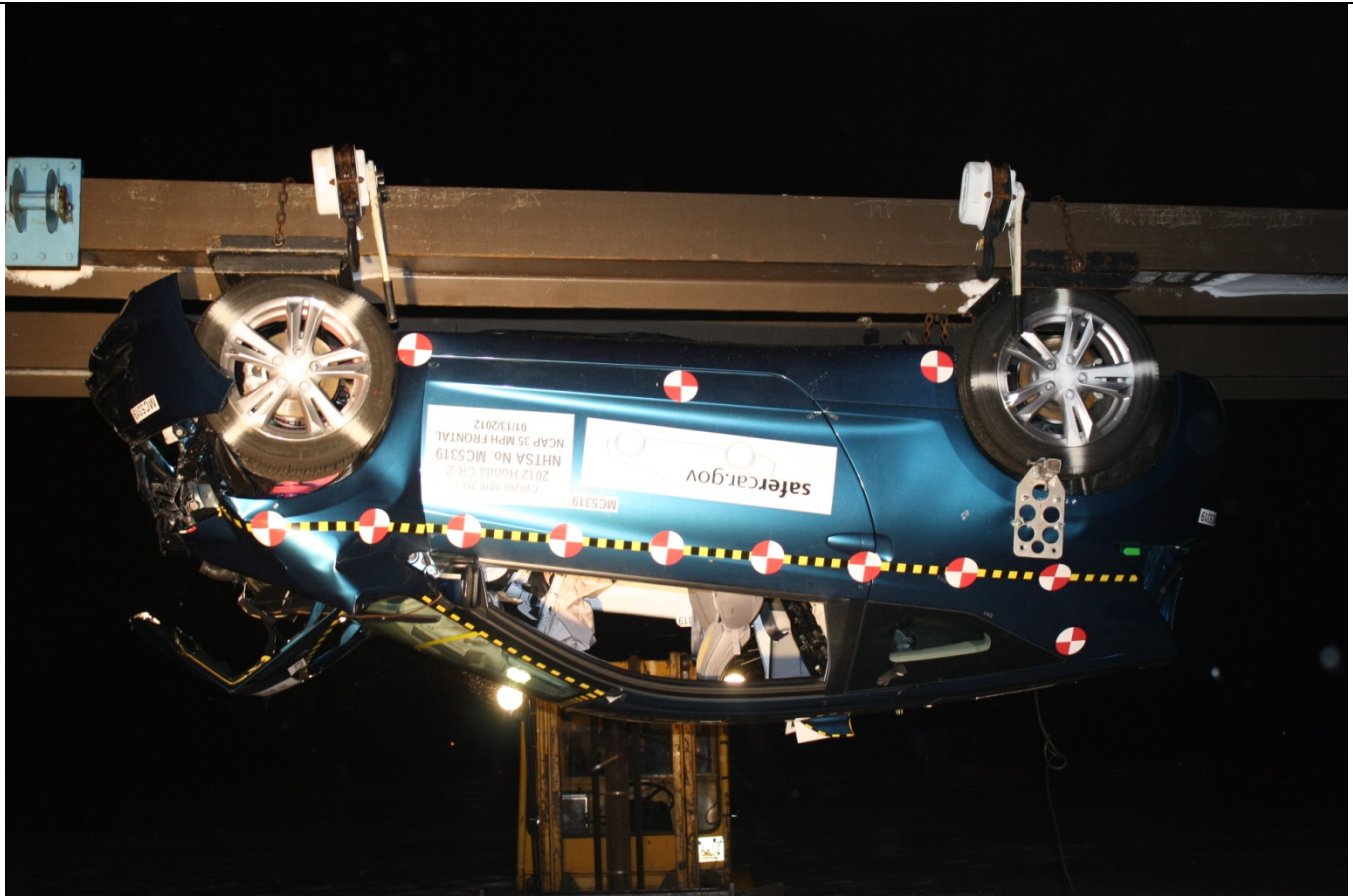
Figure A-29: FMVSS No. 305 Static Rollover at 180°

$$Ri/Vb = \underline{310490} \ \Omega/V \ @ \ 180^\circ$$

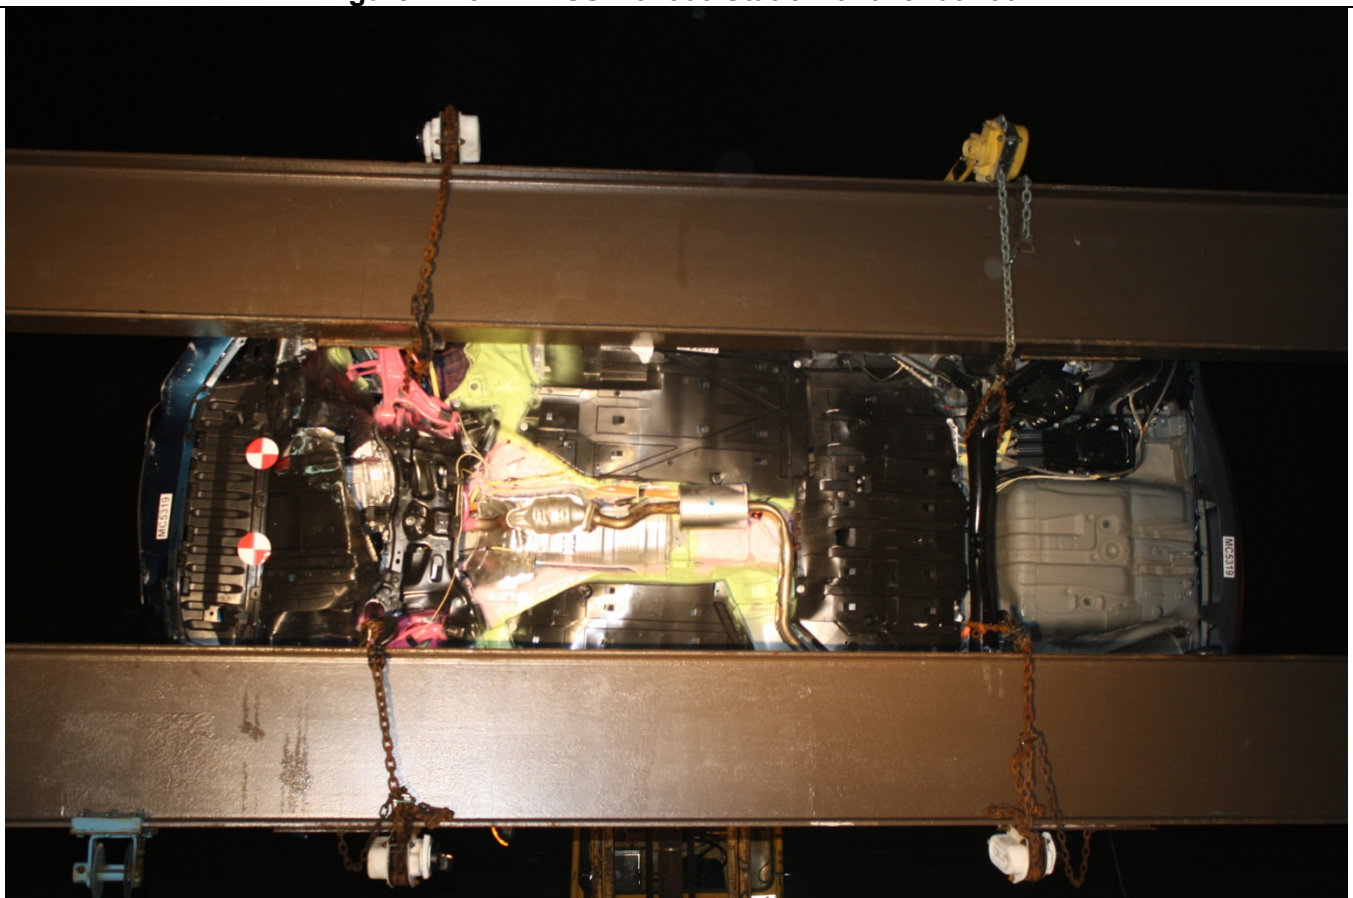
Figure A-30: FMVSS No. 305 Static Rollover at 270°

$$Ri/Vb = \underline{265689} \ \Omega/V \ @ \ 270^\circ$$

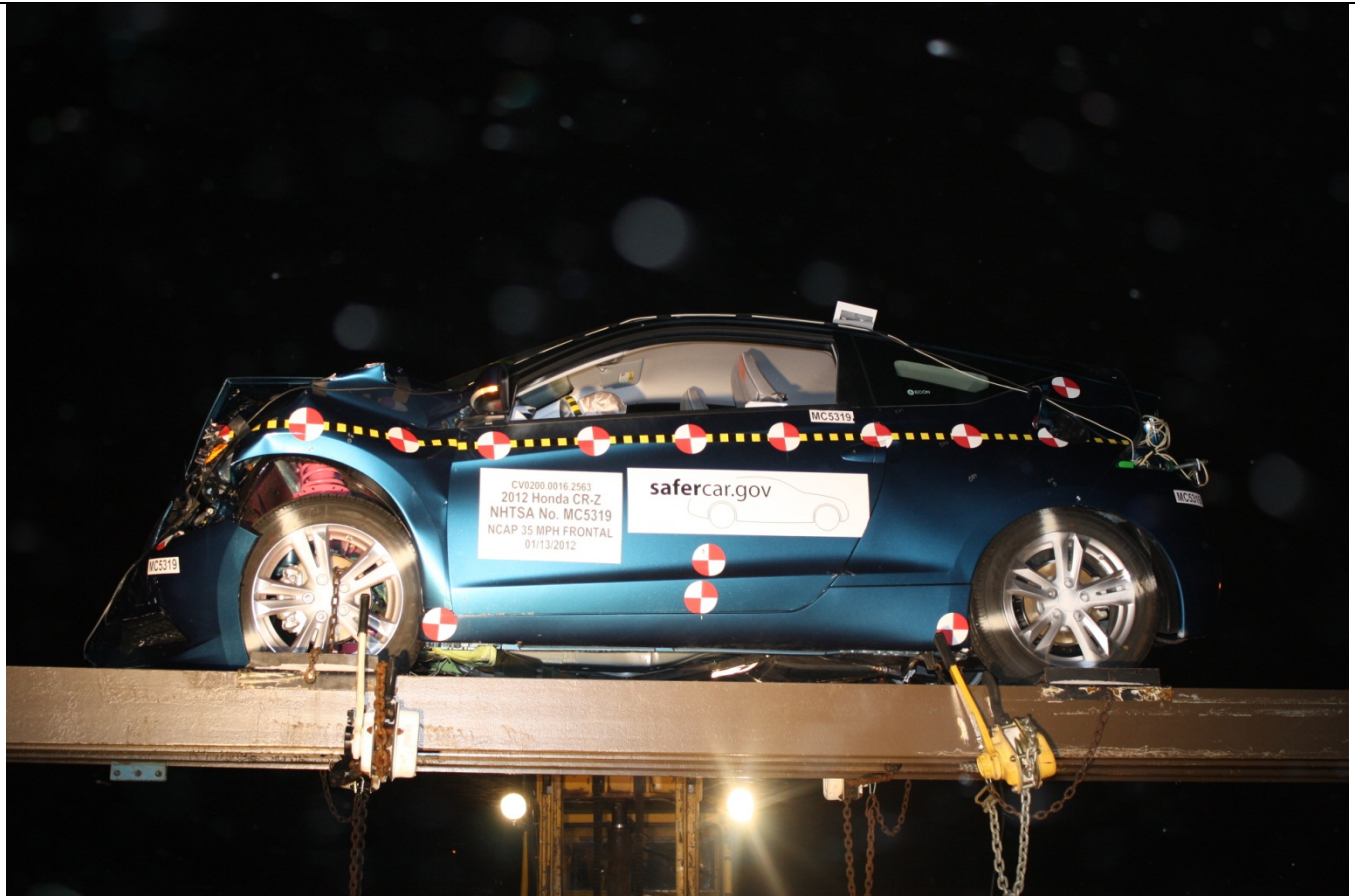
Figure A-31: FMVSS No. 305 Static Rollover at 360°

$$Ri/Vb = \underline{221408} \ \Omega/V \ @ \ 360^\circ$$
