REPORT NUMBER: NCAP305I-MGA-2012-009

**NEW CAR ASSESSMENT PROGRAM (NCAP)
FMVSS No. 305 Indicant Test**

**GENERAL MOTORS LLC
2013 Chevrolet Malibu ECO 4-Dr Hybrid Sedan
NHTSA No.: MD0100**

**MGA RESEARCH CORPORATION
5000 Warren Road
Burlington, WI 53105**

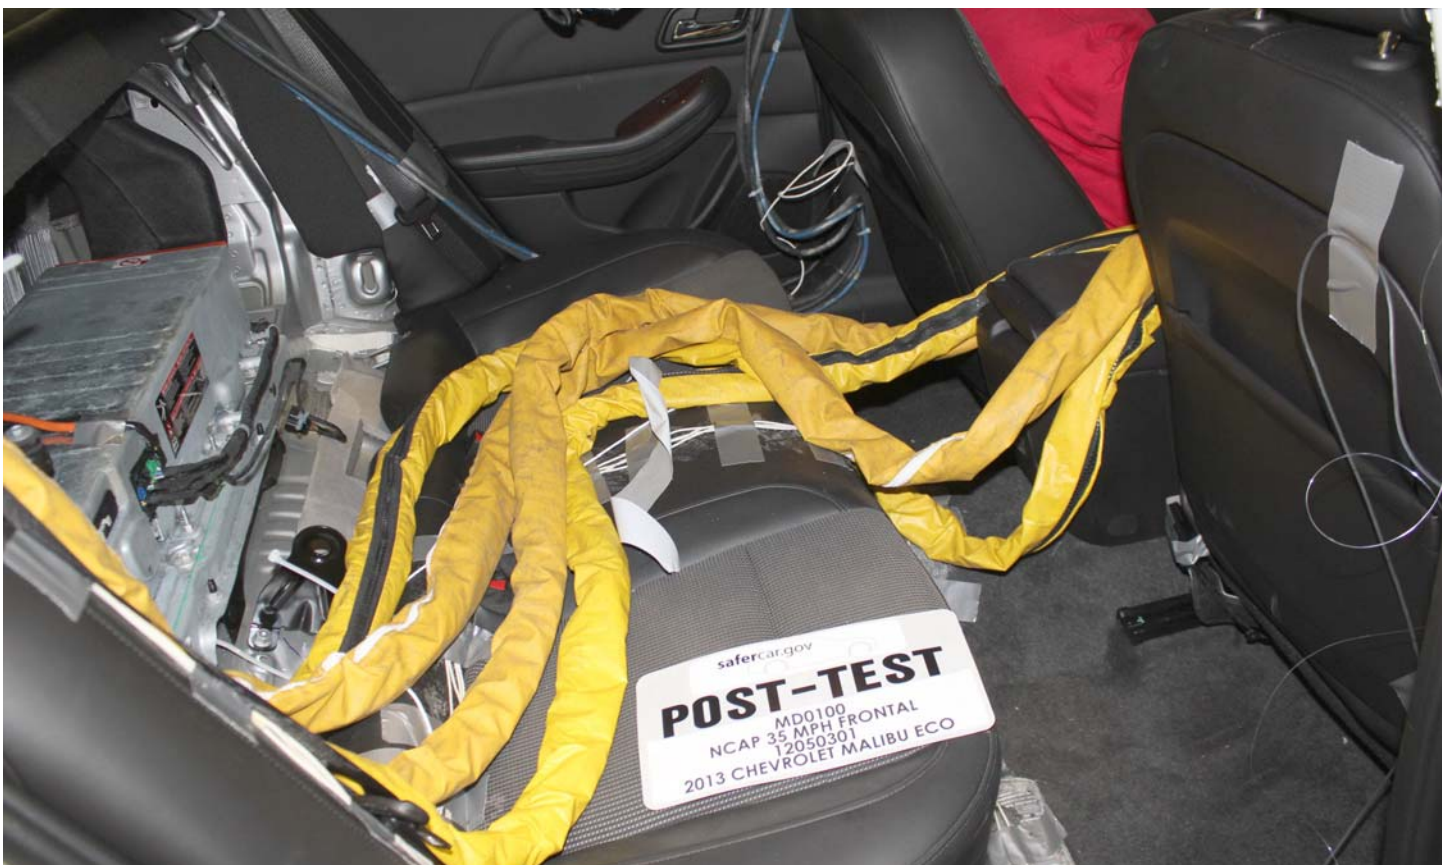
No. 033 Post-Impact View of the Vehicle Passenger Compartment Adjacent to Propulsion Battery

Describe intrusion of an outside Electric Energy Storage/Conversion Device into the passenger compartment [Supply photographs as appropriate]:
No Intrusion
