REPORT NUMBER: NCAP305I-KAR-13-009

**NEW CAR ASSESSMENT PROGRAM (NCAP)
FMVSS NO. 305 INDICANT TEST**

**CODA AUTOMOTIVE
2012 CODA 4-DOOR SEDAN**

NHTSA NUMBER: MC0533

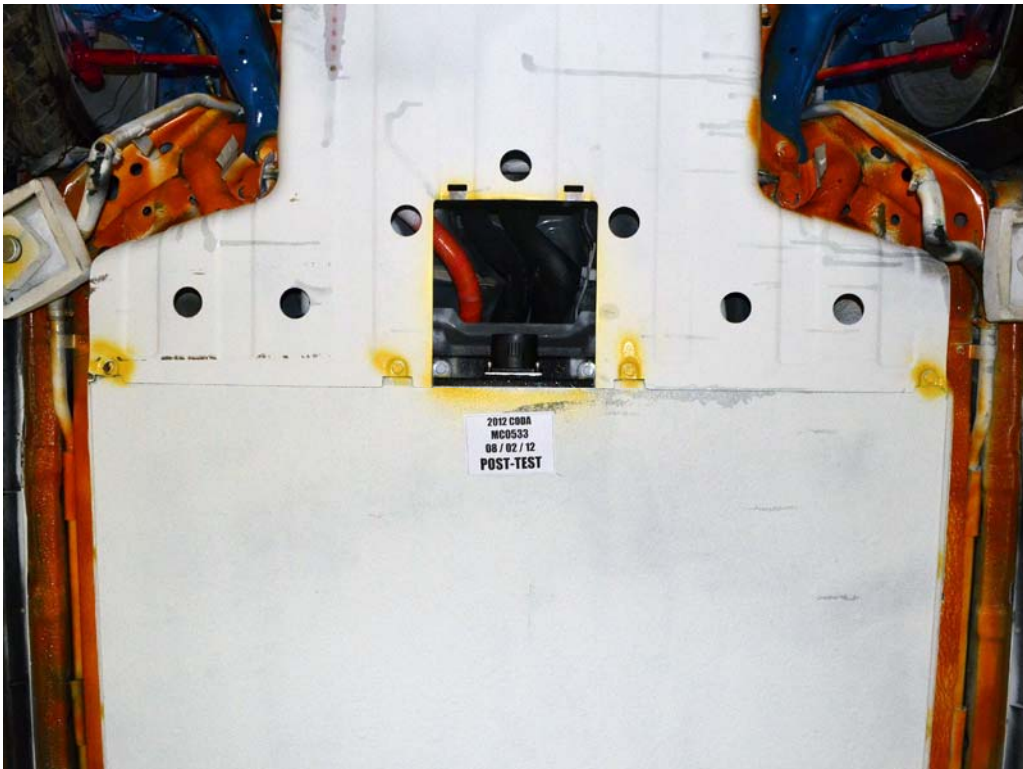
FIGURE 10. Post-Impact Front View of Propulsion Battery

Describe any intrusion: There was no battery component intrusion

Describe any spillage: There was no electrolyte spillage

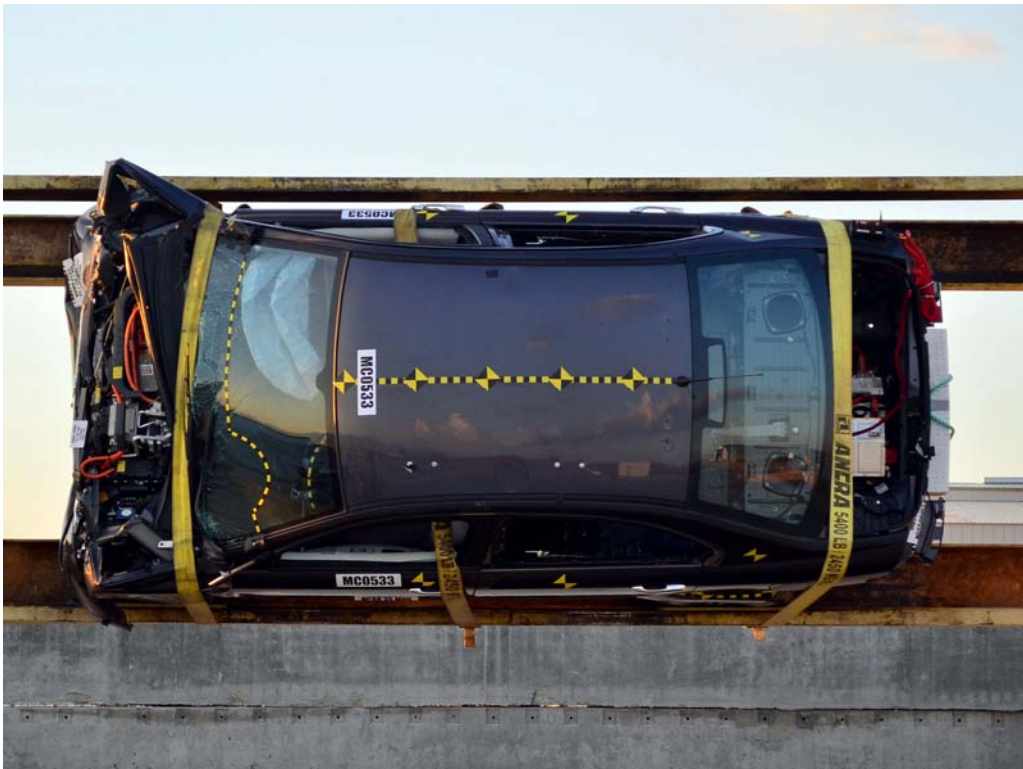
FIGURE 29. FMVSS No. 305 Static Rollover at 90 Degrees

1. The specified fixture rollover rate for each 90° of rotation is 60 to 180 seconds.
2. The position hold time at each position is 300 seconds (minimum).
3. Details of Electrolyte Spillage: There was no electrolyte spillage.
