**REPORT NUMBER: NCAP305I-KAR-13-040**

**NEW CAR ASSESSMENT PROGRAM (NCAP)  
FMVSS NO. 305 INDICANT TEST**

**TOYOTA MOTOR CORPORATION  
2013 TOYOTA PRIUS V 5-DOOR HATCHBACK**

**FINAL REPORT**

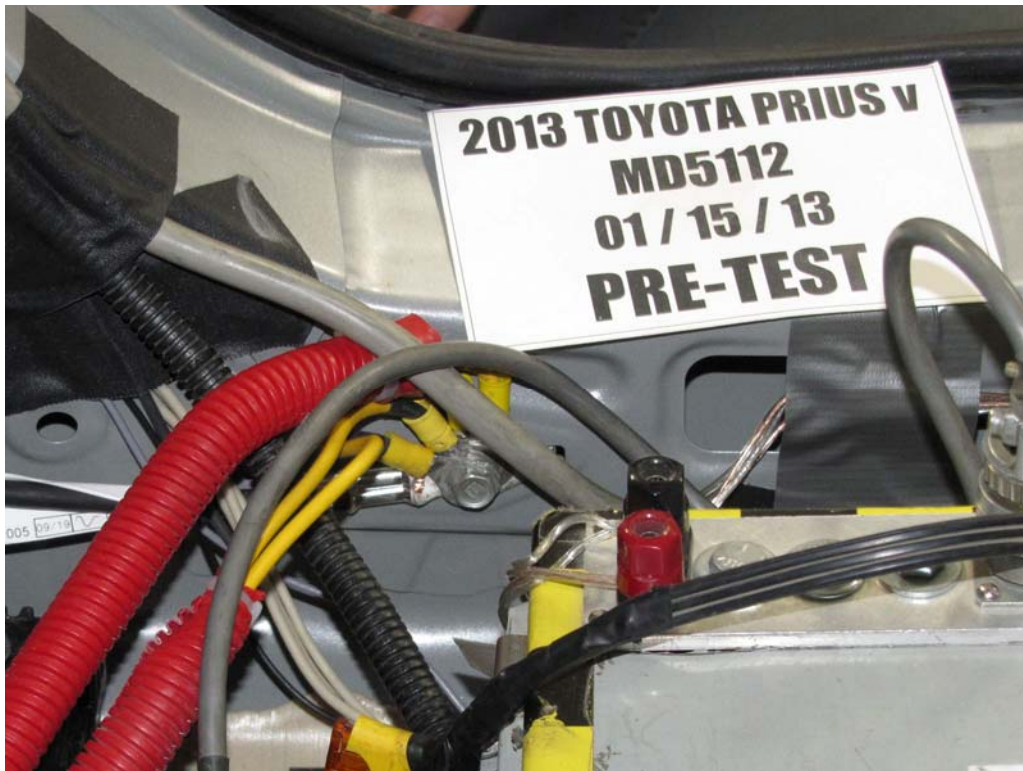
FIGURE 21. Pre-Impact View of Ground Lead Attached

The chassis ground used for the electrical isolation measurements was located on the right side of the rear panel in the cargo area. The chassis ground used for electrical isolation measurements was the same chassis ground used by the auxiliary 12 V battery. A photograph of the location is included in Figure 21 of Appendix A.

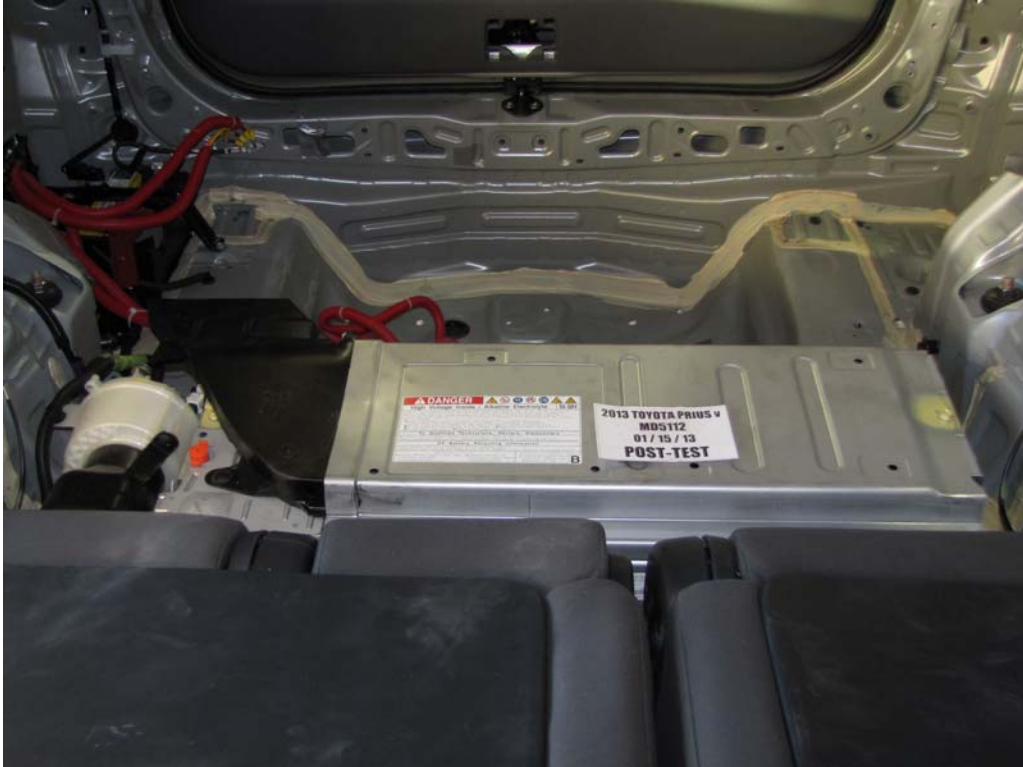
FIGURE 34. Post-Impact View of Vehicle Passenger Compartment  
Adjacent to Propulsion Battery

**PROPULSION BATTERY SYSTEM COMPONENTS**Has the propulsion battery module moved within the passenger compartment: NoDescribe any movement: Not applicable; there was no movementHas an outside propulsion battery component intruded into the passenger compartment: NoDescribe any intrusion: Not applicable; there was no intrusion.Is there propulsion battery electrolyte spillage visible in the passenger compartment: No
