**REPORT NUMBER: NCAP305I-KAR-13-041**

**NEW CAR ASSESSMENT PROGRAM (NCAP)  
FMVSS NO. 305 INDICANT TEST**

**TOYOTA MOTOR CORPORATION  
2013 TOYOTA PRIUS V 5-DOOR HATCHBACK**

**NHTSA NUMBER: MD5114**

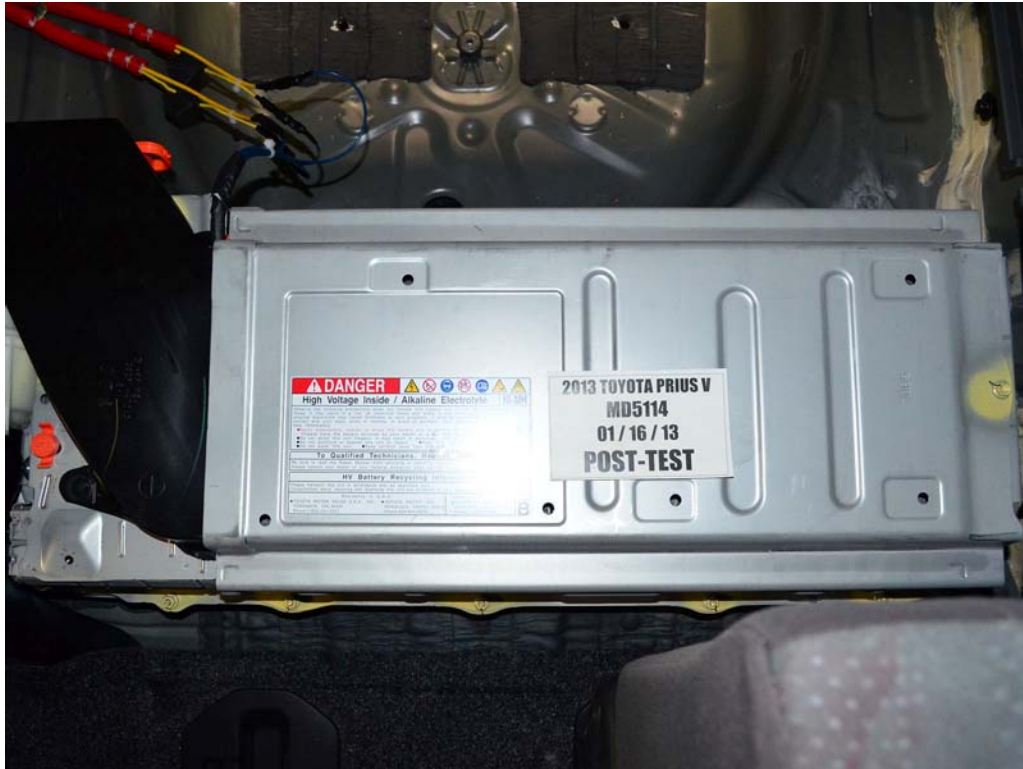
FIGURE 10. Post-Impact Front View of Propulsion Battery

**PROPULSION BATTERY SYSTEM COMPONENTS**Has the propulsion battery module moved within the passenger compartment: NoDescribe any movement: There was no movement of the propulsion batteries.Has an outside propulsion battery component intruded into the passenger compartment: NoDescribe any intrusion: There was no intrusion of the propulsion batteries into the occupant compartment.Is there propulsion battery electrolyte spillage visible in the passenger compartment: No

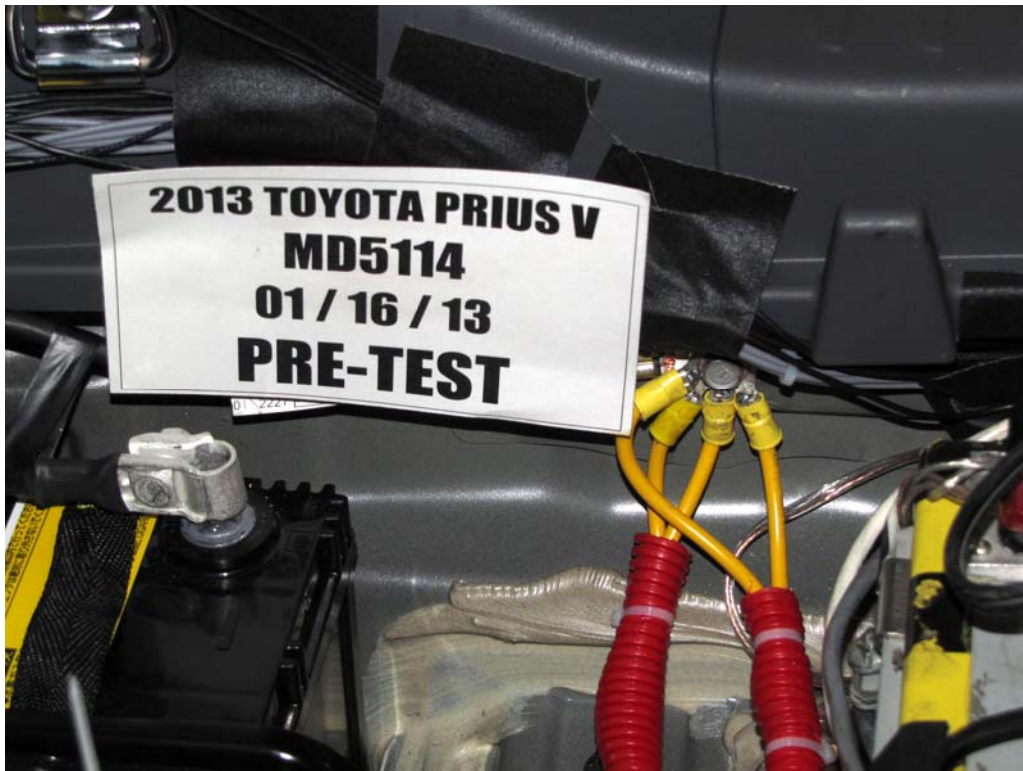
FIGURE 21. Pre-Impact View of Ground Lead Attached

The chassis ground used for the electrical isolation measurements was located on the right side of the rear panel in the cargo area. The chassis ground used for electrical isolation measurements was the same chassis ground used by the auxiliary 12 V battery. A photograph of the location is included in Figure 21 of Appendix A.
