**REPORT NUMBER: NCAP305I-KAR-13-044**

**NEW CAR ASSESSMENT PROGRAM (NCAP)  
FMVSS NO. 305 INDICANT TEST**

**TOYOTA MOTOR CORPORATION  
2013 TOYOTA PRIUS C 5-DOOR HATCHBACK**

**NHTSA NUMBER: MD5111**

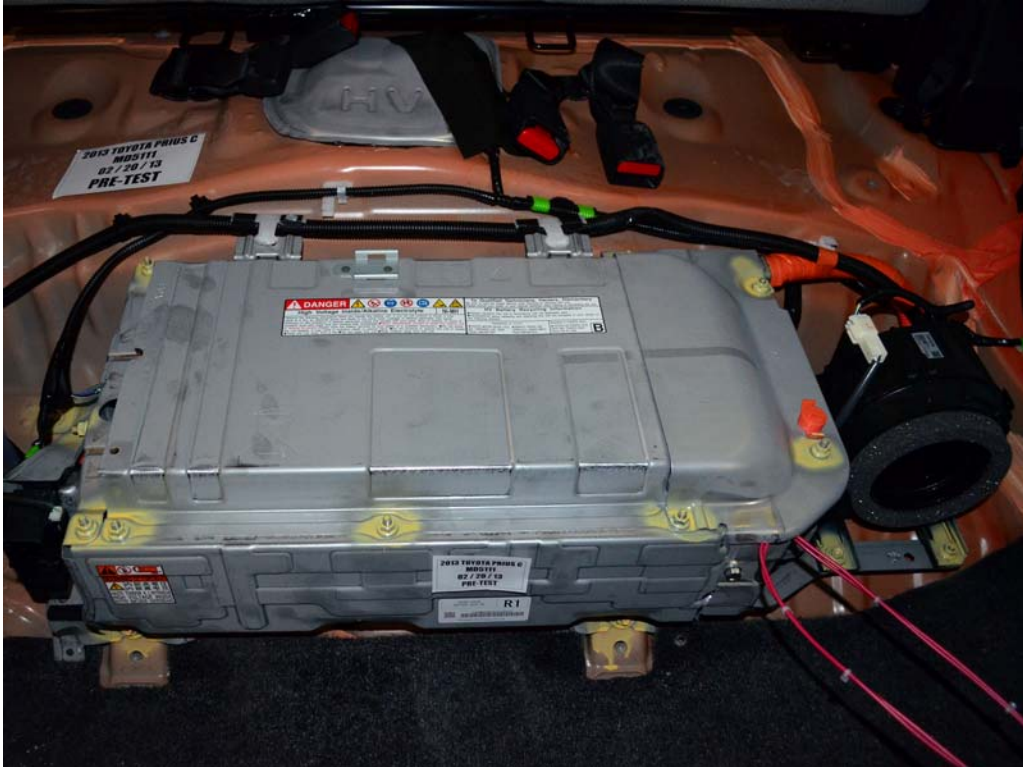
FIGURE 10. Post-Impact Front View of Propulsion Battery

Describe any movement: There was no movement of the propulsion battery.

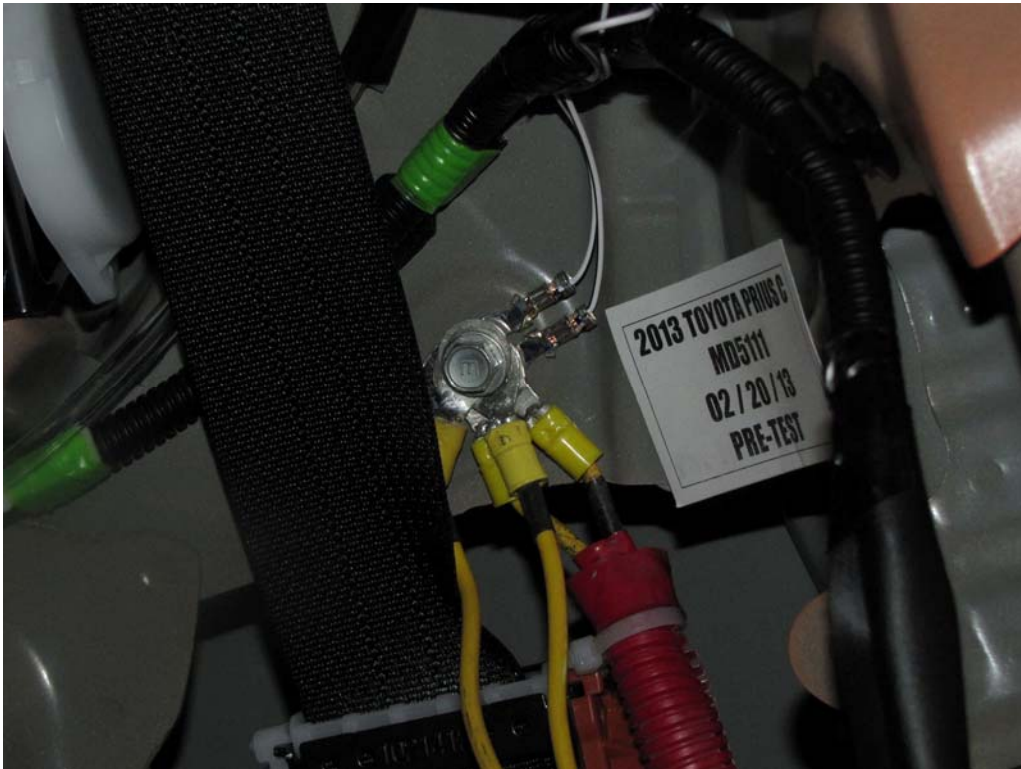
FIGURE 21. Pre-Impact View of Ground Lead Attached

The chassis ground used for the electrical isolation measurements was a pre-existing chassis ground point located on the right side C-pillar near the seat belt retractor. A photograph of the location is included in Figure 21 of Appendix A.

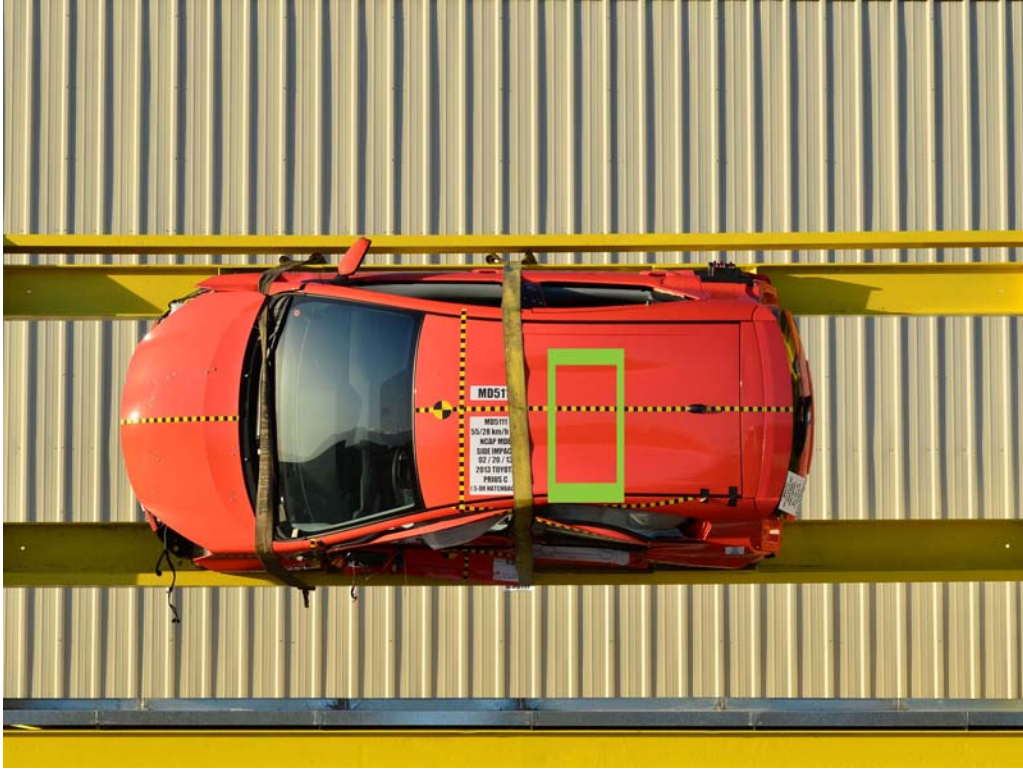
FIGURE 29. FMVSS No. 305 Static Rollover at 90°

| Test Phase | Propulsion Battery Electrolyte Spillage (L) | Spillage Location |
|---|---|---|
| 90° To 180° | 0.0 | None |

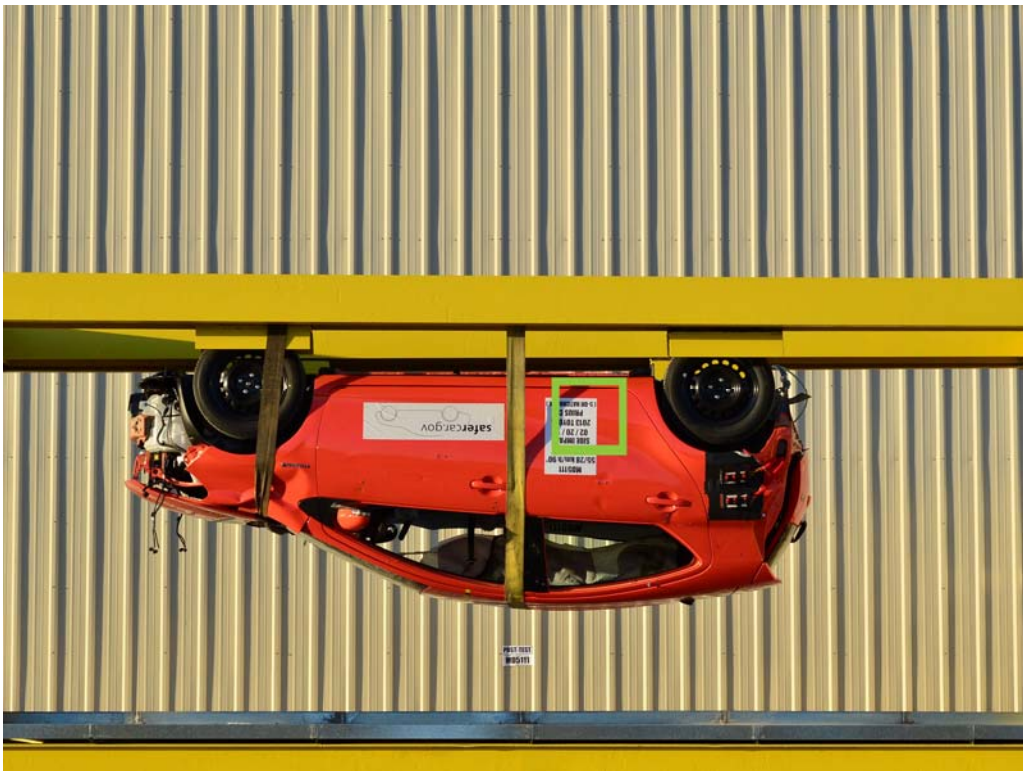
FIGURE 30. FMVSS No. 305 Static Rollover at 180°

| Test Phase | Propulsion Battery Electrolyte Spillage (L) | Spillage Location |
|---|---|---|
| 180° To 270° | 0.0 | None |

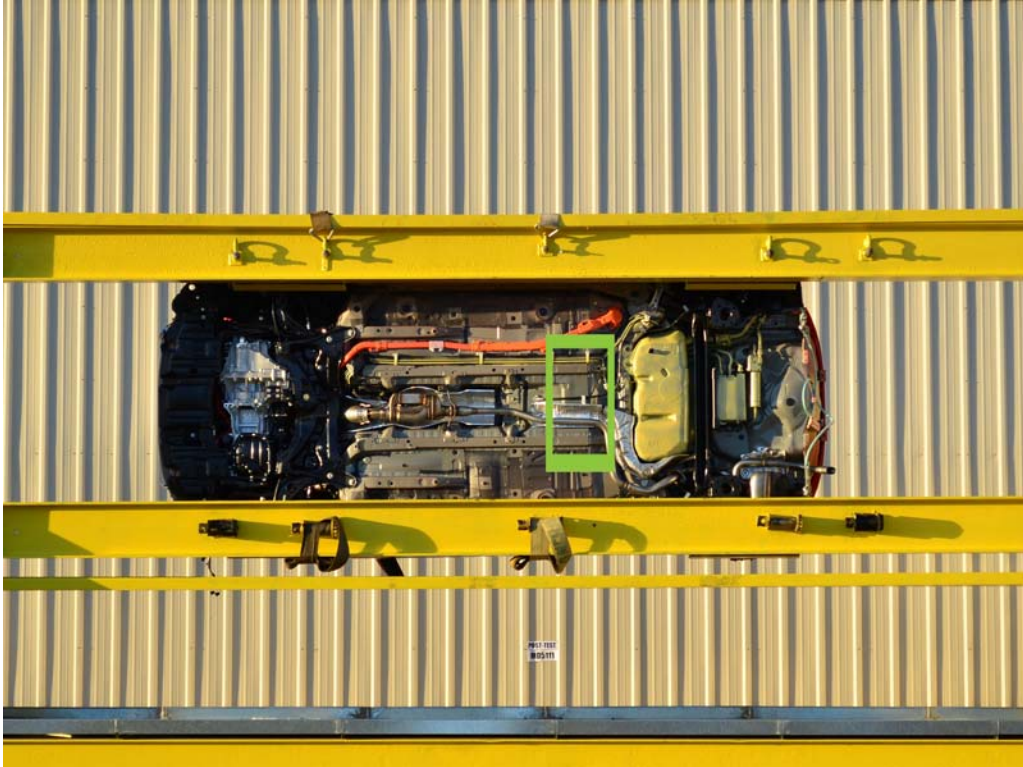
FIGURE 31. FMVSS No. 305 Static Rollover at 270°

| Test Phase | Propulsion Battery Electrolyte Spillage (L) | Spillage Location |
|---|---|---|
| 270° To 360° | 0.0 | None |

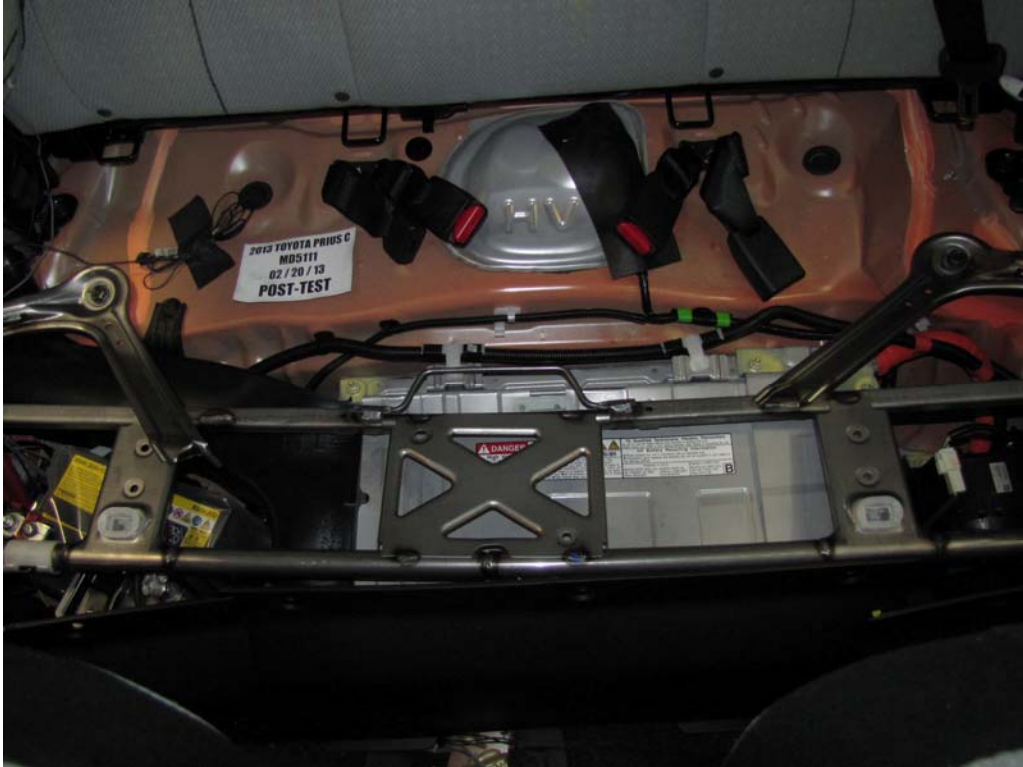
FIGURE 34. Post-Impact View of Vehicle Passenger Compartment of The Vehicle Adjacent to Propulsion Battery

Describe any intrusion: There was no intrusion of the propulsion battery into the occupant compartment.
