**REPORT NUMBER: NCAP305I-KAR-13-051**

**NEW CAR ASSESSMENT PROGRAM (NCAP)  
FMVSS NO. 305 INDICANT TEST**

**HONDA MFG. OF INDIANA, LLC  
2013 HONDA CIVIC HYBRID 4-DOOR SEDAN**

**NHTSA NUMBER: MD5310**

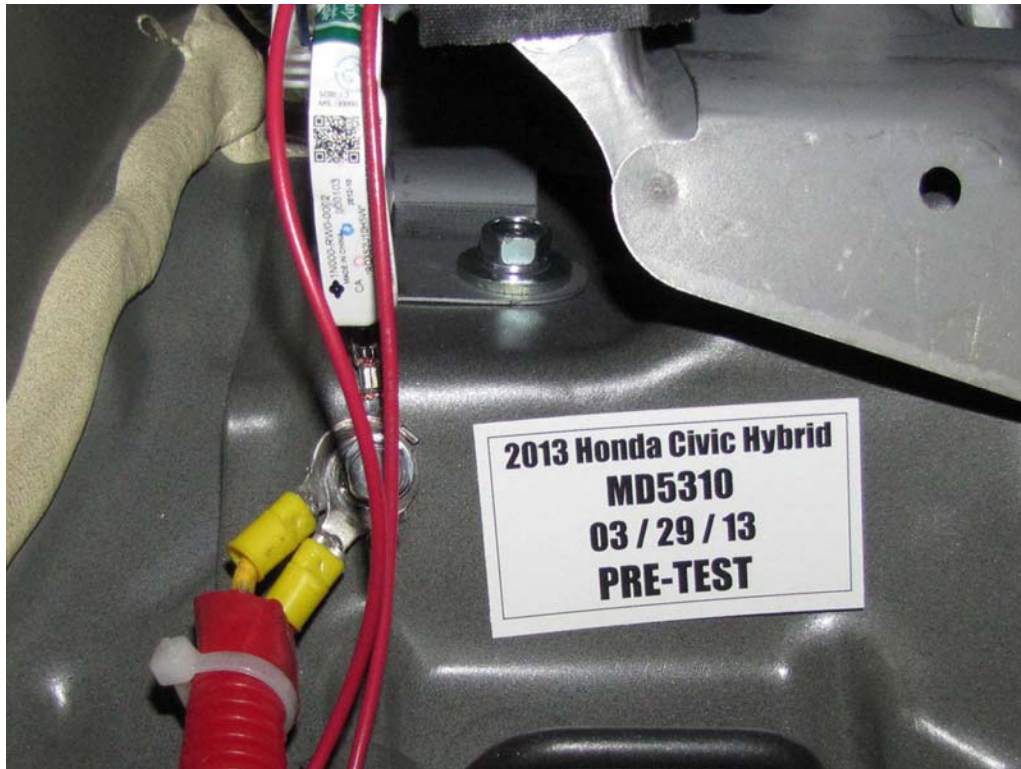
FIGURE 21. Pre-Impact View of Ground Lead Attached

The chassis ground used for the electrical isolation measurements was a pre-existing chassis ground point located behind the rear seat back on the lower right side near the right rear passenger seat belt anchor bolt. A photograph of the location is included in Figure 21 of Appendix A.
