**REPORT NUMBER: NCAP305I-KAR-13-054**

**NEW CAR ASSESSMENT PROGRAM (NCAP)  
FMVSS NO. 305 INDICANT TEST**

**TESLA MOTORS, INC.  
2013 TESLA MODEL S 5-DOOR HATCHBACK**

**FINAL REPORT**

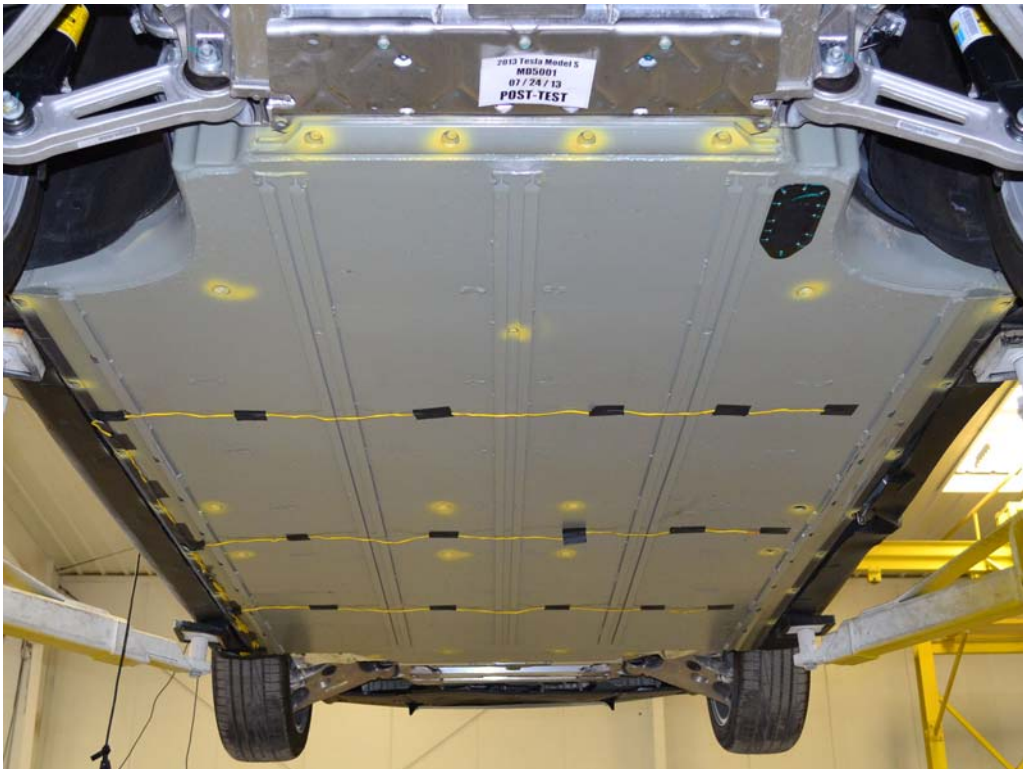
FIGURE 10. Post-Impact Front View of Propulsion Battery

Describe any movement: There was no movement of the propulsion battery.

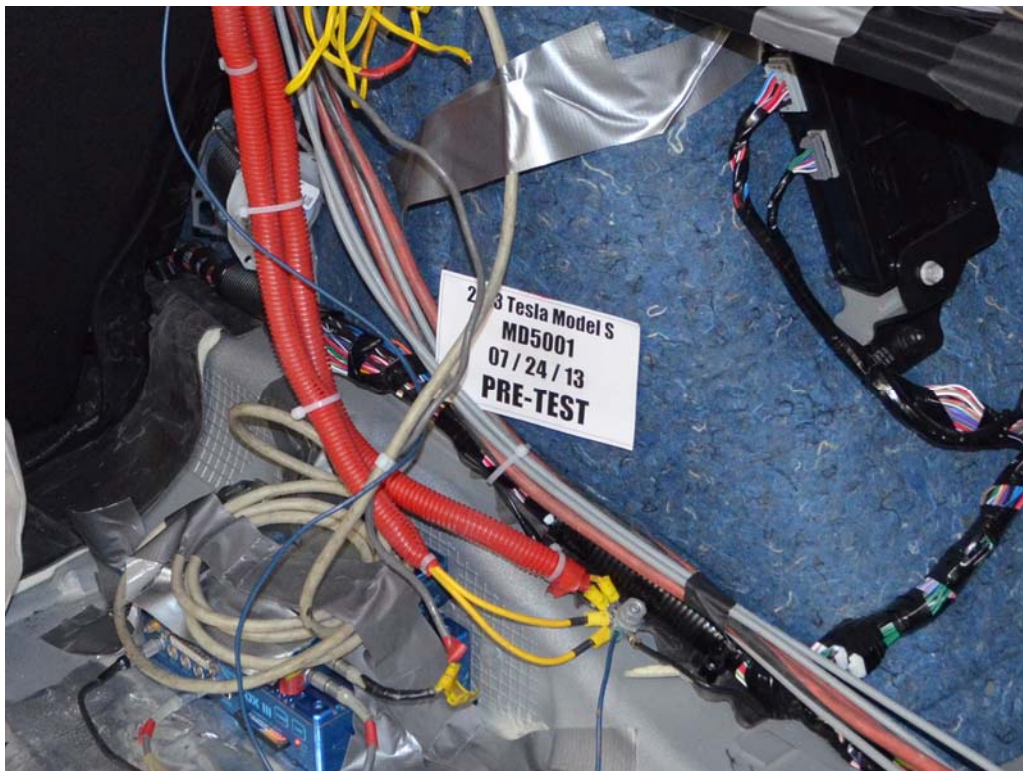
FIGURE 21. Pre-Impact View of Ground Lead Attached

The chassis ground used for the electrical isolation measurements was a pre-existing chassis ground point located in the rear trunk compartment near the right rear wheel well. A photograph of the location is included in Figure 21 of Appendix A.

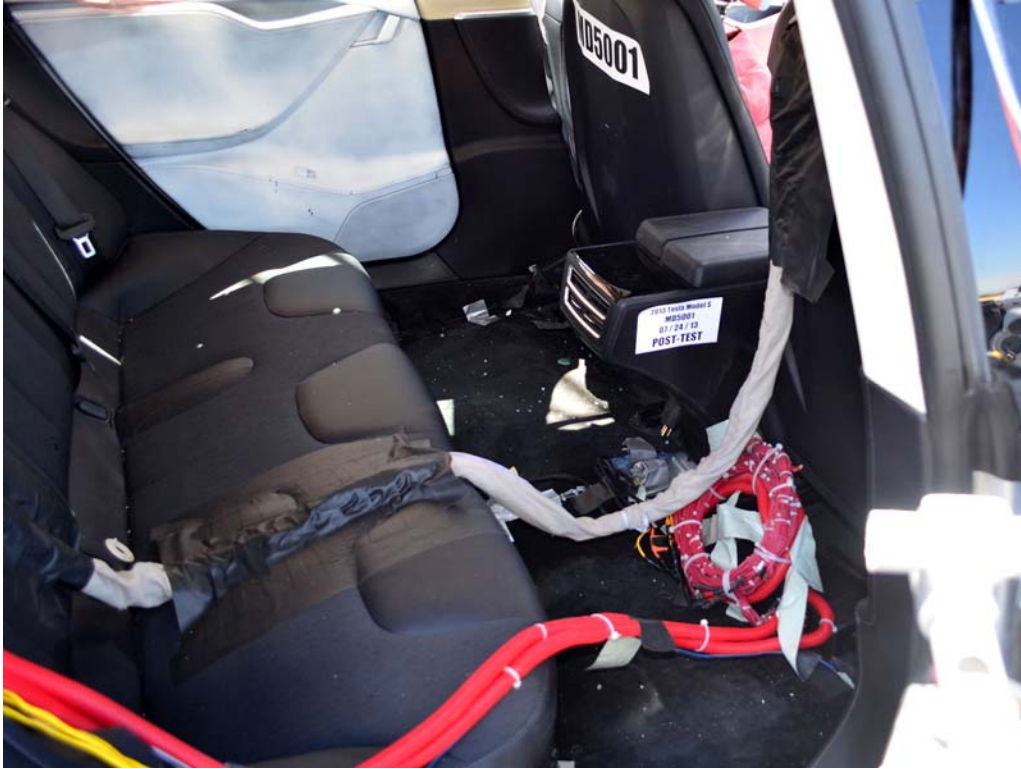
FIGURE 34. Post-Impact View of the Vehicle Passenger Compartment  
Adjacent to Propulsion Battery

Describe any intrusion: There was no intrusion of the propulsion battery into the  
occupant compartment.

Is there propulsion battery electrolyte spillage visible in the passenger compartment: No
