REPORT NUMBER: NCAP305I-KAR-14-005

**NEW CAR ASSESSMENT PROGRAM (NCAP)
FMVSS NO. 305 INDICANT TEST**

**NISSAN MOTOR CO., LLC
2014 INFINITI Q50 HYBRID 4-DOOR SEDAN**

FINAL REPORT

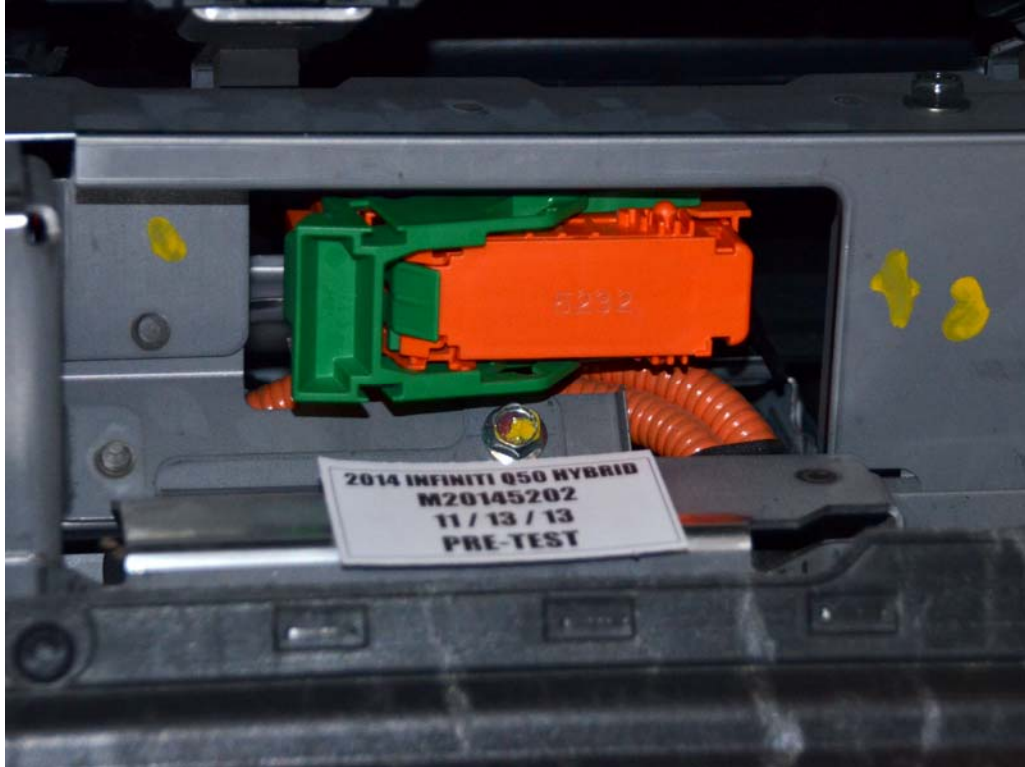
FIGURE 6. Manual High Voltage Service Disconnect in Place

The electrical propulsion system utilized one Lithium-Ion (Li-Ion) Battery module and a traction motor to propel the vehicle. The battery is located behind the rear passenger seat back. The propulsion battery service disconnect is located on the back side of the battery, behind the left rear passenger seat back. A photograph of the location is included in Figure 6 of Appendix A and is also visible in Figure 9 of Appendix A

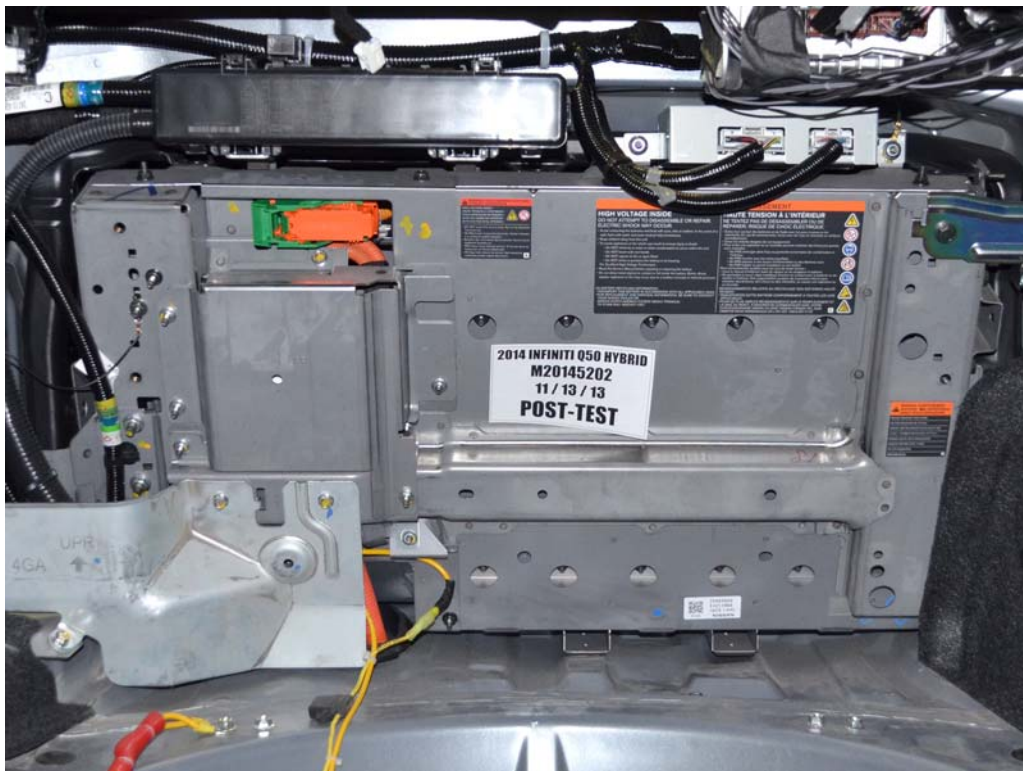
FIGURE 11. Post-Impact Rear View of Propulsion Battery

Describe any movement: There was no movement of the propulsion battery.

Describe any intrusion: There was no intrusion of the propulsion battery into the occupant compartment.

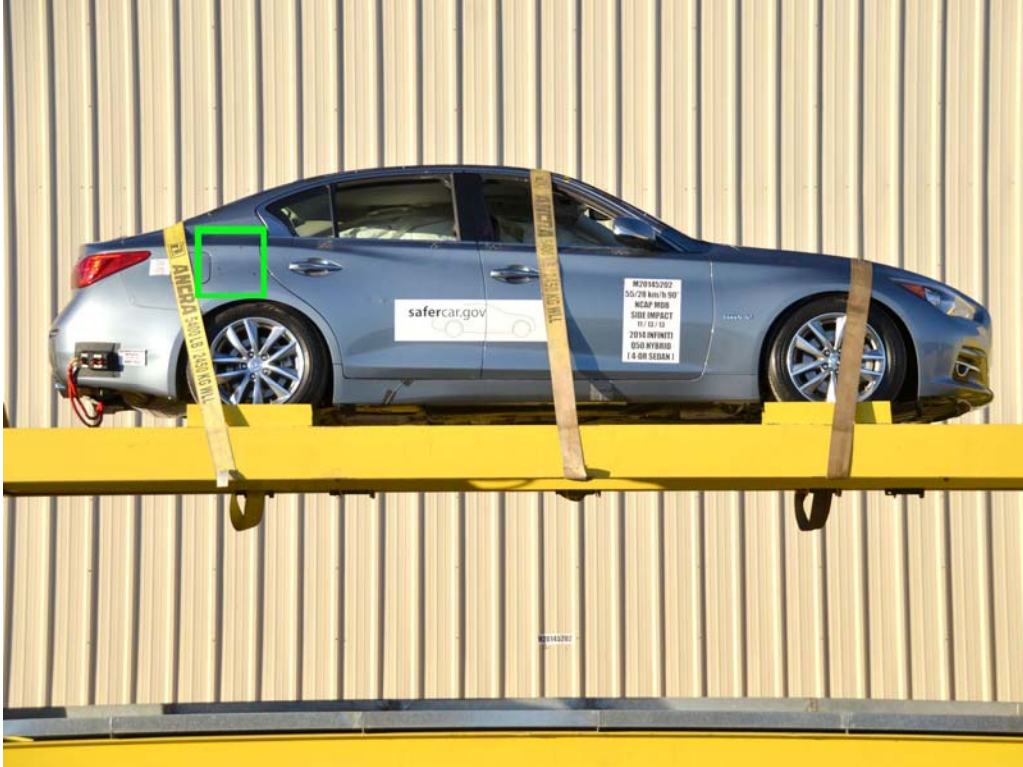
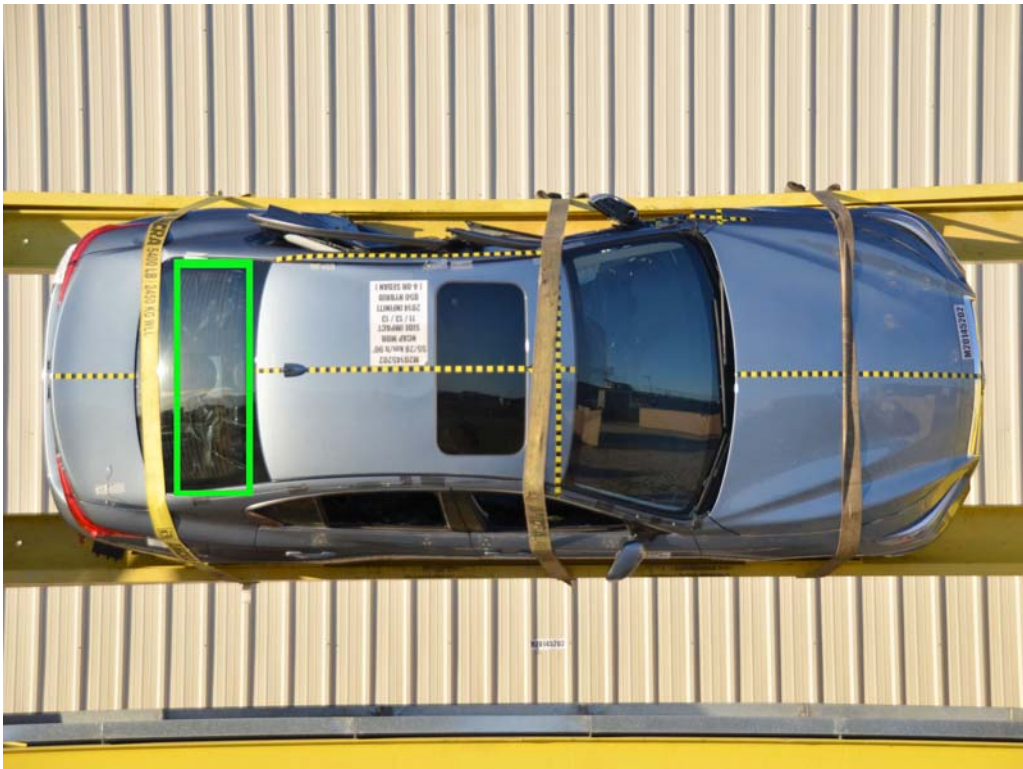
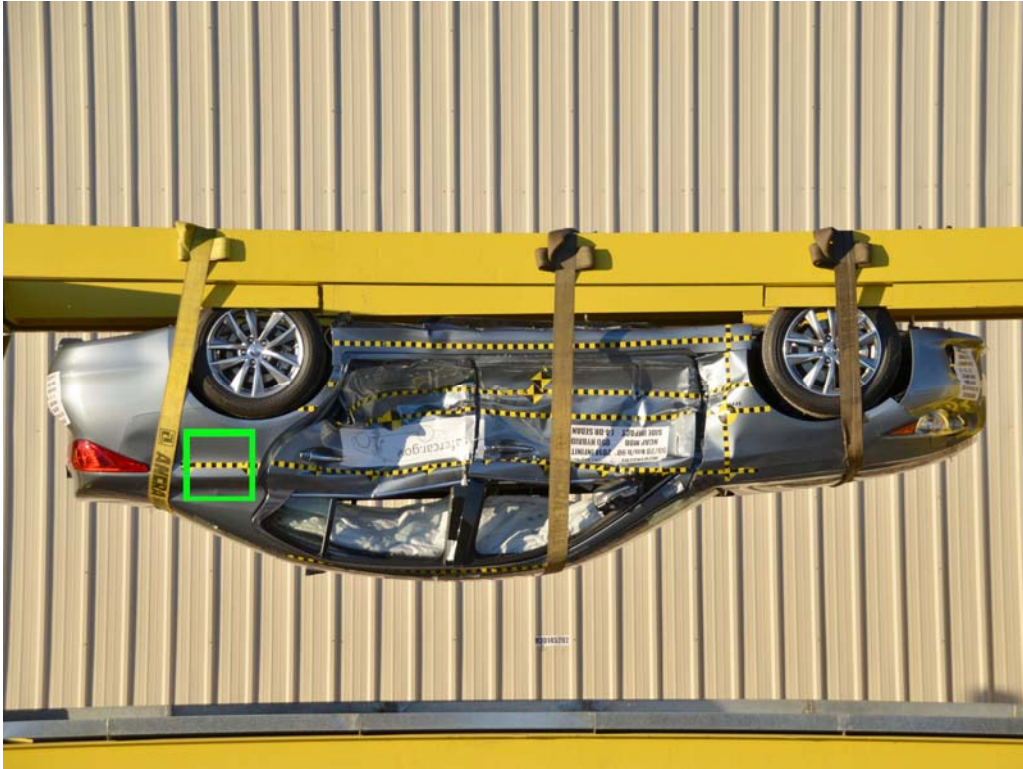
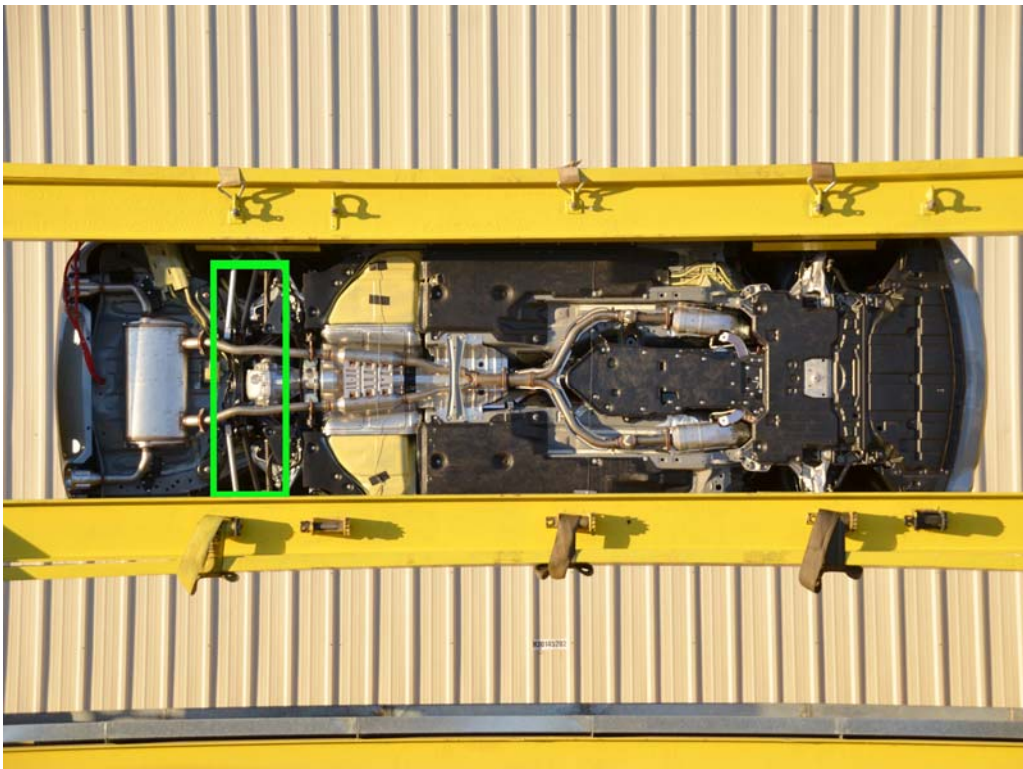
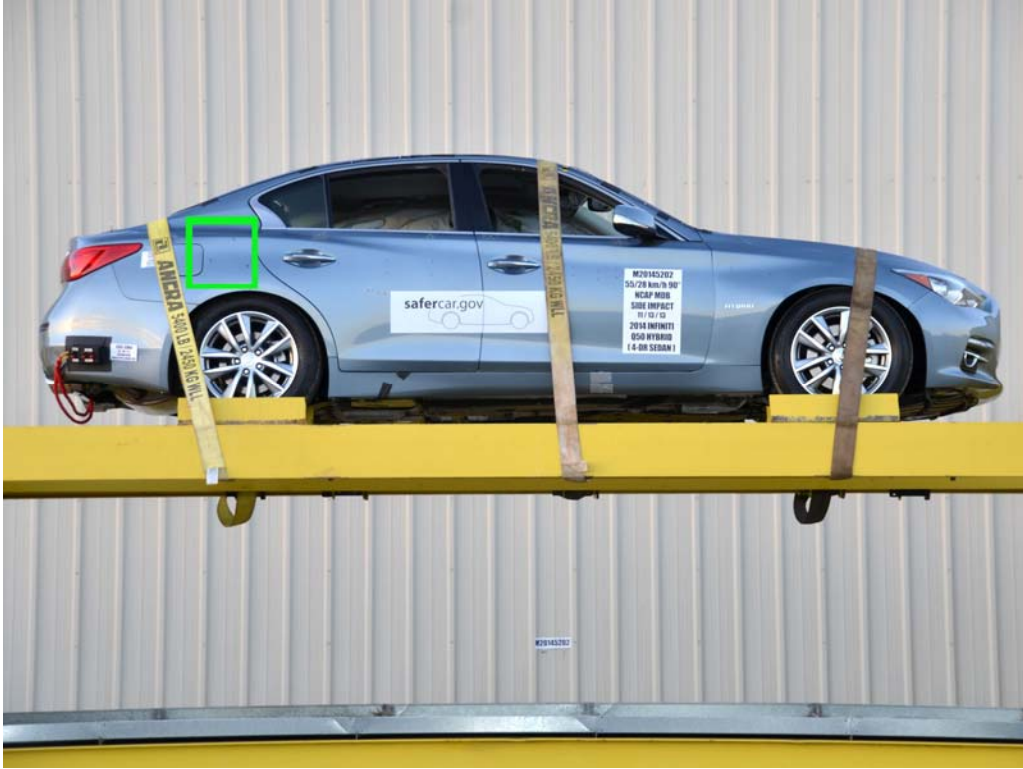
Test Phase	Propulsion Battery Electrolyte Spillage (L)	Spillage Location
0° To 90°	0.0	N/A
90° To 180°	0.0	N/A
180° To 270°	0.0	N/A
270° To 360°	0.0	N/A

Is the Total Propulsion Battery Electrolyte Spillage Greater Than 5.0 Liters?	No spillage occurred
Is the Propulsion Battery Electrolyte Spillage Visible in the Passenger Compartment?	N/A

Is the Measured Electrical Isolation Value ≥ 500 Ω/V?	Yes
---	-----

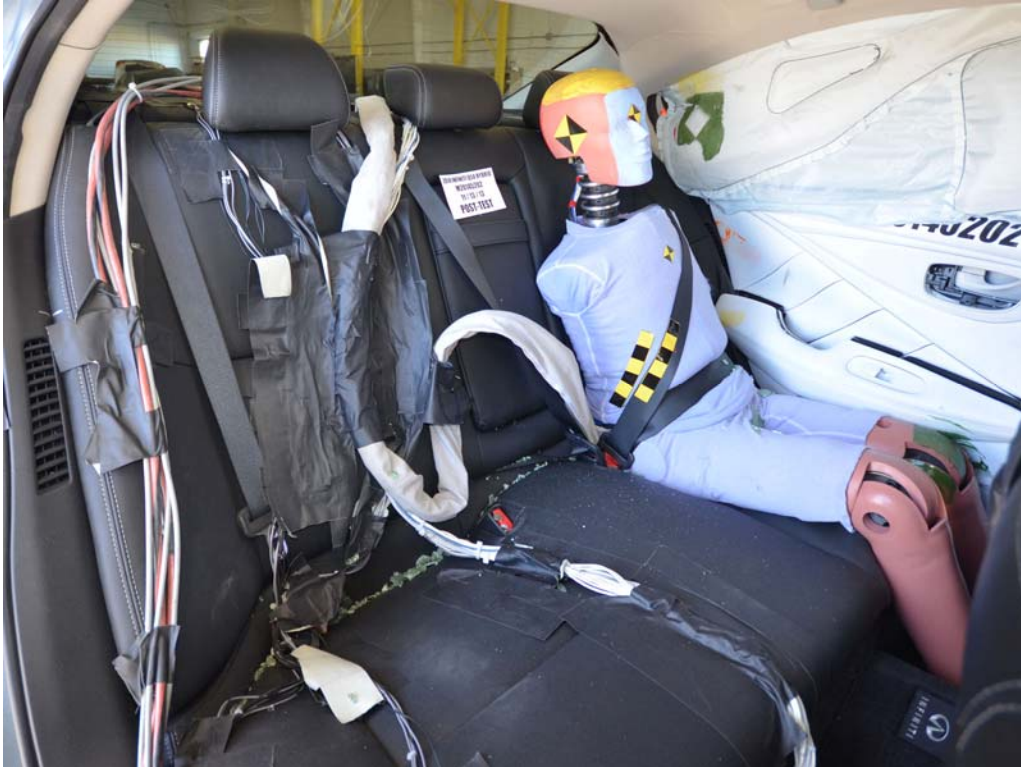
FIGURE 34. Post-Impact View of Vehicle Passenger Compartment Adjacent to Propulsion Battery

Is there propulsion battery electrolyte spillage visible in the passenger compartment: No
