REPORT NUMBER: NCAP305I-KAR-14-007

**NEW CAR ASSESSMENT PROGRAM (NCAP)
FMVSS NO. 305 INDICANT TEST**

**VOLKSWAGEN DE MEXICO S.A. DE C.V.
2014 VOLKSWAGEN JETTA HYBRID SE 4-DOOR SEDAN**

FINAL REPORT

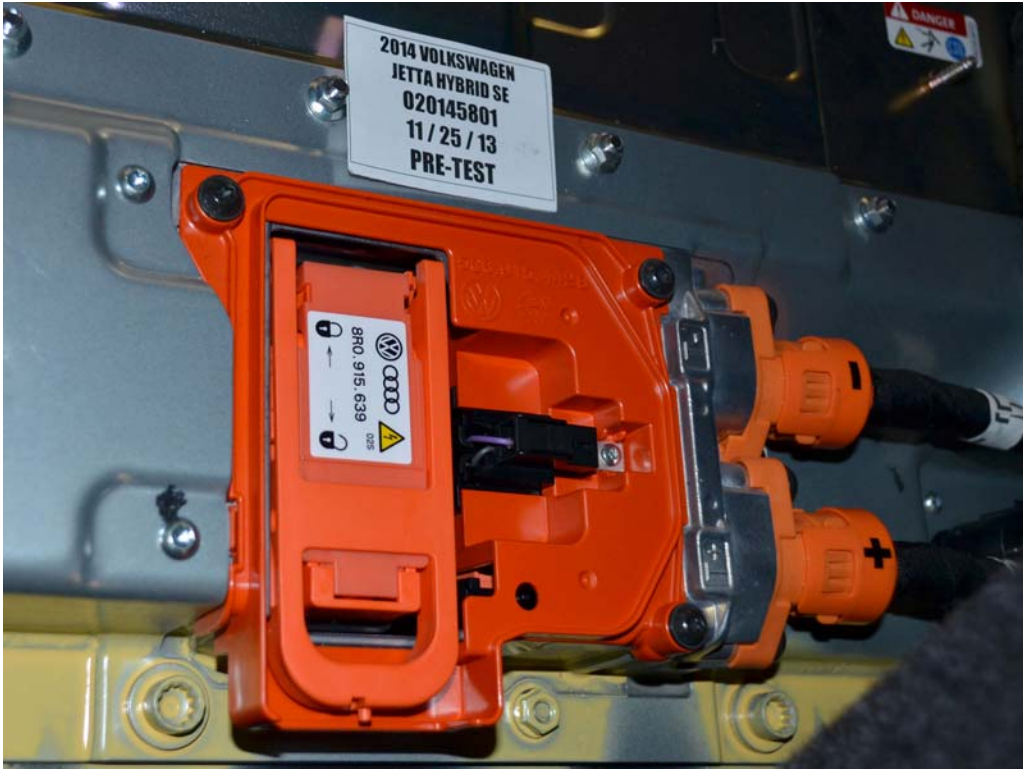
FIGURE 6. Manual High Voltage Service Disconnect in Place

The electrical propulsion system utilized one Lithium-Ion (Li-Ion) Battery and a traction motor to propel the vehicle. The battery is located behind the rear passenger seat back. The propulsion battery service disconnect is located on the front top side of the battery, behind the rear passenger seat back. The propulsion battery's automatic disconnect is physically contained within the propulsion battery. A photograph of the location of the service disconnect is included in Figure 6 of Appendix A and is also visible in Figure 9 of Appendix A.

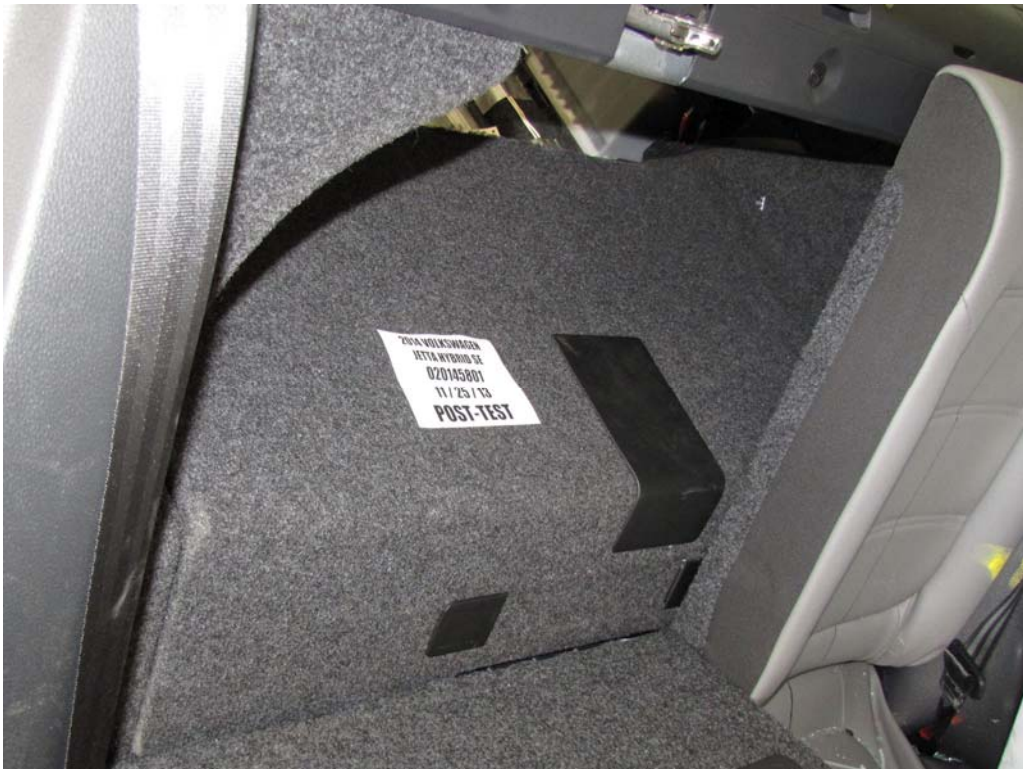
FIGURE 10. Post-Impact Front View of Propulsion Battery

Describe any movement: There was no movement of the propulsion battery.

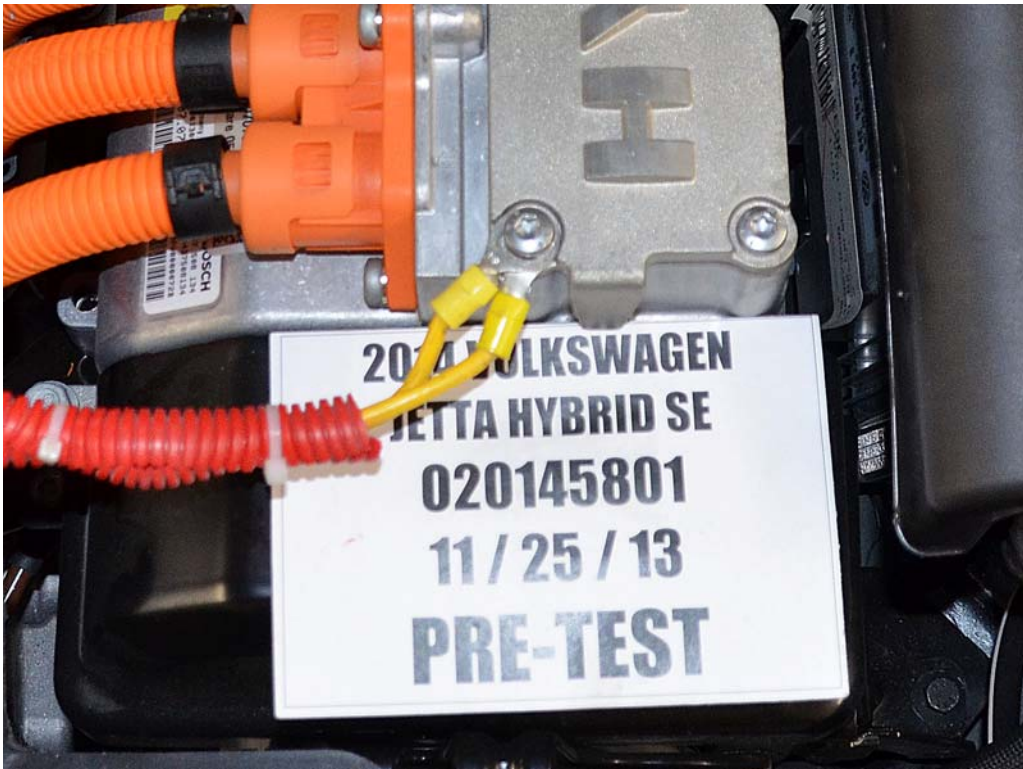
FIGURE 21. Pre-Impact View of Ground Lead Attached

The chassis ground used for the electrical isolation measurements was located on the top plate that covers the Electric Drive Power and Control Electronics compartment. The chassis ground connection was secured with one of the bolts used to seal the top plate that covers the Electric Drive Power and Control Electronics compartment. A photograph of the location is included in Figure 21 of Appendix A and is also visible in Figure 22 of Appendix A.

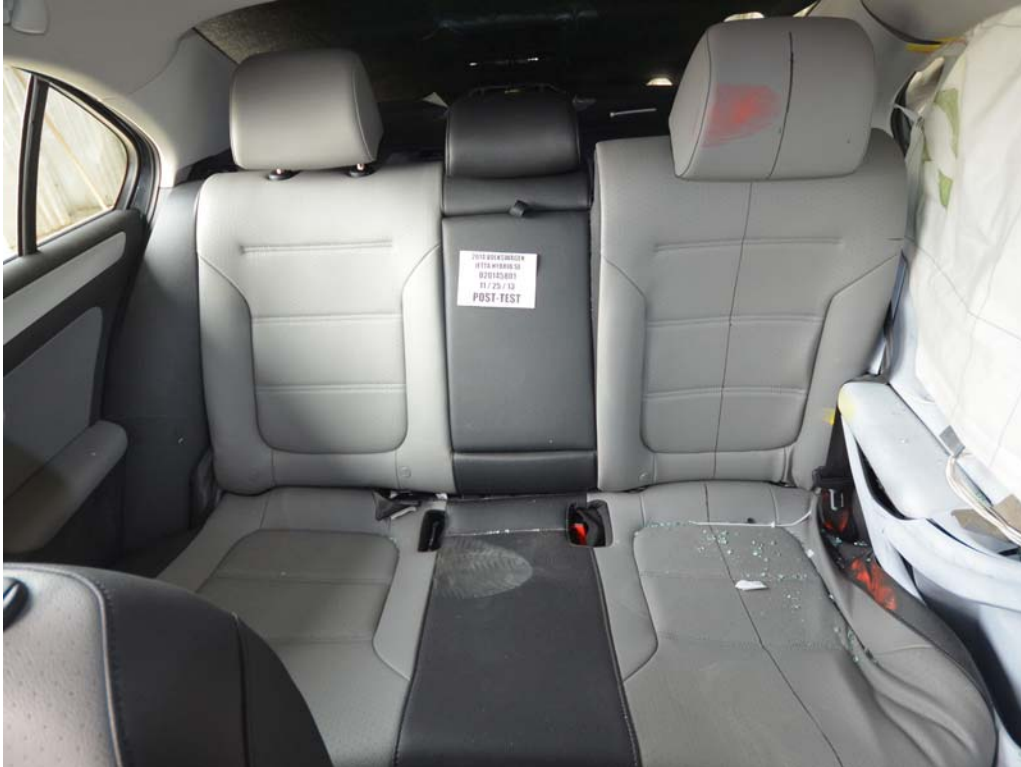
FIGURE 34. Post-Impact View of the Vehicle Passenger Compartment Adjacent to Propulsion Battery

Describe any intrusion: There was no intrusion of the propulsion battery into the occupant compartment.
