REPORT NUMBER: NCAP305I-KAR-14-010

**NEW CAR ASSESSMENT PROGRAM (NCAP)
FMVSS NO. 305 INDICANT TEST**

**TOYOTA MOTOR CORPORATION
2014 TOYOTA PRIUS 5-DOOR HATCHBACK**

FINAL REPORT

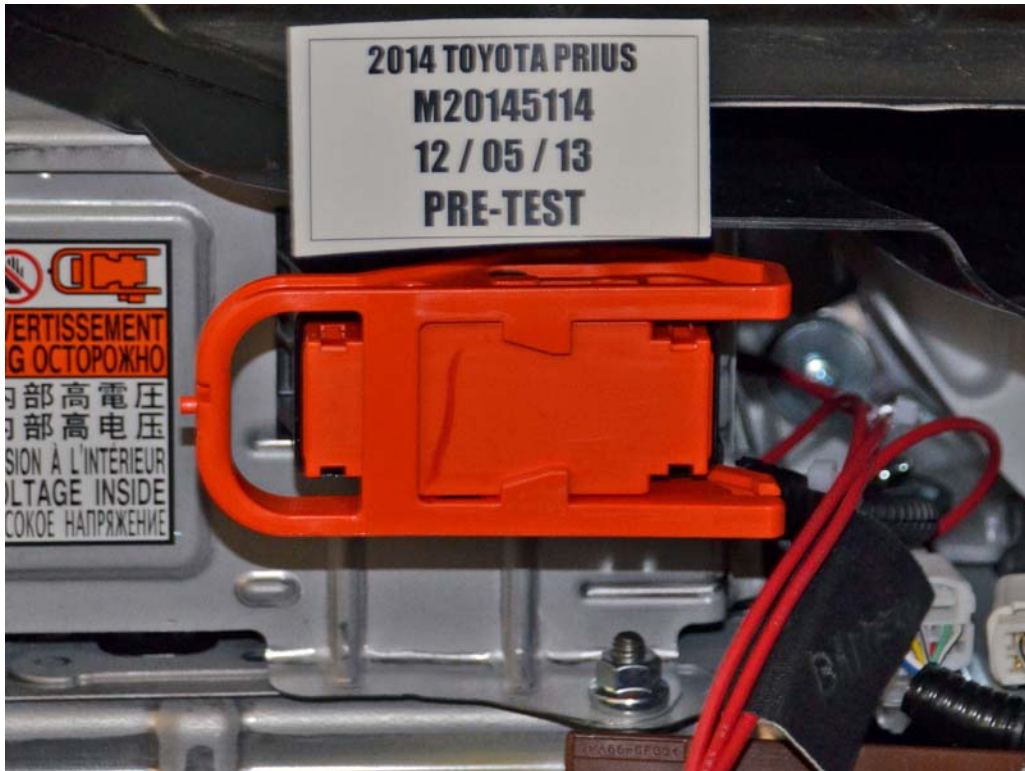
FIGURE 6. Manual High Voltage Service Disconnect in Place

The electrical propulsion system utilized one Nickel-Metal Hydride (NiMH) battery and a traction motor to propel the vehicle. The battery is located behind the rear passenger seatback. The propulsion battery service disconnect is located on the rear side of the propulsion battery. A photograph of the location of the propulsion battery service disconnect is included Figure 6 of Appendix A.

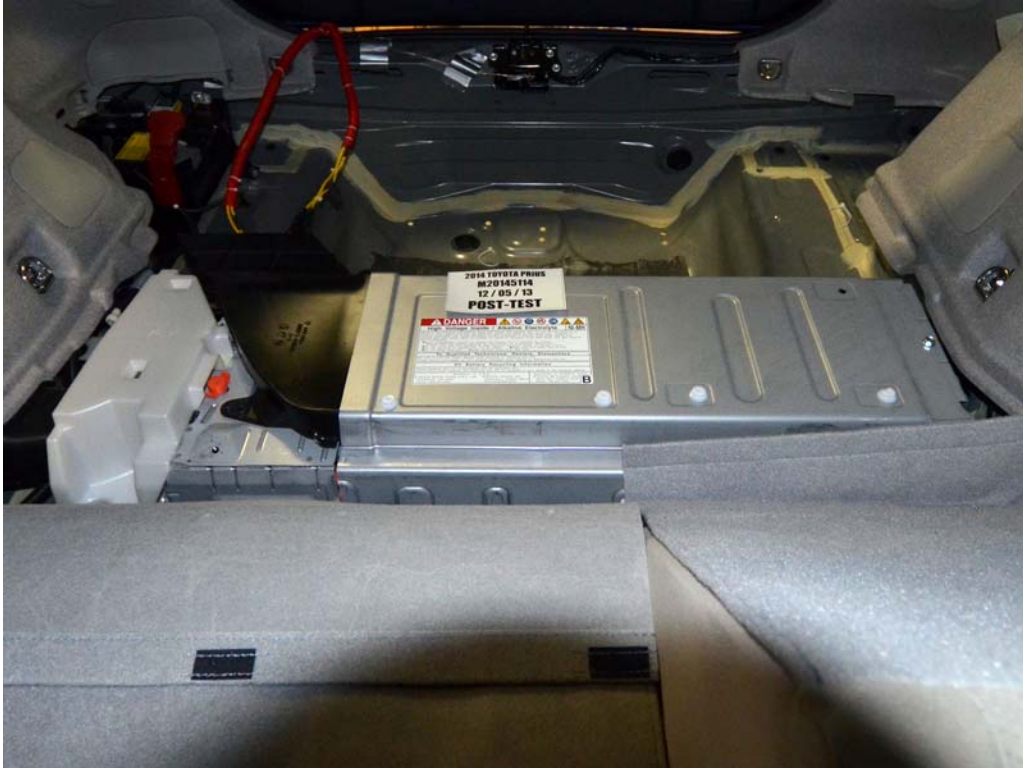
FIGURE 10. Post-Impact Front View of Propulsion Battery

Describe any movement: There was no movement of the propulsion battery.

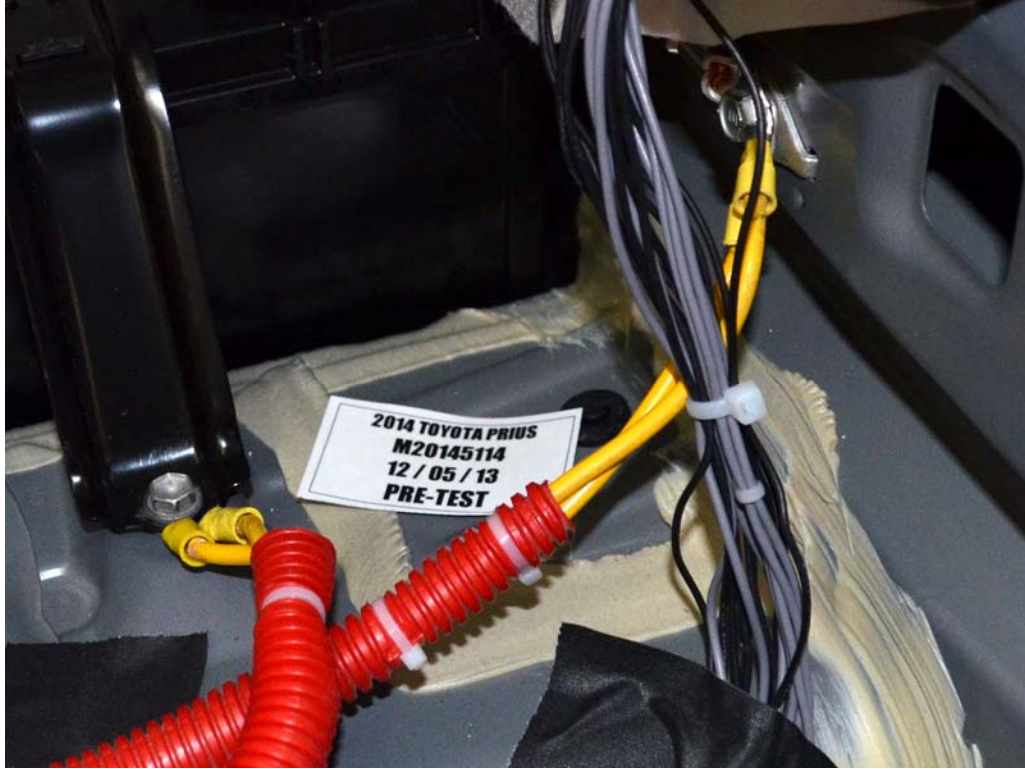
FIGURE 21. Pre-Impact View of Ground Lead Attached

Two chassis grounds were used for the electrical isolation measurements. One was a pre-existing chassis ground and the other was an unpainted surface in between the 12 V battery and the spare tire storage compartment. A photograph of the location is included in Figure 21 of Appendix A.

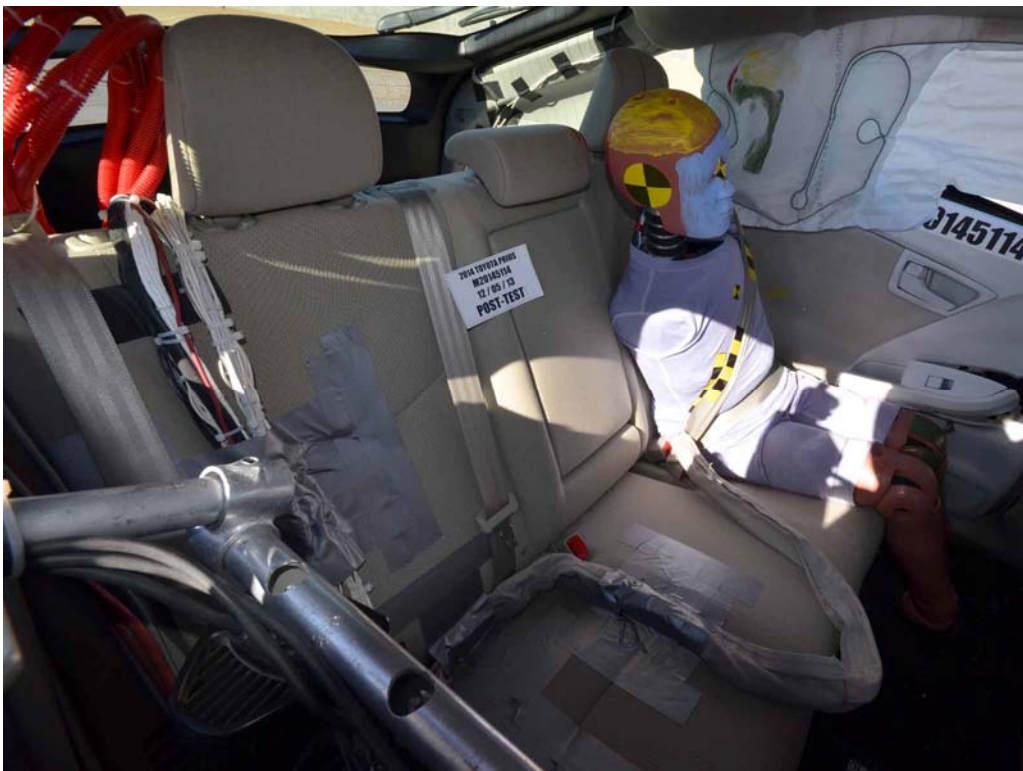
FIGURE 34. Post-Impact View of the Vehicle Passenger Compartment Adjacent to Propulsion Battery

Describe any intrusion: There was no intrusion of the propulsion battery into the occupant compartment.
