REPORT NUMBER: NCAP305I-KAR-14-009

**NEW CAR ASSESSMENT PROGRAM (NCAP)
FMVSS NO. 305 INDICANT TEST**

**TOYOTA MOTOR CORPORATION
2014 TOYOTA PRIUS 5-DOOR HATCHBACK**

FINAL REPORT

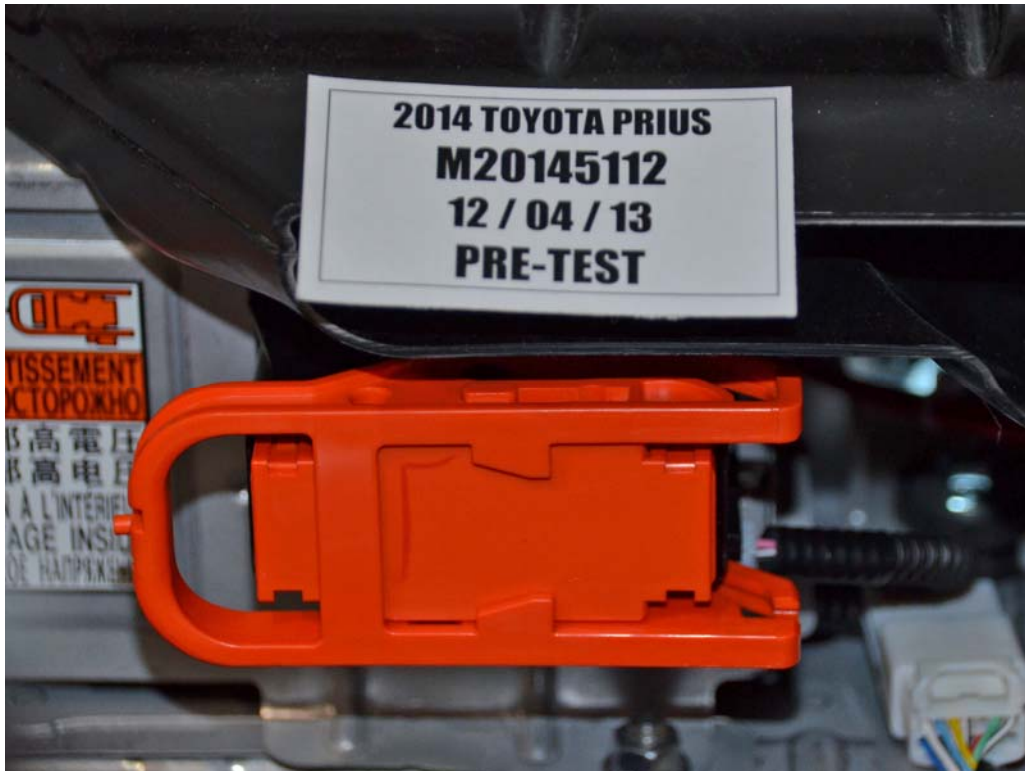
FIGURE 6. Manual High Voltage Service Disconnect in Place

The electrical propulsion system utilized one Nickel-Metal Hydride (NiMH) battery and a traction motor to propel the vehicle. The battery is located behind the rear passenger seatback. The propulsion battery service disconnect is located on the rear side of the propulsion battery. A photograph of the location is included Figure 6 of Appendix A.

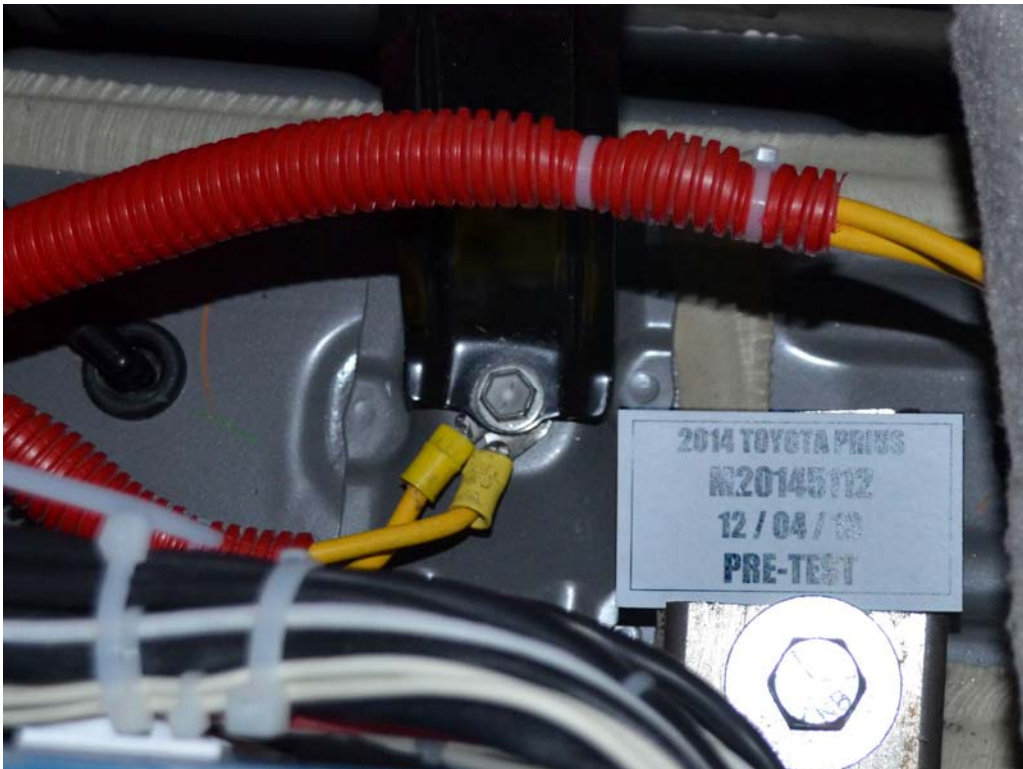
FIGURE 21. Pre-Impact View of Ground Lead Attached

Two chassis grounds were used for the electrical isolation measurements. One was a pre-existing chassis ground and the other was an unpainted surface in between the 12 V battery and the spare tire storage compartment. A photograph of the location is included in Figure 21 of Appendix A.

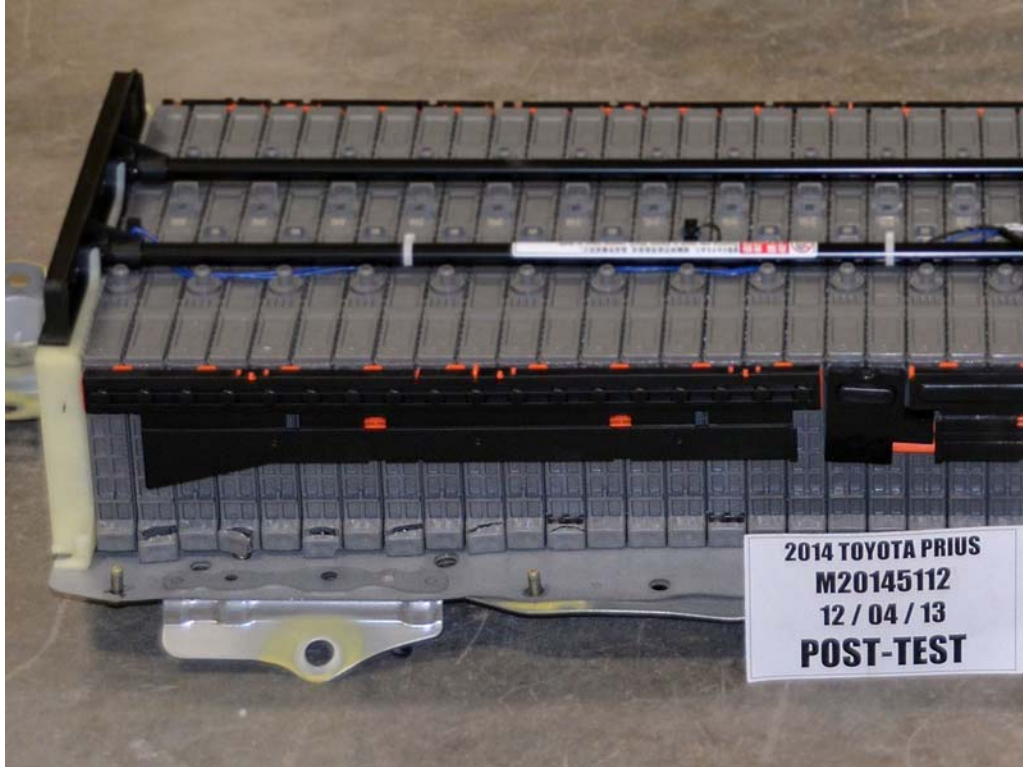
FIGURE 35. Post-Impact Propulsion Battery System Mounting and/or Intrusion Failure

Has the propulsion battery module moved within the passenger compartment: No

Describe any movement: There was no movement of the propulsion battery.

Has an outside propulsion battery component intruded into the passenger compartment: No

Describe any intrusion: There was no intrusion of the propulsion battery into the occupant compartment.
