REPORT NUMBER: TR-P32096-04-NC

**RESEARCH AND DEVELOPMENT
80 KM/H 70% OVERLAP REAR IMPACT**

**SATURN CORPORATION
1996 SATURN SL1 4-DOOR SEDAN**

**REPORT DATE:
AUGUST 30, 2012
FINAL REPORT**

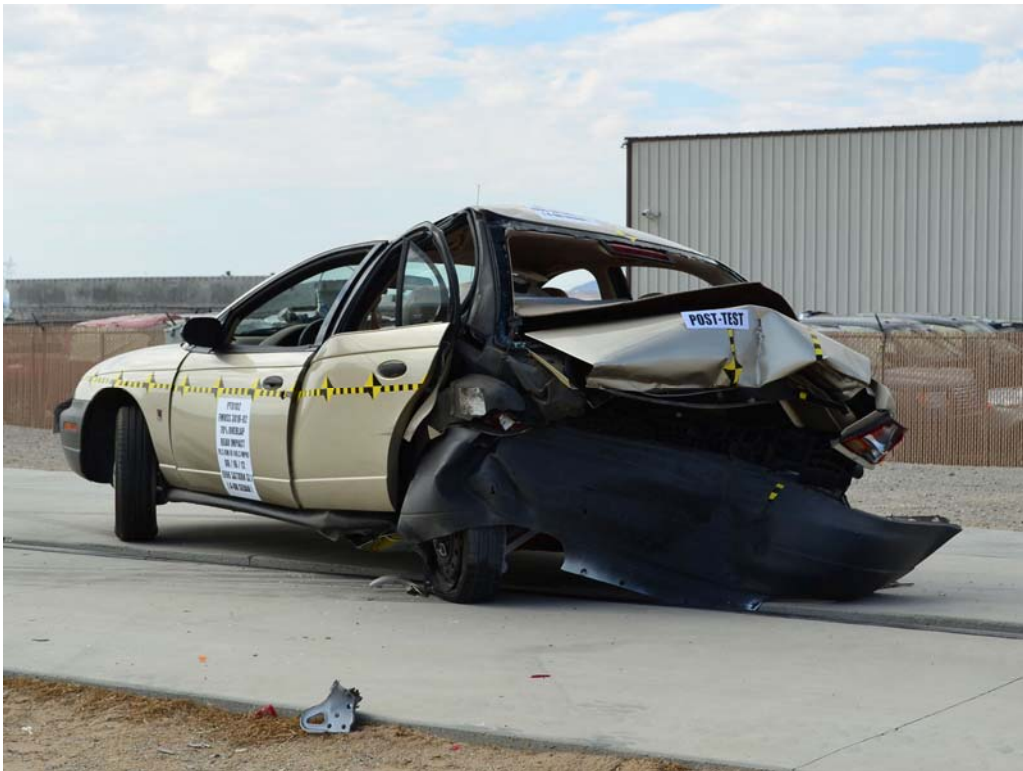
FIGURE 10. Post-Test Left Rear $\frac{3}{4}$ View of Test Vehicle

Description	Driver	Passenger
Front Door Opening	Remained closed and latched	Remained closed and latched
Rear Door Opening	Jammed Shut	Remained closed and latched
Hatch and Other Doors	Jammed Shut

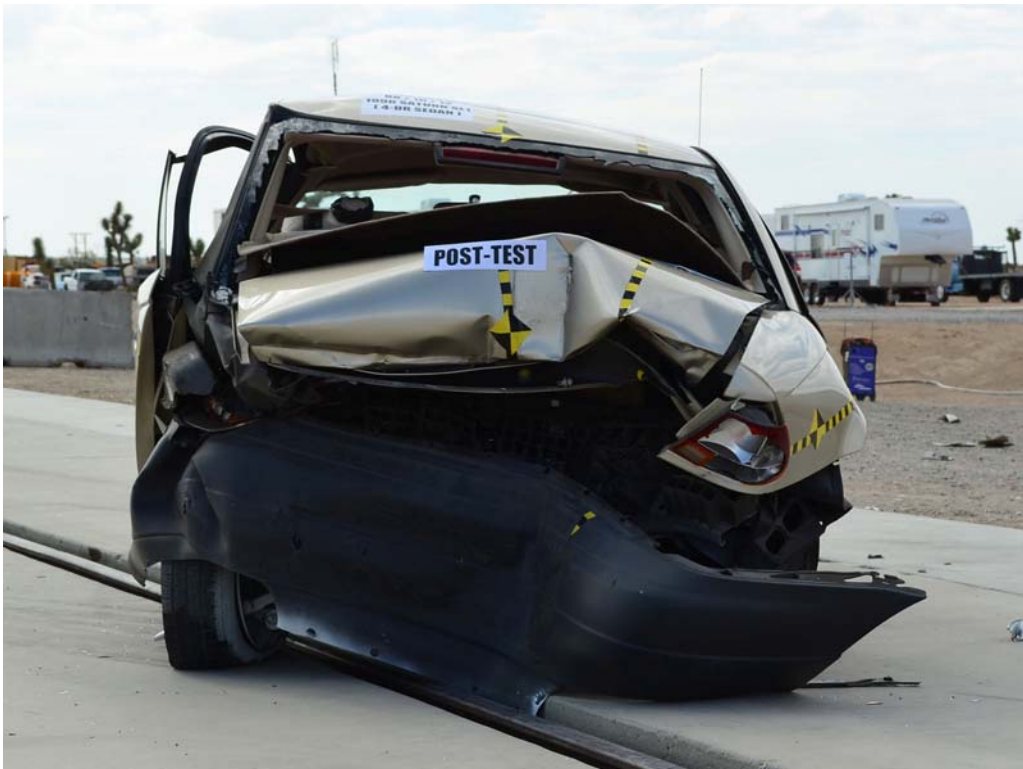
FIGURE 12. Post-Test Rear View of Test Vehicle

Both the driver and passenger side doors remained closed during the impact event. The left front, right front and right rear doors remained operational after the event. The left rear door and hatch were jammed shut.

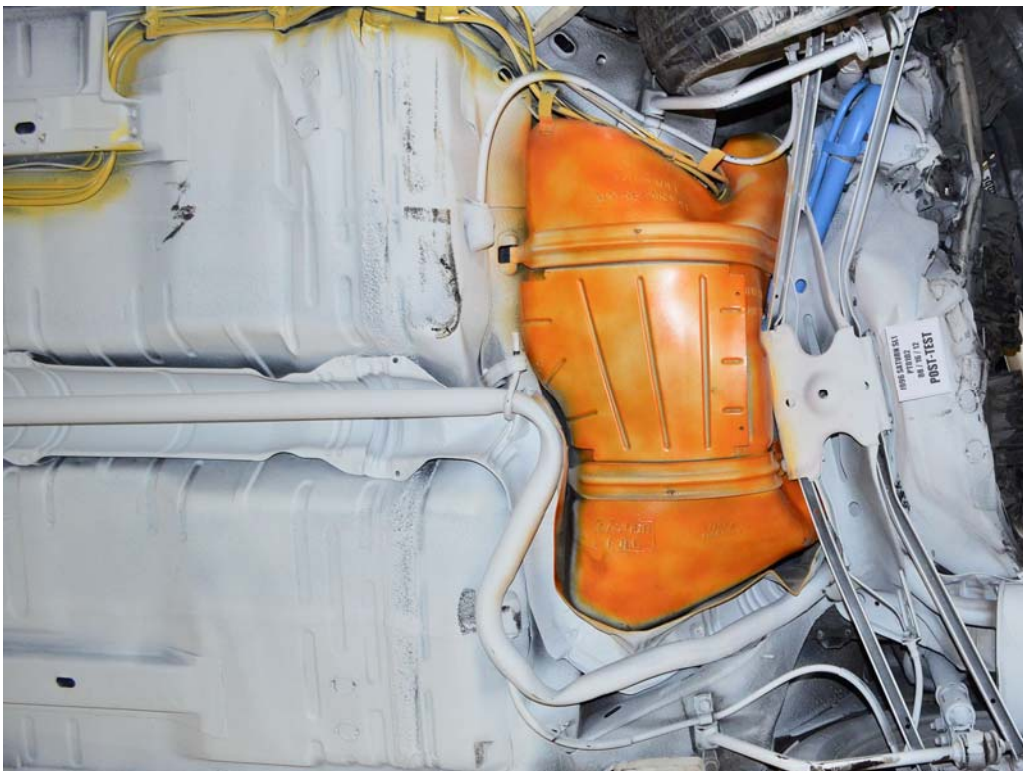
FIGURE 20. Post-Test Underbody, Fuel Tank Location

Stoddard solvent leaked from the underside of the vehicle immediately after the test. Solvent was observed leaking from the front and rear of the fuel tank. Actual leakage location is in an unidentified region of the fuel tank. The solvent continued to leak throughout the static rollover at every position from 0°-360°. Solvent leakage is summarized in Data Sheets 5 and 6. Photographs of the damaged area are presented in Appendix A.

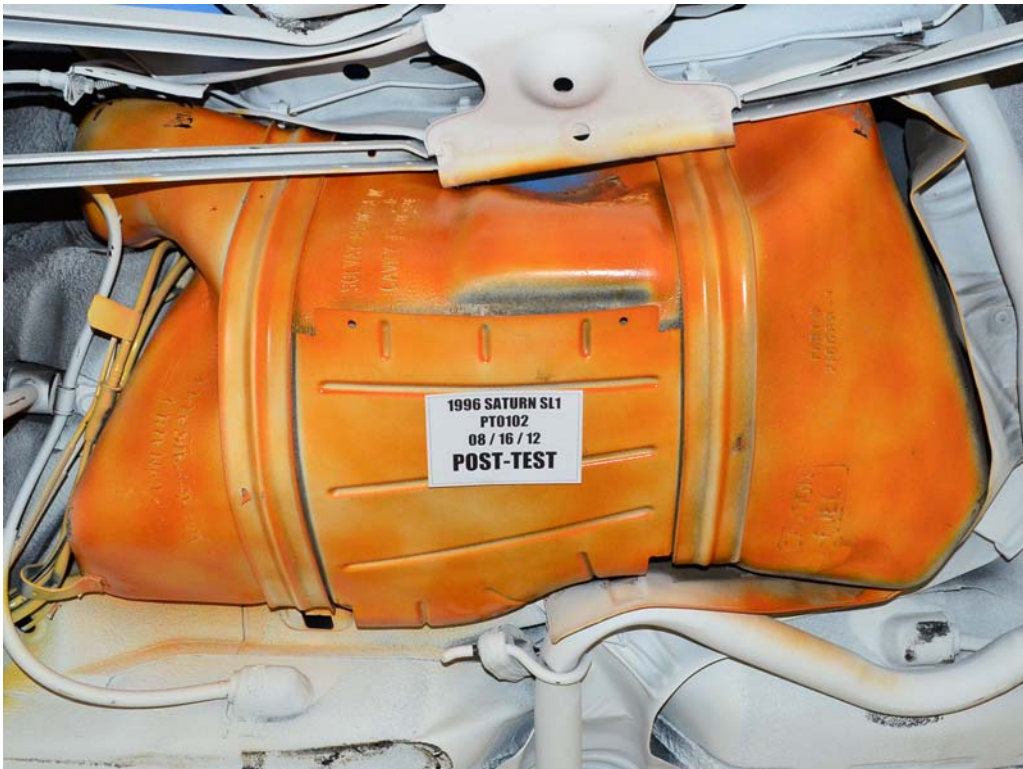
FIGURE 30. Post-Test Stoddard Solvent Spillage Location View

- A. From impact until vehicle motion ceases: 0 g
(Maximum allowable = 28 g)
- B. For the 5 minute period after motion ceases: 573.7 g
(Maximum allowable = 28 g)
- C. For the following 25 minutes: 387.2 g
(Maximum allowable = 28 g/minute)
- D. Spillage: Solvent was observed leaking from the front and rear of the fuel tank. Actual leakage location is in an unidentified region of the fuel tank.

Stoddard solvent leaked from the underside of the vehicle immediately after the test. Solvent was observed leaking from the front and rear of the fuel tank. Actual leakage location is in an unidentified region of the fuel tank.
