REPORT NUMBER: TR-P32096-06-NC

**RESEARCH AND DEVELOPMENT
80 KM/H 70% OVERLAP REAR IMPACT**

**MAZDA MOTOR CORPORATION
1996 MAZDA PROTÉGÉ 4-DOOR SEDAN**

NHTSA NUMBER: PT5400

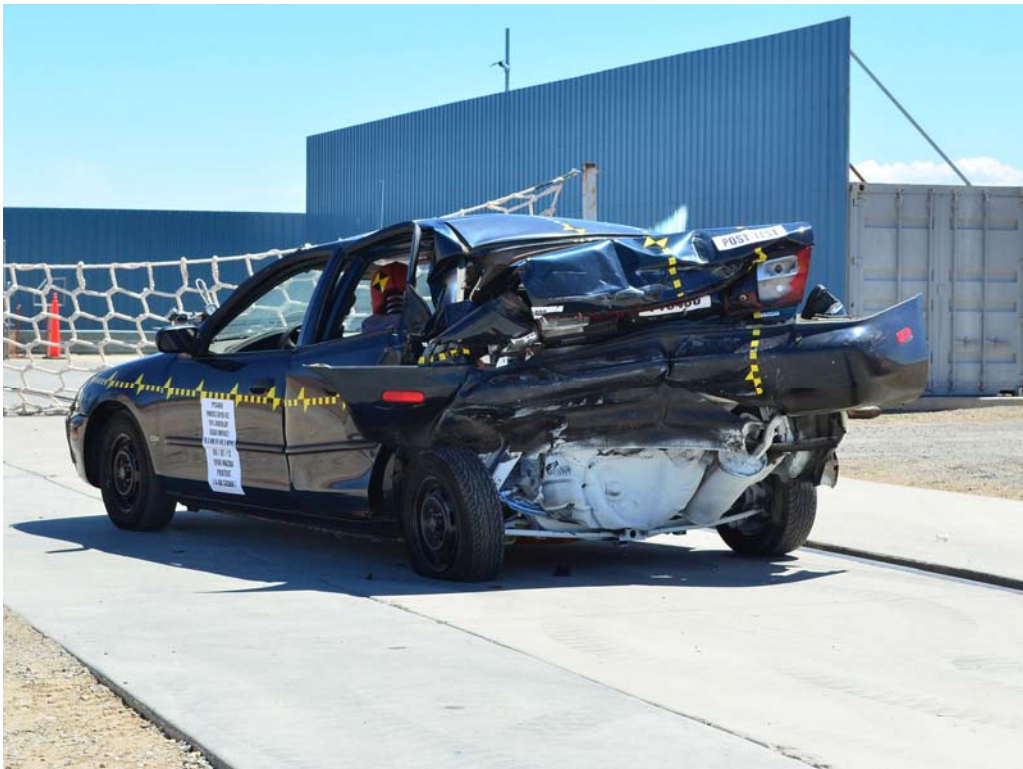
FIGURE 10. Post-Test Left Rear $\frac{3}{4}$ View of Test Vehicle

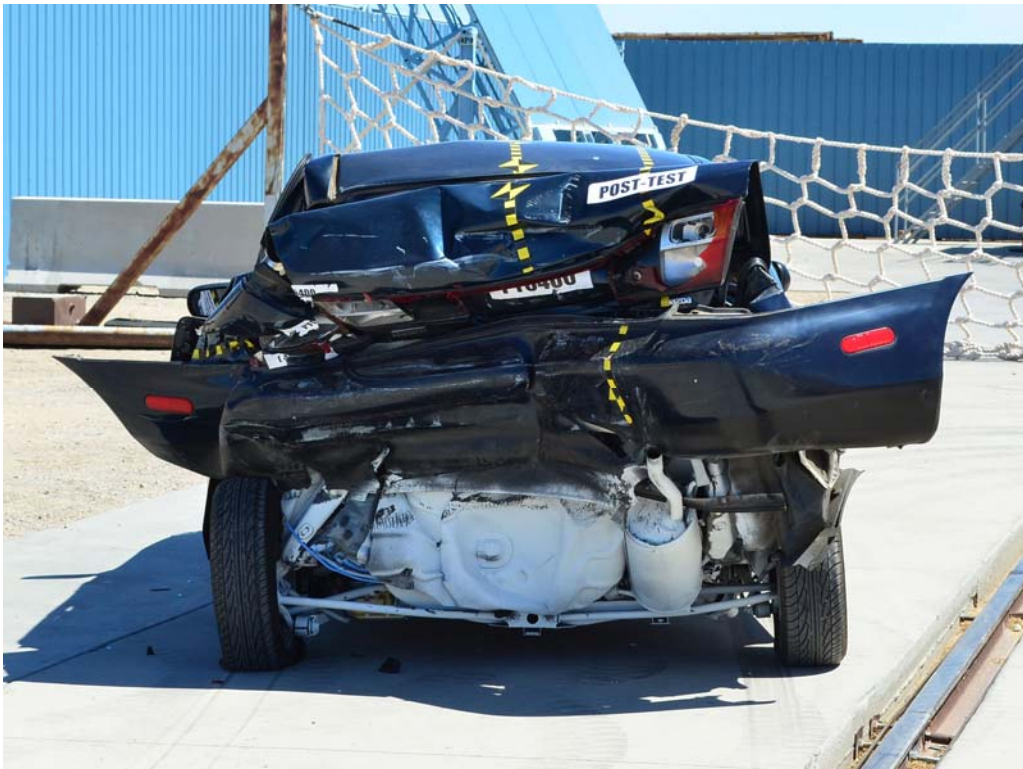
FIGURE 12. Post-Test Rear View of Test Vehicle

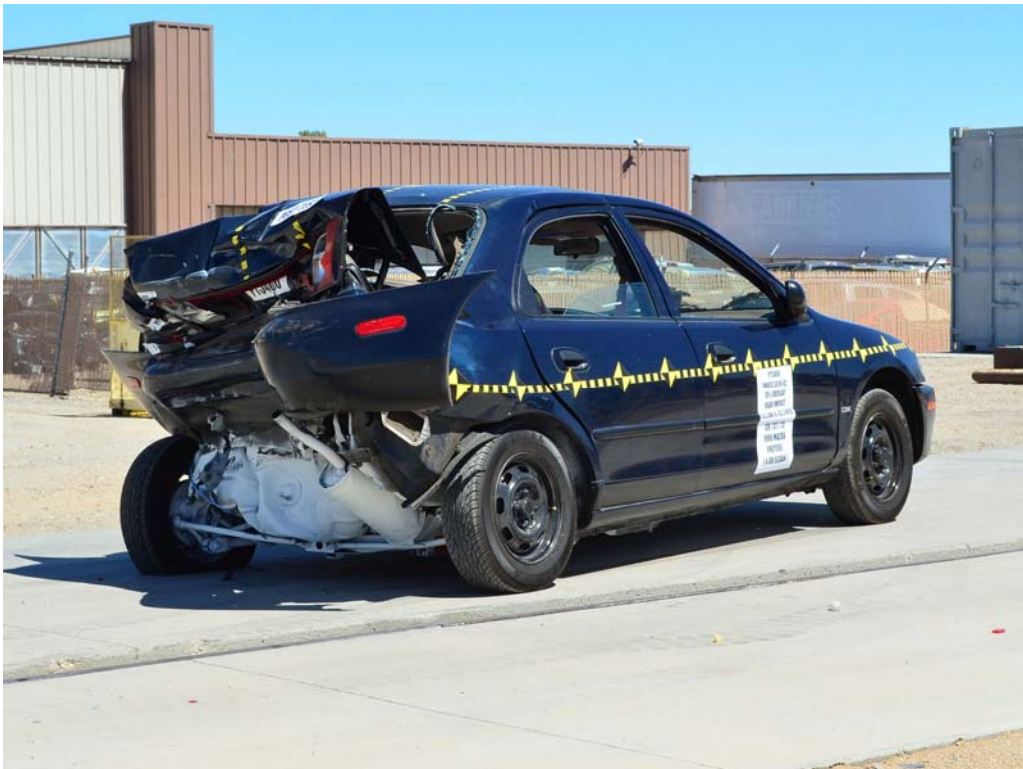
FIGURE 14. Post-Test Right Rear $\frac{3}{4}$ View of Test Vehicle

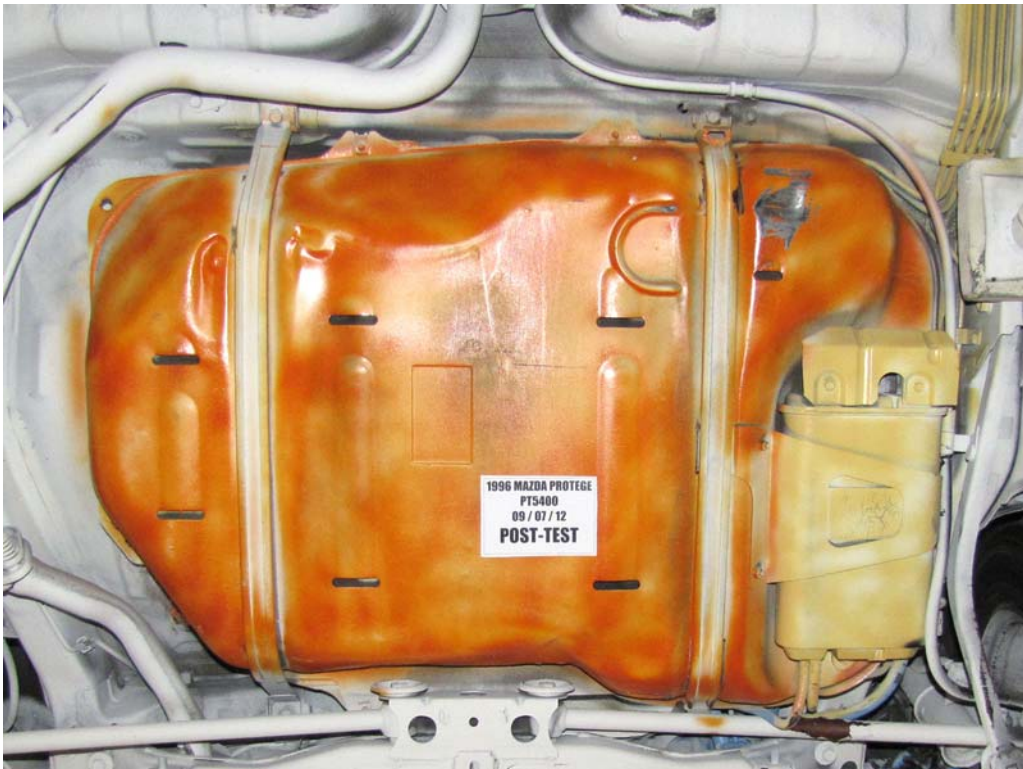
FIGURE 20. Post-Test Underbody, Fuel Tank Location

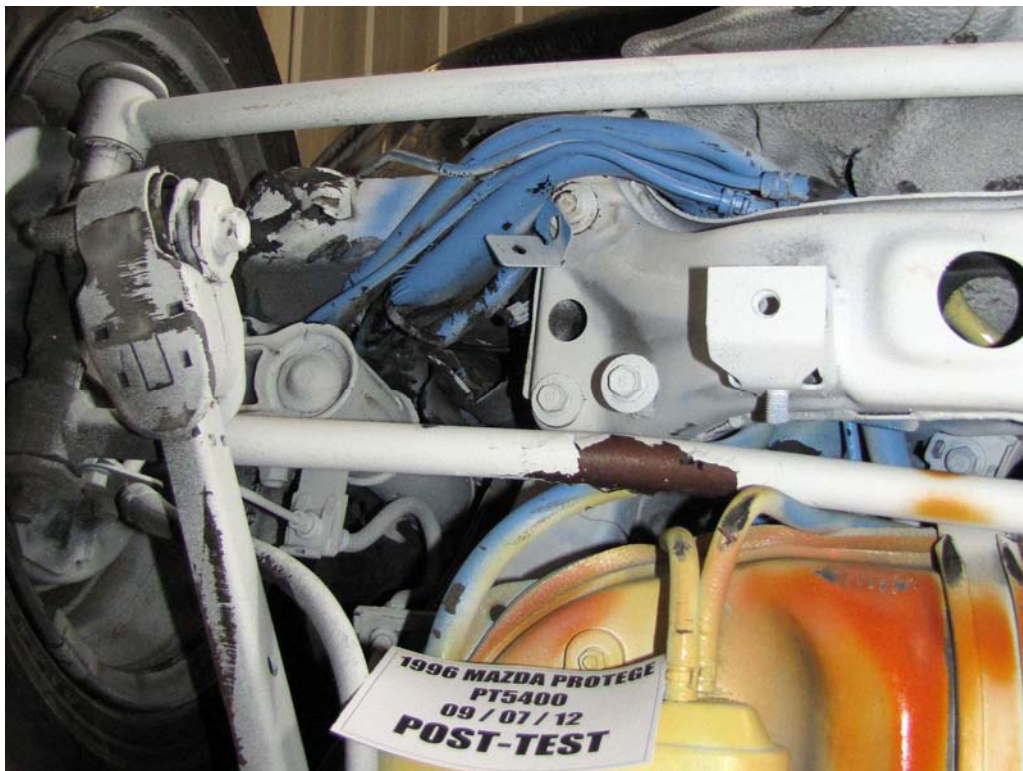
FIGURE 22. Post-Test Underbody, Fuel Filler Neck Location

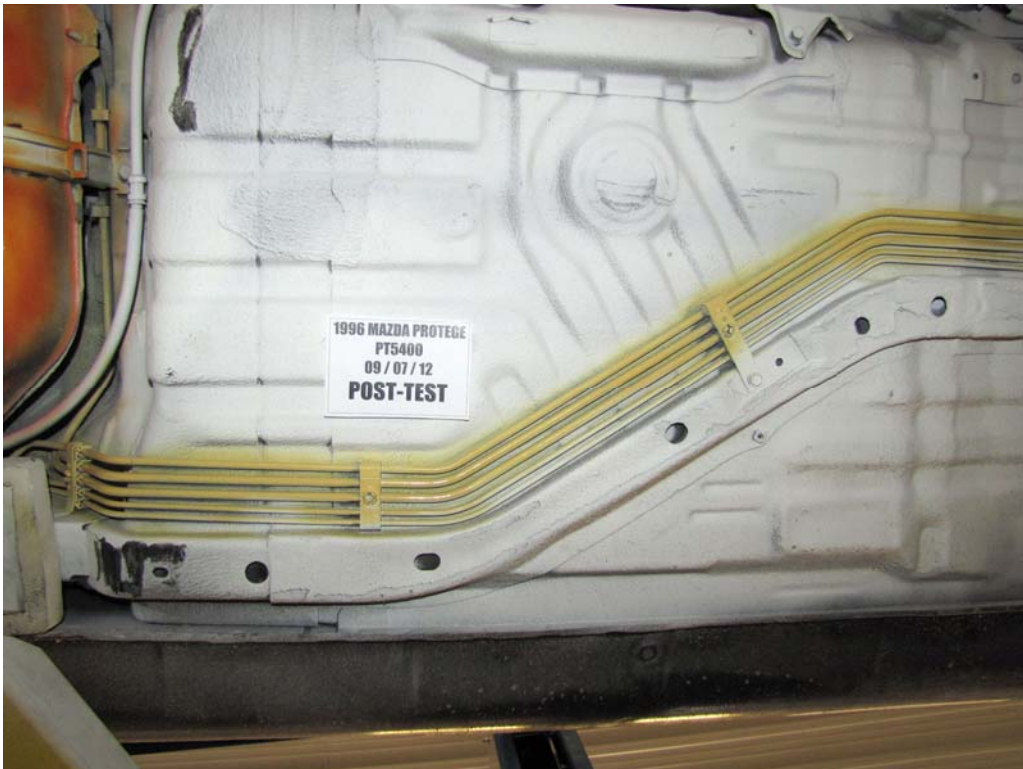
FIGURE 24. Post-Test Underbody, Fuel Line Location

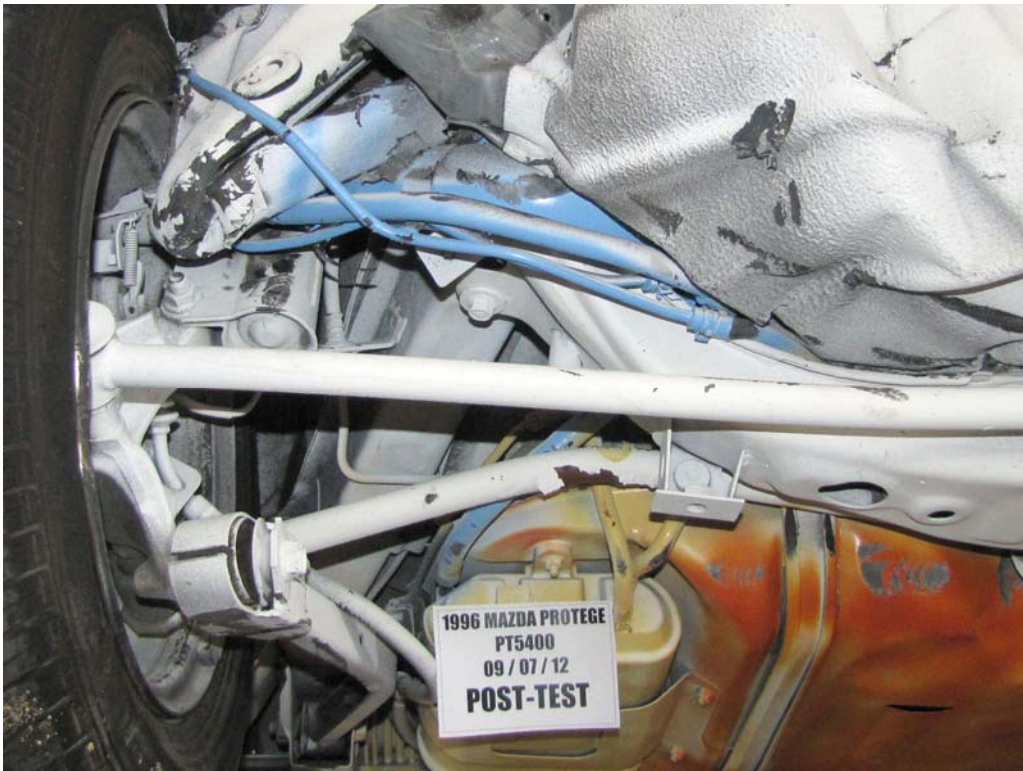
Stoddard solvent leaked from the fuel filler neck area on the left rear fender of the vehicle during portions of the static rollover. Leaks were visible while moving from 0° to 90°, while holding at the 90° position, while moving from 90° to 180°, while holding at 180°, and while moving from 180° to 270°

FIGURE 30. Post-Test Stoddard Solvent Spillage Location View

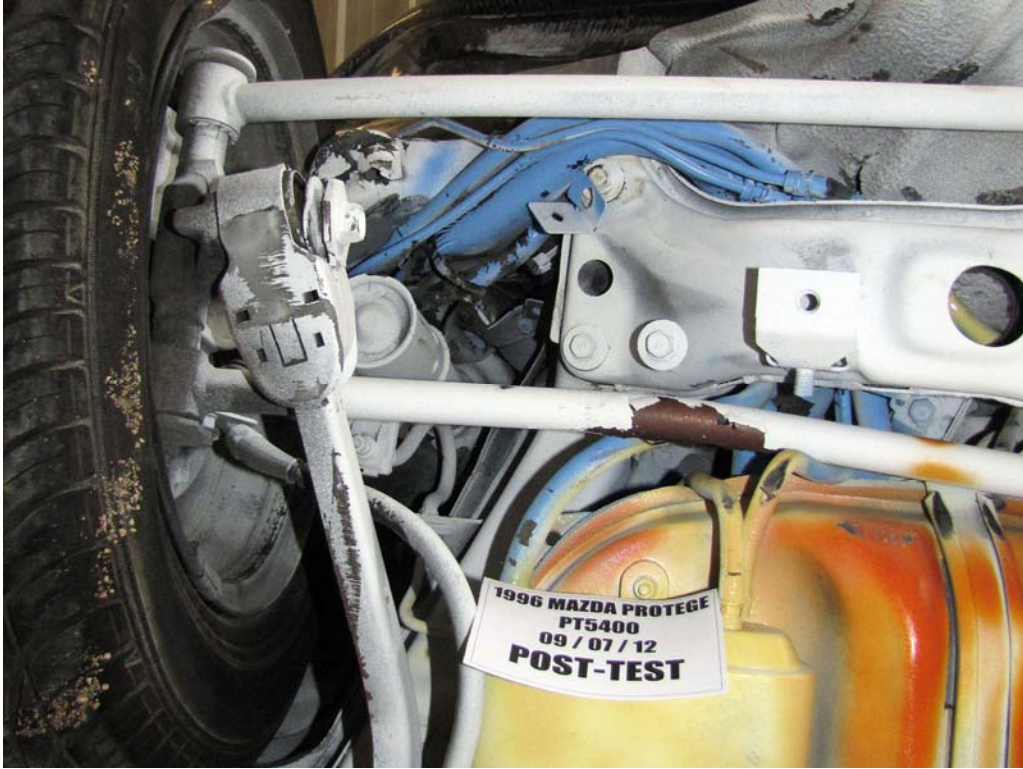
FIGURE 31. Post-Test Stoddard Solvent Spillage Location View
