REPORT NUMBER: TR-P32096-12-NC

**RESEARCH AND DEVELOPMENT
80 KM/H 70% OVERLAP REAR IMPACT**

**AUTOALLIANCE INTERNATIONAL, INC.
1997 MAZDA 626 4-DOOR SEDAN**

NHTSA NUMBER: PV5400

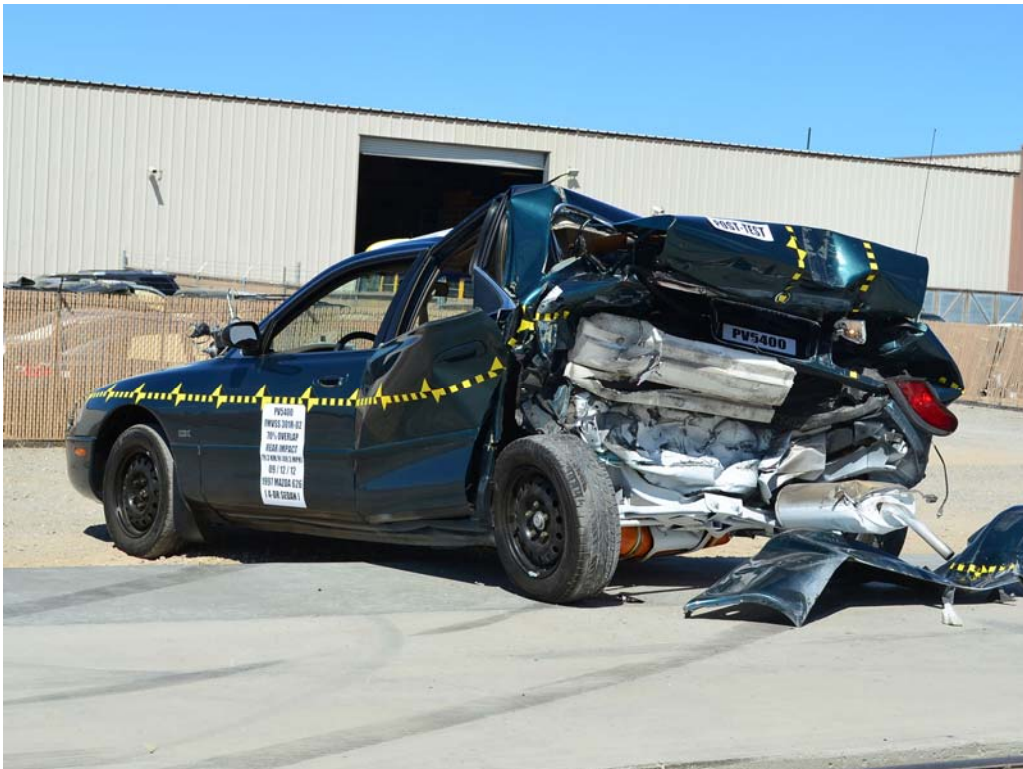
FIGURE 10. Post-Test Left Rear $\frac{3}{4}$ View of Test Vehicle

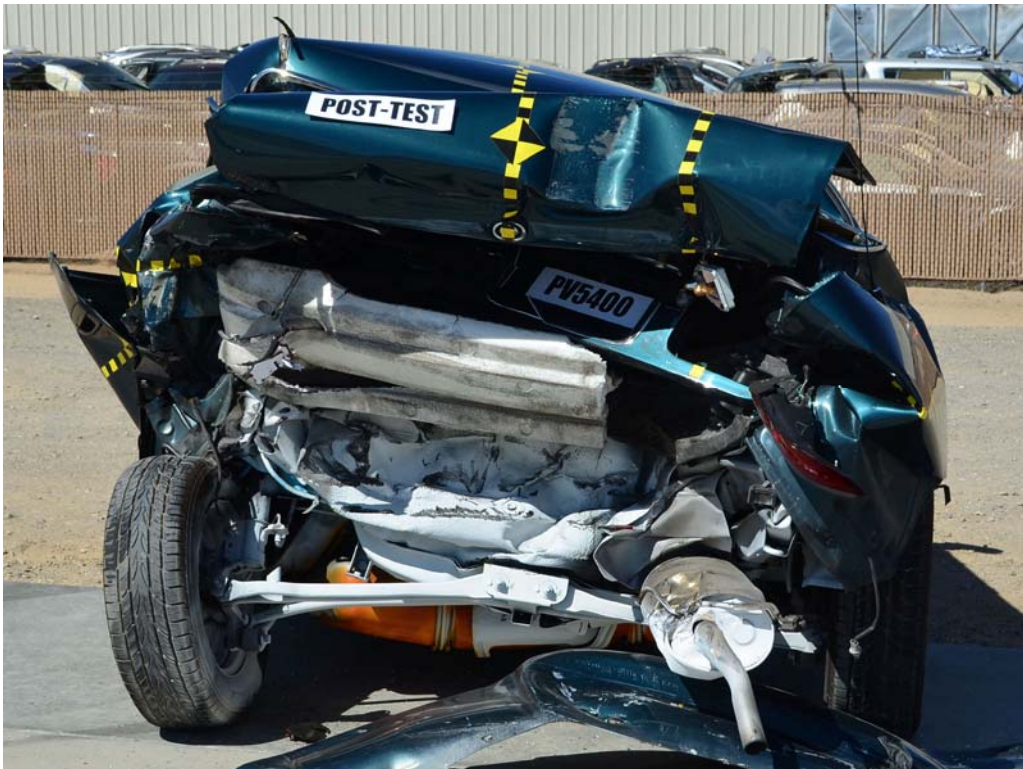
FIGURE 12. Post-Test Rear View of Test Vehicle

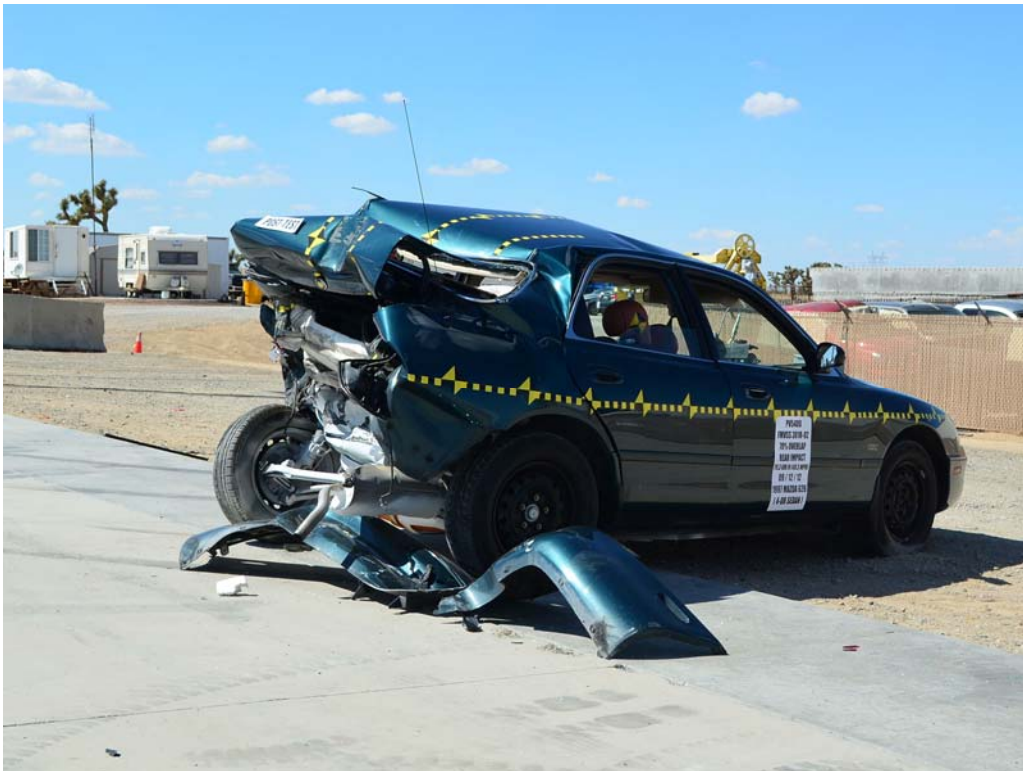
FIGURE 14. Post-Test Right Rear $\frac{3}{4}$ View of Test Vehicle

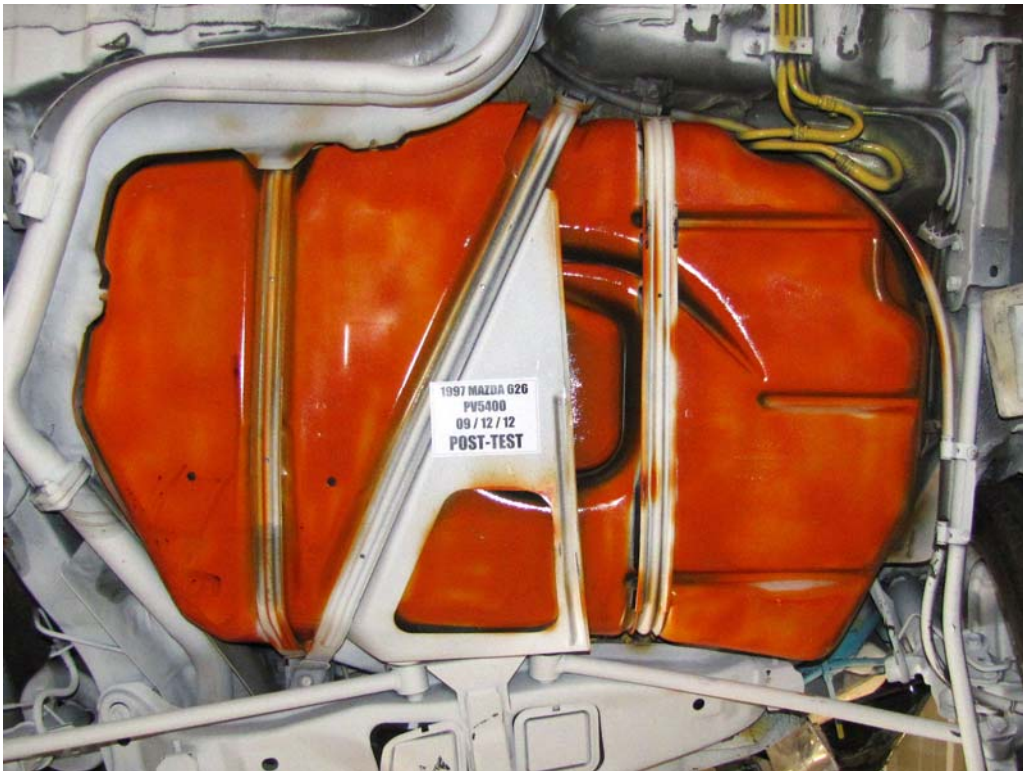
FIGURE 20. Post-Test Underbody, Fuel Tank Location

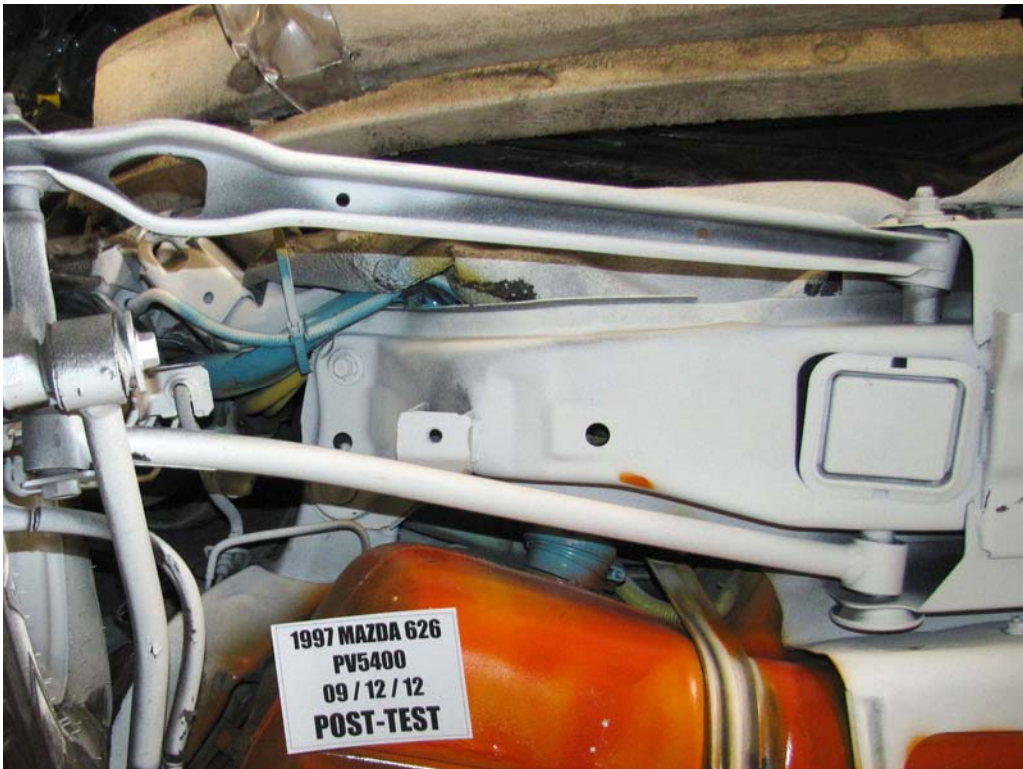
FIGURE 22. Post-Test Underbody, Fuel Filler Neck Location

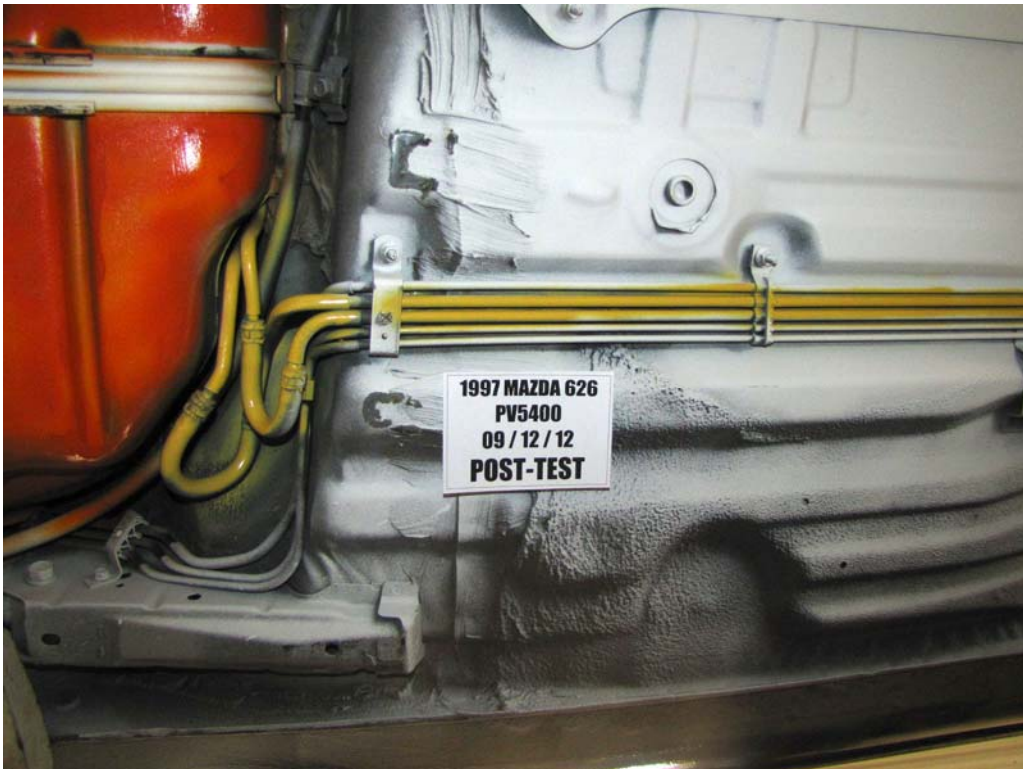
FIGURE 24. Post-Test Underbody, Fuel Line Location
