REPORT NUMBER: TR-P32096-14-NC

**RESEARCH AND DEVELOPMENT
80 KM/H 70% OVERLAP REAR IMPACT**

**MITSUBISHI MOTOR MFG. OF AMERICA, INC.
1998 DODGE AVENGER 2-DOOR COUPE**

**REPORT DATE:
OCTOBER 2, 2012
FINAL REPORT**

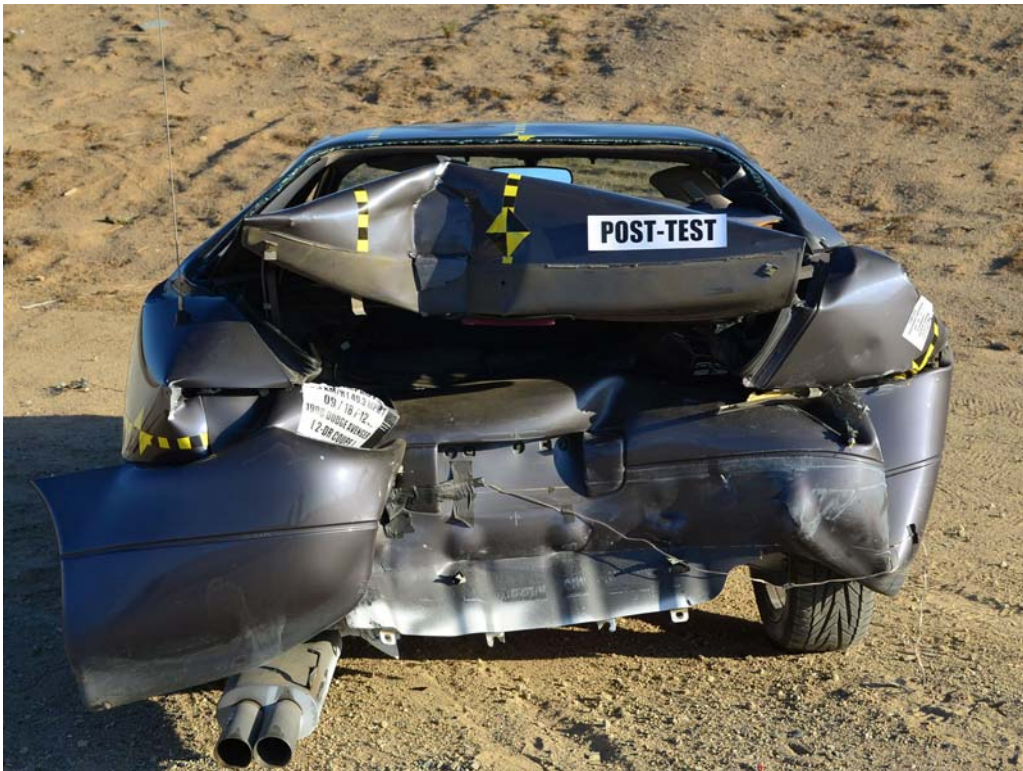
FIGURE 12. Post-Test Rear View of Test Vehicle

No.	Description	Pre-Test	Post-Test	Difference
1	Total Length at Centerline	4835	4209	-626
2	Total Length	4835	4359	-476
3	Total Width	1735	1925	190
4	Left Side Wheelbase	2635	2605	-30
5	Right Side Wheelbase	2635	2307	-328

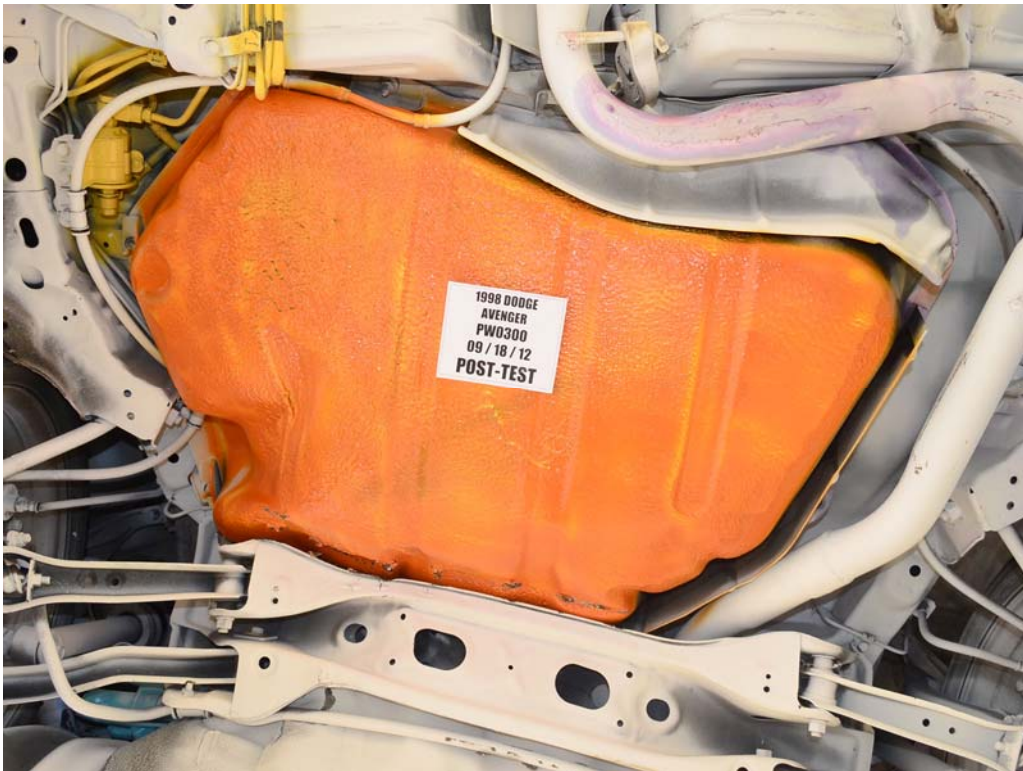
FIGURE 20. Post-Test Underbody, Fuel Tank Location

- A. From impact until vehicle motion ceases: 0 g
(Maximum allowable = 28 g)
- B. For the 5 minute period after motion ceases: 86 g
(Maximum allowable = 142 g)
- C. For the following 25 minutes: 10.3 g/min
(Maximum allowable = 28 g/minute)
- D. Spillage: Stoddard Solvent leaked from the left front area of the gas tank

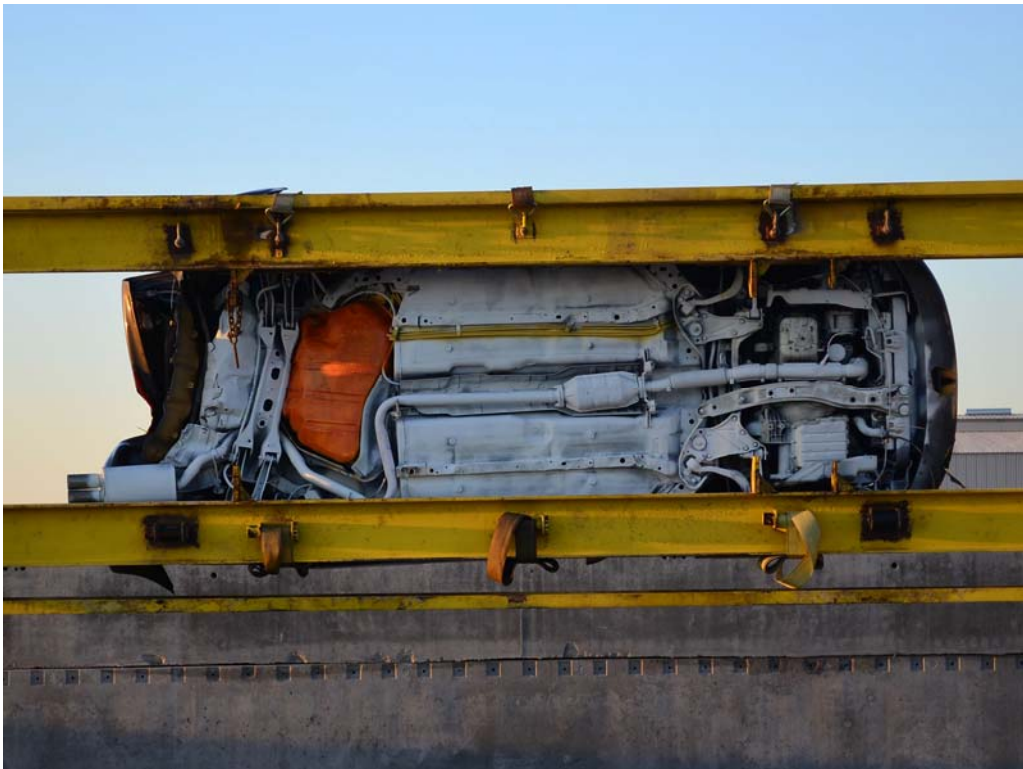
FIGURE 28. Vehicle at 270° on Static Rollover Device

Test Phase	Spillage Location
0° To 90°	Top Front Area of Fuel Tank
90° To 180°	No Spillage
180° To 270°	Top Front Area of Fuel Tank
270° To 360°	Top Front Area of Fuel Tank

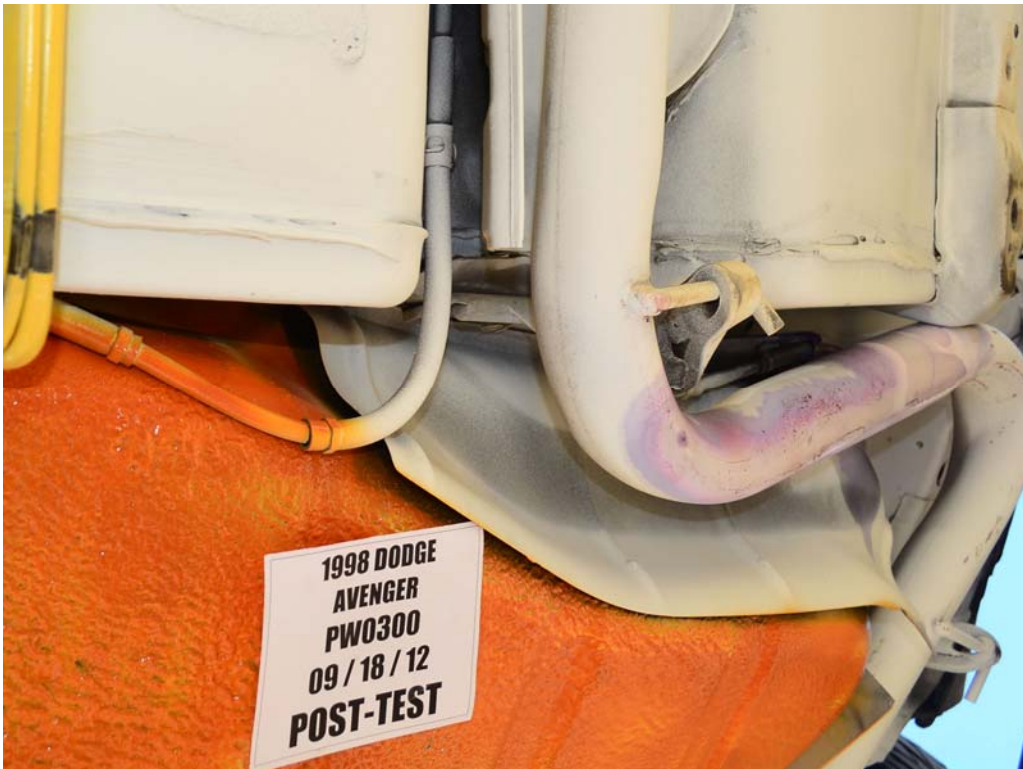
FIGURE 30. Post-Test Stoddard Solvent Spillage Location View

Details of Stoddard solvent spillage: Stoddard solvent leaked from the left front area of the fuel tank of the vehicle during portions of the static rollover

Stoddard solvent leaked from the top front area of the fuel tank of the vehicle during portions of the static rollover. Leaks were visible while moving from 0° to 90°, while moving from 180° to 270°, while holding at the 270° position and while moving from 270° to 360°.
