**REPORT NUMBER: TR-P32096-05-NC**

**RESEARCH AND DEVELOPMENT  
80 KM/H 70% OVERLAP REAR IMPACT**

**GENERAL MOTORS CORPORATION  
1999 BUICK LESABRE 4-DOOR SEDAN**

**NHTSA NUMBER: PX0100**

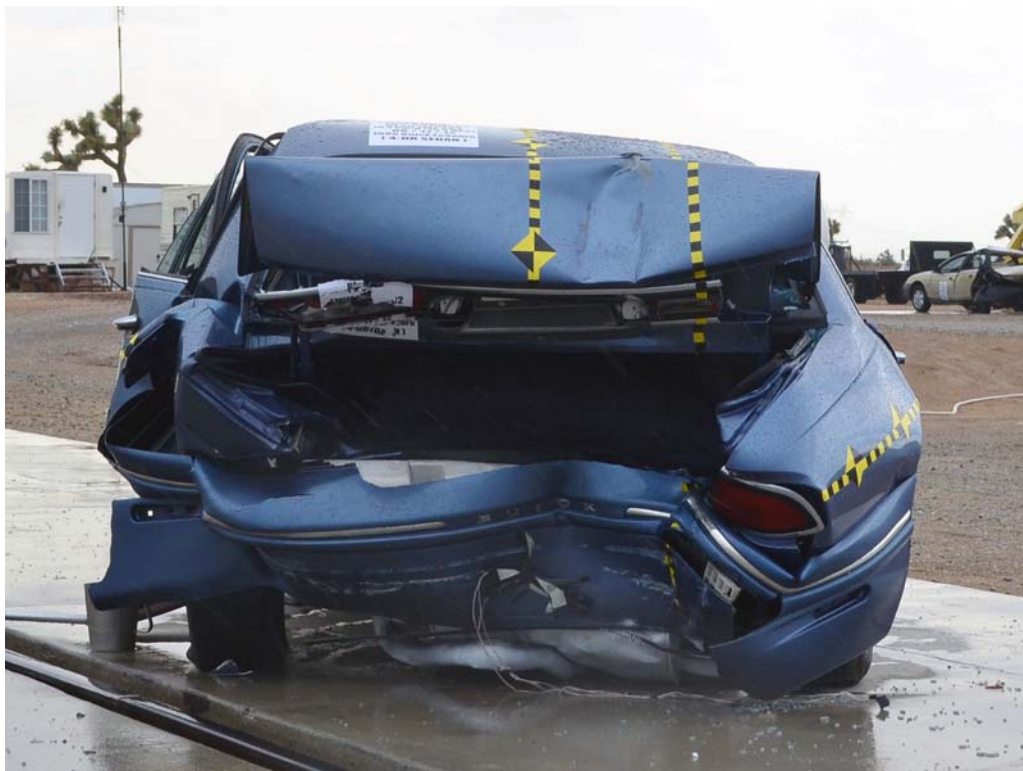
FIGURE 12. Post-Test Rear View of Test Vehicle

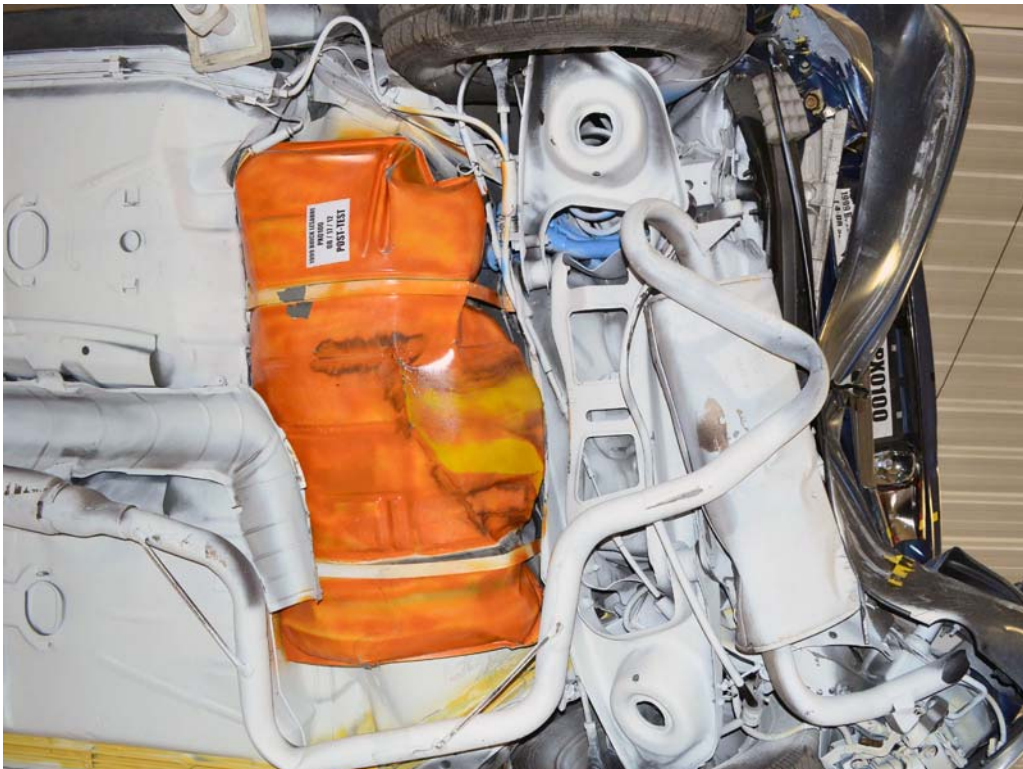
FIGURE 20. Post-Test Underbody, Fuel Tank Location

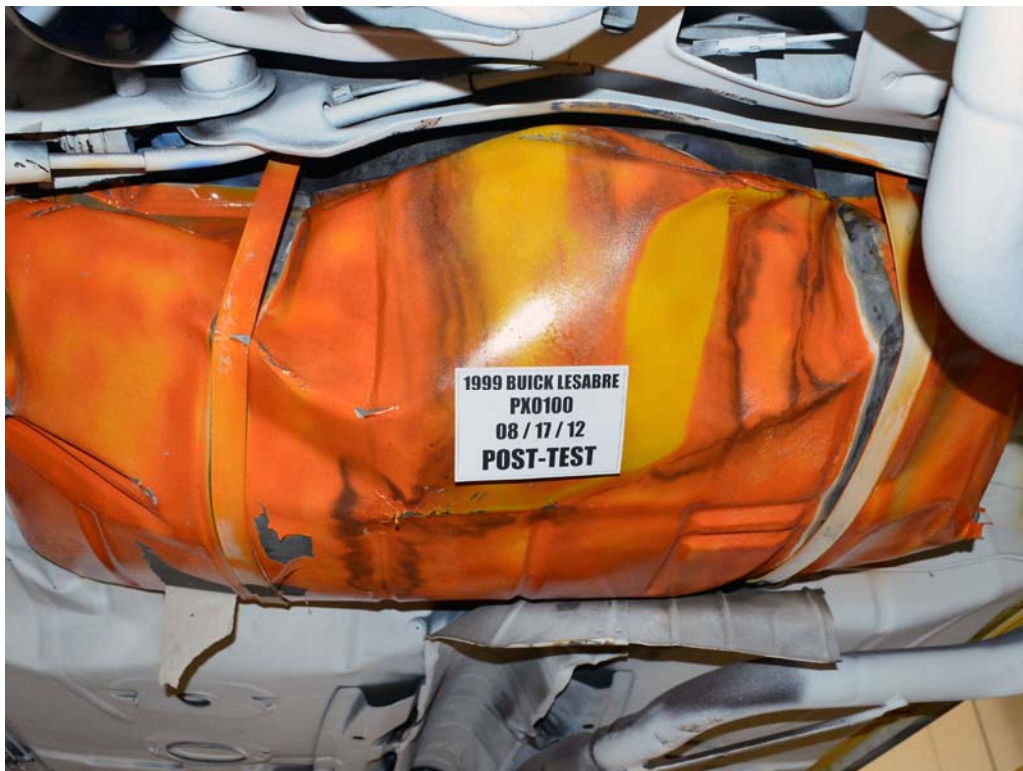
Stoddard solvent leaked from the fuel tank of the vehicle immediately after the test. Solvent was observed leaking from the bottom of the fuel tank. Due to the test failure after the impact, the static rollover test was not conducted.

FIGURE 30. Post-Test Stoddard Solvent Spillage Location View

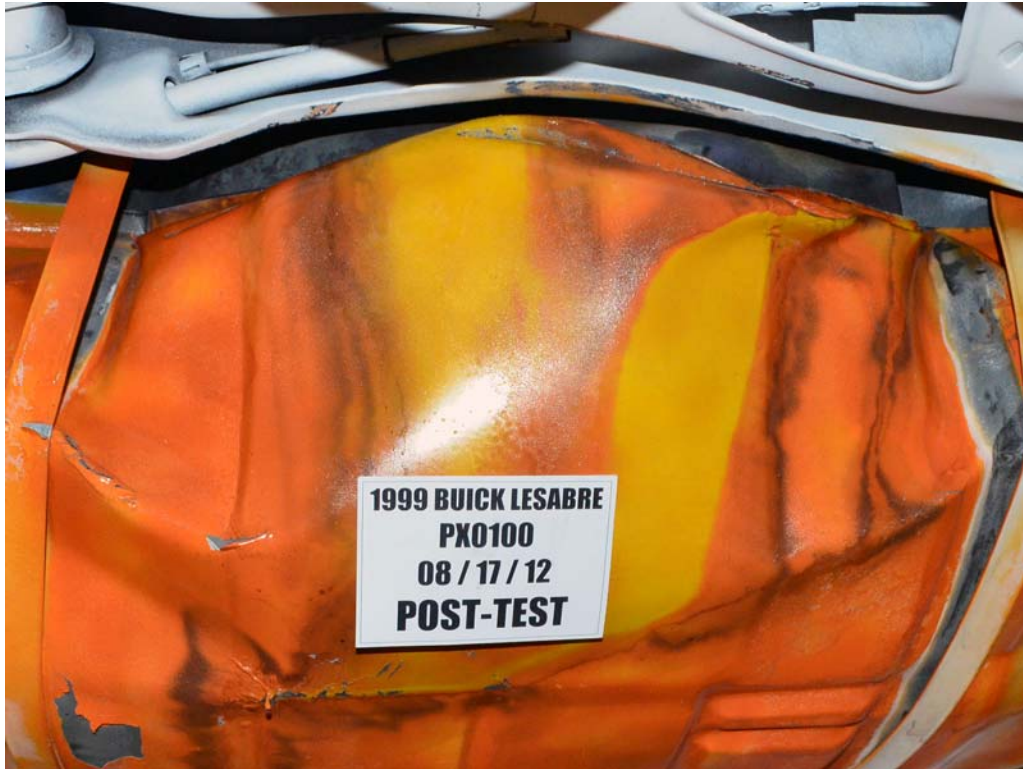
FIGURE 31. Post-Test Stoddard Solvent Spillage Location View
