**REPORT NUMBER: TR-P32096-03-NC**

**RESEARCH AND DEVELOPMENT  
80 KM/H 70% OVERLAP REAR IMPACT**

**GENERAL MOTORS OF CANADA LTD.  
2000 BUICK CENTURY 4-DOOR SEDAN**

**NHTSA NUMBER: PY0100**

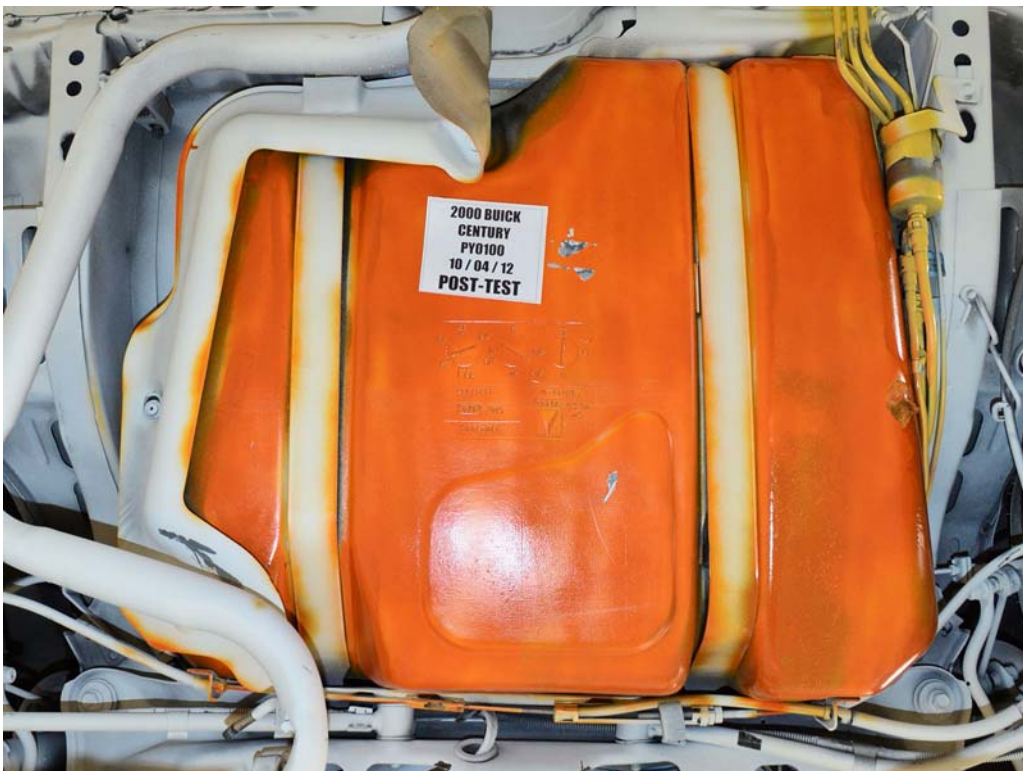
FIGURE 20. Post-Test Underbody, Fuel Tank Location

There was no Stoddard solvent leakage after the test or during any portion of the static rollover. FMVSS 301 data is summarized in Data Sheets 6 and 7. Photographs are presented in Appendix A.

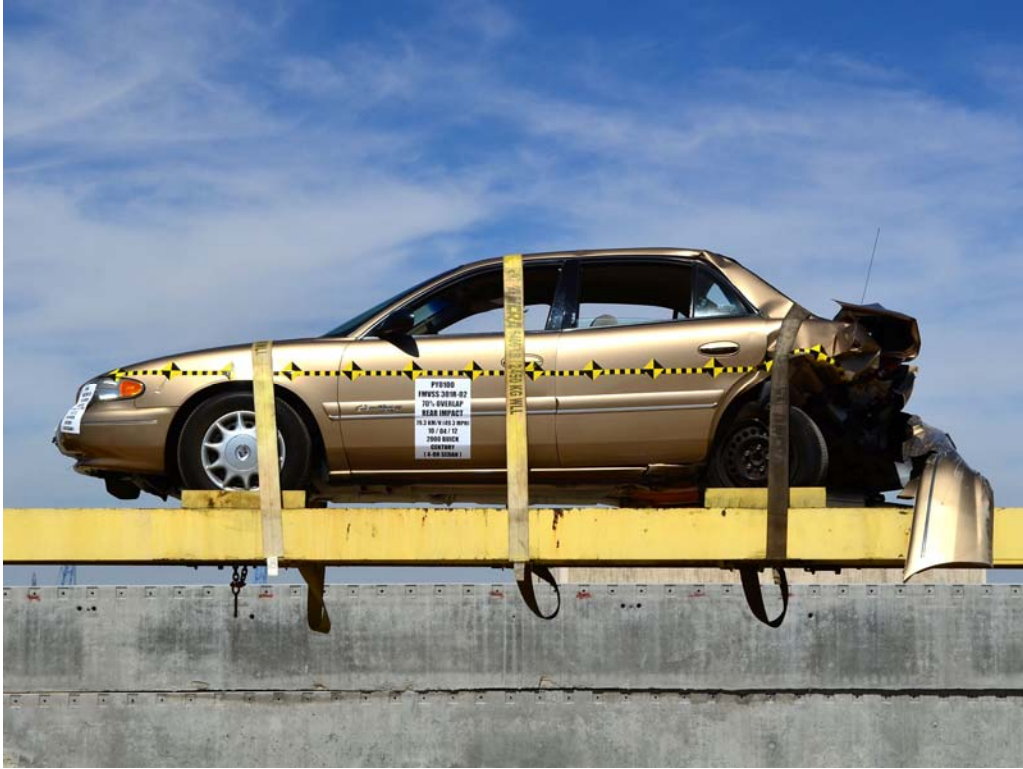
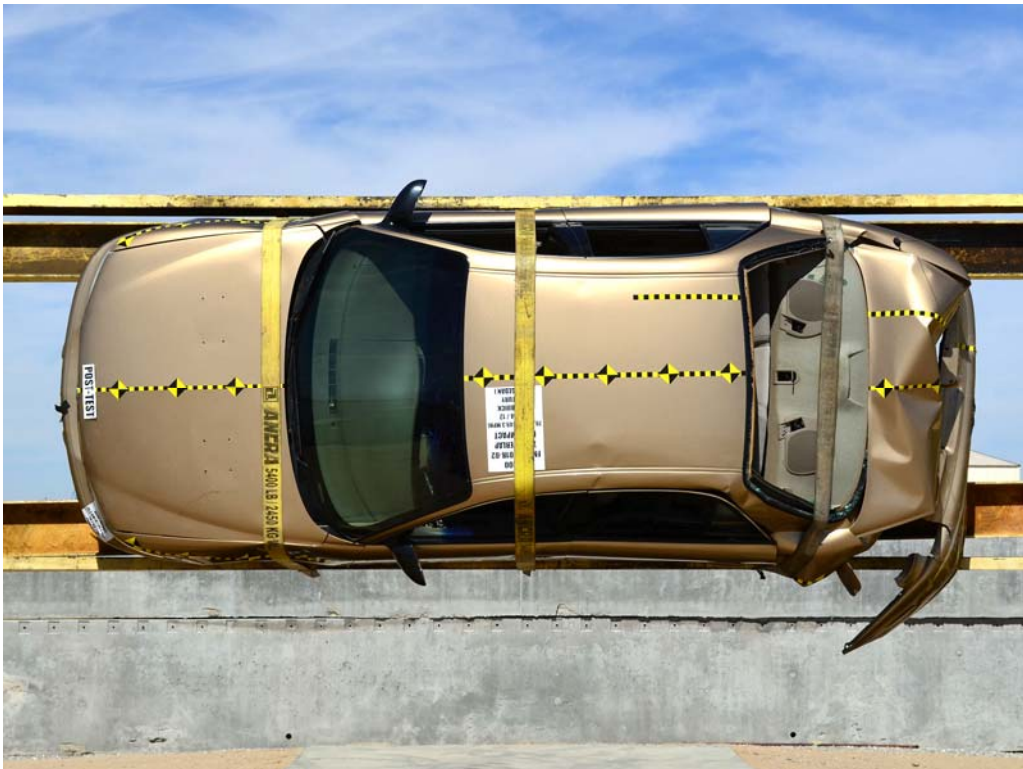
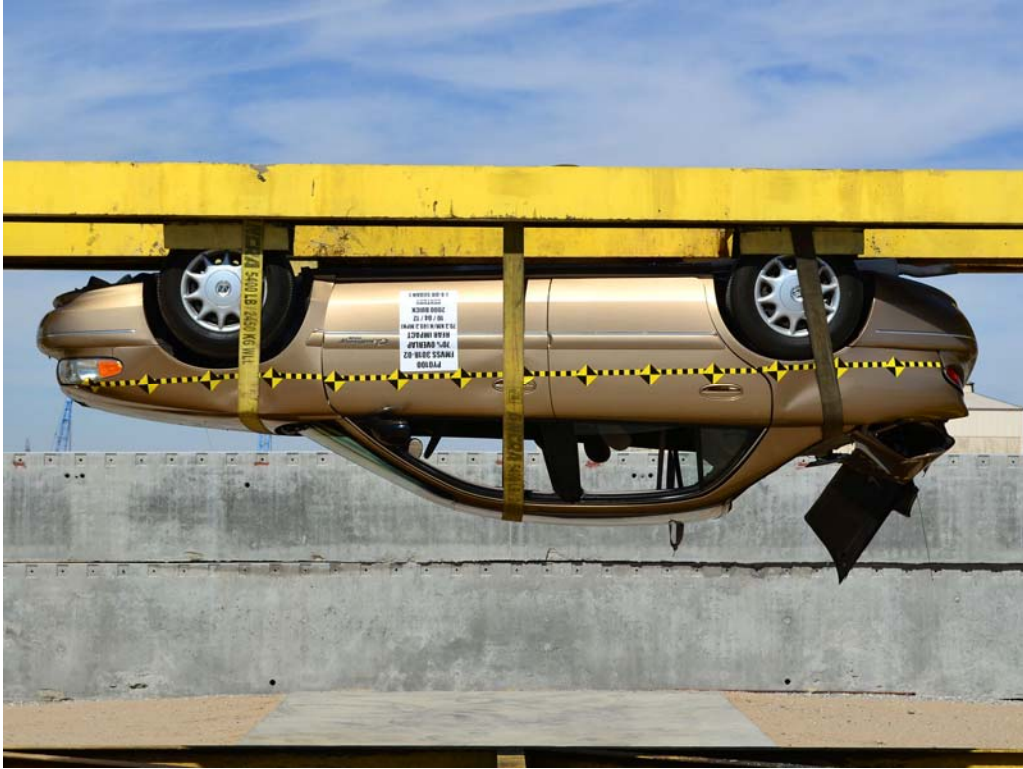
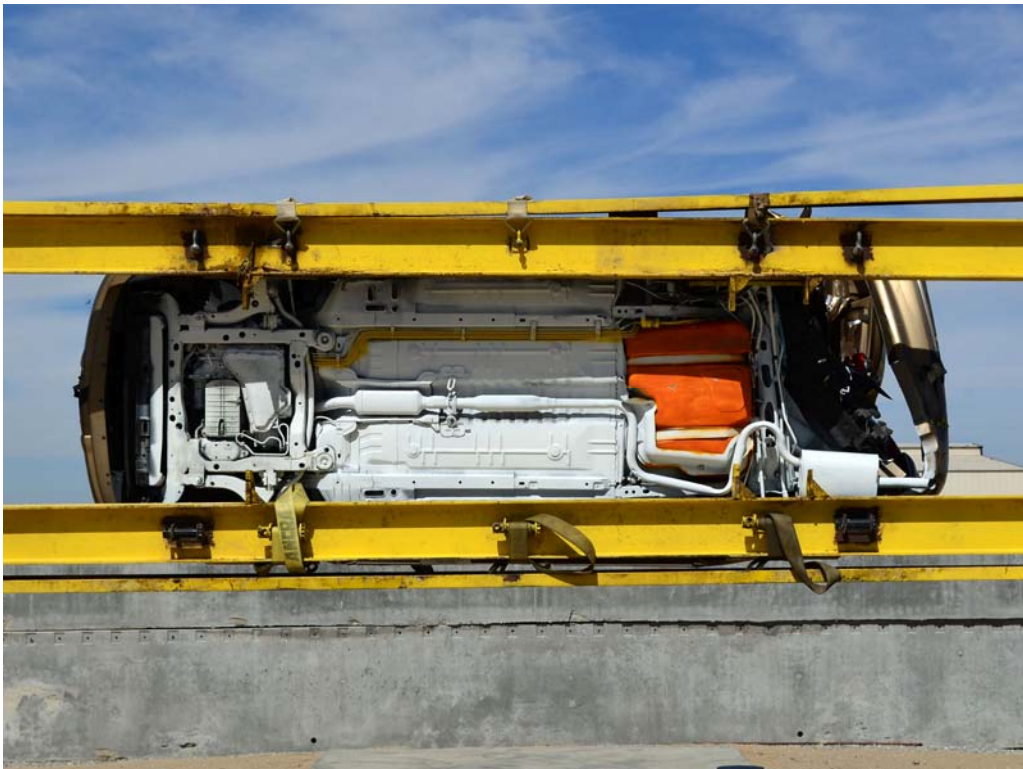
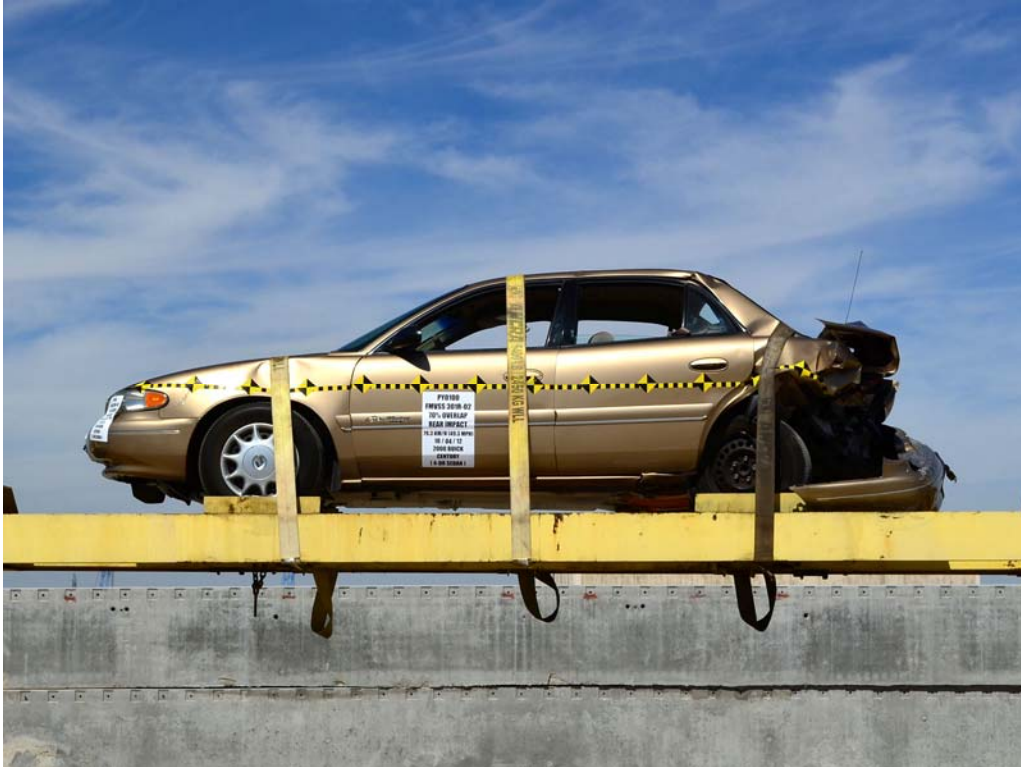
Details of Stoddard solvent spillage: No Stoddard solvent spillage
