**REPORT NUMBER: TR-P32096-02-NC**

**RESEARCH AND DEVELOPMENT  
80 KM/H 70% OVERLAP REAR IMPACT**

**HYUNDAI MOTOR COMPANY  
2000 HYUNDAI ELANTRA 4-DOOR SEDAN**

**NHTSA NUMBER: PY0500**

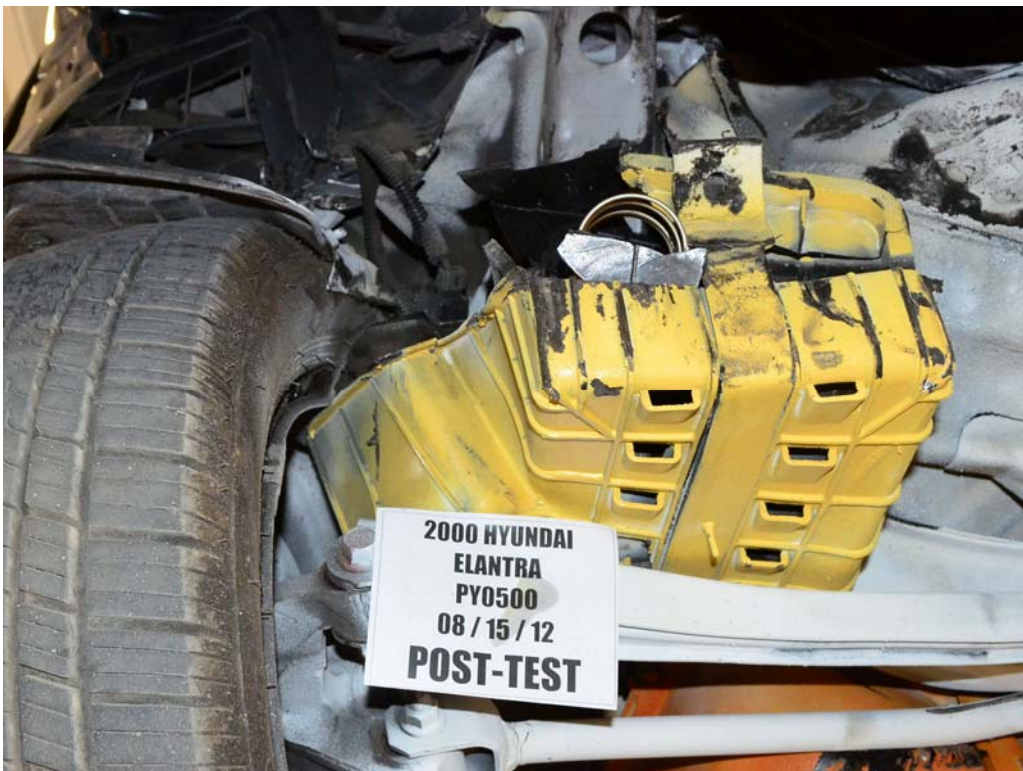
FIGURE 30. Post-Test Stoddard Solvent Spillage Location View

Stoddard solvent leaked from the fuel filler neck area on the left rear fender of the vehicle during portions of the static rollover. Leaks were visible while moving from 0° to 90°, while holding at the 90° position, while moving from 90° to 180°, and while holding at 180°.
